Final Report for EPA Work Assignment RO2013

Corrective Action Prior to Loss of Interim Status

Corning Glasworsk - Steuben Plant

FINAL REPORT CORRECTIVE ACTION PRIOR TO LOSS OF INTERIM STATUS CORNING GLASSWORKS - STEUBEN PLANT CORNING, NEW YORK

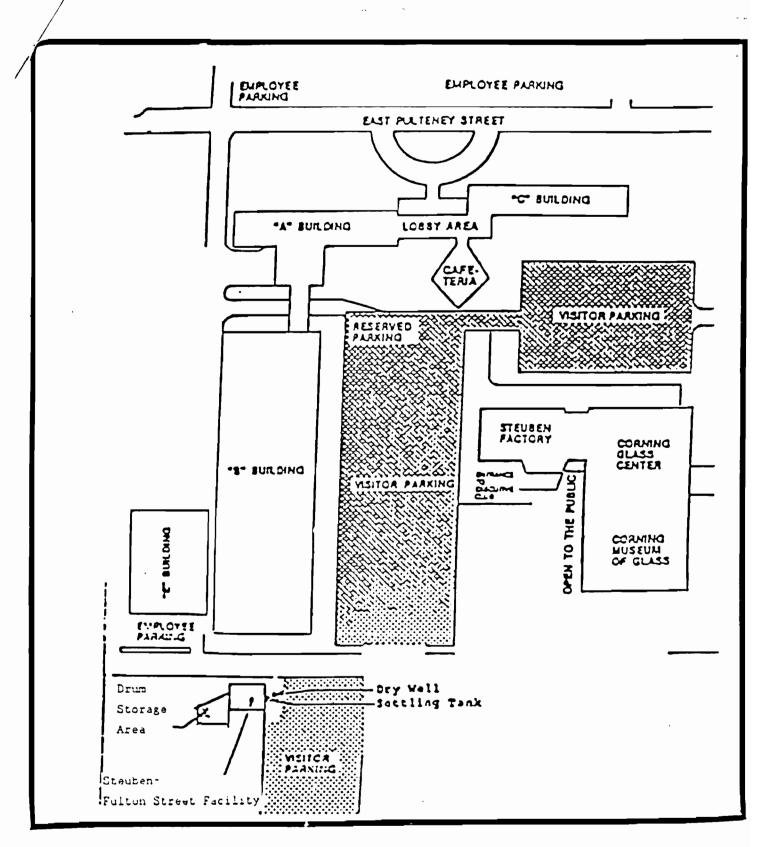
FIGURE 1
FACILITY LAYOUT

The solid waste management unit (SWMU) identified during the pre-site visit research and during the site visit are illustrated on Figure 1. The SWMU and other areas of interest are discussed in Sections 3.0 and 4.0, respectively, of this report.

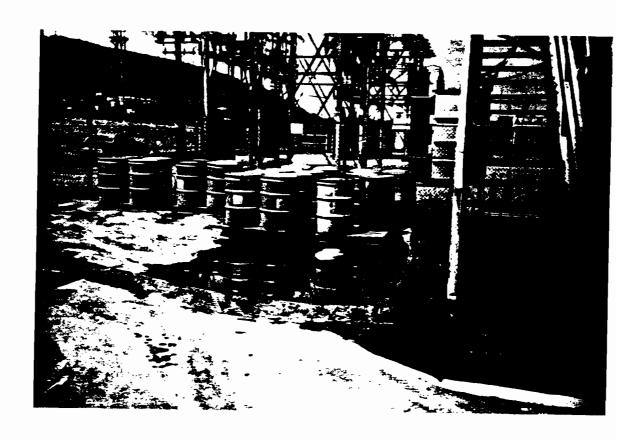
Photograph 3 - Drum Storage Area for Steuben, across street at Fulton Street Building (21 drums glass dust sludge, 7 drums lube oil (1 TCE))

The drum storage area is situated outside the Steuben Plant adjacent to the Fulton Street facility. Grinding sludge is stored in 55-gallon drums. The storage area is paved and diked. At the time of the site visit, 21 drums of waste sludge were stored onsite. The drums are placed on wooden pallets (see Attachment, Photograph 3). Seven drums of lube oil (new product) were also stored in this area, but segregated from the drums of hazardous waste. Standing water from recent rainfall was observed on part of the waste storage pad; impact to the drums is not anticipated since the drums are stored on pallets.

Waste is collected from machines and sumps (see Attachment, Photograph 2), placed in 55-gallon drums (see Attachment, Photograph 1), and stored in the secured storage area (see Attachment, Photograph 3).

No releases were reported to have occurred in the drum storage area, nor is there evidence that a release has occurred. The drum storage pad is in good condition.
