# **2007 ANNUAL REPORT OF OPERATIONS AND MAINTENANCE ACTIVITIES**

## **PARTIAL RIVER CHANNELIZATION PROJECT FORMER SINCLAIR REFINERY SITE WELLSVILLE, NEW YORK**

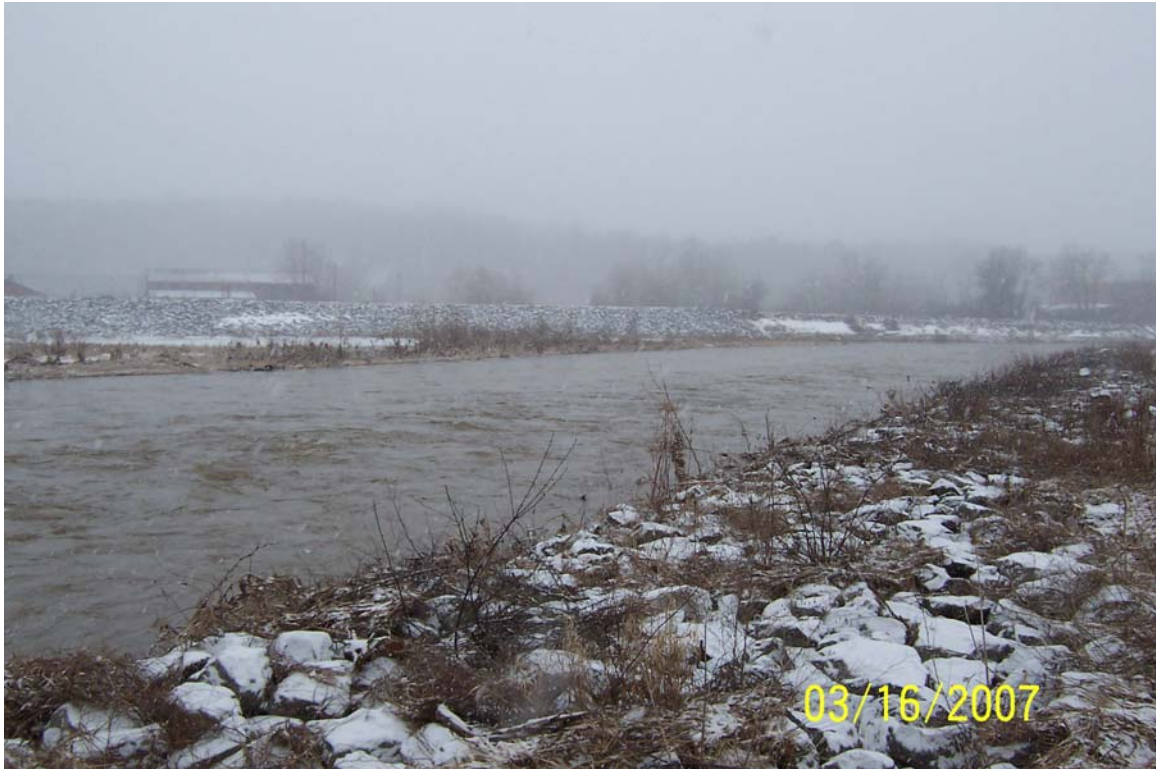
3/16/2007 East Dike Station 4+00 view to the North

- No settlement, sloughing or loss of grade with the exception of minor riprap displacement/scouring at the toe of West Dike Station 12+00.
- No caving on either side of the dike.
- No seepage, saturated areas, or sand boils.
- No evidence of riprap displacement or unusual settlement (except as noted above).
- Access roads are in good condition.
- No evidence of unauthorized traffic.
- Minimal accumulation of drift, trash or debris.
- Vegetative cover in good condition.
- Woody growth present.
- No unauthorized excavation, loose sod, or sod removal.
- No evidence of burrowing animals.
- No evidence of fires or vandalism.
- No shoaling in the channel.

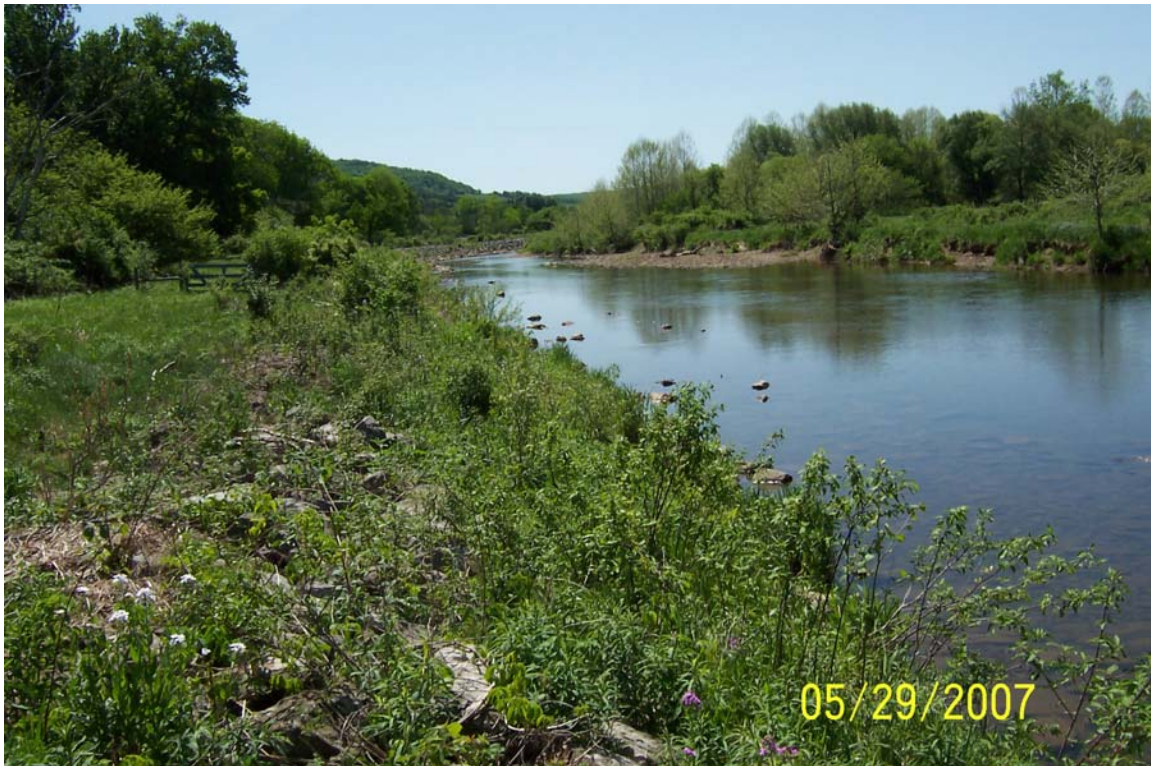
5/29/2007 East Dike Station 8+00 view to the South

- No observed settlement, sloughing or loss of grade, with the exception of minor riprap displacement/scouring out the toe of West Dike Station 12+00.
- No observed caving on either side of dike.
- No evidence of seepage, saturated areas, or sand boils.
- No evidence of riprap displacement or unusual settlement was observed at the toe of the riprap slope protection (except as noted above).
- Access roads were in good condition.
- No evidence of unauthorized traffic.
- Minimal accumulation of drift, trash or debris.
- Vegetative cover in good condition.
- Woody growth present during inspection.
- No evidence of unauthorized excavation, loose sod, or sod removal.
- No evidence of fires or vandalism.
- Routine mowing completed to date.
- No shoaling observed in the channel opposite west dike station 20+00.
