# **2010 ANNUAL REPORT OF OPERATIONS AND MAINTENANCE ACTIVITIES**

## **PARTIAL RIVER CHANNELIZATION PROJECT FORMER SINCLAIR REFINERY SITE WELLSVILLE, NEW YORK**

**On-Site Technical Services, Inc.**  
72 Railroad Avenue  
Wellsville, New York 14895

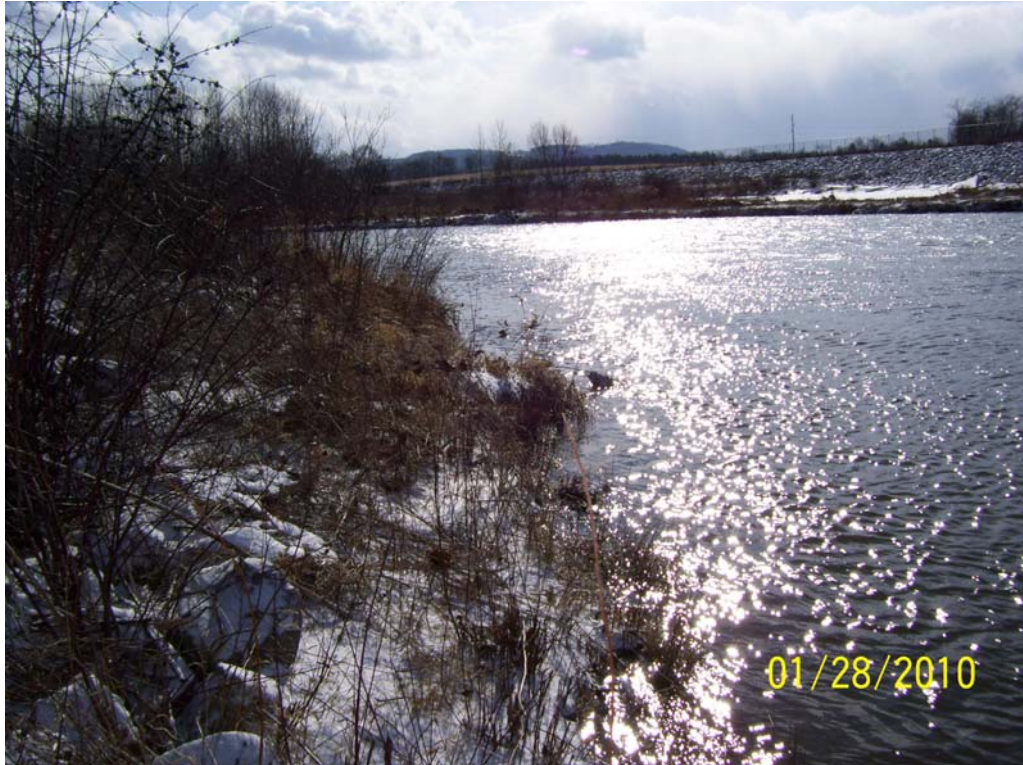
4+00 facing north

A general summary of the post high water dike inspection findings completed on January 28, 2010, April 1, 2010, November 4, 2010 and December 10, 2010 is provided below. The April and November post high water event inspections were conducted following events where instantaneous flows exceeded 4500 cfs, but not the daily average. Instantaneous flows exceeded 4500 cfs on March 13 and 14, 2010 and September 30, 2010. Completed inspection checklists and inspection photographs are presented in Appendix D of this report.

- No settlement, sloughing or loss of grade.
- No caving on either side of the dike.
- No seepage, saturated areas, or sand boils.
- No evidence of riprap displacement or unusual settlement.
- Access roads are in good condition.
- No evidence of unauthorized traffic.

- Minimal accumulation of drift, trash or debris.
- Vegetative cover in good condition.
- Woody growth present.
- No unauthorized excavation, loose sod, or sod removal.
- No evidence of burrowing animals.
- No evidence of fires or vandalism.
- No shoaling in the channel.

HIGH WATER INSPECTION - JANUARY 28, 2010

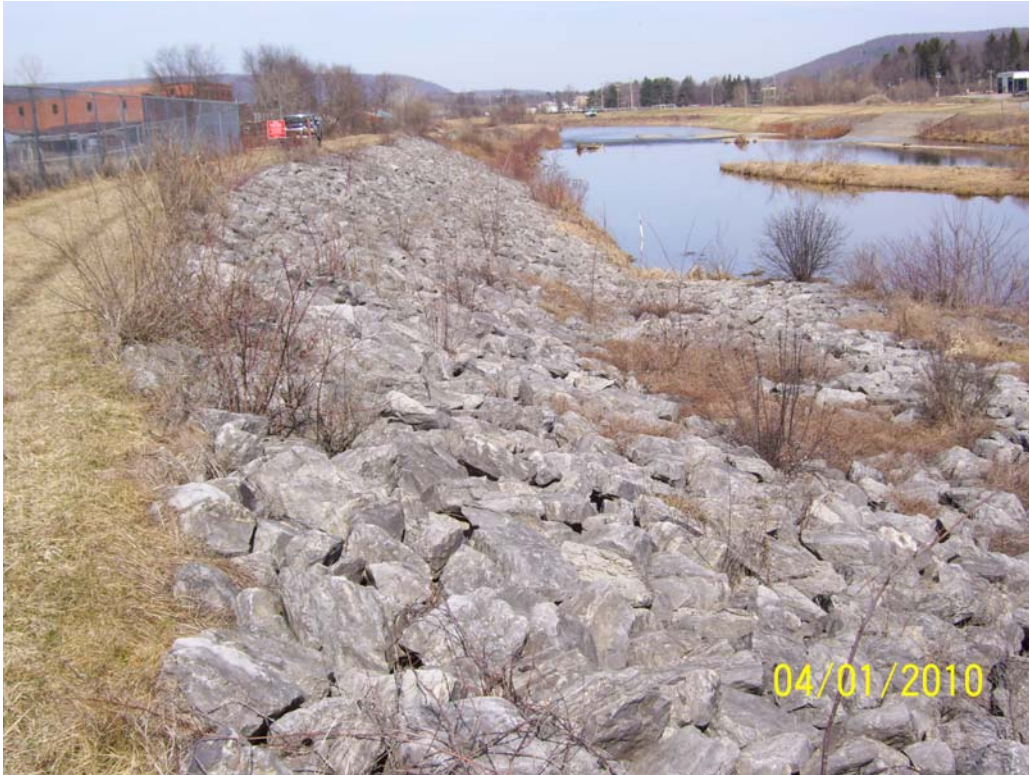
8+00 facing north

HIGH WATER INSPECTION - APRIL 1, 2010

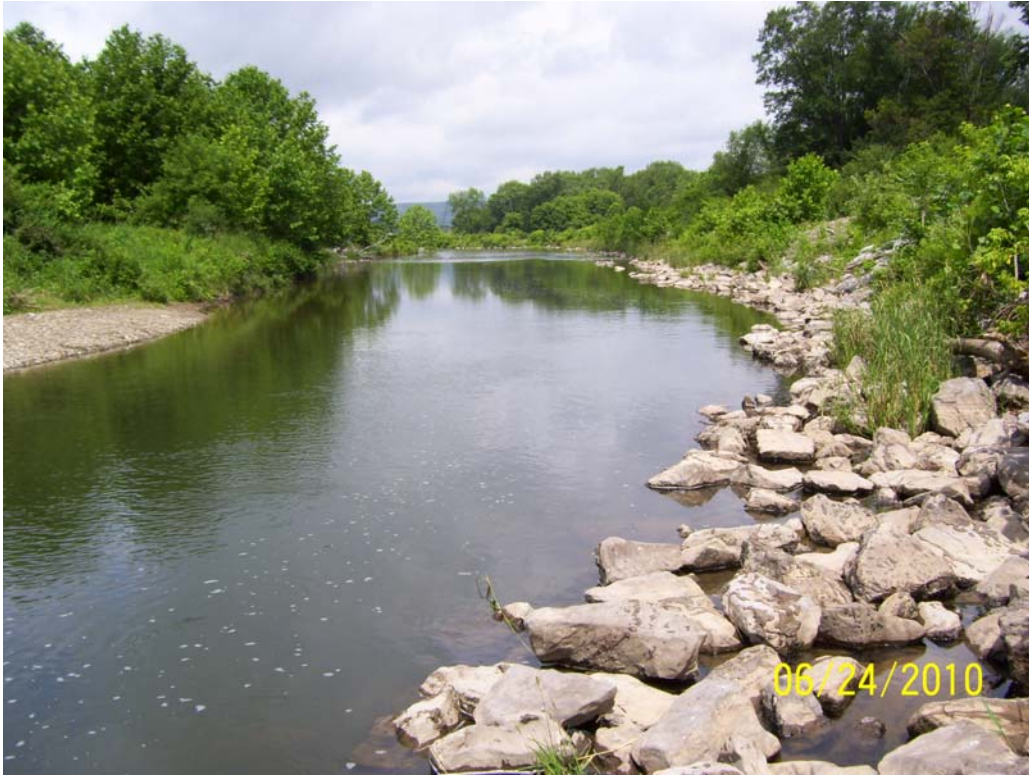
16+00 facing north

East bank, west dike and river bed low flow inspections were conducted on June 24, 2010. No significant issues were noted during the inspection. No corrective action requiring greater than 30 days to complete occurred in 2010.

- No observed settlement, sloughing or loss of grade.
- No observed caving on either side of dike.
- No evidence of seepage, saturated areas, or sand boils.
- No evidence of riprap displacement or unusual settlement was observed at the toe of the riprap slope protection.
- Access roads were in good condition.
- No evidence of unauthorized traffic.
- Minimal accumulation of drift, trash or debris.
- Vegetative cover in good condition.
- Woody growth present during inspection.
- No evidence of unauthorized excavation, loose sod, or sod removal.
- No evidence of fires or vandalism.
- Routine mowing completed to date.
- No shoaling observed in the channel opposite west dike station 20+00.

LOW WATER INSPECTION – JUNE 24, 2010

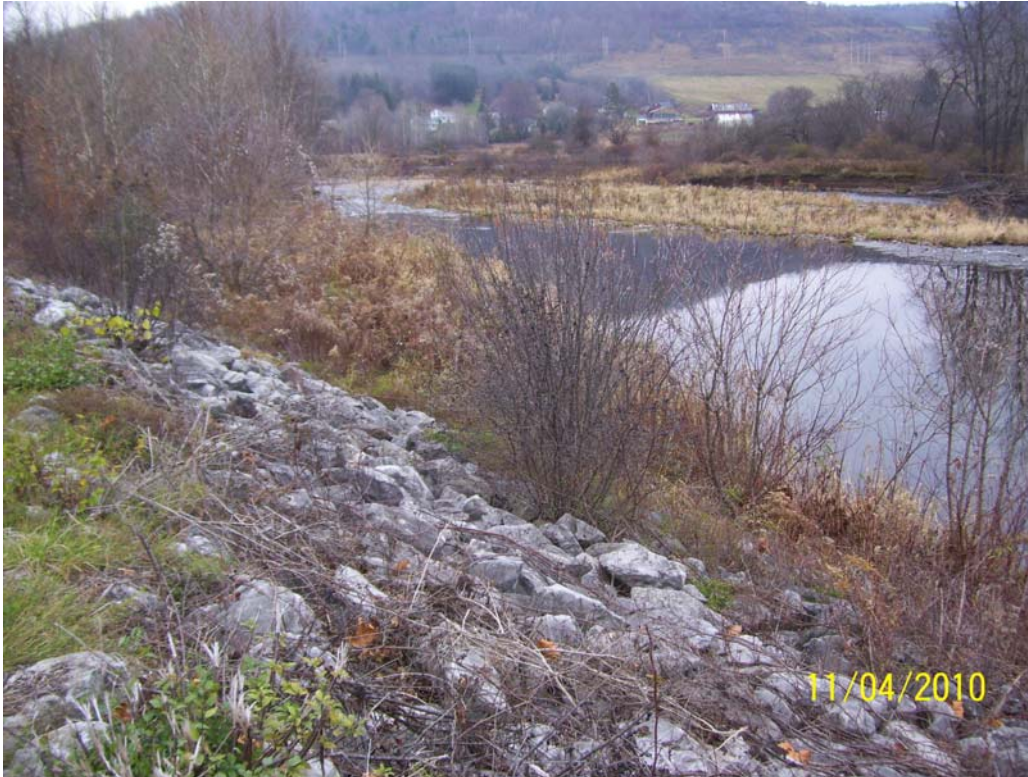
16+00 facing north

HIGH WATER INSPECTION – NOVEMBER 4, 2010

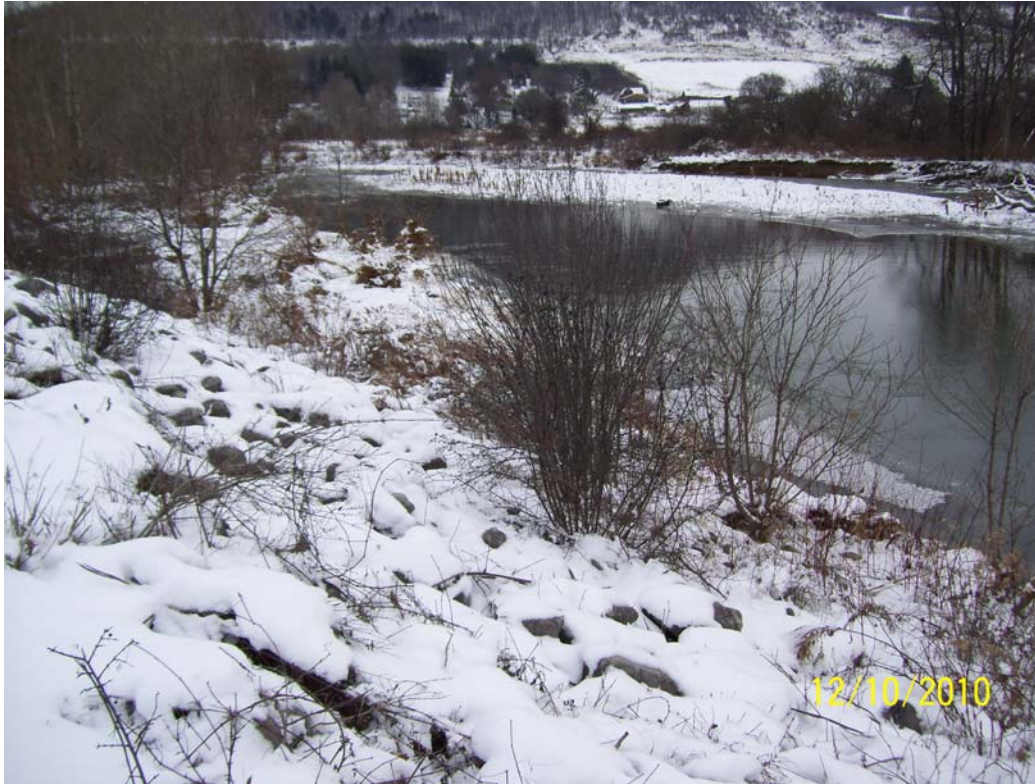
14+00 facing north

HIGH WATER INSPECTION – DECEMBER 10, 2010
