2011 Annual Report of Operations and Maintenance Activities
Partial River Channelization Project
Former Sinclair Refinery Site, Operable Unit 1
Wellsville, New York

2011 ANNUAL REPORT OF OPERATIONS AND MAINTENANCE ACTIVITIES

PARTIAL RIVER CHANNELIZATION PROJECT FORMER SINCLAIR REFINERY SITE WELLSVILLE, NEW YORK

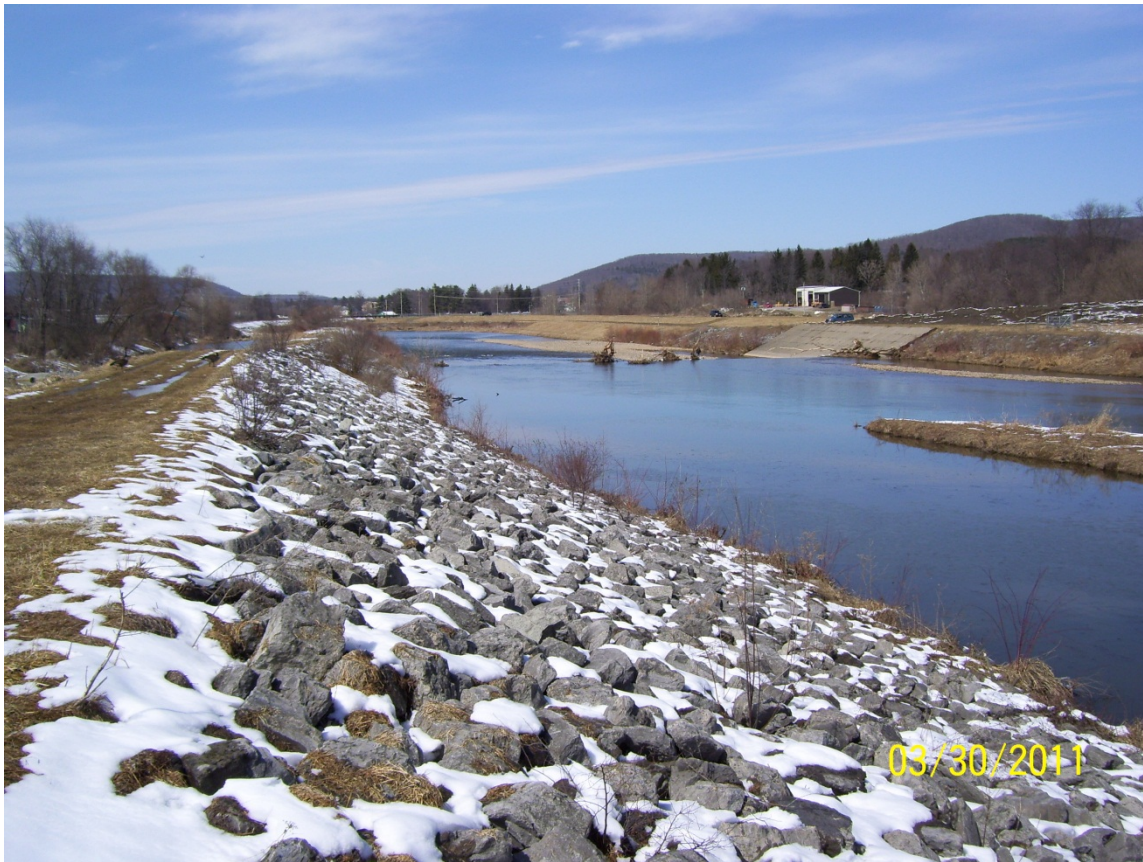
West Dike, 0+00 facing north

- No settlement, sloughing or loss of grade.
- No caving on either side of the dike.
- No seepage, saturated areas, or sand boils.
- No evidence of riprap displacement or unusual settlement.
- Access roads are in good condition.
- No evidence of unauthorized traffic.
- Minimal accumulation of drift, trash or debris.
- Vegetative cover in good condition.
- Woody growth present.
- No unauthorized excavation, loose sod, or sod removal.
- No evidence of burrowing animals.
- No evidence of fires or vandalism.
- No shoaling in the channel.

High Water Inspection: March 30, 2011

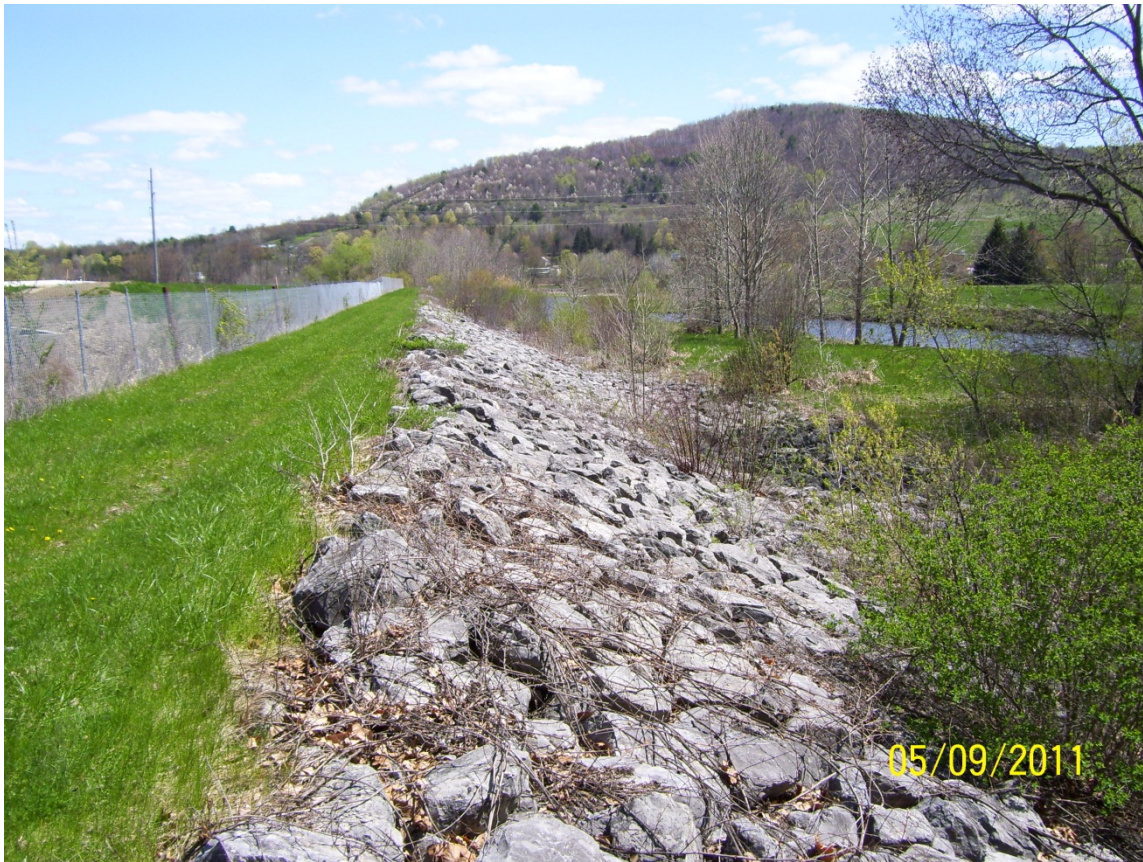
West Dike, 26+00 facing north

High Water Inspection: May 9, 2011

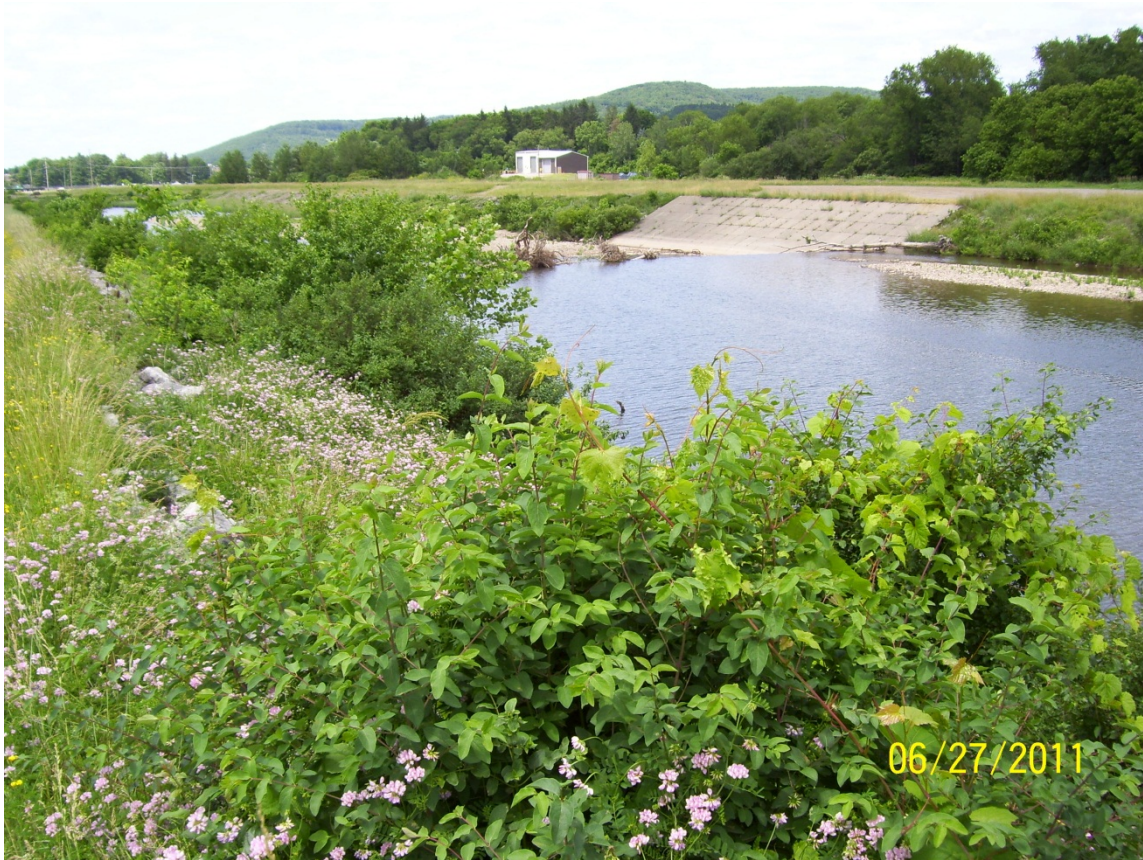
West Dike, 0+00 facing north

High Water Inspection: June 27, 2011

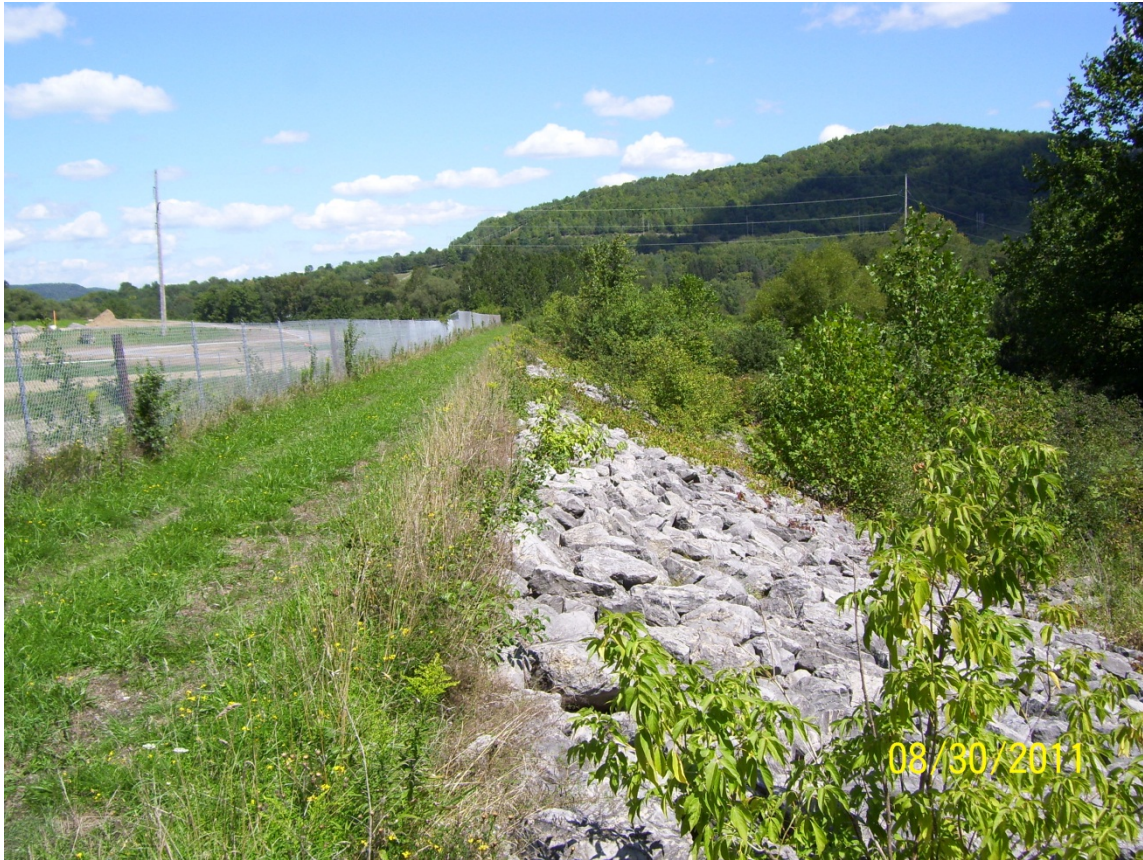
West Dike, 25+00 facing north

- No observed settlement, sloughing or loss of grade.
- No observed caving on either side of dike.
- No evidence of seepage, saturated areas, or sand boils.
- No evidence of riprap displacement or unusual settlement was observed at the toe of the riprap slope protection.
- Access roads were in good condition.
- No evidence of unauthorized traffic.
- Minimal accumulation of drift, trash or debris.
- Vegetative cover in good condition.
- Woody growth present during inspection.
- No evidence of unauthorized excavation, loose sod, or sod removal.
- No evidence of fires or vandalism.
- Routine mowing completed to date.
- No shoaling observed in the channel opposite west dike station 20+00.

Low Water Inspection: August 30, 2011
