**FORMER CHEMICAL STORAGE SHED
SURFACE AND SUBSURFACE
SOILS REMOVAL PROGRAM**

FINAL REPORT

**DOWCRAFT Corporation
Ellison Bronze Company
Falconer, New York**

APRIL 1993

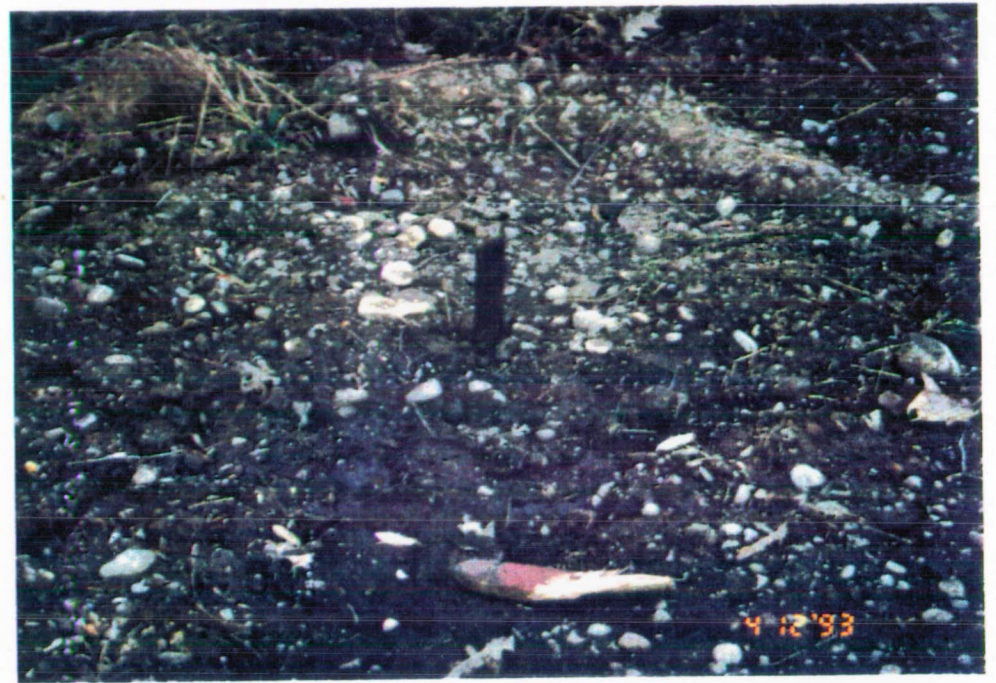
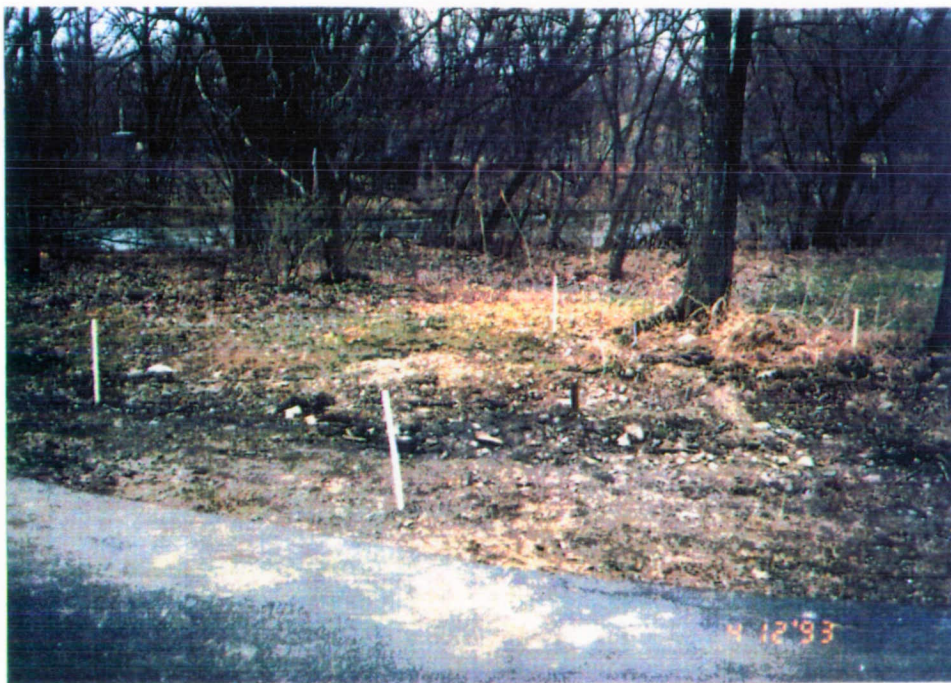
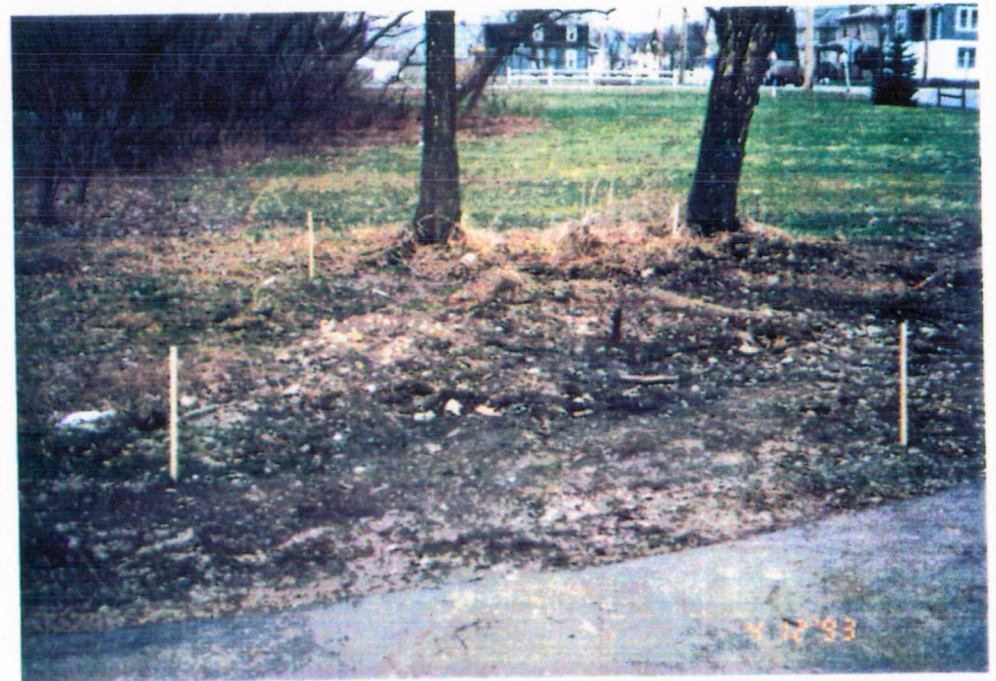
PICTURES TAKEN PRIOR TO EXCAVATION

Upon arriving at the Site, the DOWCRAFT Maintenance Manager furnished the Site plan from which we were able to measure and re-establish the exact location of the former chemical storage shed and prior sample collection points. Wooden stakes were placed at the four corners of the former location of the chemical storage shed and one stake was placed at the location of the prior sample collection point in the middle of the shed area. Appendix A provides pictures that were taken of the location prior to the commencement of the soils removal activities.

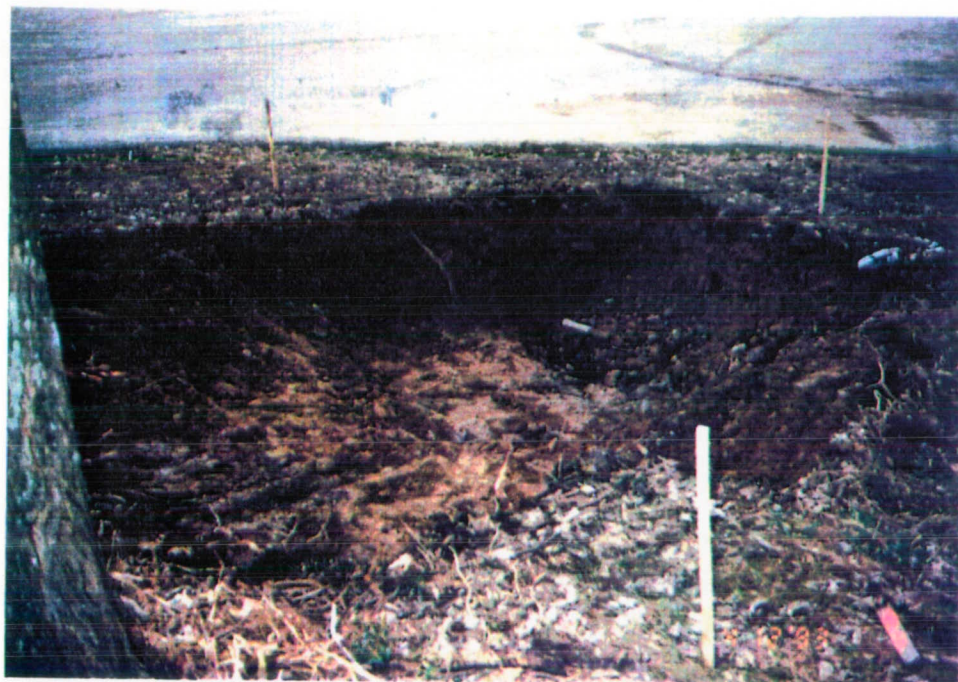
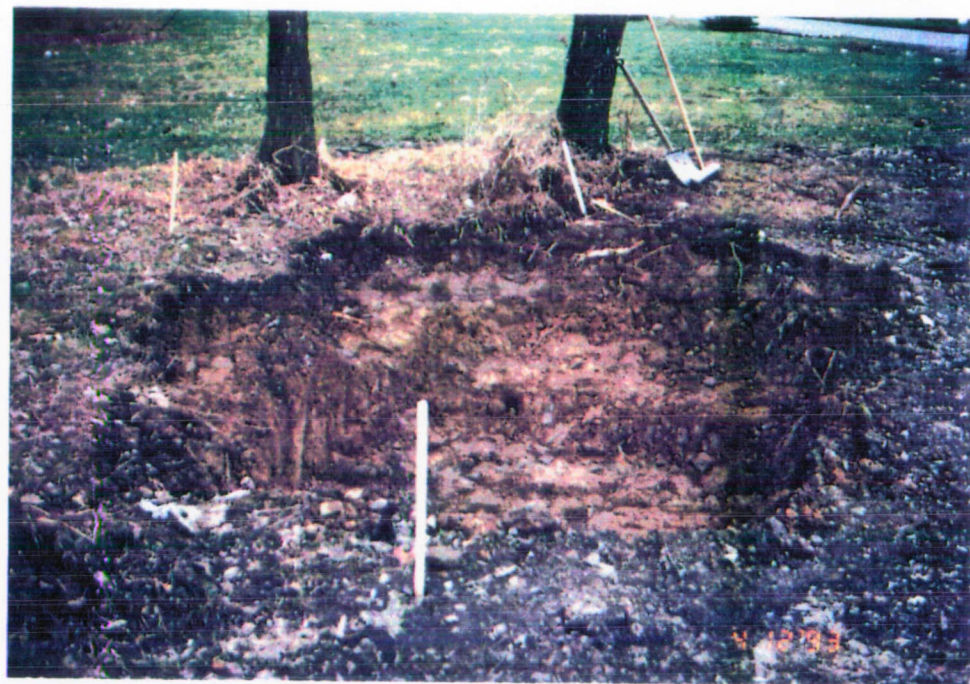
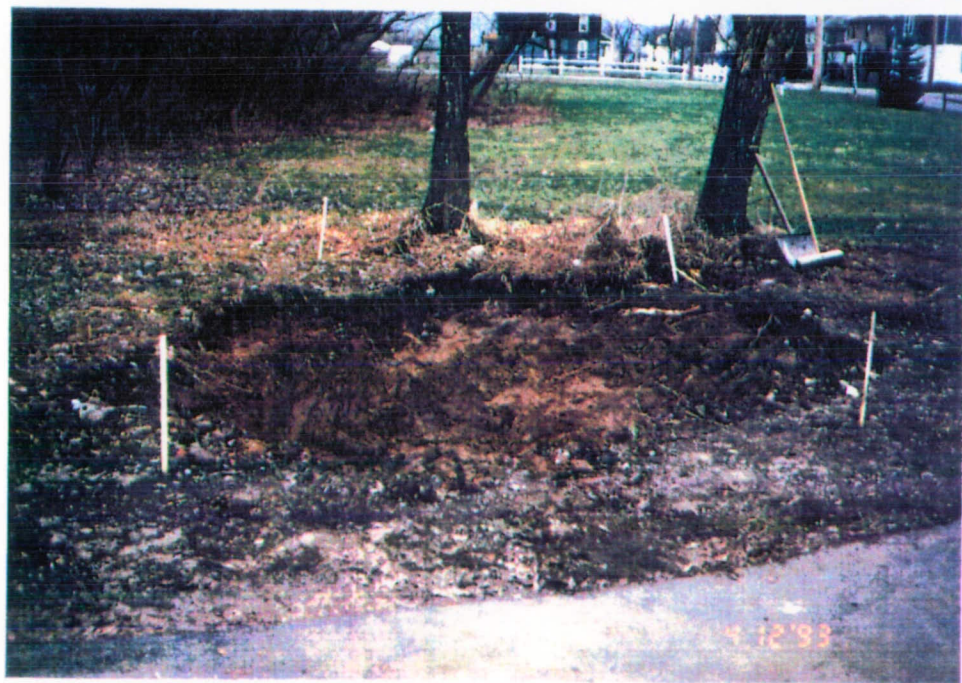
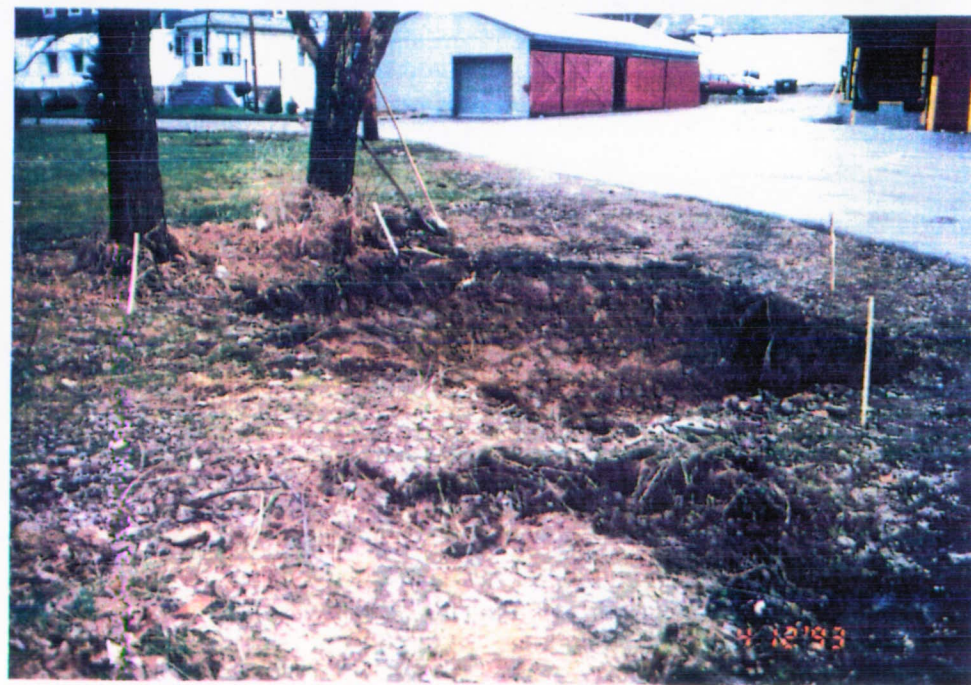
PICTURES TAKEN AFTER EXCAVATION

Approximately 8 cubic yards of soil was removed. The depth of the excavation ranged from 6 inches to 3 feet and sloped from west to east. Appendix B provides a set of pictures which were taken after the excavation was completed. The length of the excavation at the longest point was 15 feet running west to east while the width of the excavation at its widest point was 13 feet running north to south. The width of the excavation on the surface ran outside the boundary of the location of the former chemical storage shed.

Upon notification that the sample was non-detectable for toluene at a concentration of 2 ppb, arrangements were made to have the temporary fence removed and clean imported fill brought in by Barnes. The area was left unseeded due to future paving activities scheduled for this area. This work was completed on April 15, 1993.
