**PERIODIC REVIEW REPORT**

**FOR  
DOWCRAFT, SOUTH DOW STREET  
NYSDEC SITE #907020  
FALCONER, CHAUTAUQUA COUNTY, NEW YORK**

**C&S ENGINEERS, INC.**  
141 ELM STREET, SUITE 100  
BUFFALO, NEW YORK 14203

**NOVEMBER 2021**

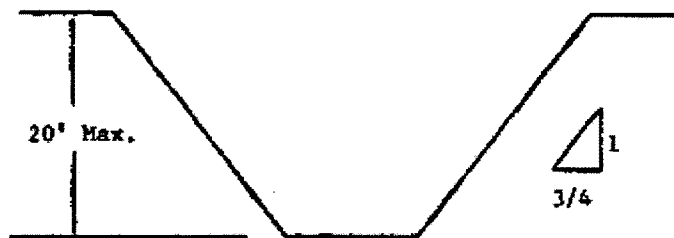
1. All simple slope excavation 20 feet or less in depth shall have a maximum allowable slope of 3/4:1.

SIMPLE SLOPE -- GENERAL
