## REMEDIAL ACTION IMPLEMENTATION REPORT

ERNST STEEL SITE

1728 AND 1746 WALDEN AVENUE  
CHEEKTOWAGA, NEW YORK

(NYSDEC Site Number 915022)

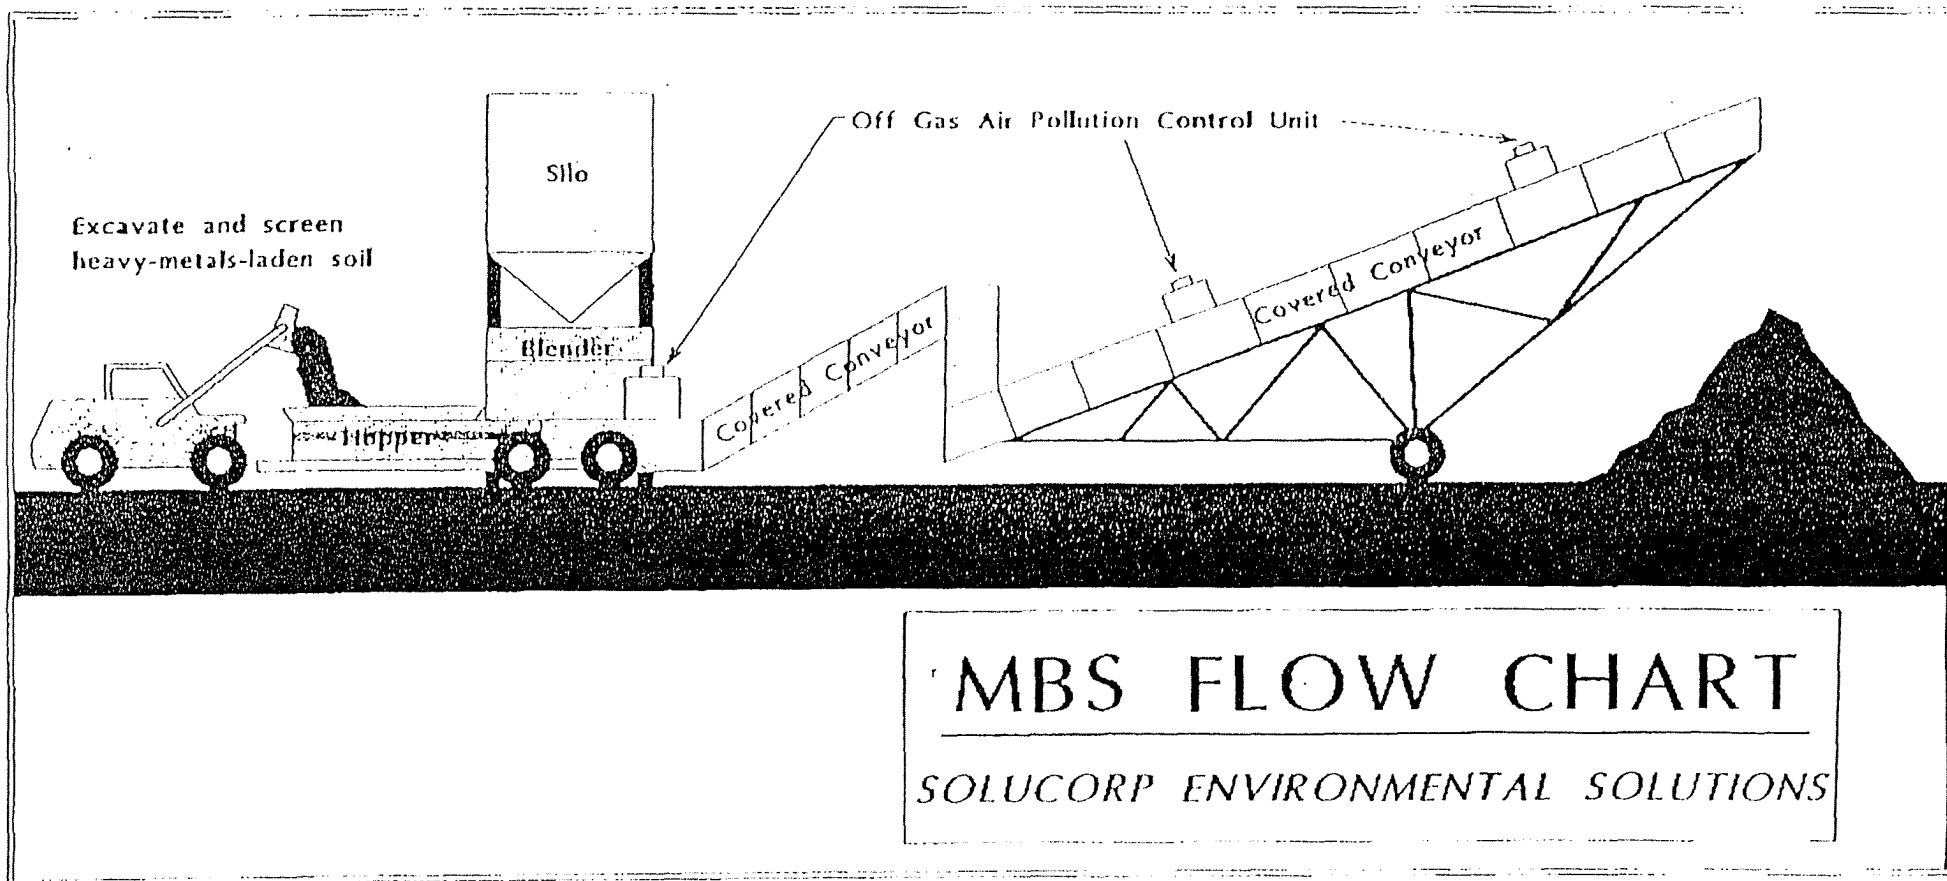
# MBS SOIL REMEDIATION PROCESS

As depicted in the attached process flow diagram provided, the MBS treatment process is completely mobile and easily transportable (to allow for on-site treatment). Waste material is screened and crushed as required to reduce particle sizes to an average 1" diameter (particle size reduction increases surface area, which maximizes contact with the reagents). The waste media is then mixed with powdered reagents in a closed hopper pug mill (the reagent mixture is established through treatability studies for the site specific conditions). Water is then added to catalyze the reaction and to ensure homogeneous mixing. Curing time is essentially immediate and the resulting increase in volume is between 2%-3%. The treated media is then conveyed to a stockpile. Solucorp fully enclosed pug mill is provided with a vacuum system which pulls the exhaust vapors (and odors) through a regenerable-wet scrubber (backed-up by an activated carbon adsorption system) prior to discharge to the atmosphere. The treated media can then be either returned to the original site or disposed in a Subtitle D landfill (the negligible increase in treated waste volume significantly reduces T&D costs, compared to conventional treatment processes).
