FINAL
~~Draft~~ Remedial Investigation Report
Volume I

Pfohl Brothers Landfill

*Cheektowaga, New York
Site Number 9-15-043*

January, 1991

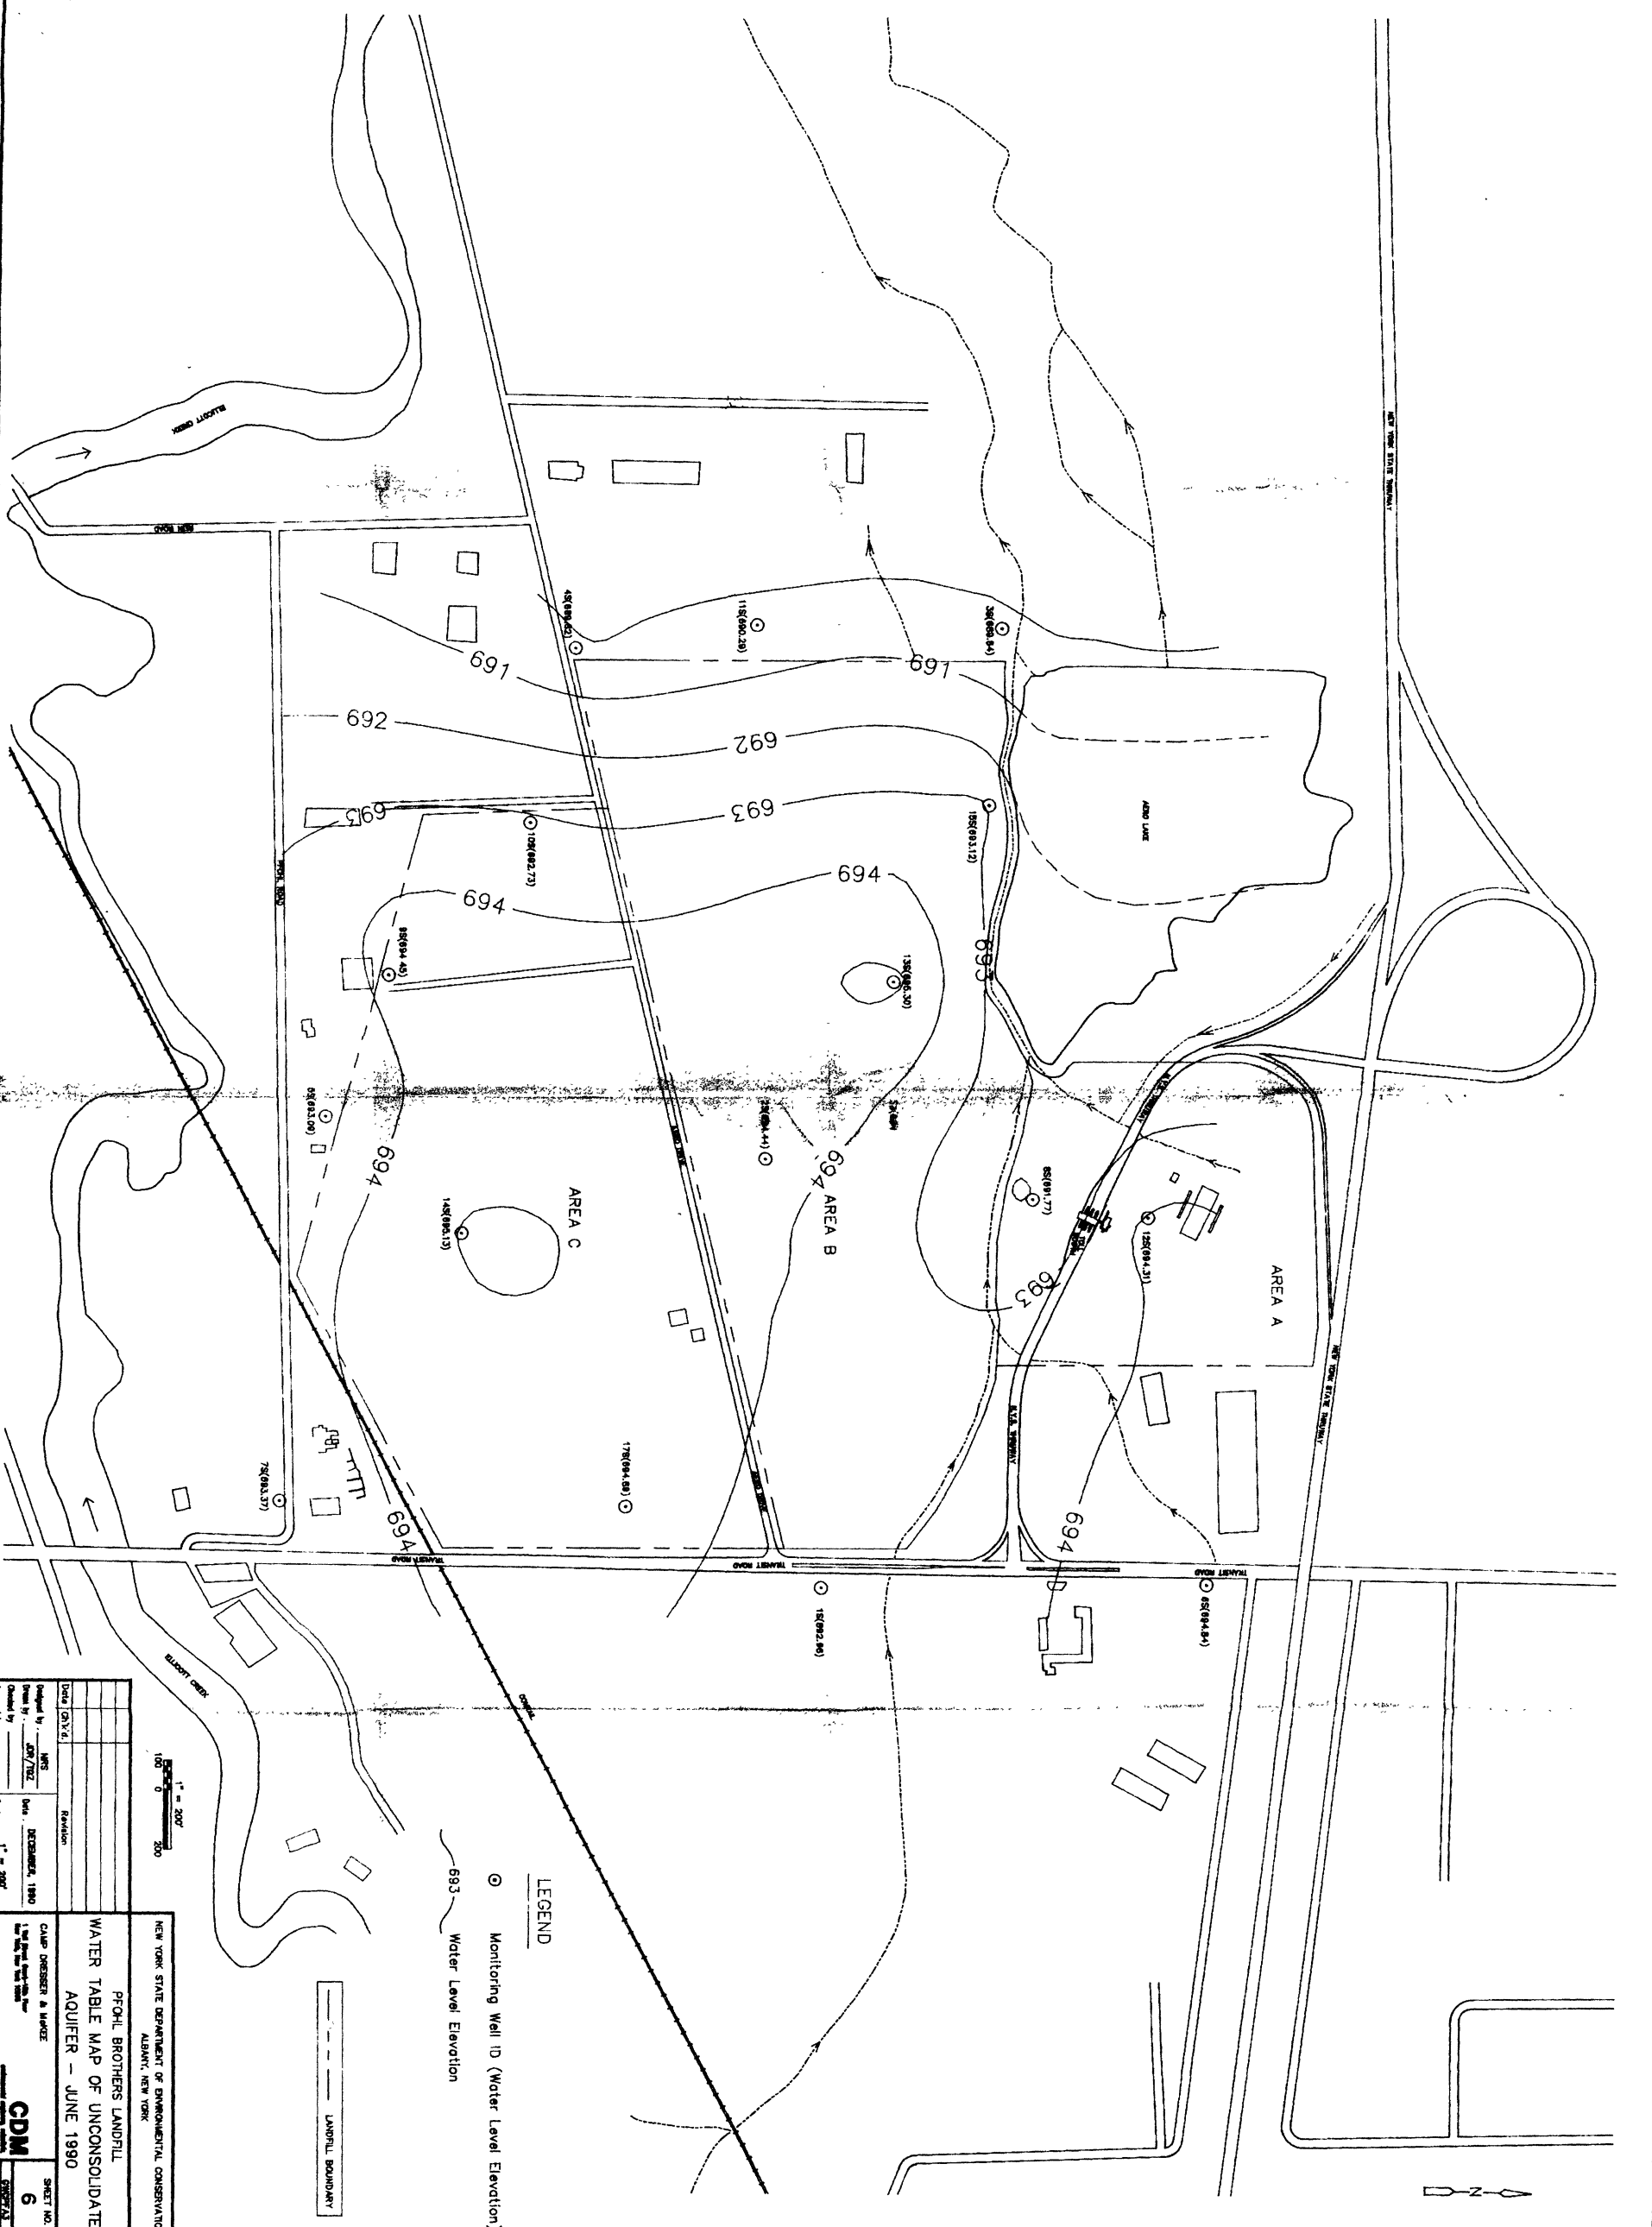
○ Monitoring Well ID (Water Level Elevation)

NEW YORK STATE DEPARTMENT OF ENVIRONMENTAL CONSERVATION ALBANY, NEW YORK	PROHL, BROTHERS LANDFILL WATER TABLE MAP OF UNCONSOLIDATED AQUIFER - JUNE 1990
Designed by: MRS. J. J. J.	Checked by: J. J. J.
Date: 01/16	Revision:
Drawn by: J. J. J.	Date: DECEMBER, 1990
Scale: 1" = 200'	
CDM GROUP, INC.	SHEET NO. 6
