New York Department of Environmental Conservation  
Division of Environmental Remediation  
Region 9 Office-Buffalo

**FIELD REPORT**

**Date:** May 14, 2008  
**Site Name:** Snyder Tank - 3773 Lake Shore Rd., Area B- Diesel Impacted Area  
**Site Number:** Spill # 0651400  
**Location:** 3773- 3774 Lake Shore Rd., Blasdell, NY  
**DEC Project Engineer:** Jaspal S. Walia  
**Contract Engineer:** BenchMark Env. Engineering & Science, LLC  
**Contractor:** AAA Environmental

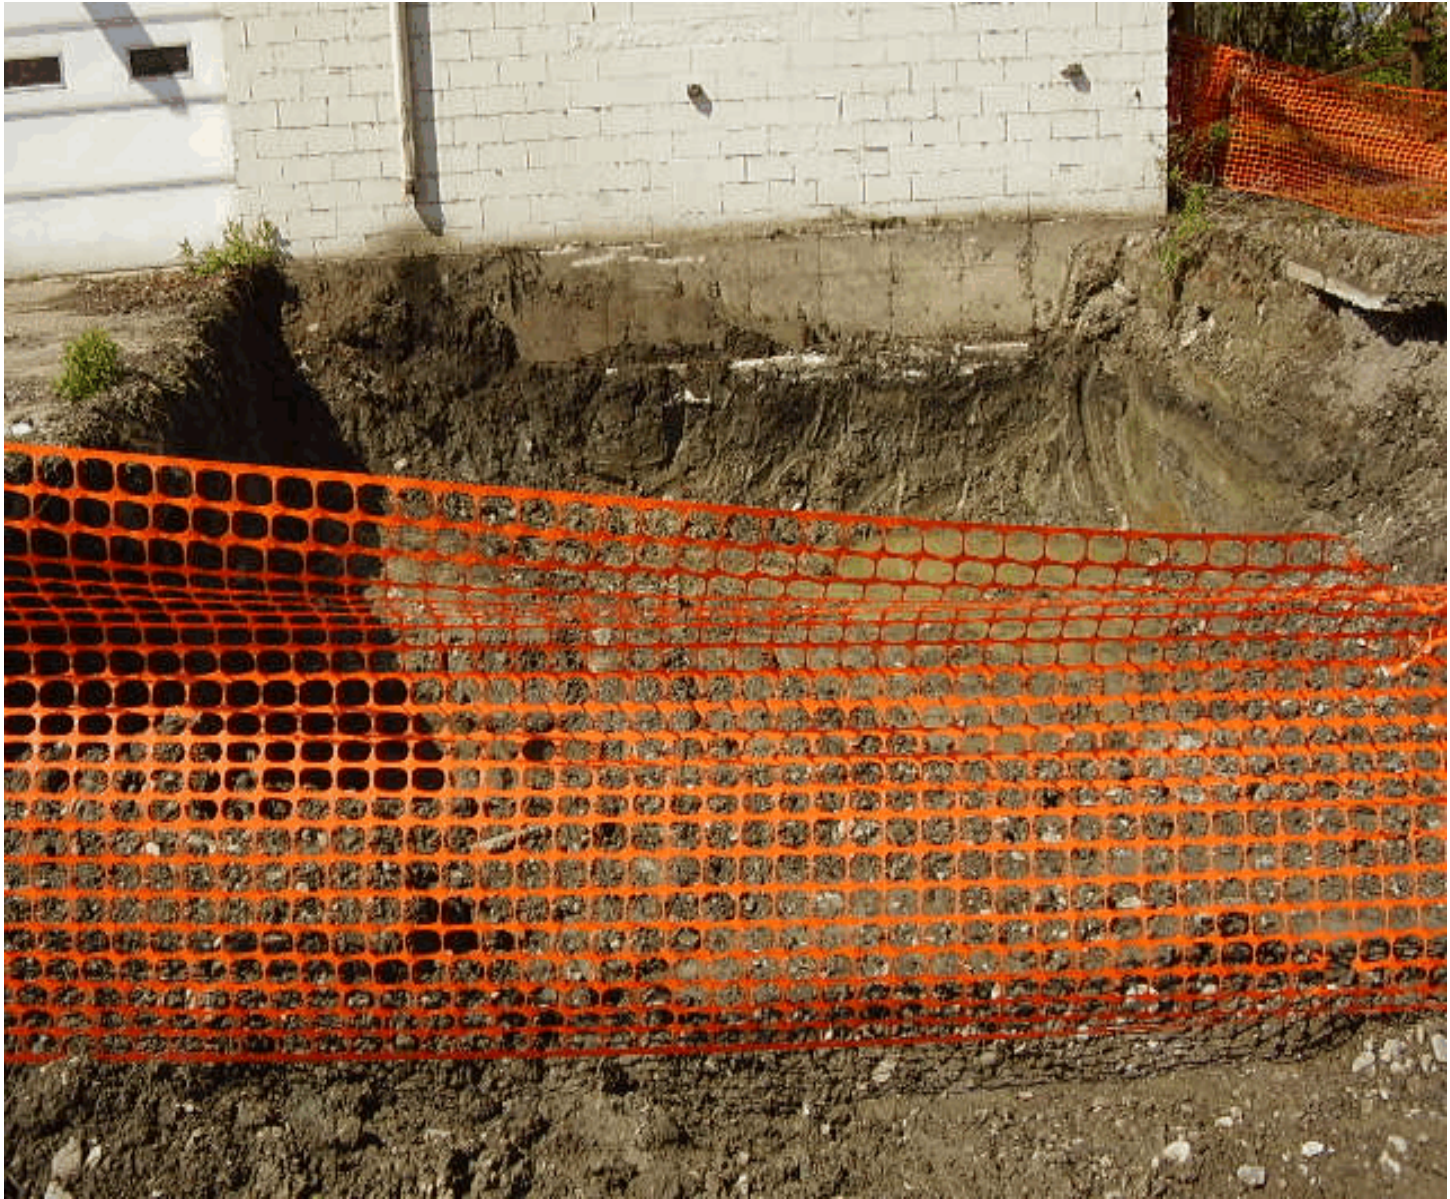
- AAA excavated impacted soils at ETP-7. Excavation was approx. 30'x26'x7.5'. The depth varied from 5' on south of excavation to 9' on north side. The excavation was upto the building foundation to the south, concrete driveway to the east, concrete pad to the west, and 30' towards north of the building. No PID readings above background were noticed in the pit after excavation was completed. Slight water on north side of the excavation but no visible contamination or sheens were noticed in the excavation. (Note: the attached picture was taken next day after the rain). A small area ~ 5'x10' was also excavated around ETP-6.
