**Environmental Restoration
Record of Decision
Buffalo Lakeside Commerce Park
Parcel 4 Site
City of Buffalo, Erie County, New York
Site Number E-9-15-193**

March 2009

DECLARATION STATEMENT ENVIRONMENTAL RESTORATION RECORD OF DECISION

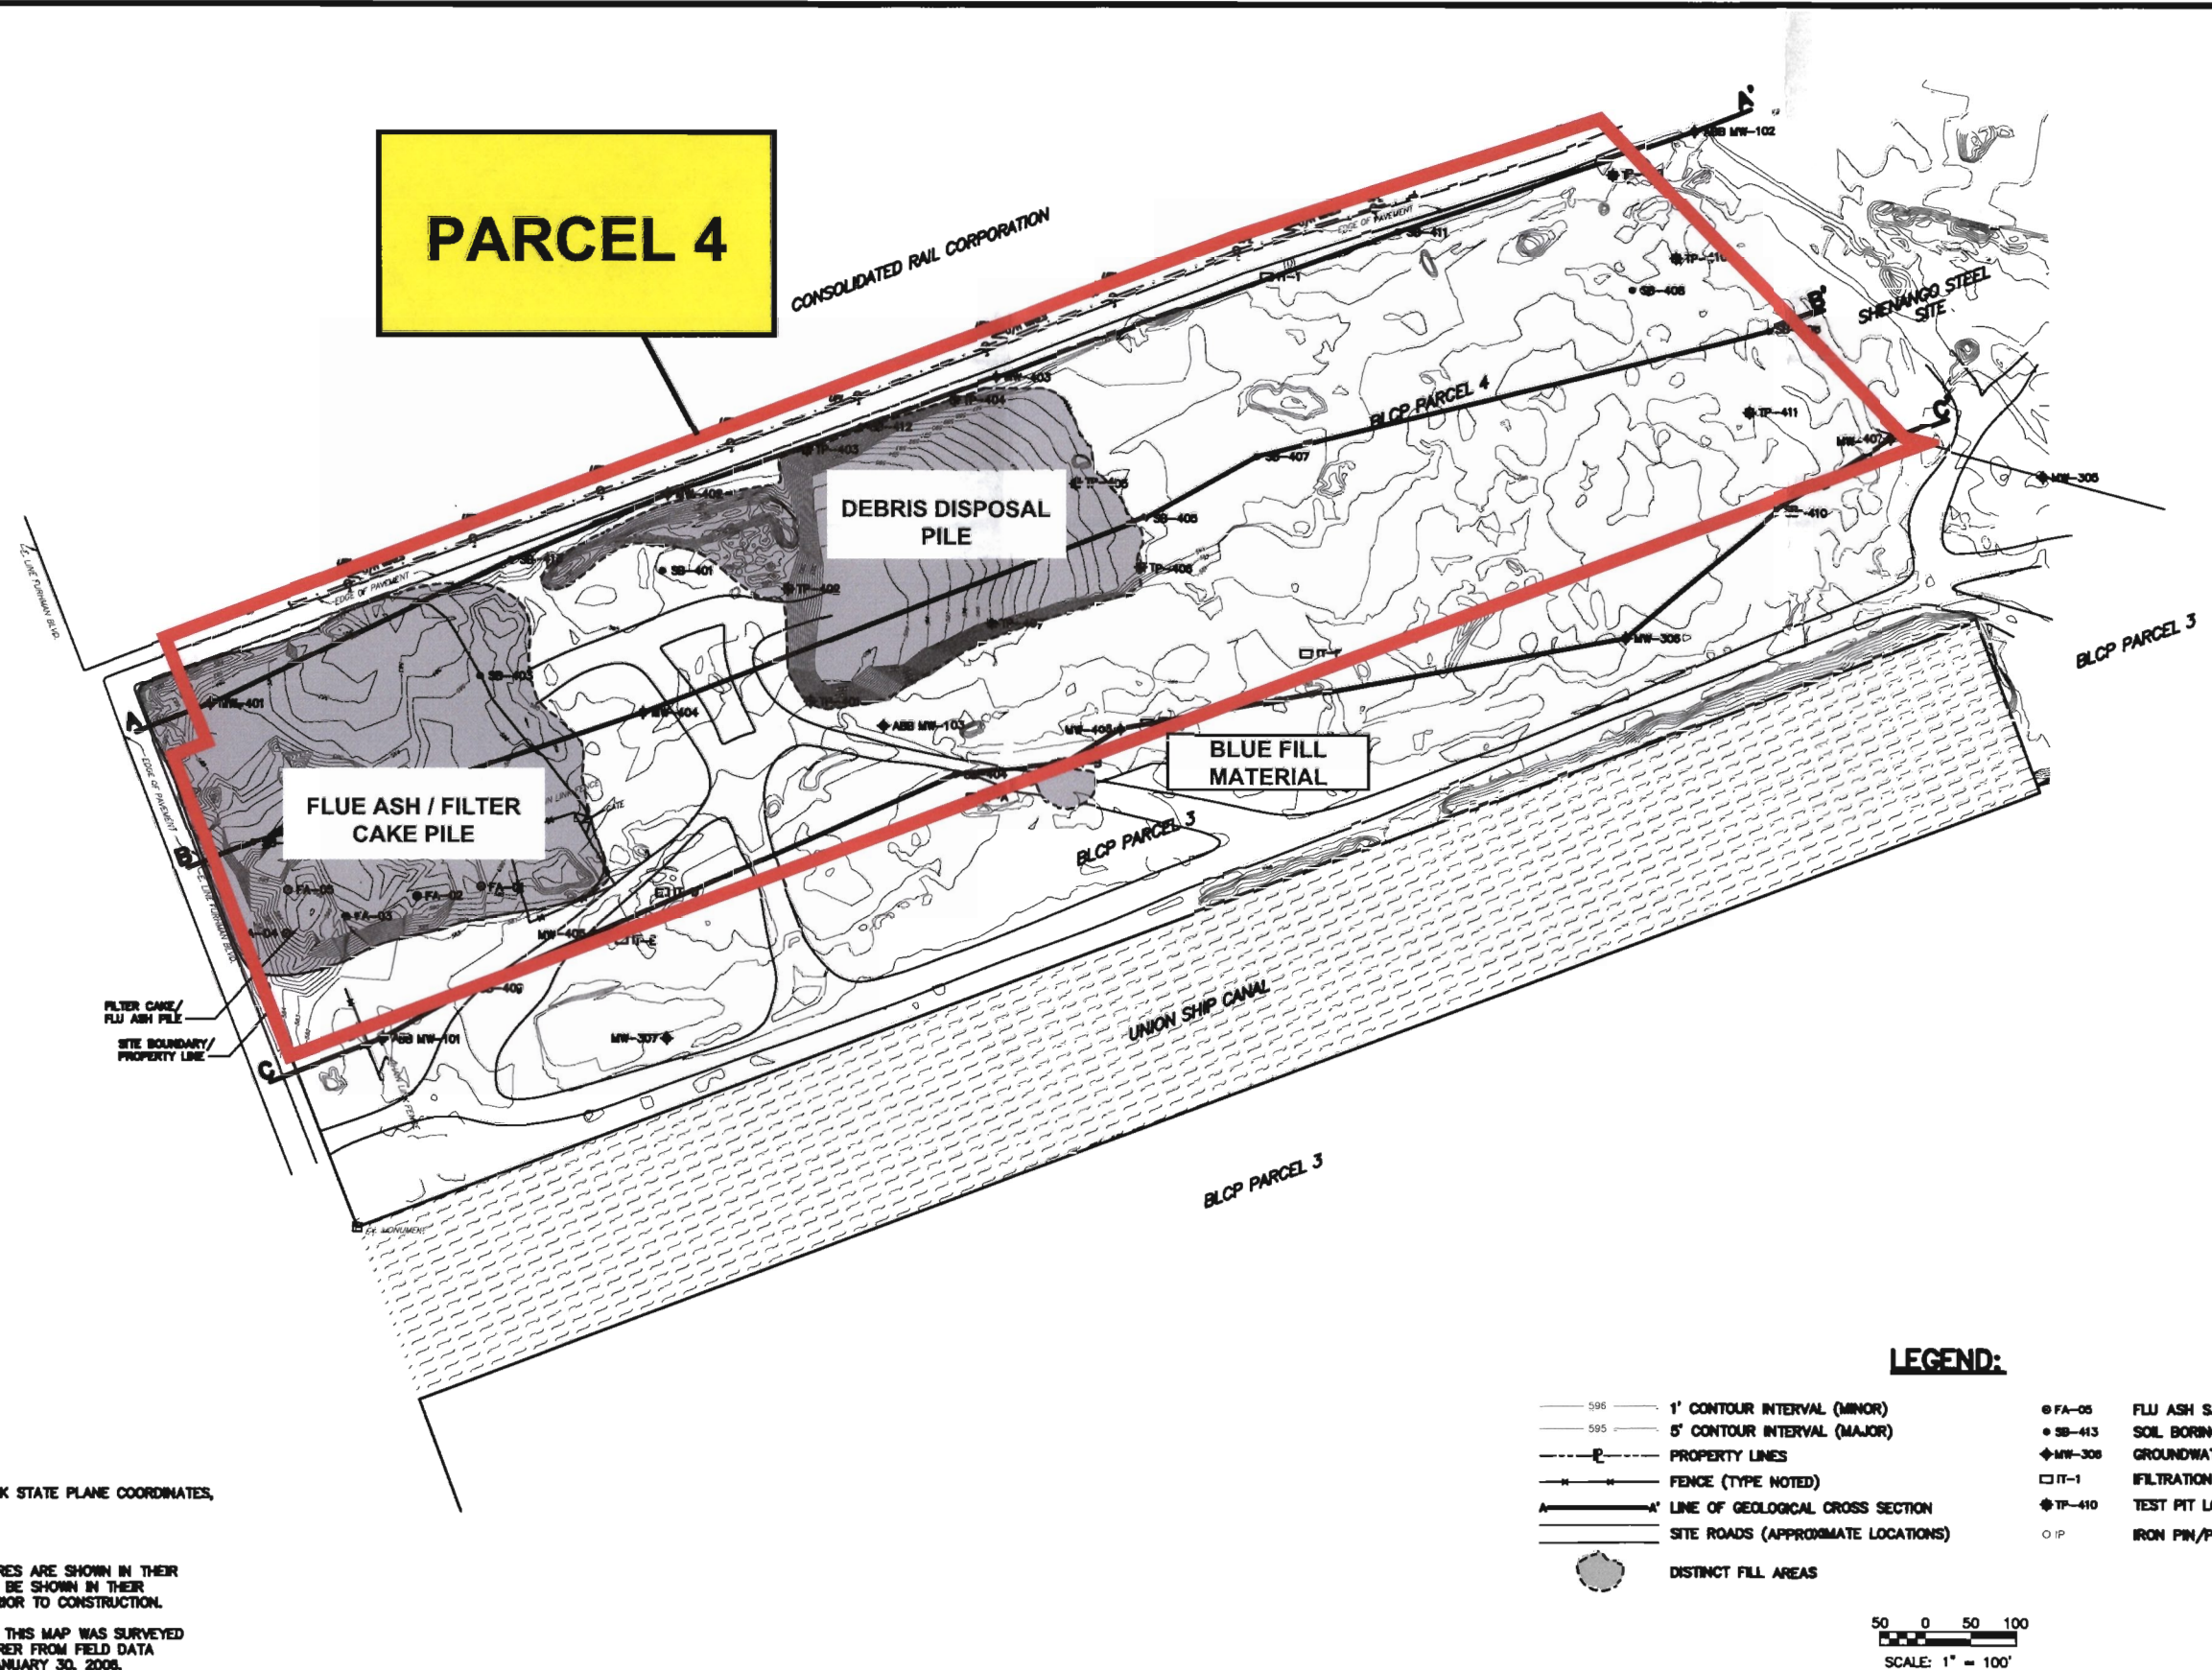
FIGURE 2 SITE MAP

The Site is generally flat with two areas of pronounced fill material in raised fill mounds, see Figure 2. The first mound is located in the approximate center of the Site and is referred to as the "Debris Disposal Pile". This 3-acre mound is a ramp-like feature that gradually rises to the west to a maximum relief of approximately 20 feet, with a steep western face. The Debris Disposal Pile is composed of native materials including sand, gravel, cobbles and boulders and fill materials including black sand, ash, slag, brick concrete, wire rope (cable), tires, crushed stone, metal debris and various other construction and demolition debris.

Blue Fill – A deep blue-colored layer of fill that was encountered during the excavation of one of the infiltration test trenches (IT-B), located near the center of the southern Site property boundary, see Figure 2. The material was composed of wood chips approximately 1/8 inch in size but stained a deep indigo blue color. The composition and color of this fill material indicates that it may be a byproduct of coal gasification from an off-site source. The extent of this material was defined using multiple extended trenches which were subsequently backfilled. This material was sampled for SVOCs, pesticides, PCBs, metals, cyanide, and “free” cyanide (i.e. the more toxic forms of cyanide, not bound or complexed with metals). Analytical results of this sample of blue fill are included on Table 2. One SVOC (dibenzo-a,h-anthracene) and one metal (arsenic) were present at concentrations slightly above SCOs. Cyanide was also present at 918 ppm which is significantly higher than the SCO of 27 ppm.

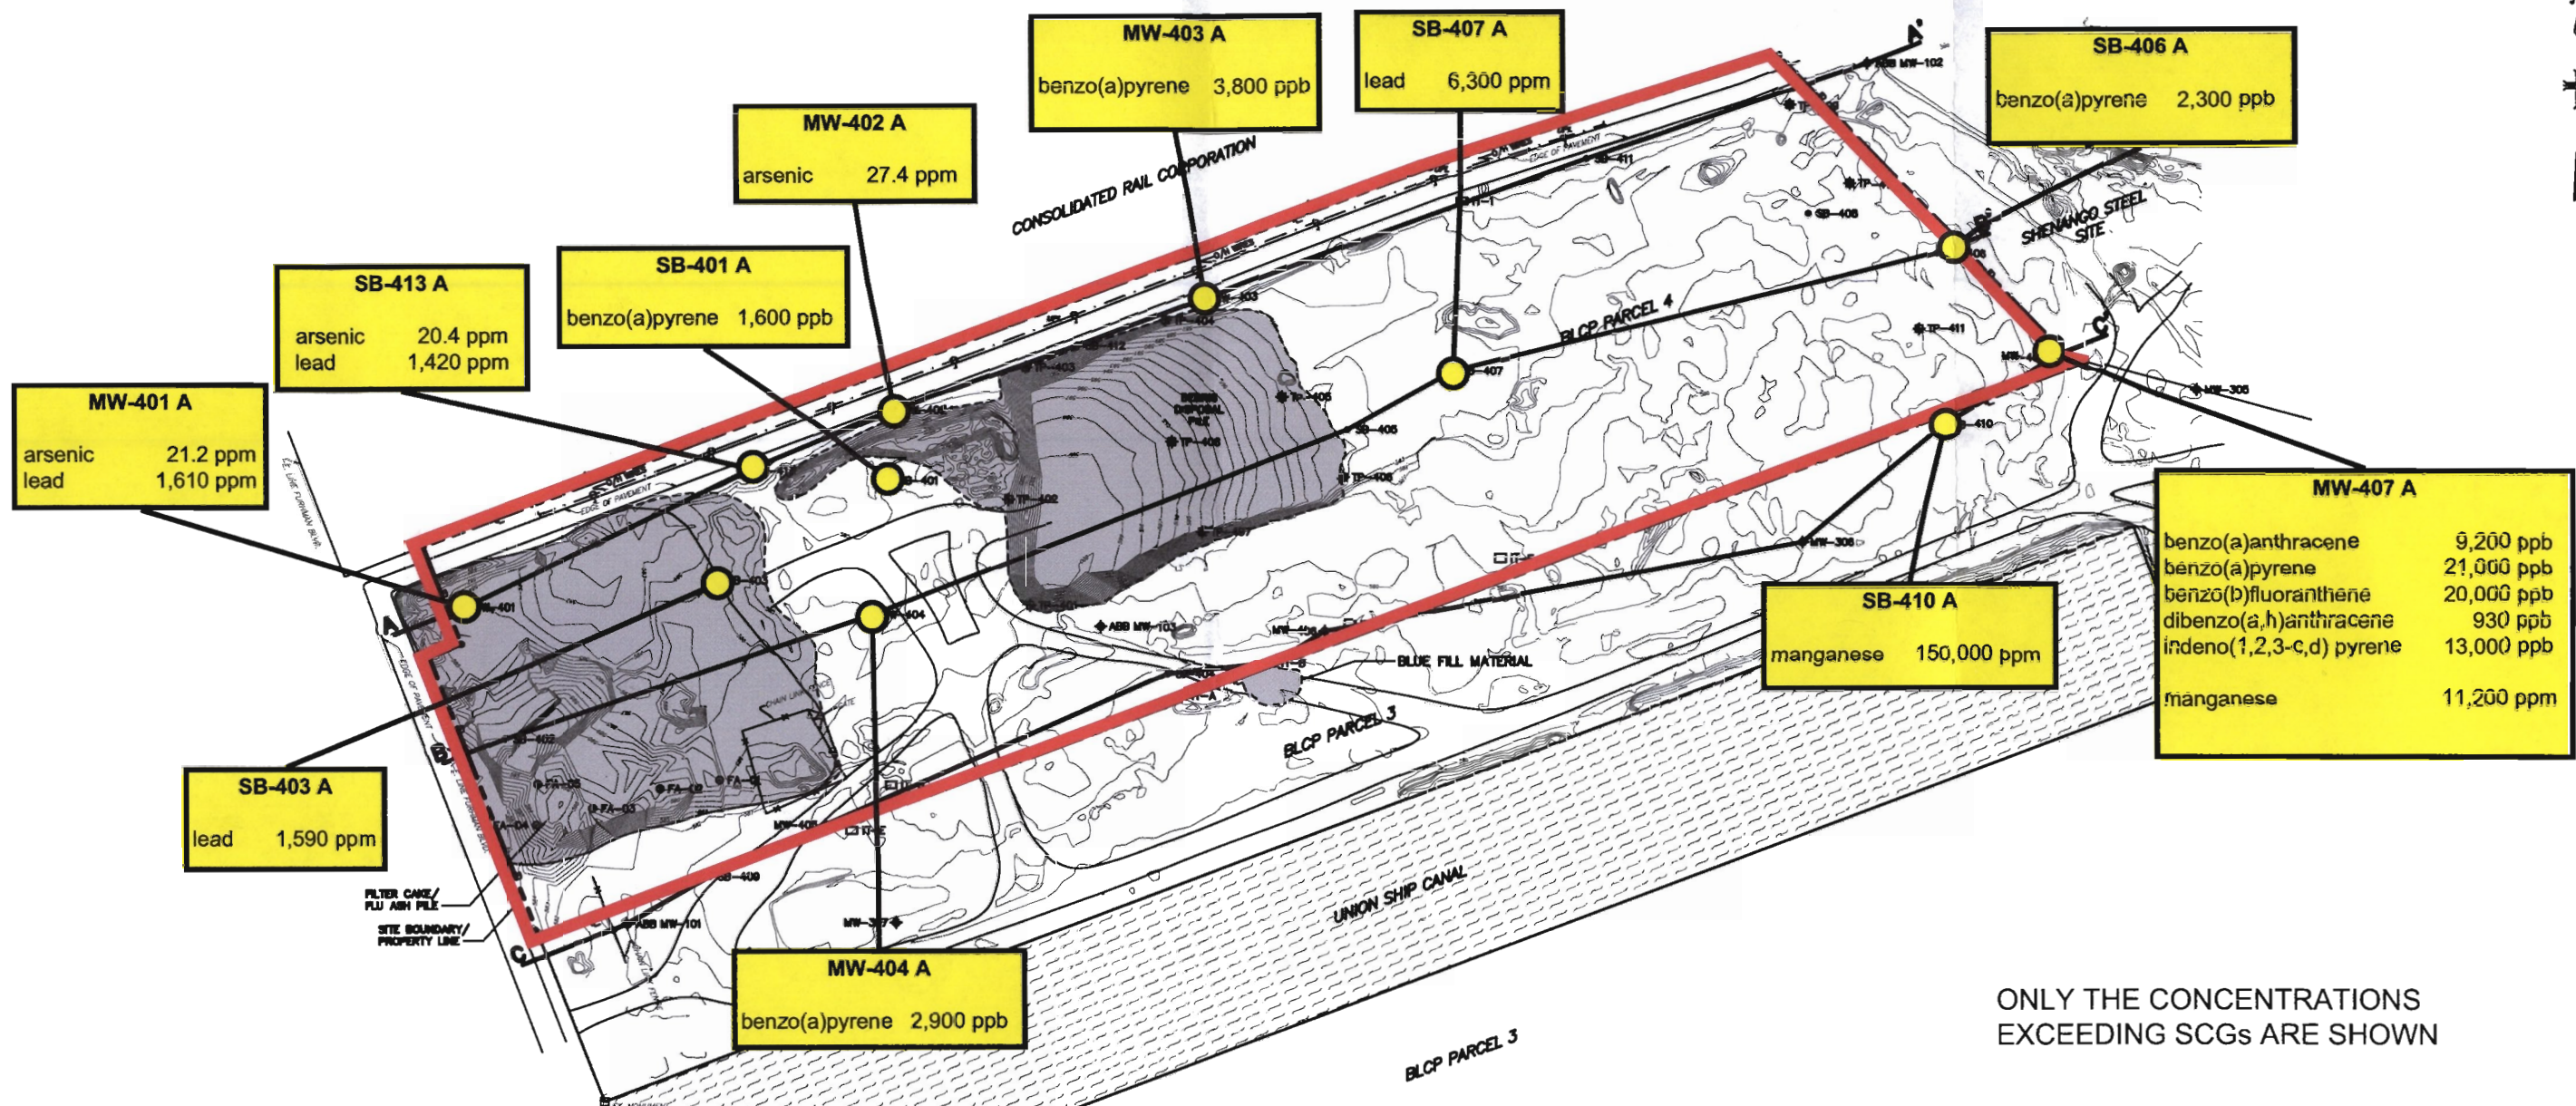
**FIGURE 3
ANALYTICAL RESULTS
SURFACE SOIL/FILL**

Seven PAHs were present in surface soil/fill at the Site at concentrations in excess of the 6 NYCRR Subpart 375-6 SCOs for unrestricted use in seven of the twenty surface soil/fill samples collected. Only five of these PAHs were present at levels in excess of the SCOs for restricted commercial use. All five of these PAHs are known carcinogenic PAHs, however, only one of these, benzo(a)pyrene, was present above the typical range found in urban soils. All other PAHs detected were within or below the typical urban background concentrations for PAHs.

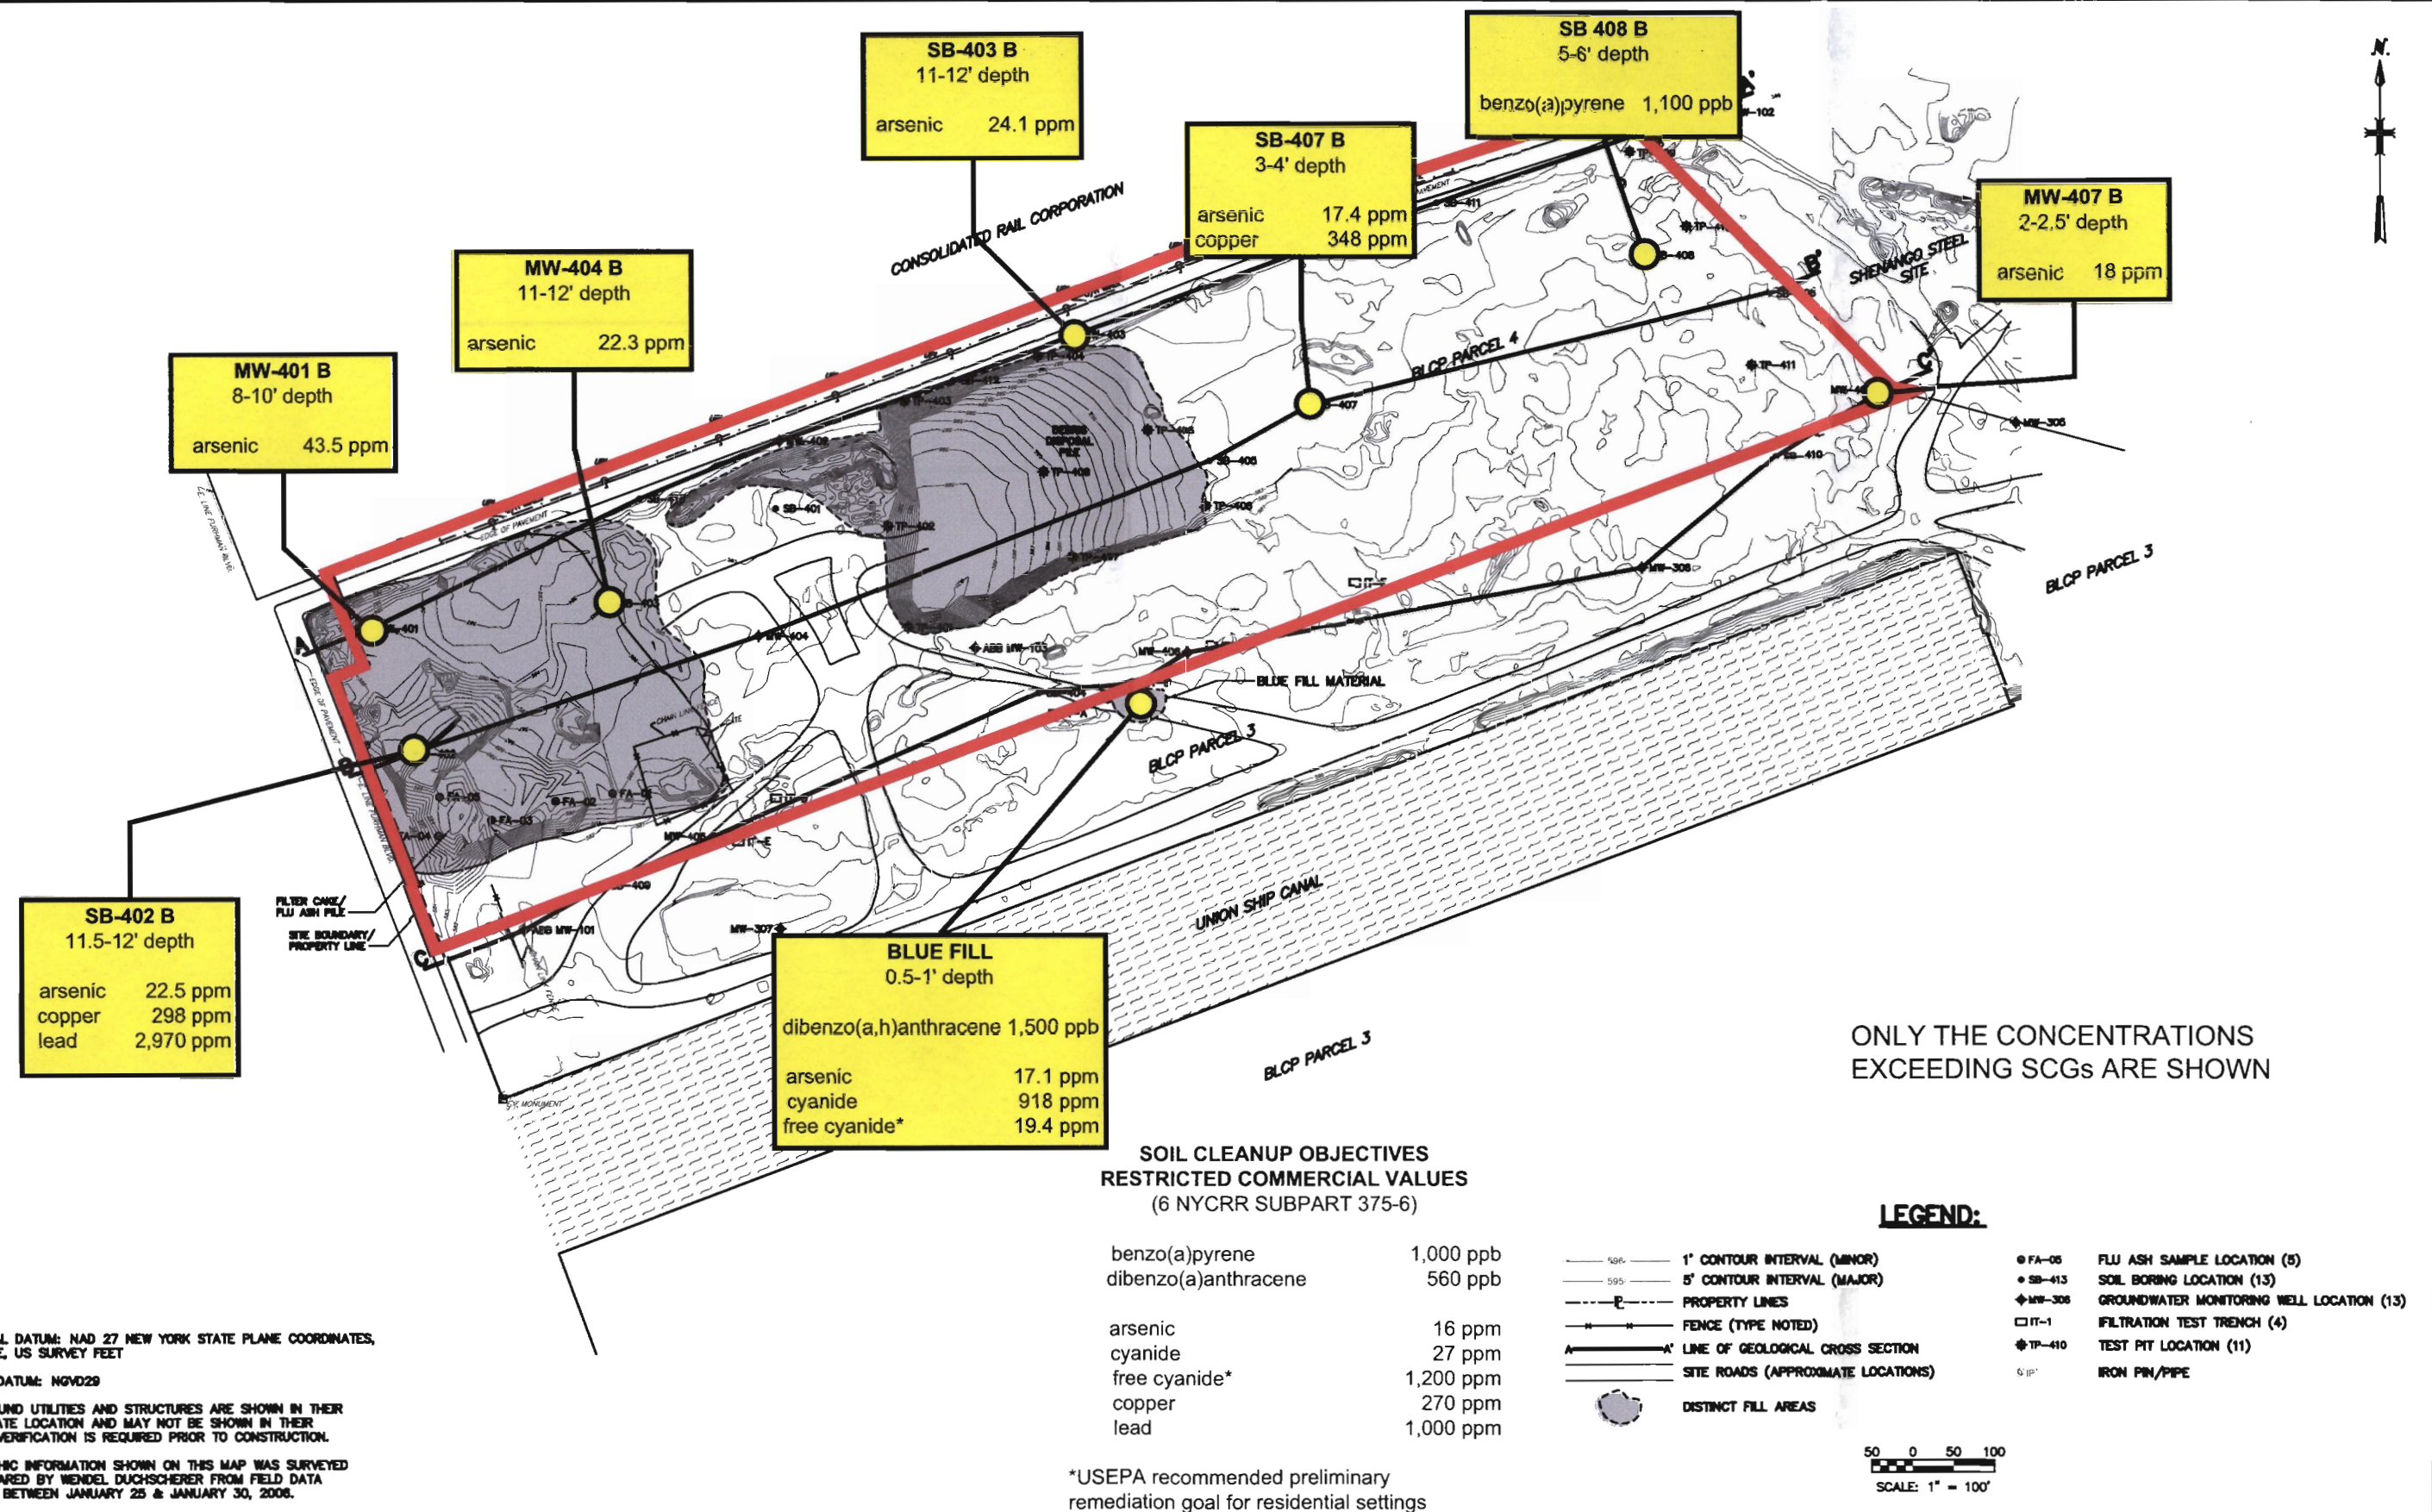
FIGURE 4 ANALYTICAL RESULTS SUB-SURFACE SOIL/FILL

One subsurface soil/fill sample was collected from each of the 20 soil borings at the depth exhibiting the greatest evidence of potential contamination, or directly above the saturated zone if no evidence of contamination was observed. Samples were analyzed for VOCs, SVOCs, pesticides, PCBs, TAL metals, and cyanide. Three samples collected near the southwestern portion of the Site (MW-405B, SB-404B, and SB-409B) were also analyzed for free cyanide based on historic data in that area of the Site. One of the 20 samples (MW-402B) consisted of flue ash. The location of subsurface soils containing constituents greater than SCOs or urban background concentrations was well distributed across the Site; these concentrations are likely characteristic of the general soil/fill material underlying the Site rather than a former or current on-site point source. Analytical results for subsurface soil/fill samples are summarized in Table 2 and compared to the SCOs for unrestricted use. Analytical results that exceeded the SCOs for both unrestricted use and restricted commercial use are discussed below and depicted in Figure 4.

Only one sample, SB-408B (5'-6') contained PAHs above the SCOs for unrestricted use. The two PAHs found, benzo(a)pyrene and benzo(b)fluoranthene, are known carcinogens. Only benzo(a)pyrene was detected at a concentration exceeding its SCO for restricted commercial site use; 1100 ppb was found, which is slightly above the SCO of 1000 ppb.

Arsenic, copper, and lead were detected in one or more samples at concentrations above but within the same order of magnitude of the respective SCOs. The samples containing metals at concentrations in excess of SCOs and eastern United States background concentrations were generally well distributed across the Site with no one concentrated area of contamination observed. Sample SB-402B was one notable exception; lead was detected at a concentration of 2,970 ppm, which was higher than most other samples and above the 63 ppm and 1,000 ppm SCOs for unrestricted and restricted commercial use respectively. Subsurface soil contamination identified during the SI/RAR will be addressed in the remedy selection process.

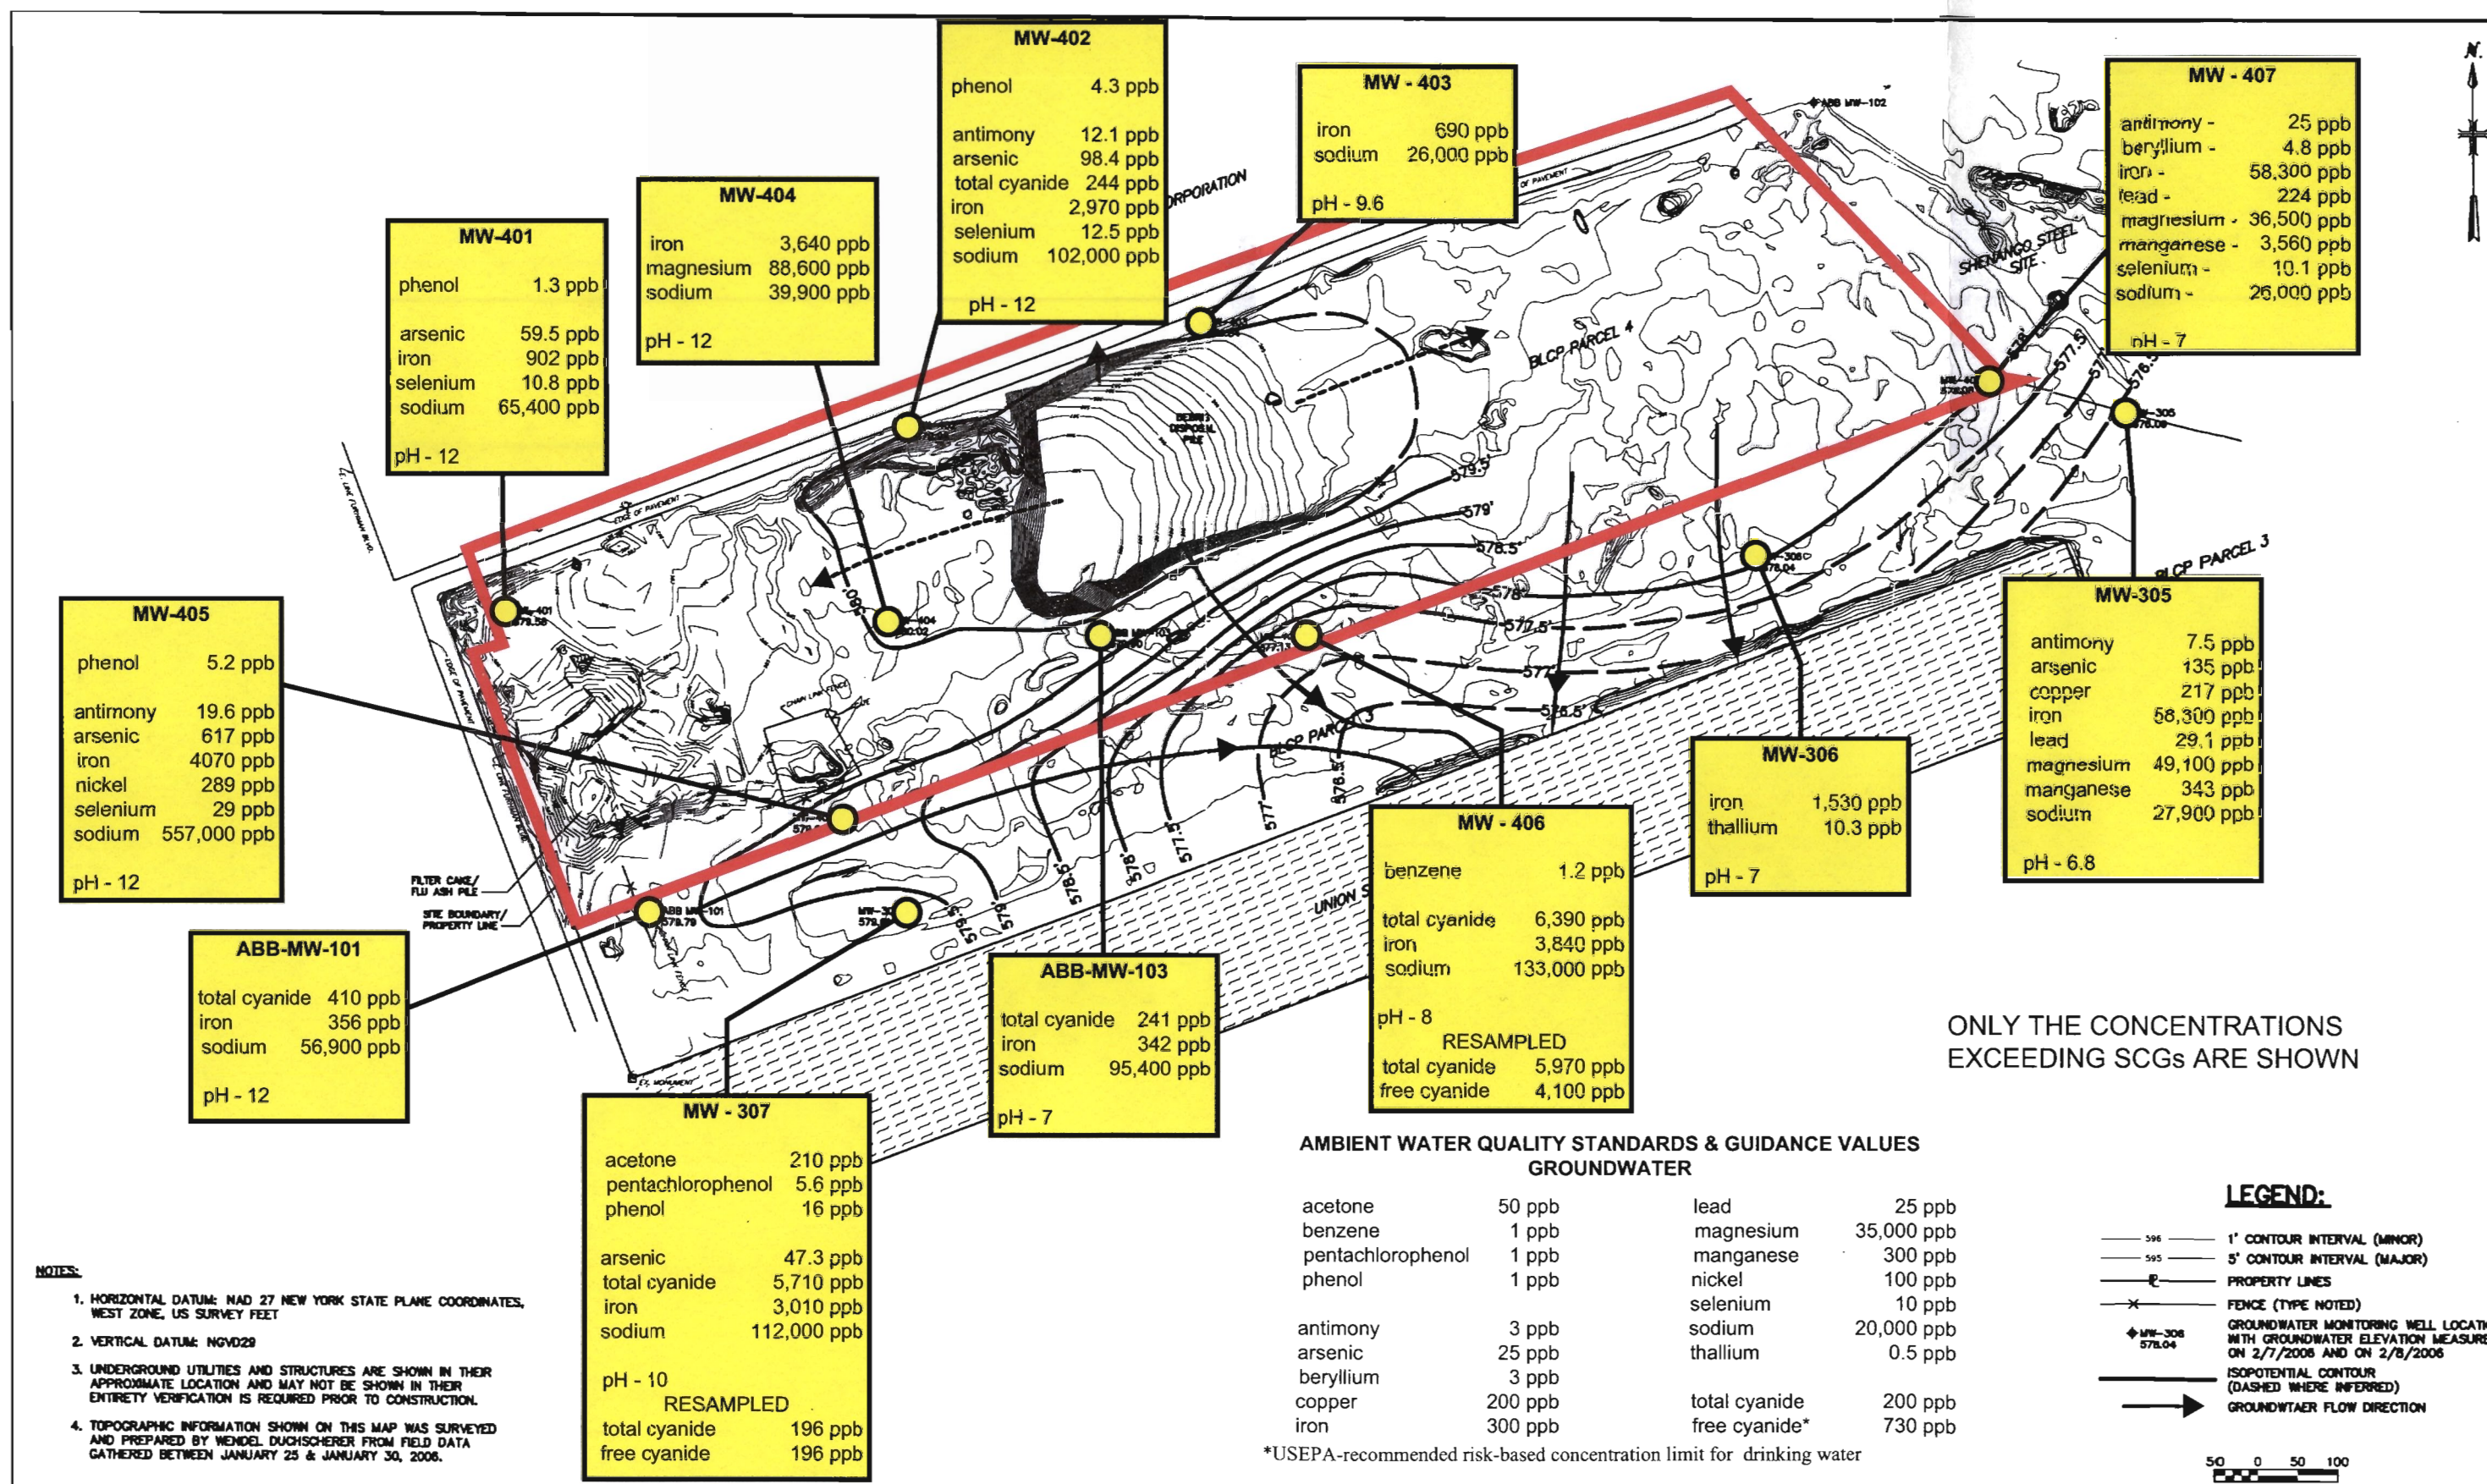
**FIGURE 5
ANALYTICAL RESULTS
GROUNDWATER**

Several SVOCs were detected, most at very low concentrations, and only three compounds were detected at concentrations above their respective groundwater standards. All three SVOCs were phenolic compounds: 2,4-dichlorophenol, pentachlorophenol and phenol. One or two of these compounds were present in 5 of the 12 wells sampled. The highest concentration of 2,4 dichlorophenol found was 5.4 ppb, its groundwater standard is 5 ppb. A groundwater standard of 1 ppb has been established for the sum of the pentachlorophenol and phenol concentrations; the highest combined concentration found was 21.6 ppb in well MW-307 located off-site on the adjacent Parcel 3, whereas the highest concentration on the Site was 5.8 ppb in well MW-405.

Several metals were present at concentrations above groundwater standards in one or more samples. Iron and sodium exceeded groundwater standards in nearly every well sampled. Other metals and inorganic compounds, including arsenic, copper, and lead were detected at concentrations similar to those found in the adjacent parcels of the BLCP. Notable exceptions were two relatively high concentrations of cyanide. Well MW-406, located in close proximity to the cyanide-contaminated blue fill material, contained 6,390 ppb of total cyanide. Off-site well MW-307, located on Parcel 3, contained 5,710 ppb of total cyanide. Both wells were resampled and analyzed for both total cyanide and free cyanide. Groundwater from MW-406 contained 5,970 ppb of total cyanide and 4,100 ppb of free cyanide. The groundwater from MW-307 contained 196 ppb of total cyanide, all of which was
