Re: Phase I Environmental Site Assessment  
Commercial Property, 4245 Clark Street, Hamburg, NY  
Project No. e2121

## PHASE I ENVIRONMENTAL SITE ASSESSMENT

**Commercial Property**  
**4245 Clark Street**  
**Hamburg, New York 14127**

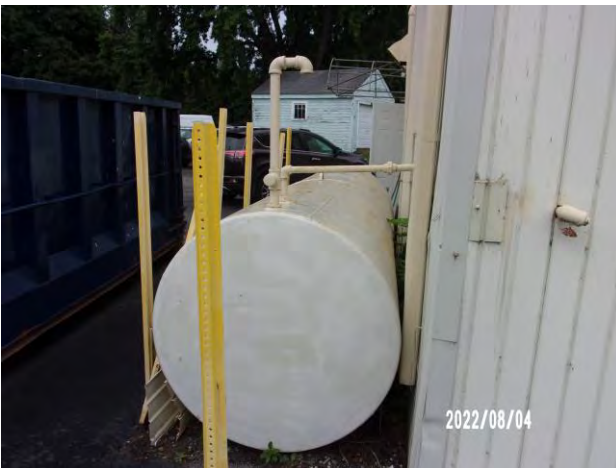
**6.2.2 Underground and Aboveground Storage Tanks** – No USTs were observed during the exterior site reconnaissance. One 1,000-gallon AST labeled ‘mineral spirits’ was located at the rear of the structure to the south. The AST appeared to be in fair/good condition, with limited surficial rust and some stained soil beneath the AST. Mr. Waterfield indicated two approximate 800-gallon ASTs on stilts were formerly located along the southeastern exterior of the structure that were utilized for the storage of petroleum solvents.

5. View of 1,000-gallon mineral spirits AST located at the rear of the building.

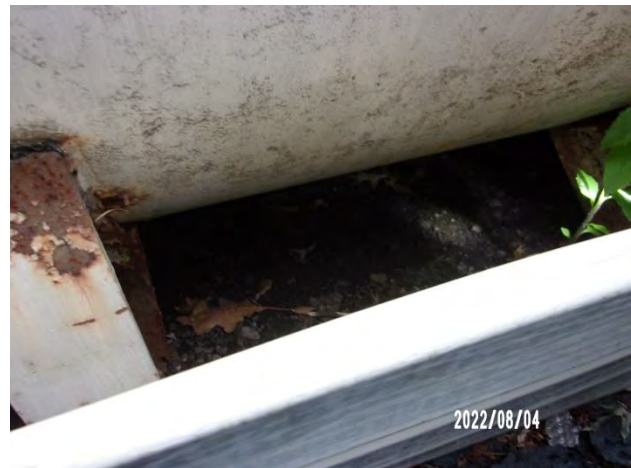
**6.2.4 Stained Soil or Pavement** – An area of darkened/discolored soil was observed at the rear of the structure to the south underneath the existing AST.

6. View of limited stained soil underneath the AST at the rear of the building

In this context, EA recommends that a Phase II ESA subsurface investigation be completed on the subject site to assess if the soil profile and/or groundwater have been impacted by the historical site and off-site chemical usages.

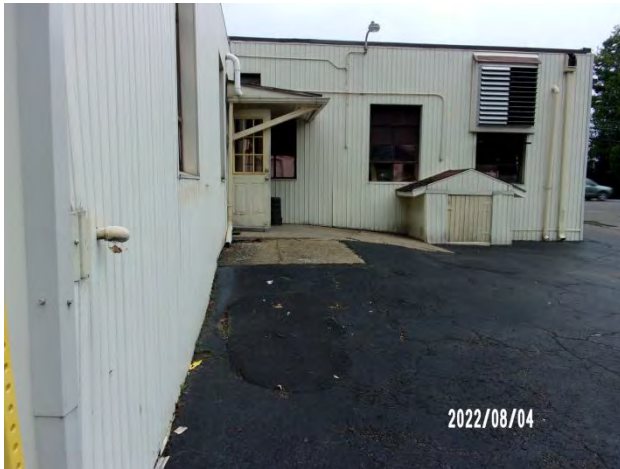
Surficial repairs to the asphalt were noted at the locations of the two former ASTs along the southeastern exterior of the structure. A piece of steel was slightly protruding from the asphalt, which was likely used as a support for one of the ASTs.

7. View of eastern exterior of the structure where historic ASTs were located.

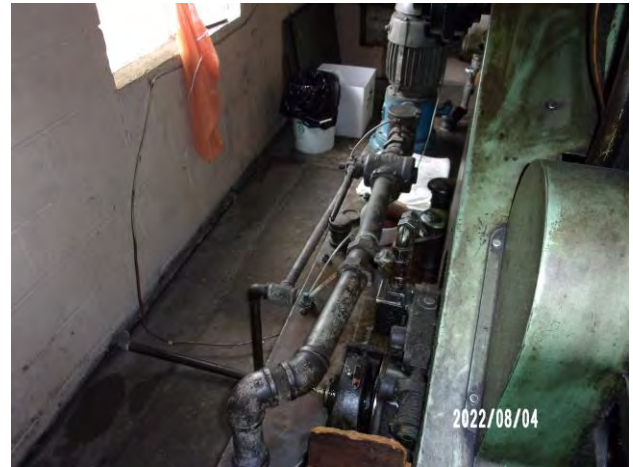
- The concrete floor between and surrounding the dry cleaning tumbler and dryer.
- An approximate 1 by 2 foot area of light staining/discoloration, which appeared to be generated from the solvent carbon filter system, was observed adjacent to the dry cleaning unit.

10. Rear view of the dry cleaning equipment with staining.

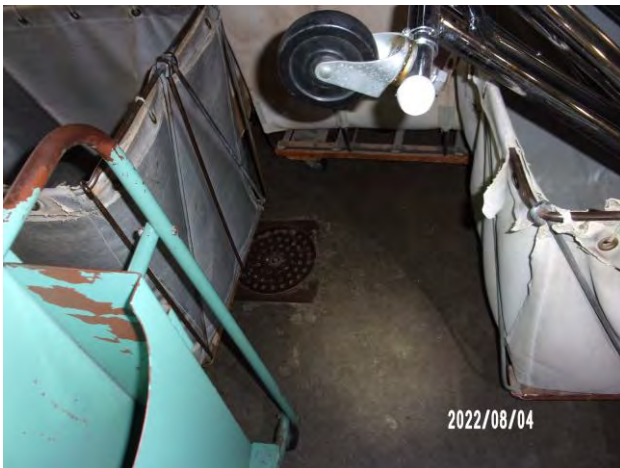
The concrete floor in the dry cleaning room exhibited staining, limited cracking and deterioration, and one floor drain was present which reportedly discharges to the rear of the property. Stressed vegetation and staining on the asphalt parking lot were observed and appeared to be associated with the boiler blowdown discharge from two pipes along the southwestern corner of the structure. Additionally, small volumes of wastewater from an air vacuum connected to the steamers is directly discharged to the ground surface along the southeastern exterior of the structure.

11. Floor drain in the center of the dry cleaning room with staining.

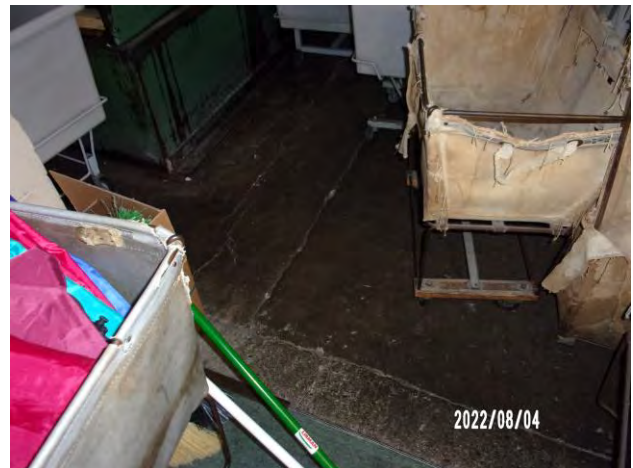
12. View of cracks and staining in the dry cleaning room.

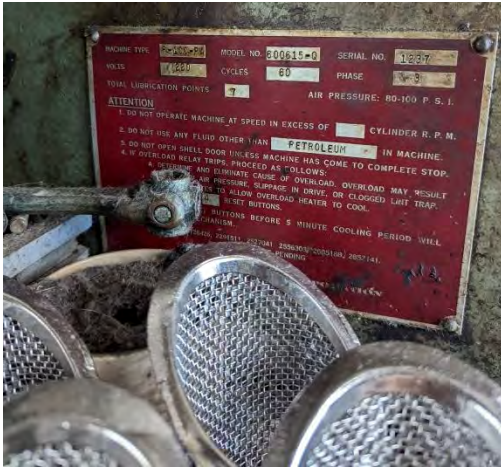
EA observed lint from stainless steel filters in a 5-gallon container associated with the dry cleaning machine. This waste is added to the general waste stream.

13. View of dry cleaner specs and stainless steel lint traps.

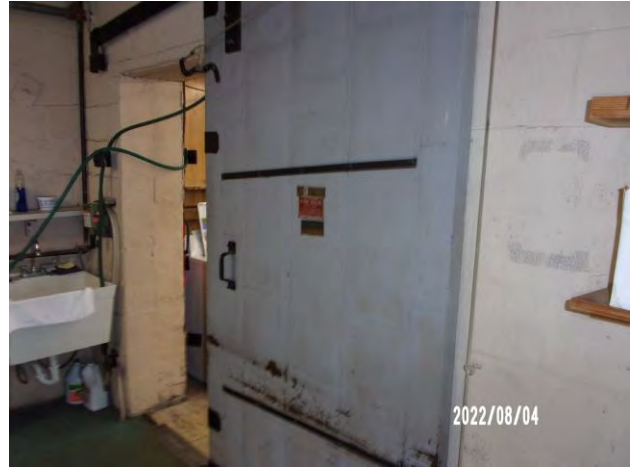
**6.4.1 Asbestos** – A cursory asbestos survey was completed at the time of the site reconnaissance. EA observed several wrapped pipes throughout the building, boiler insulation, and two fireproof doors which may contain asbestos. The pipe wrap and doors appeared to be in good condition (not friable). Based

14. View of the fireproof doors in the steam press area.

- A cursory asbestos and lead paint inspection was completed at the time of the site reconnaissance. Two fire doors, pipe wrapping, and boiler tank insulation may contain asbestos. These items were in fair to good condition (non-friable). Some areas of peel and chipping paint were observed. Based on the age of the on-site building (built prior to 1978), additional asbestos containing materials (ACMs) and/or lead paint may have been utilized during construction or renovations. Prior to building renovation and/or demolition, EA recommends appropriate survey of suspect asbestos-containing materials and suspect lead-based paint followed by any necessary abatement.

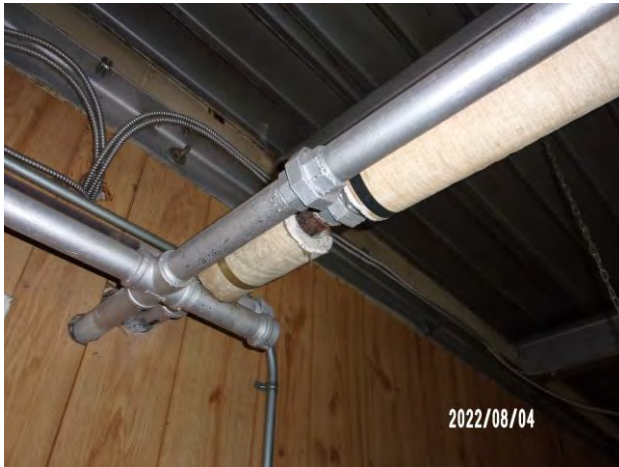
15. View of suspected asbestos wrapped piping.

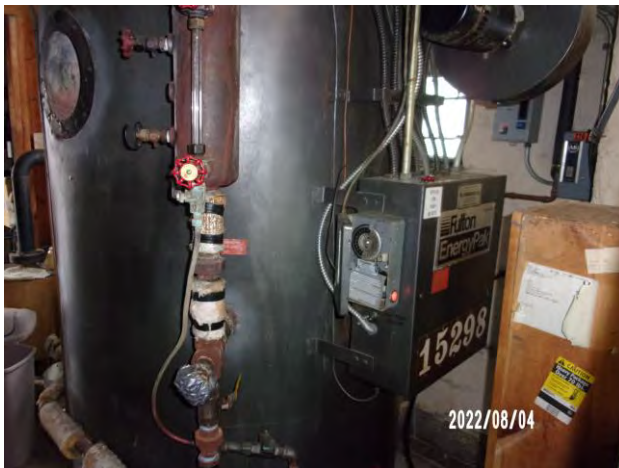
An air compressor and boiler system was observed in the maintenance room in the southwest portion of the structure.

17. View of boiler in the maintenance room.

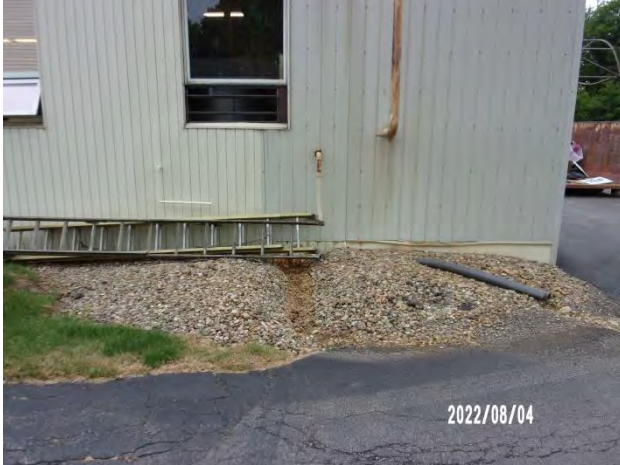
**6.2.5 Stressed Vegetation** – A limited area of stressed vegetation was observed along the southwestern exterior of the structure where the boiler blowdown apparently discharges.

One approximate 3-inch diameter black pipe and one approximate 1-inch pipe, both of which discharge water from the boiler system to the southwestern exterior of the structure were observed.

19. View of the southwest exterior of the building where the water from the boiler blowdown is discharged.
