**PERIODIC REVIEW REPORT (PRR)**

**INACTIVE LANDFILL AREA**

**SAINT GOBAIN ABRASIVES, INC.**

**Site No. 932007**

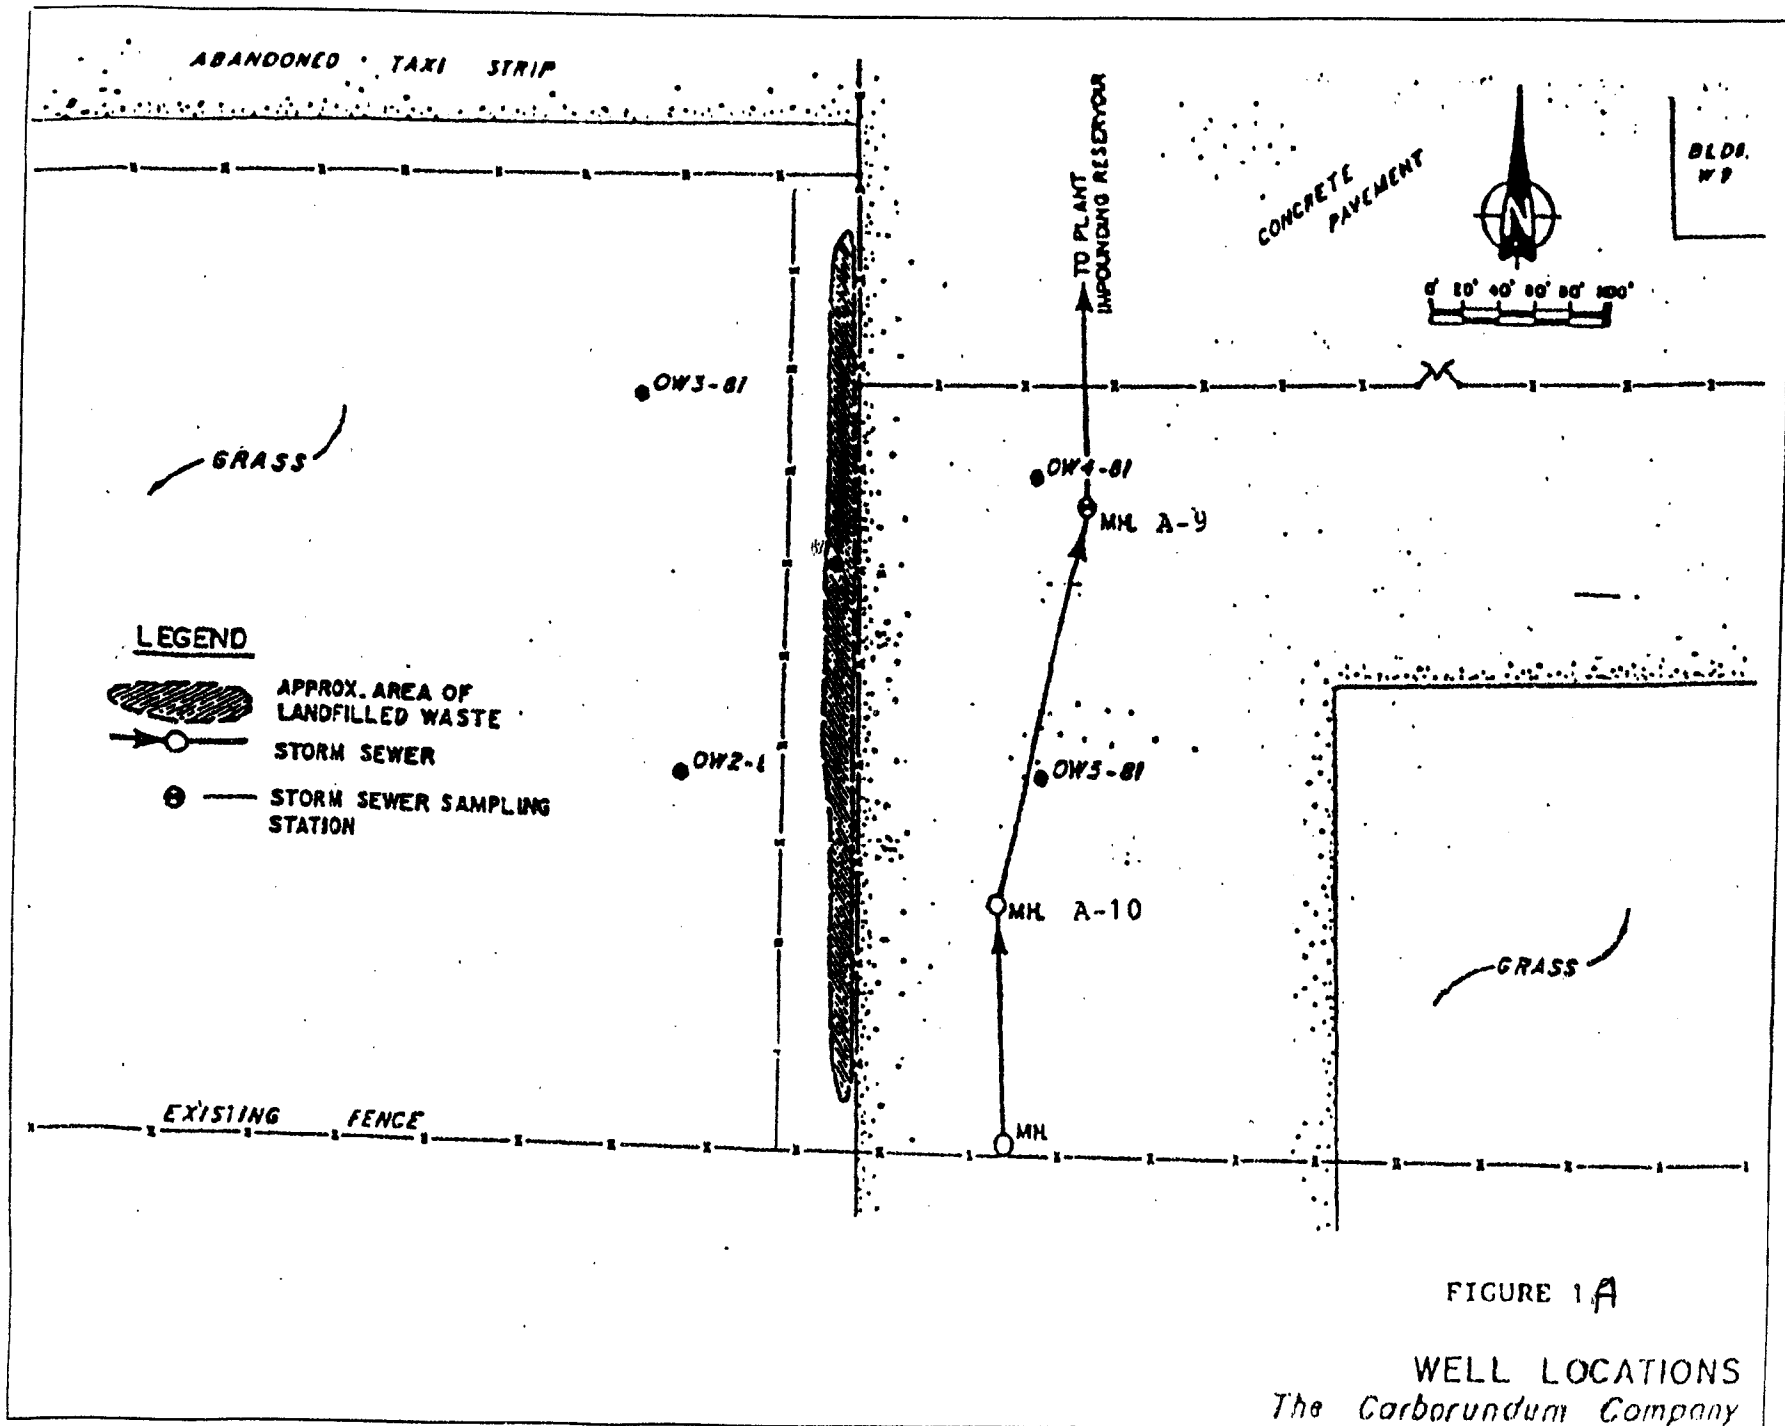
# Figure 1B. SCG Landfill Locations

As indicated previously, Figure 1A and 1B illustrate the sample locations. Four wells are sampled together with one catch basin (MH-9 located on the "A" Storm Line). Table 1 presents the sample locations and USEPA or Standard Methods analytical methods used for samples from each location. All methods used conformed to the USEPA Methods of

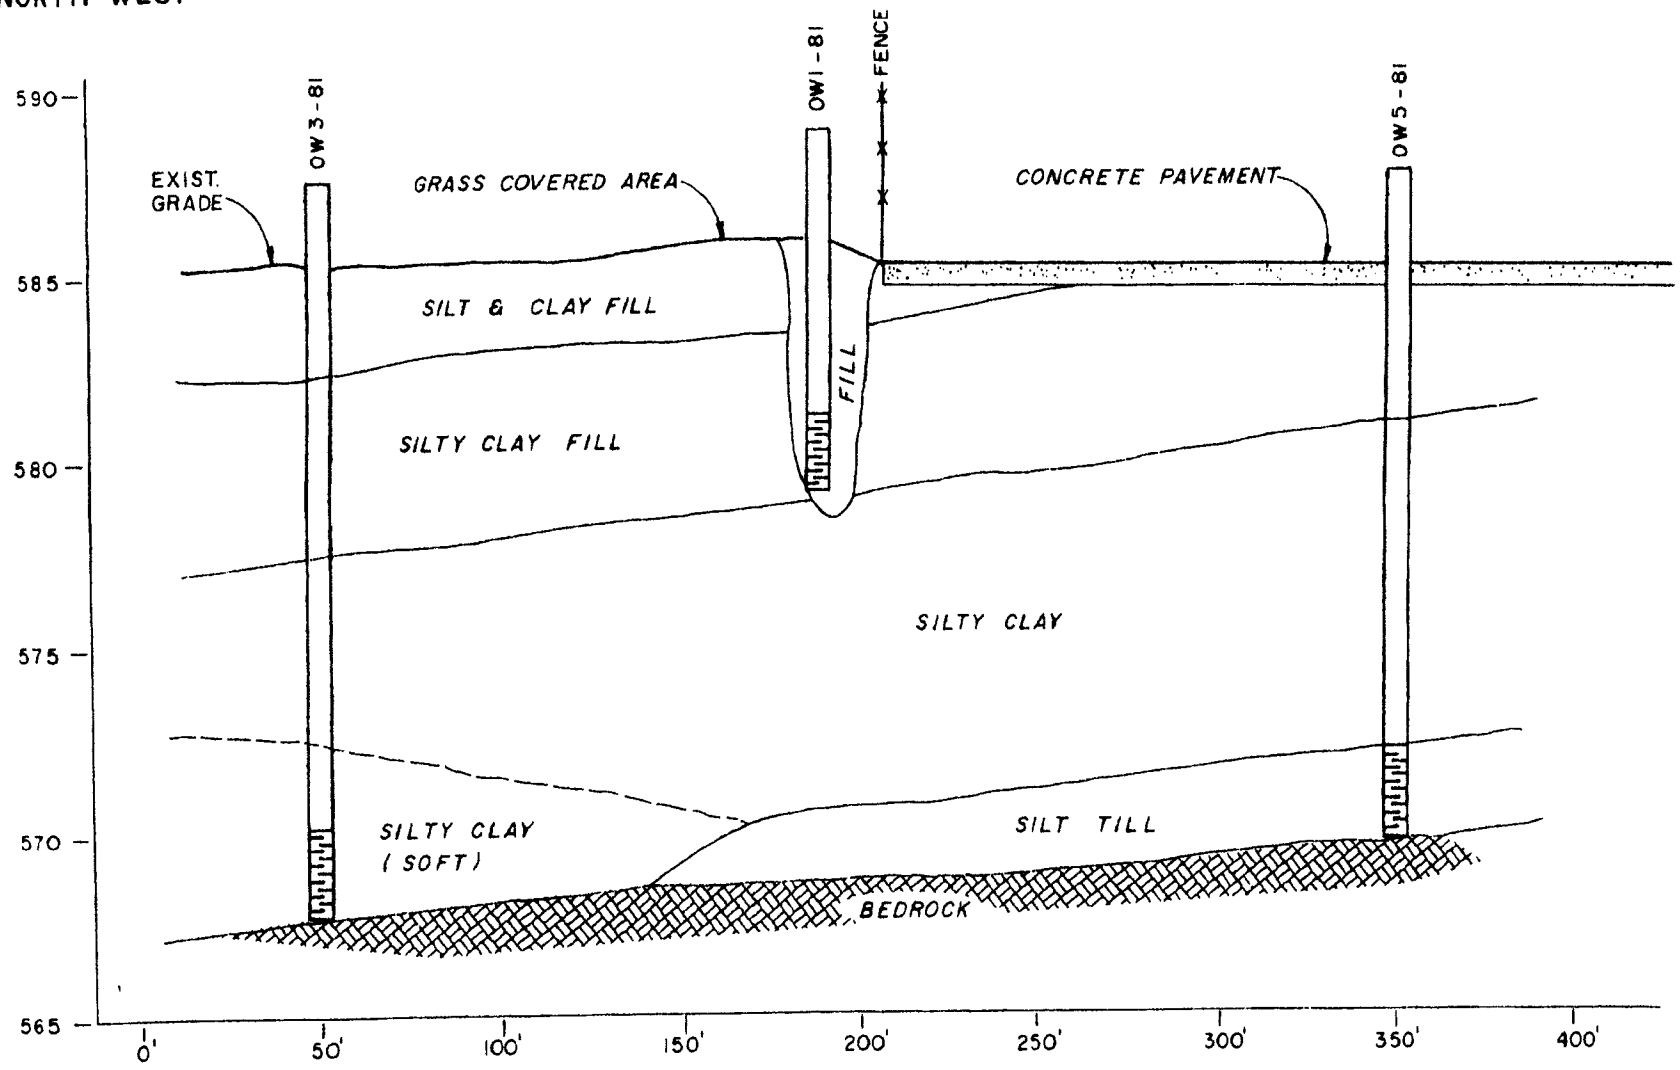
**Figure 2**  
GEOLOGIC CROSS SECTION A - A'  
The Carborundum Company

The bedrock underlying the site consists of approximately 160 feet of dolomite of the Lockport Formation. The upper zone of the Lockport Formation is generally highly weathered, medium gray dolomite with extensive vertical fractures. It is generally striated on the surface, has extensive partings which are argillaceous or gypsum-coated. Water produced from this upper zone in the Bergholtz area of Wheatfield is generally of very poor quality, with a characteristic odor. The water generally is not suitable for drinking but occasionally is used for watering livestock or agricultural purposes. The Town of Wheatfield has extended its water lines throughout the area and recent information indicates that there are few wells in use throughout the area. Those that were used occasionally along Walmore Rd to the south were closed as part of a groundwater remediation effort conducted by the former Bell Aerospace-Textron in the late 1980's and early 1990's. This groundwater withdrawal and treatment on-site continues to the present.

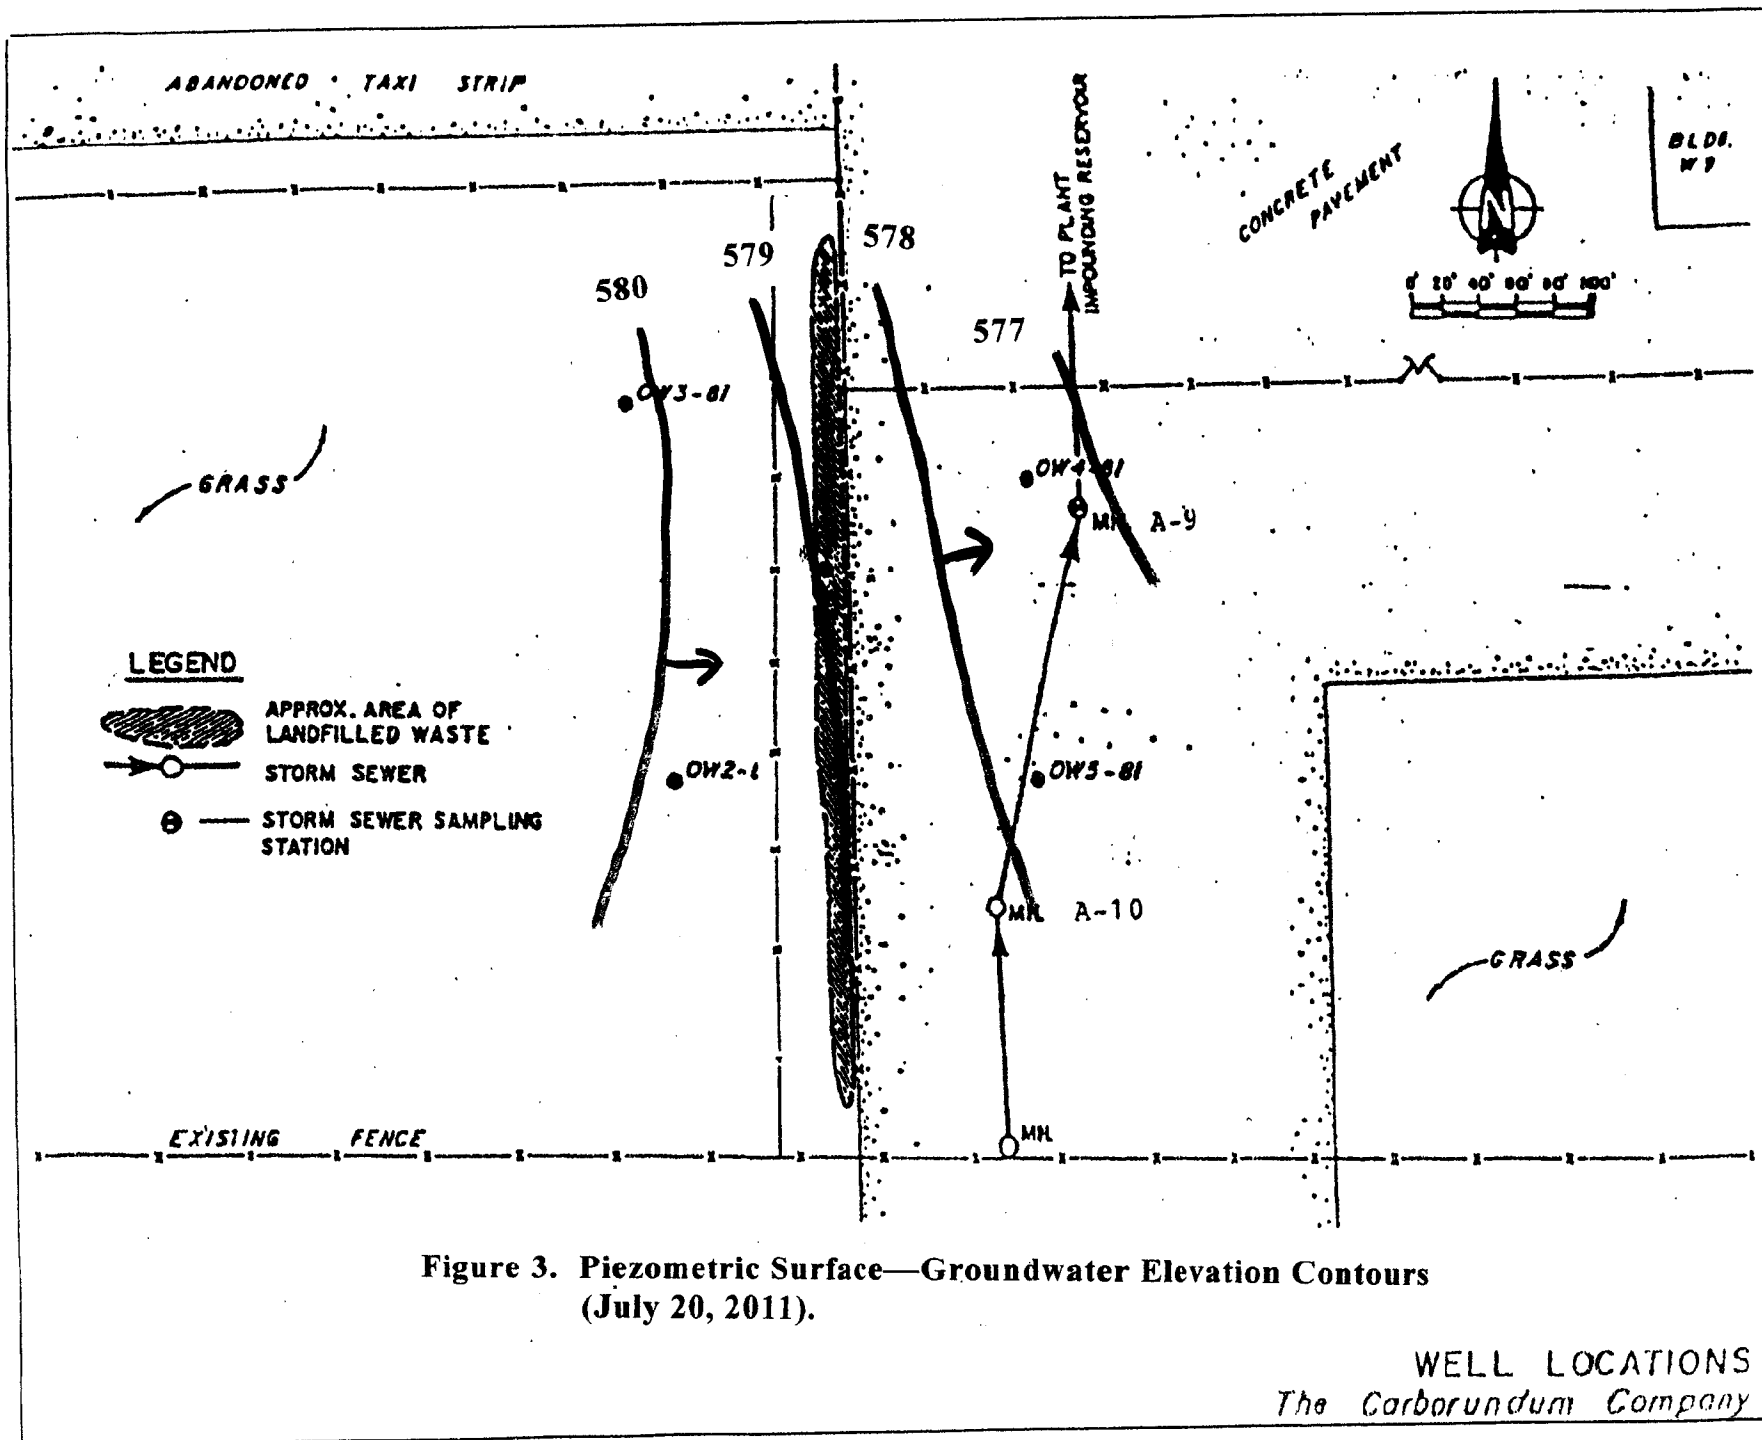
Figure 3. Piezometric Surface—Groundwater Elevation Contours (July 20, 2011).

The initial piezometric surface observed differs little from 1981 to the present time. The direction of groundwater flow is from the southwest to northeast and has remained constant through the series of investigations carried on over the last 20 years of monitoring by Frontier Technical Associates, Inc. In addition, based up the analysis of the groundwater, the landfill cap has remained intact, and the quality of the groundwater has not been impaired. The landfill is functioning to contain the waste materials present. In addition, it would appear that the waste resins either were polymerized or became polymerized and thus very resistant to breakdown. No phenolic compounds are present in the catch basin draining the immediate area during recent sampling episodes in the last ten years. .

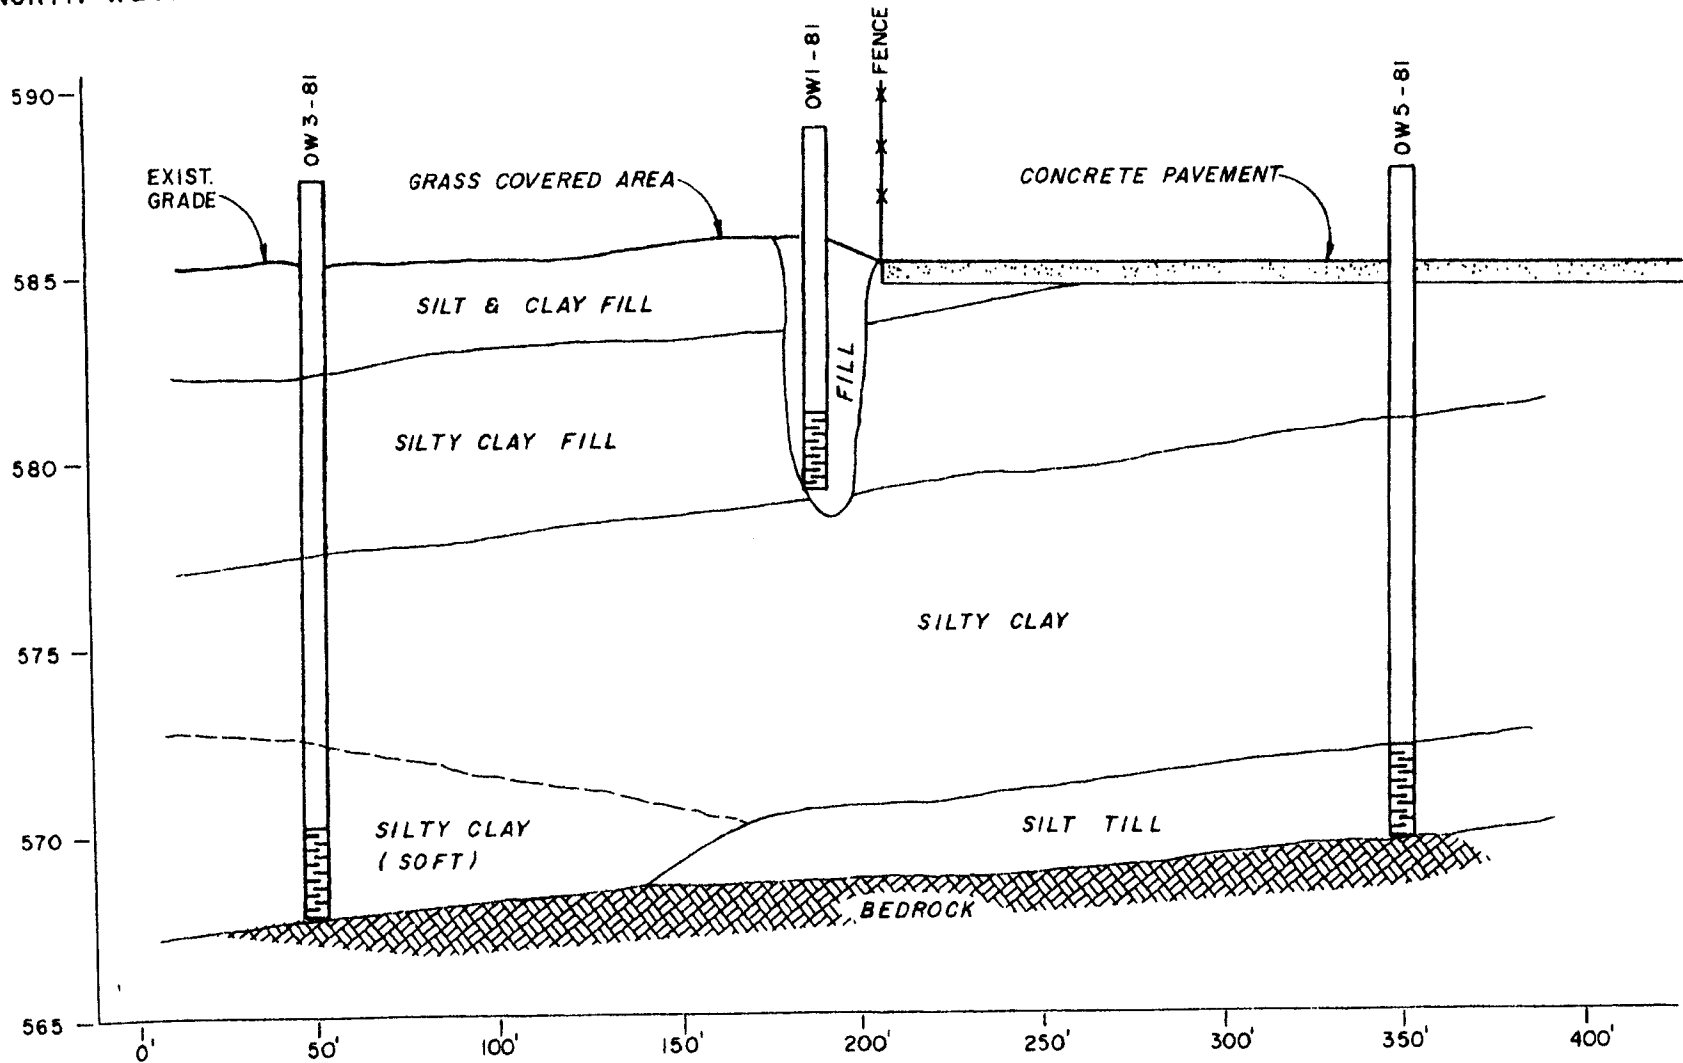
**Figure 2**

GEOLOGIC CROSS SECTION A - A'  
The Carborundum Company

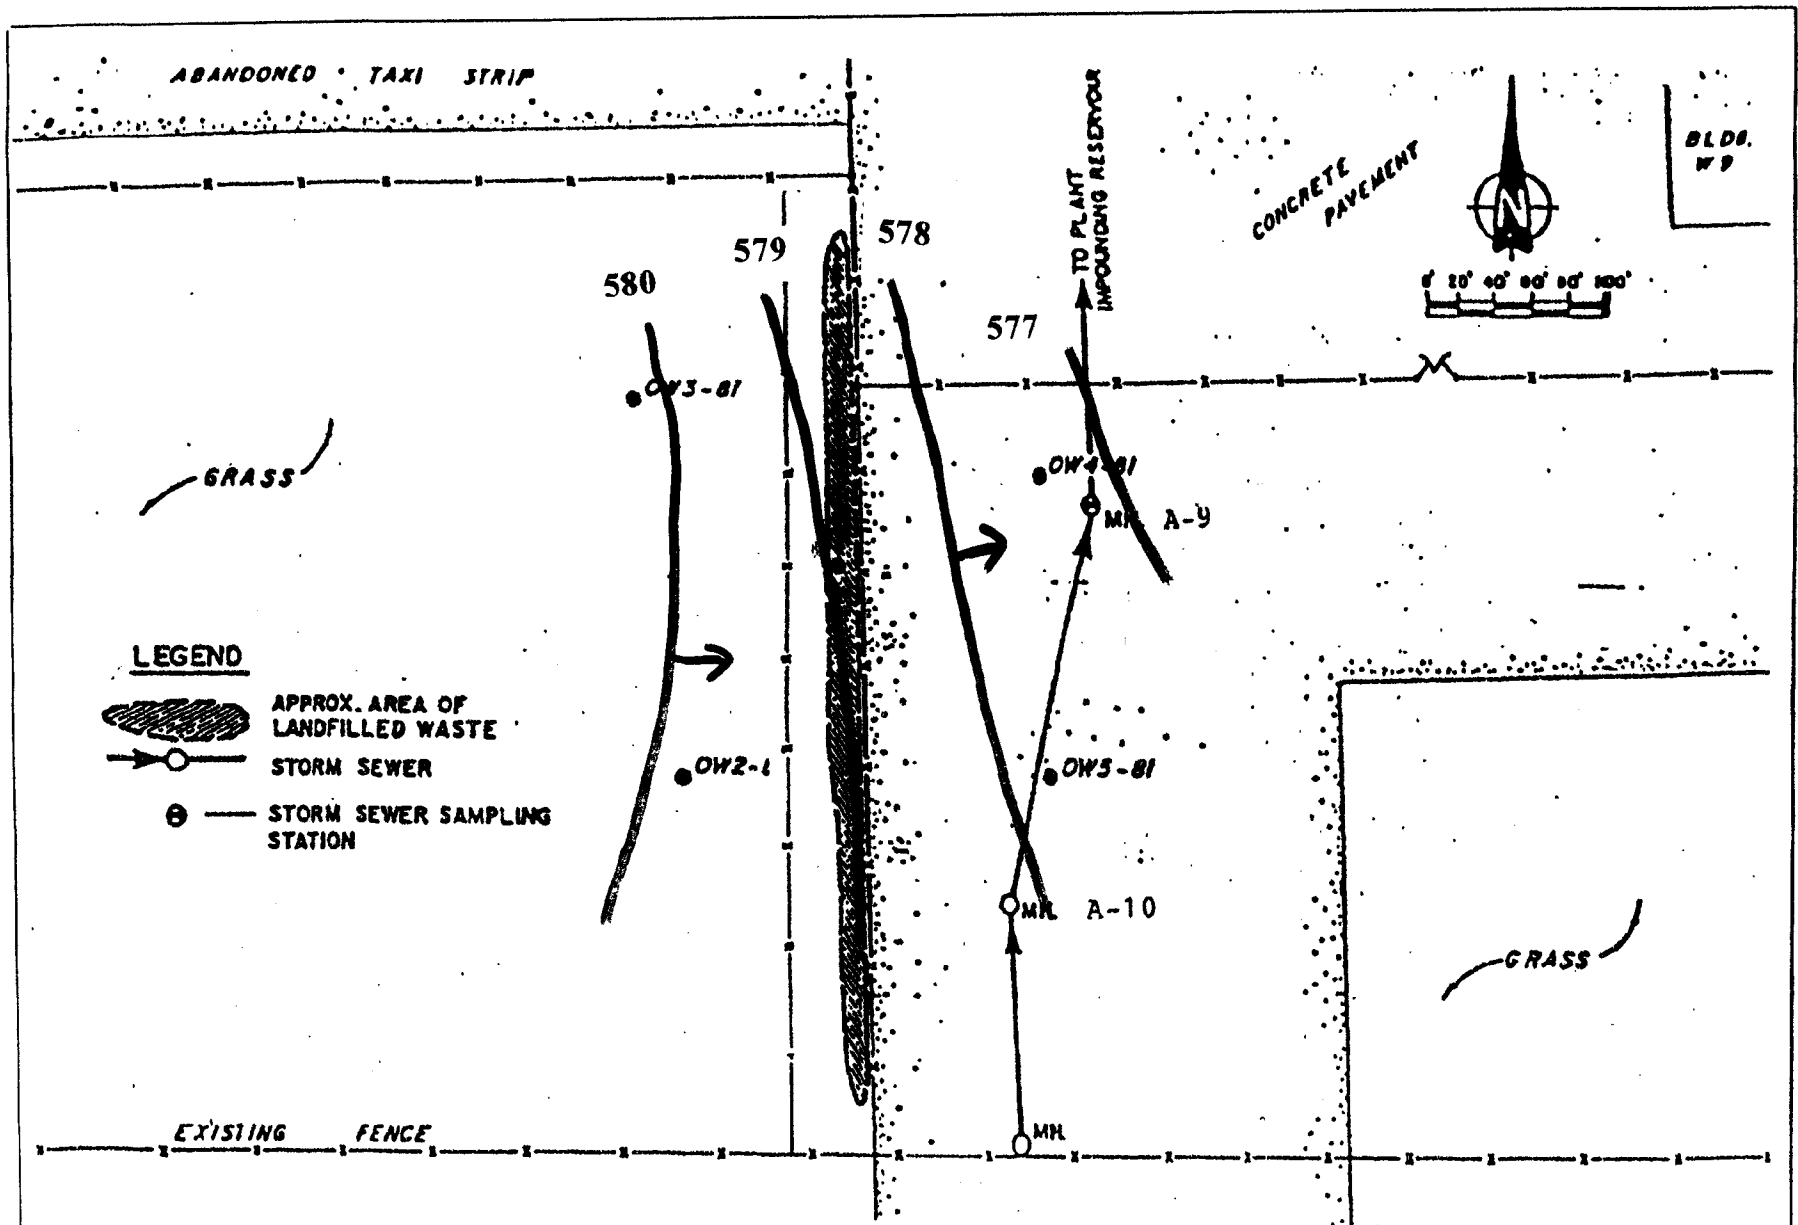
Figure 3. Piezometric Surface—Groundwater Elevation Contours (July 20, 2011).

WELL LOCATIONS  
The Carborundum Company
