Re: 102<sup>nd</sup> Street Landfill Site, Niagara Falls, NY  
2003 Annual Report

**102<sup>ND</sup> STREET LANDFILL SITE**  
**NIAGARA FALLS, NEW YORK**  
**ANNUAL REPORT 2003**

figure 1  
 102nd STREET LANDFILL  
 GROUNDWATER COLLECTION SYSTEM  
 Niagara Falls, New York

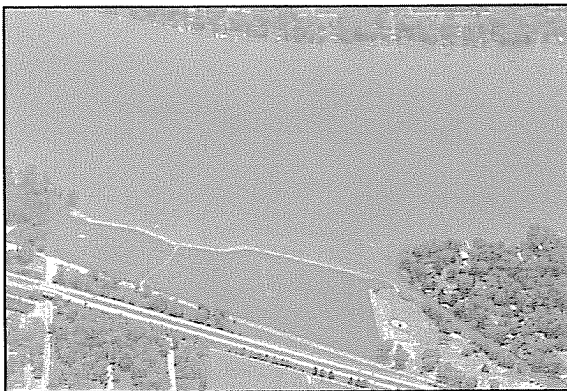
FIGURE 1      GROUNDWATER COLLECTION SYSTEM

The RA system components at the Site that have associated O&M activities are as follows (see figure 1 for the site layout):

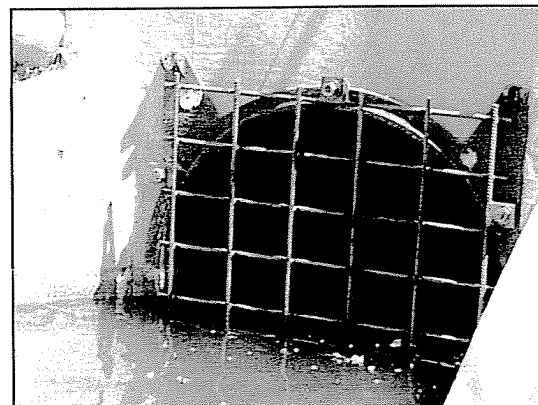
One major item of concern noted during the previous year inspections was that the ductile iron flap gate covering the end of the 48" diameter storm sewer had broken off and was lying in the river next to the shore. The original plan called for the gate to be reinstalled on the sewer but further study showed that the gate could possibly become jammed shut with ice and debris. It was agreed that the flap gate would not be reinstalled but a grate would be placed over the sewer outlet to prevent debris from entering the pipe. This grate has been installed (see photo). Sewer conditions would be monitored to determine if the reinstallation of the gate would be necessary.

| Maintenance Required | Date Performed |
|---|---|
| <u>Replacement of storm sewer flapper gate with grating.</u> | <u>June-2003</u> |

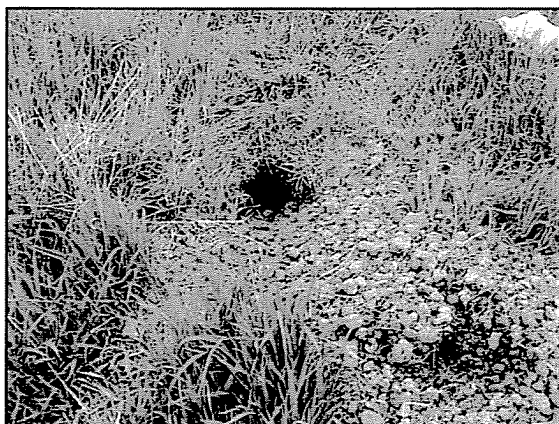
Partially collapsed culvert piping under the NAPL Well access roads was repaired and additional stone was added over the pipe to provide additional protection. Markers were installed to keep vehicles away from the culvert ends.

| Item | Action | Date | Status |
|---|---|---|---|
| Culvert pipe on access road. | Repair cover with stone and add markers. | Oct-2003. | Repair in Spring-2004. |
