**THIRD FIVE-YEAR REVIEW REPORT  
NIAGARA COUNTY REFUSE SUPERFUND SITE  
TOWN OF WHEATFIELD  
NIAGARA COUNTY, NEW YORK**

**U.S. Environmental Protection Agency  
Region II  
New York, New York**

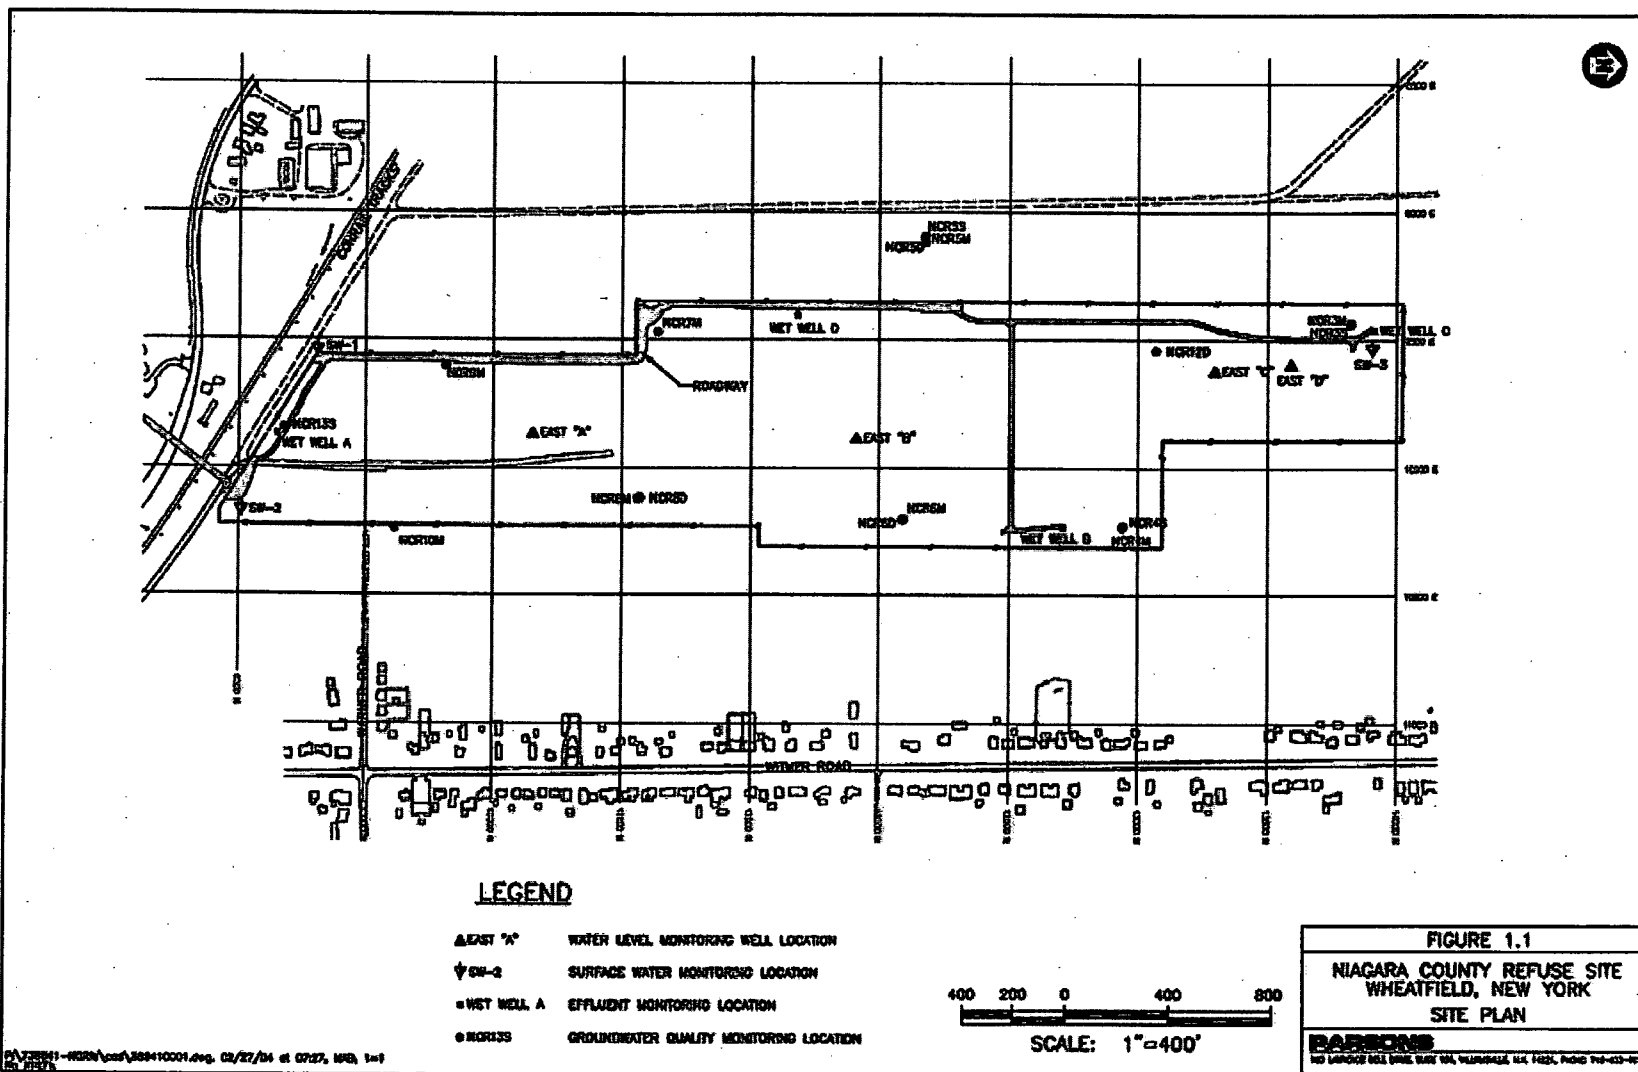
Figure 1, Site Map

The Niagara County Refuse Site is a former municipal landfill, comprised of approximately 65 acres, located along the eastern border of the Town of Wheatfield, New York and the western border of the City of North Tonawanda. The Site lies approximately 500 feet north of the Niagara River. To the west of the Site lies former farmland, currently undeveloped; to the north is wooded wetlands, a Niagara-Mohawk Power Corporation transmission line, and a right-of-way owned by the New York State Department of Transportation; to the east are woodlands and low-density housing (approximately 1,000 feet from the Site boundary); and to the south are access roads, railroad tracks, River Road, and the Niagara River.
