# *Data Gap Analysis Report*

**for the Former Guterl Specialty Steel Corporation**  
*Lockport, New York*

**Data Gap Analysis Report**  
**Former Guterl Specialty Steel Corporation**  
**FUSRAP Site**  
Lockport, New York

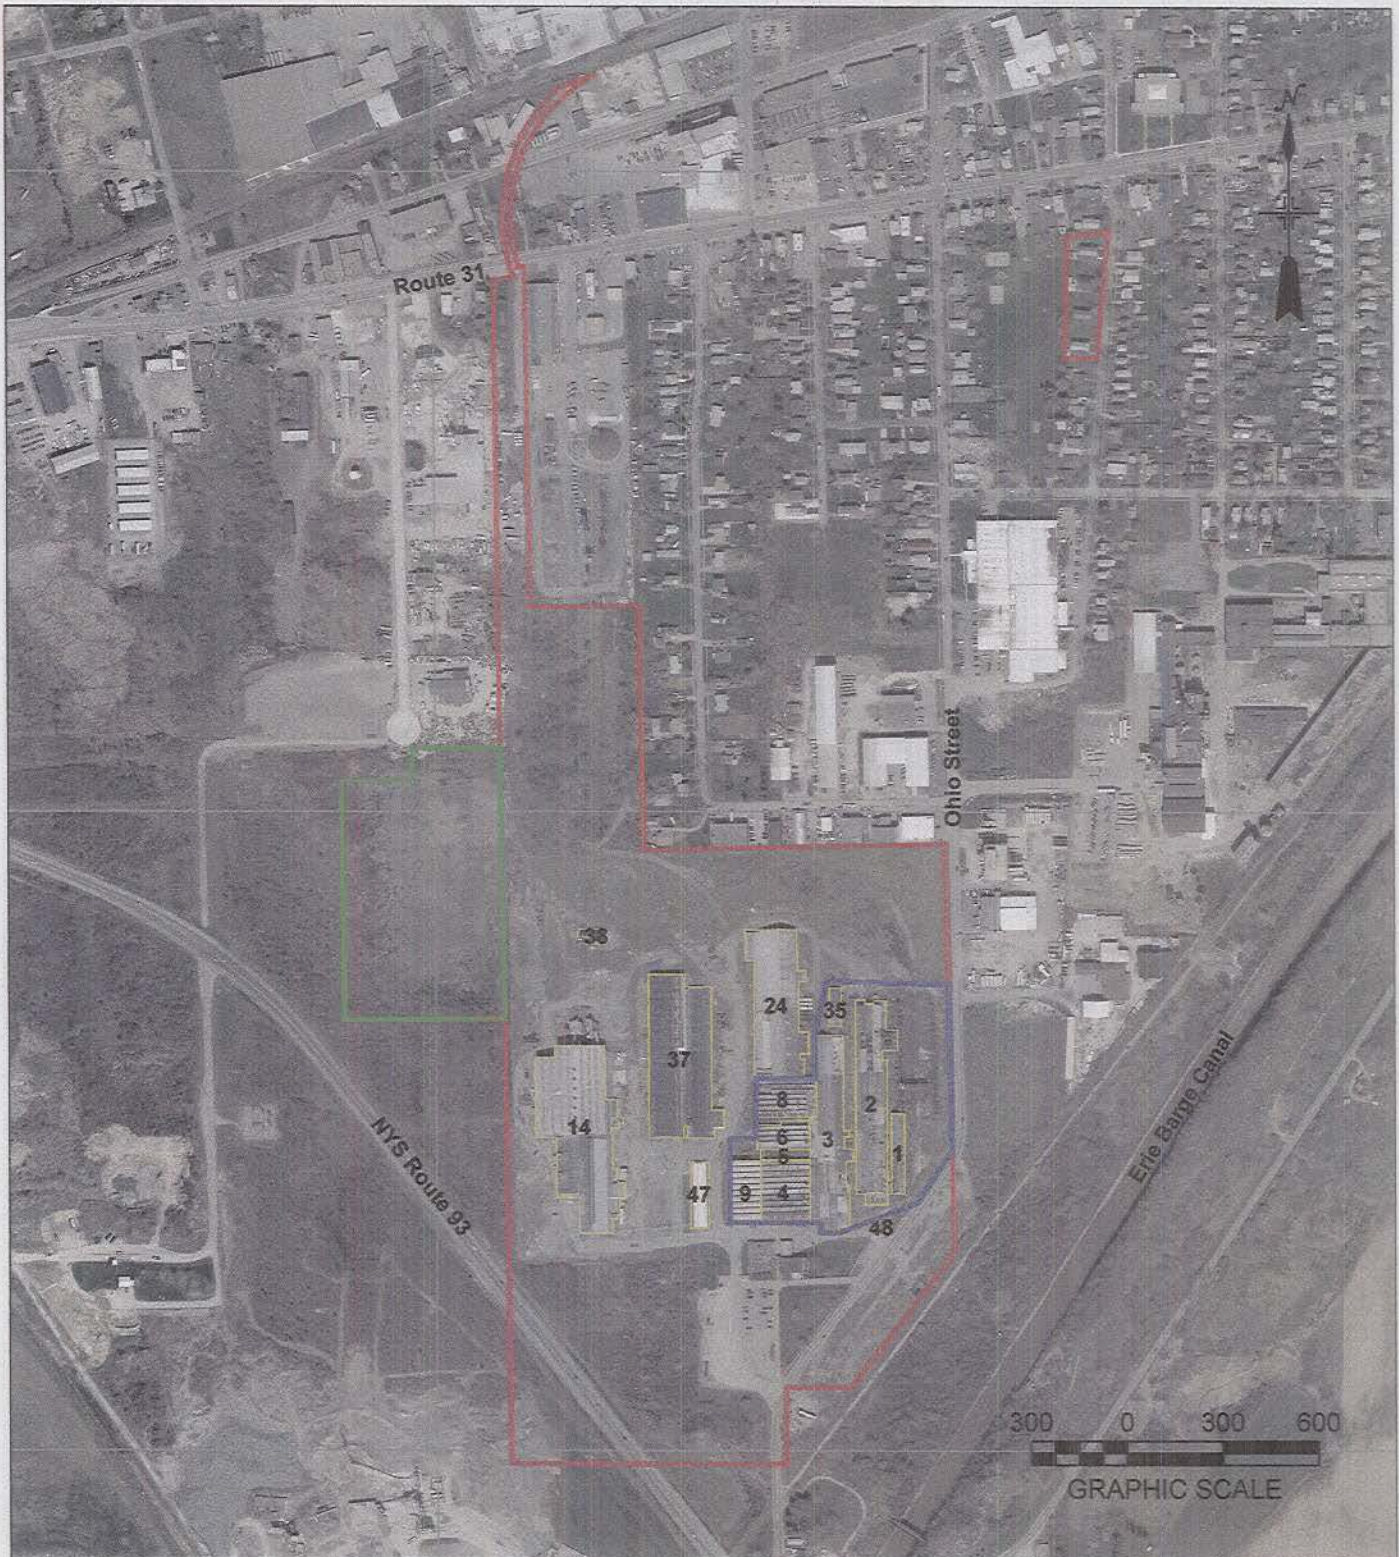
Guterl Site Boundary
-   Guterl Excised Boundary
-   Guterl Landfill Boundary
-   Guterl Buildings

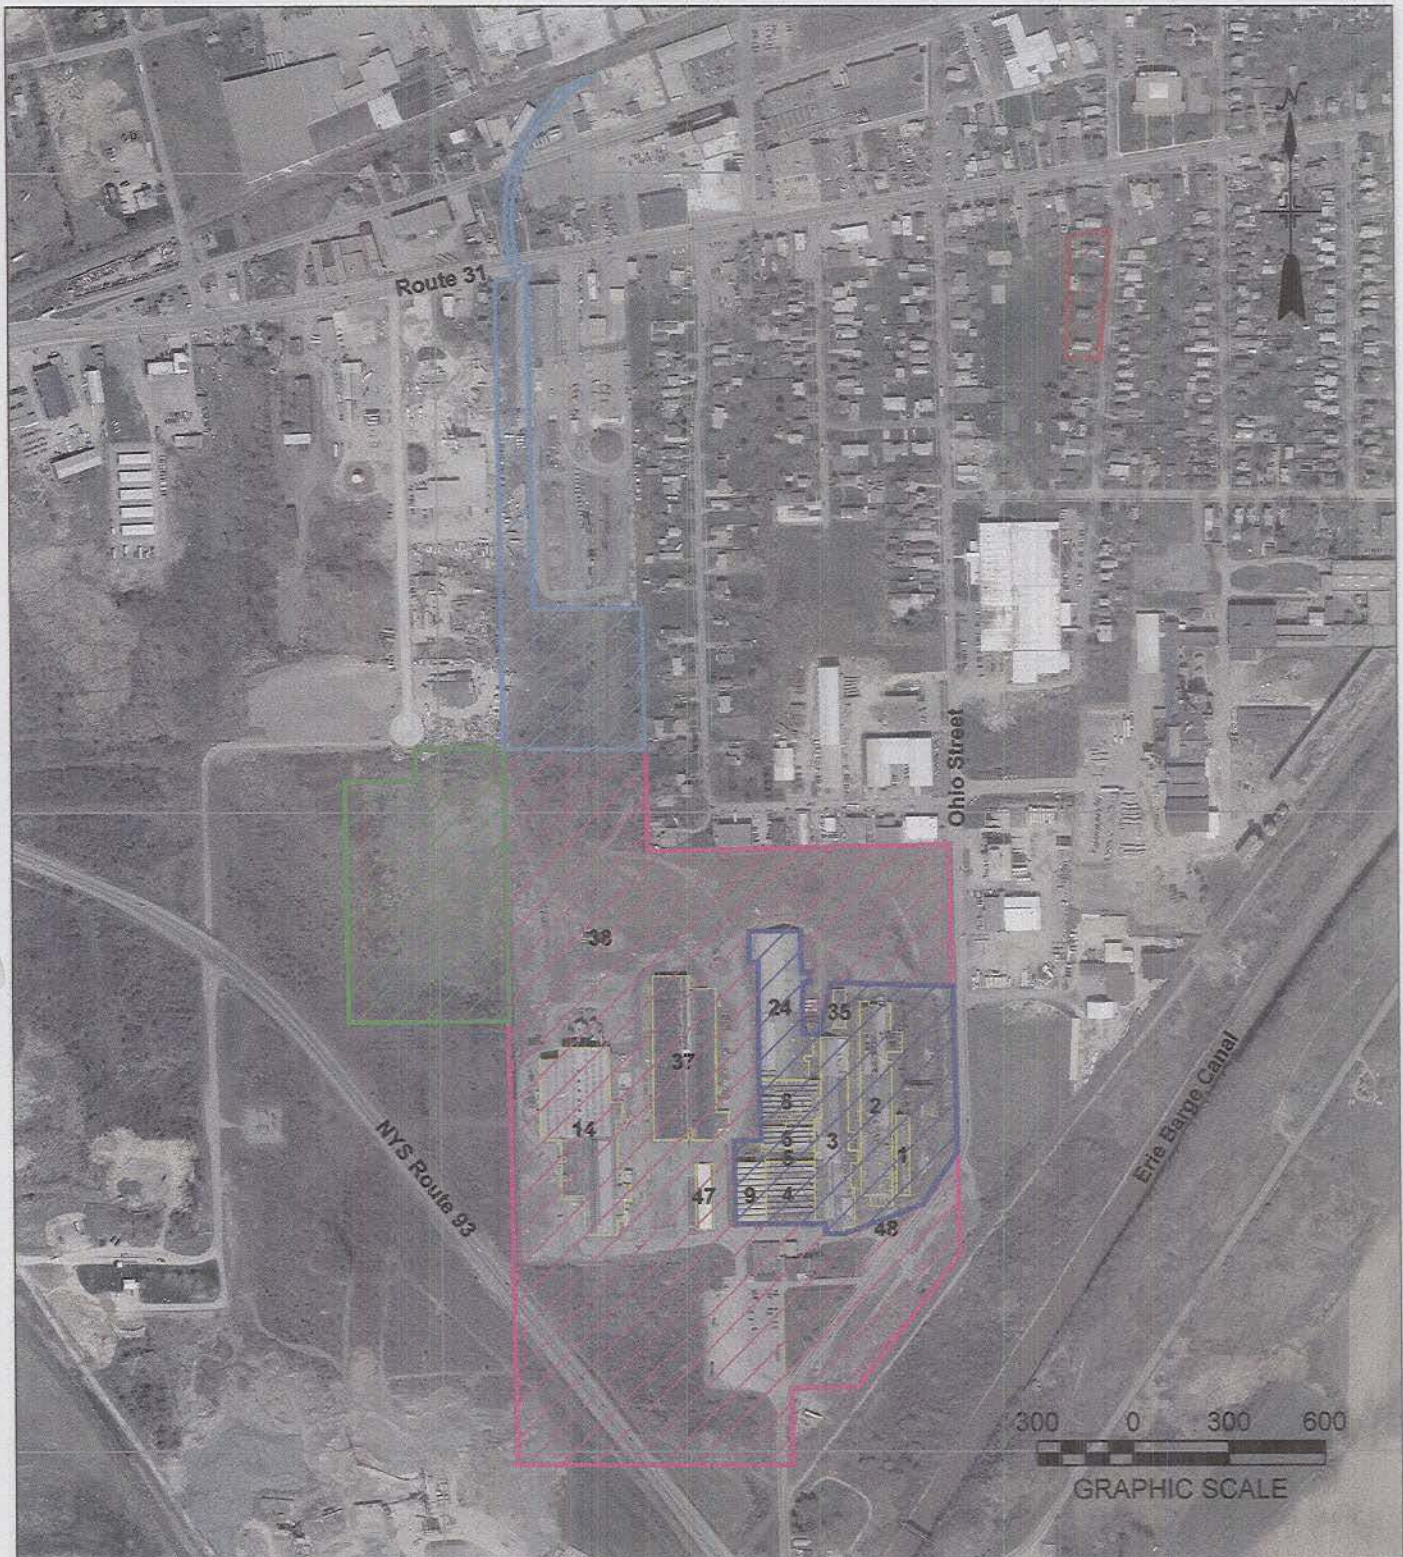
- 24 Guterl Buildings
- / IA01 Excised Area - Building Surfaces and Interiors & IA02 Excised Area - Building Exteriors
- / IA03 Landfill Area
- / IA04 NCIDA Property
- / IA05 Railroad Right-of-Way
- / IA06 Off-site Northeast Properties
- IA07 Groundwater & IA08 Site Utilities includes all hatched areas.
