Data Gap Analysis Report

Former Guterl Specialty Steel Corporation FUSRAP Site Lockport, New York

9 March 2012
Final

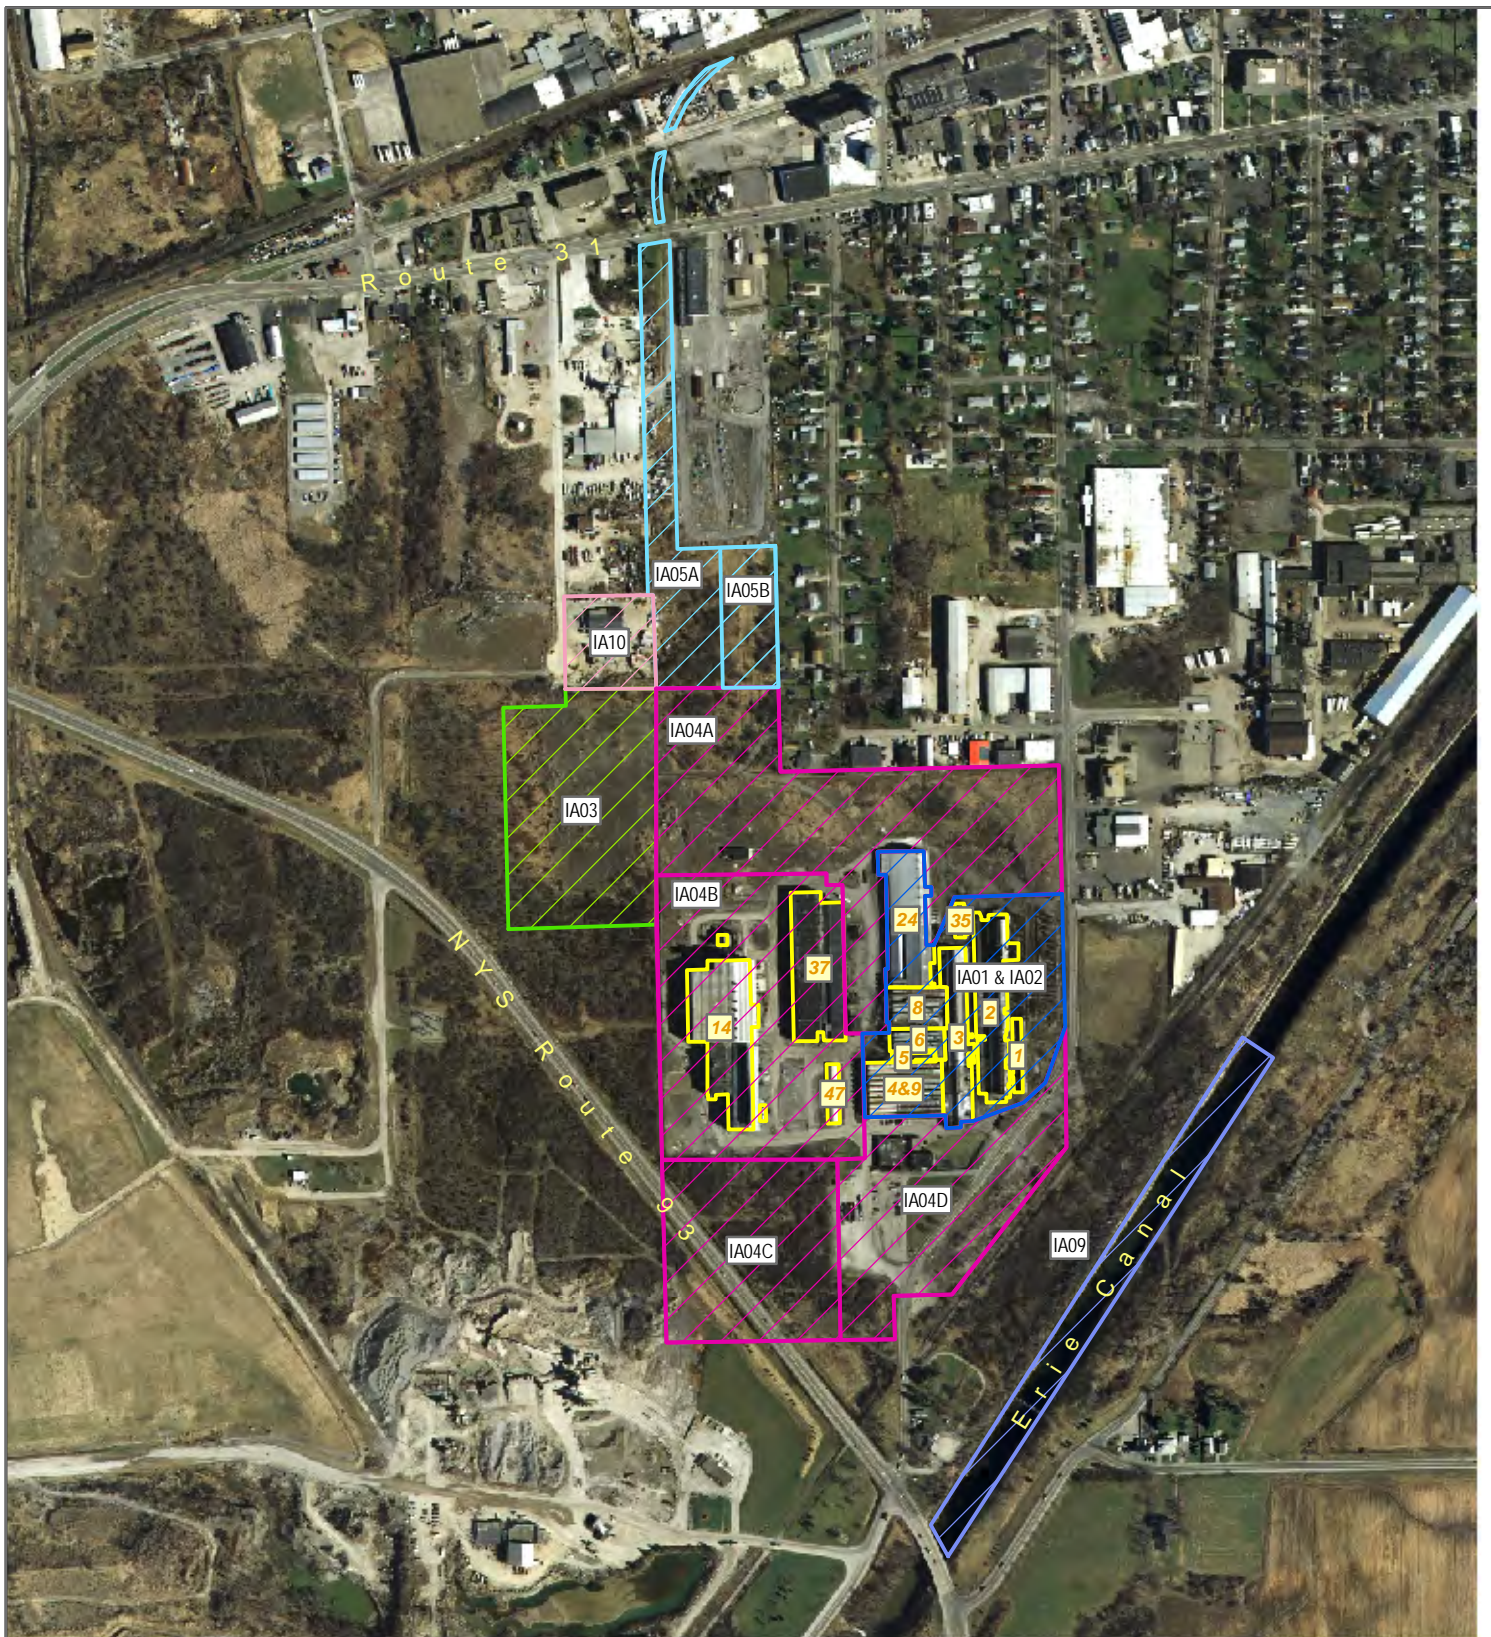
Figure No. :
1-2

- IA01 - Excised Area - Building Surfaces and Interiors
- IA02 - Excised Area - Building Exteriors
- IA03 - Landfill Area
- IA04 - NCIDA Property
- IA05 - Railroad Right-of-Way
- IA09 - Erie Canal
- IA10 - Lot 7.1
- Guterl Buildings

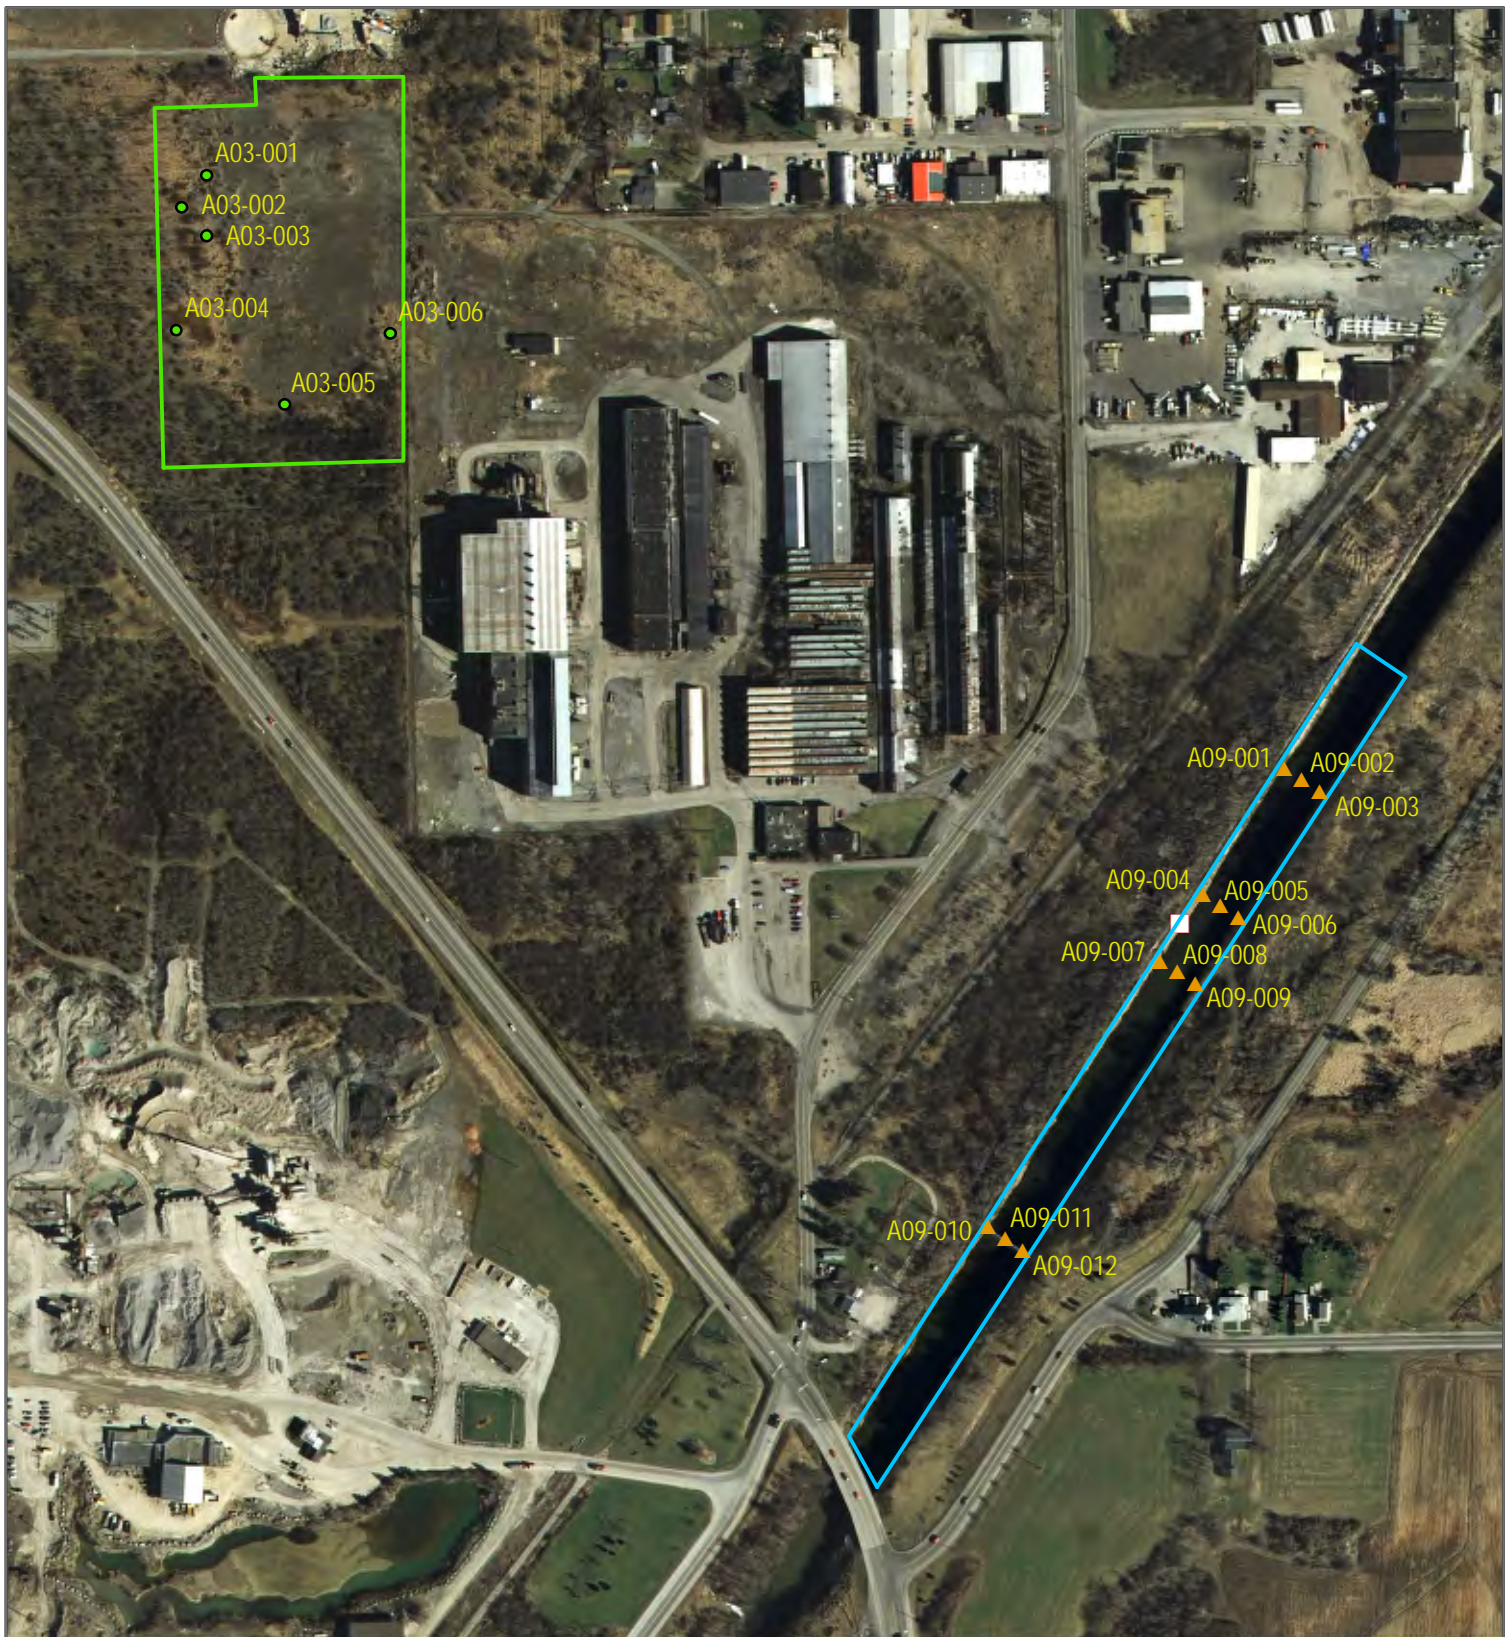
Figure No. :
3-16

Sediment and Surface Water Sample Locations

- Sediment Only
- ▲ Sediment and Surface Water
- IA03 - Landfill Area
- IA09 - Erie Canal Southeast of Site
- Former Guterl Steel Industrial Water Pump House Intake and Oil/Water Separator Outfall

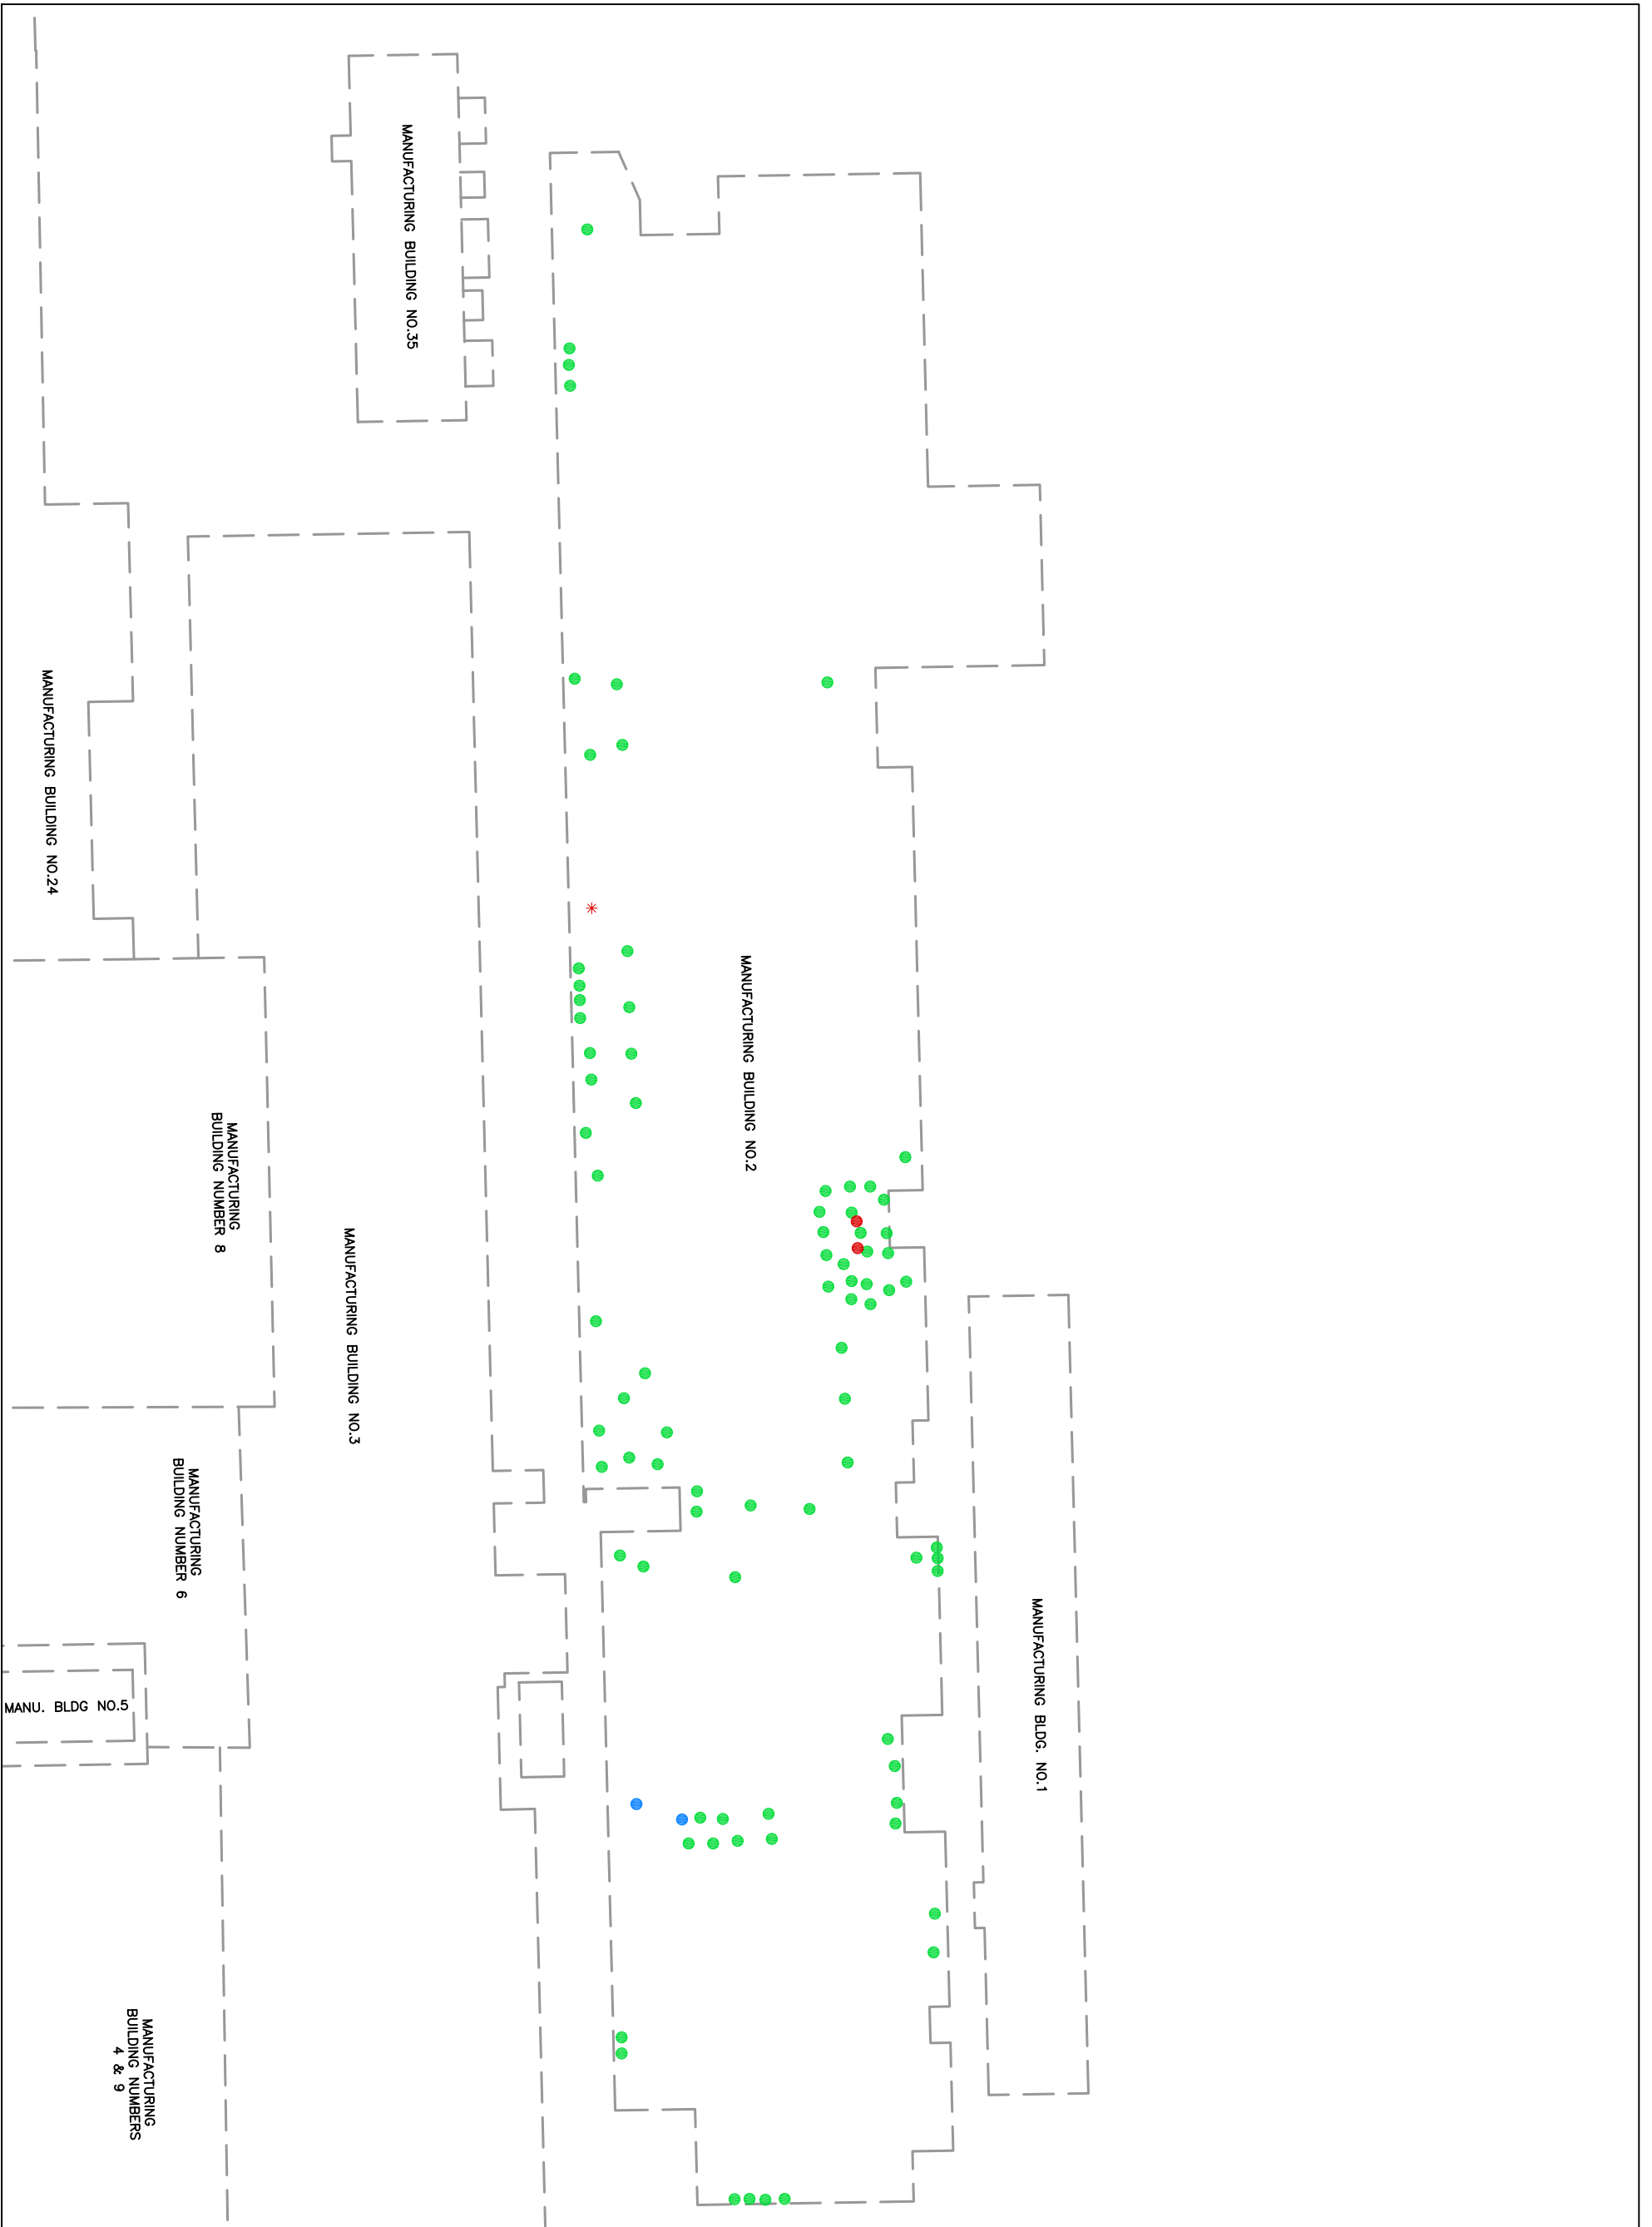
Figure No.: 4-31

MEASUREMENT/SAMPLING LOCATIONS

- >1,000 and ≤ 5,000 dpm/100 cm² β
- >5,000 and ≤ 15,000 dpm/100 cm² β
- >15,000 dpm/100 cm² β
- * >1,000 dpm/100 cm² α

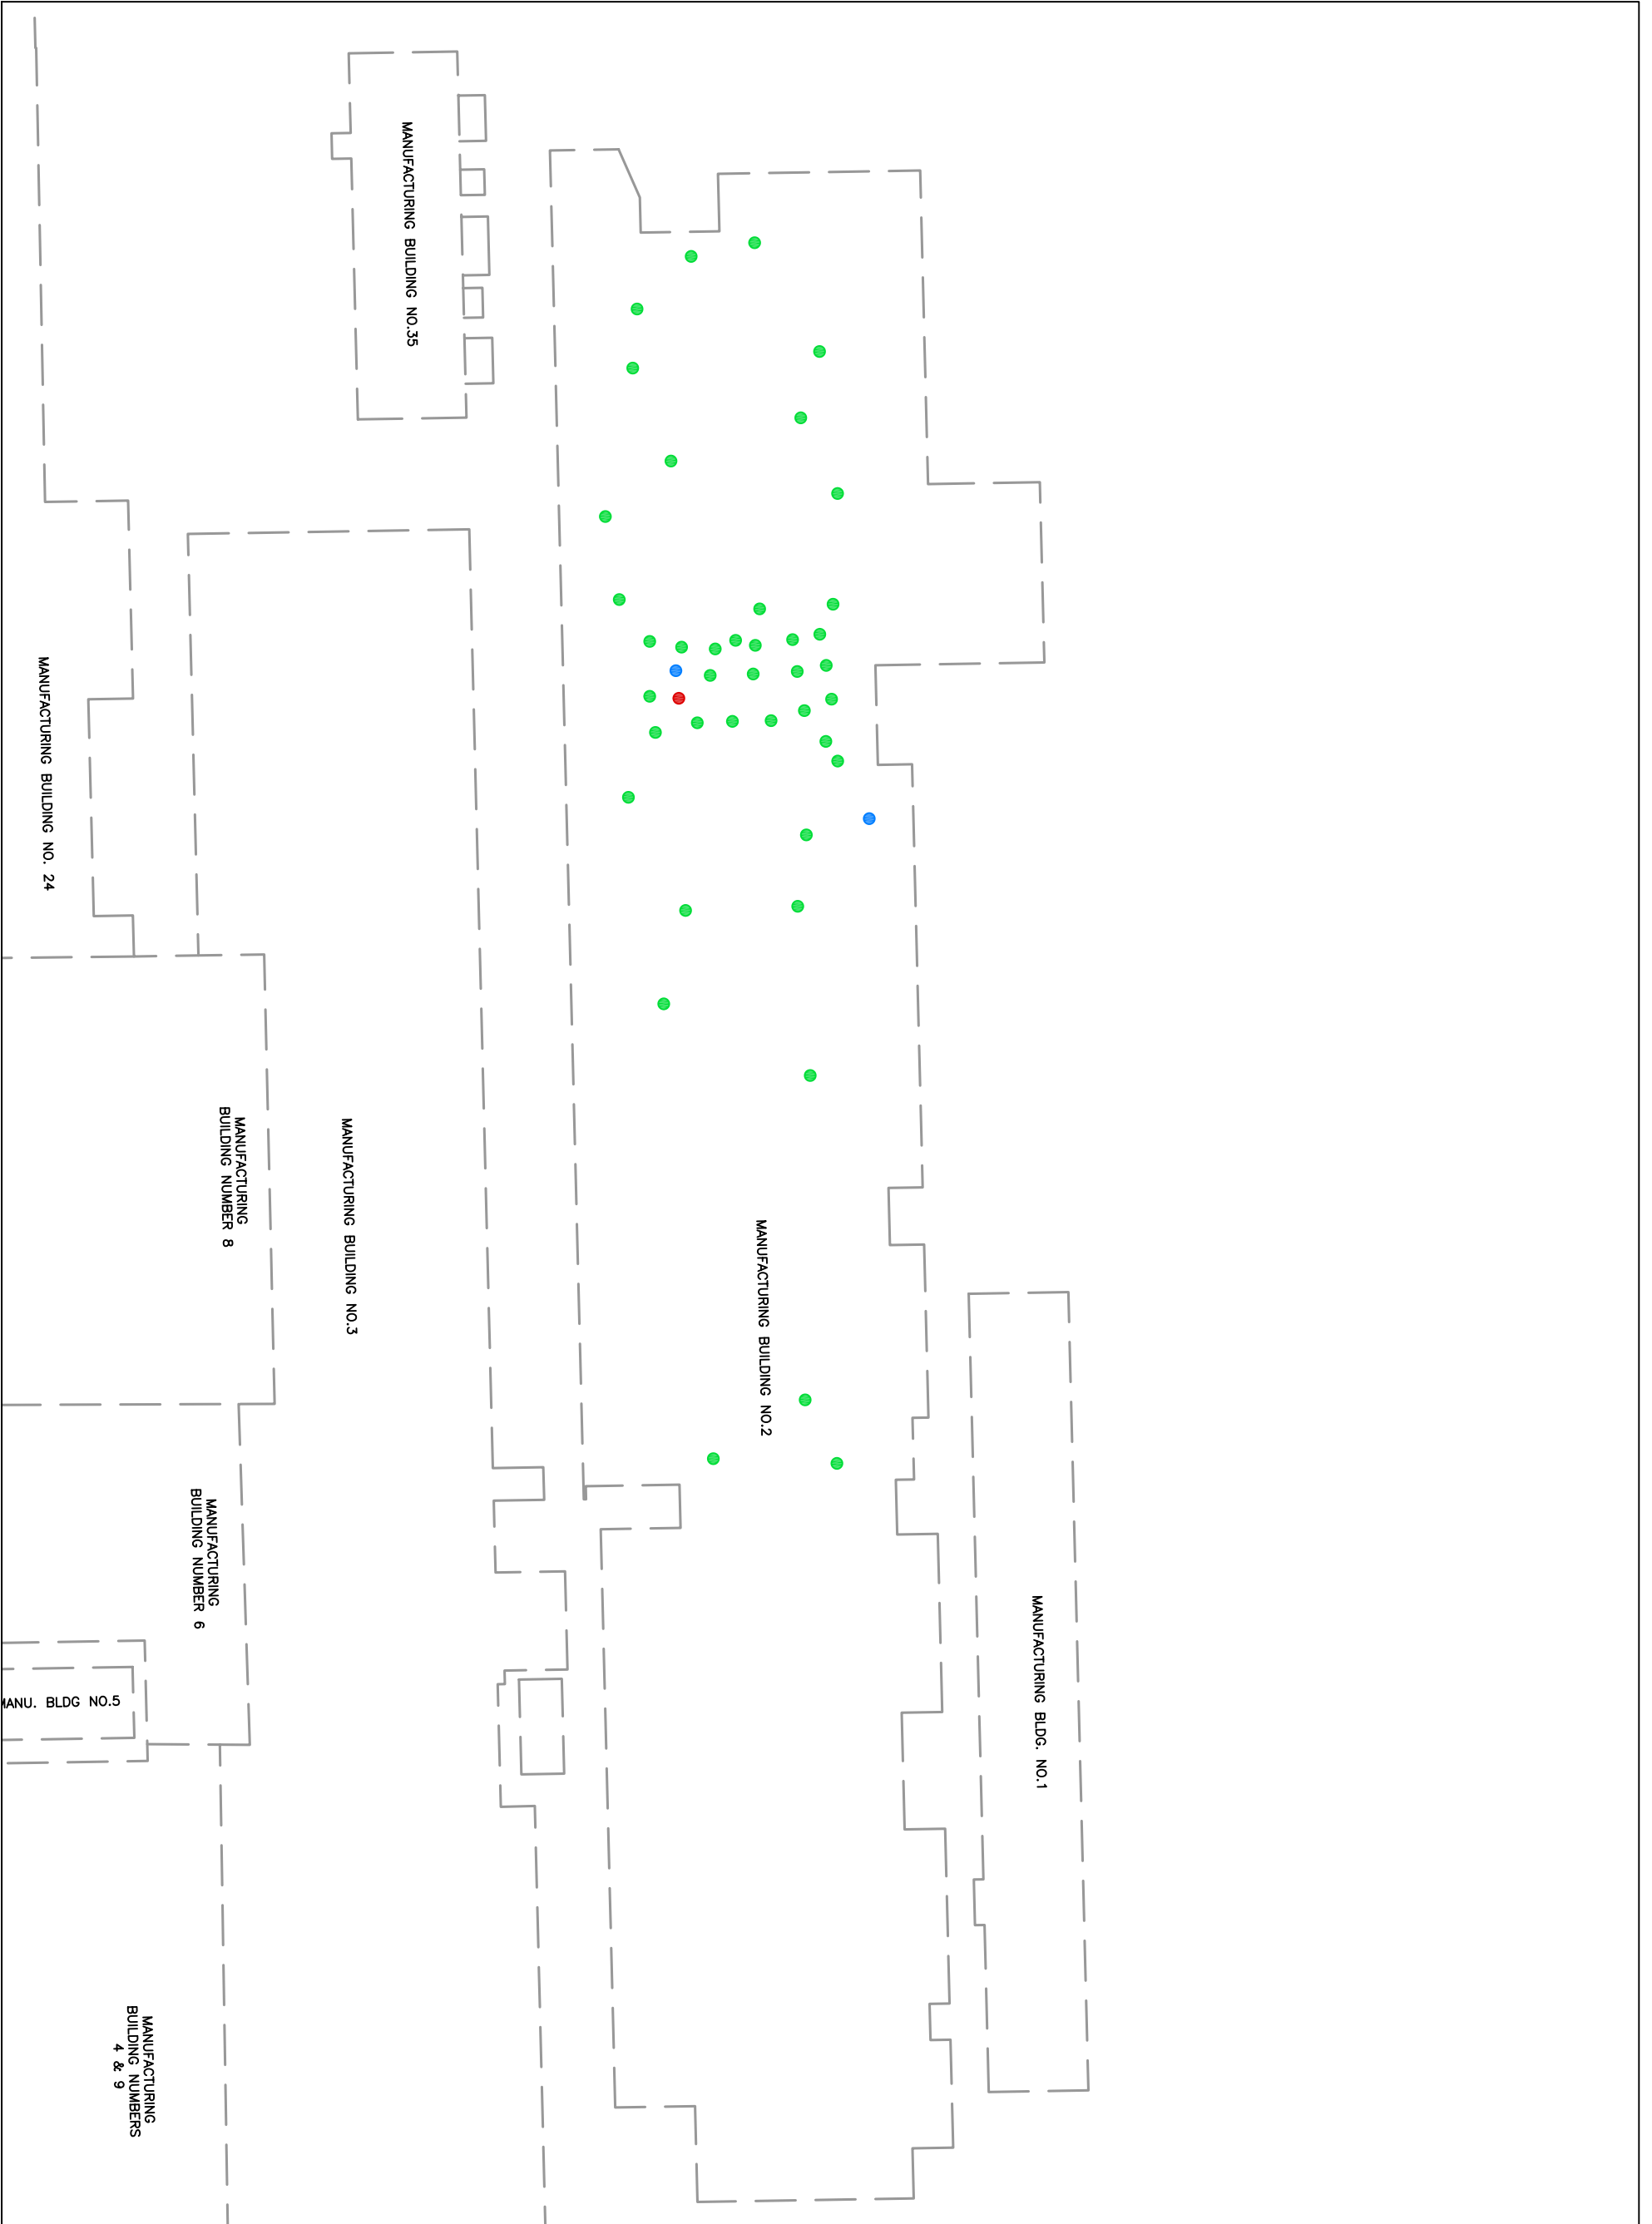
Figure No.: 4-32

MEASUREMENT/SAMPLING LOCATIONS

- >1,000 and ≤ 5,000 dpm/100 cm² β
- >5,000 and ≤ 15,000 dpm/100 cm² β
- >15,000 dpm/100 cm² β

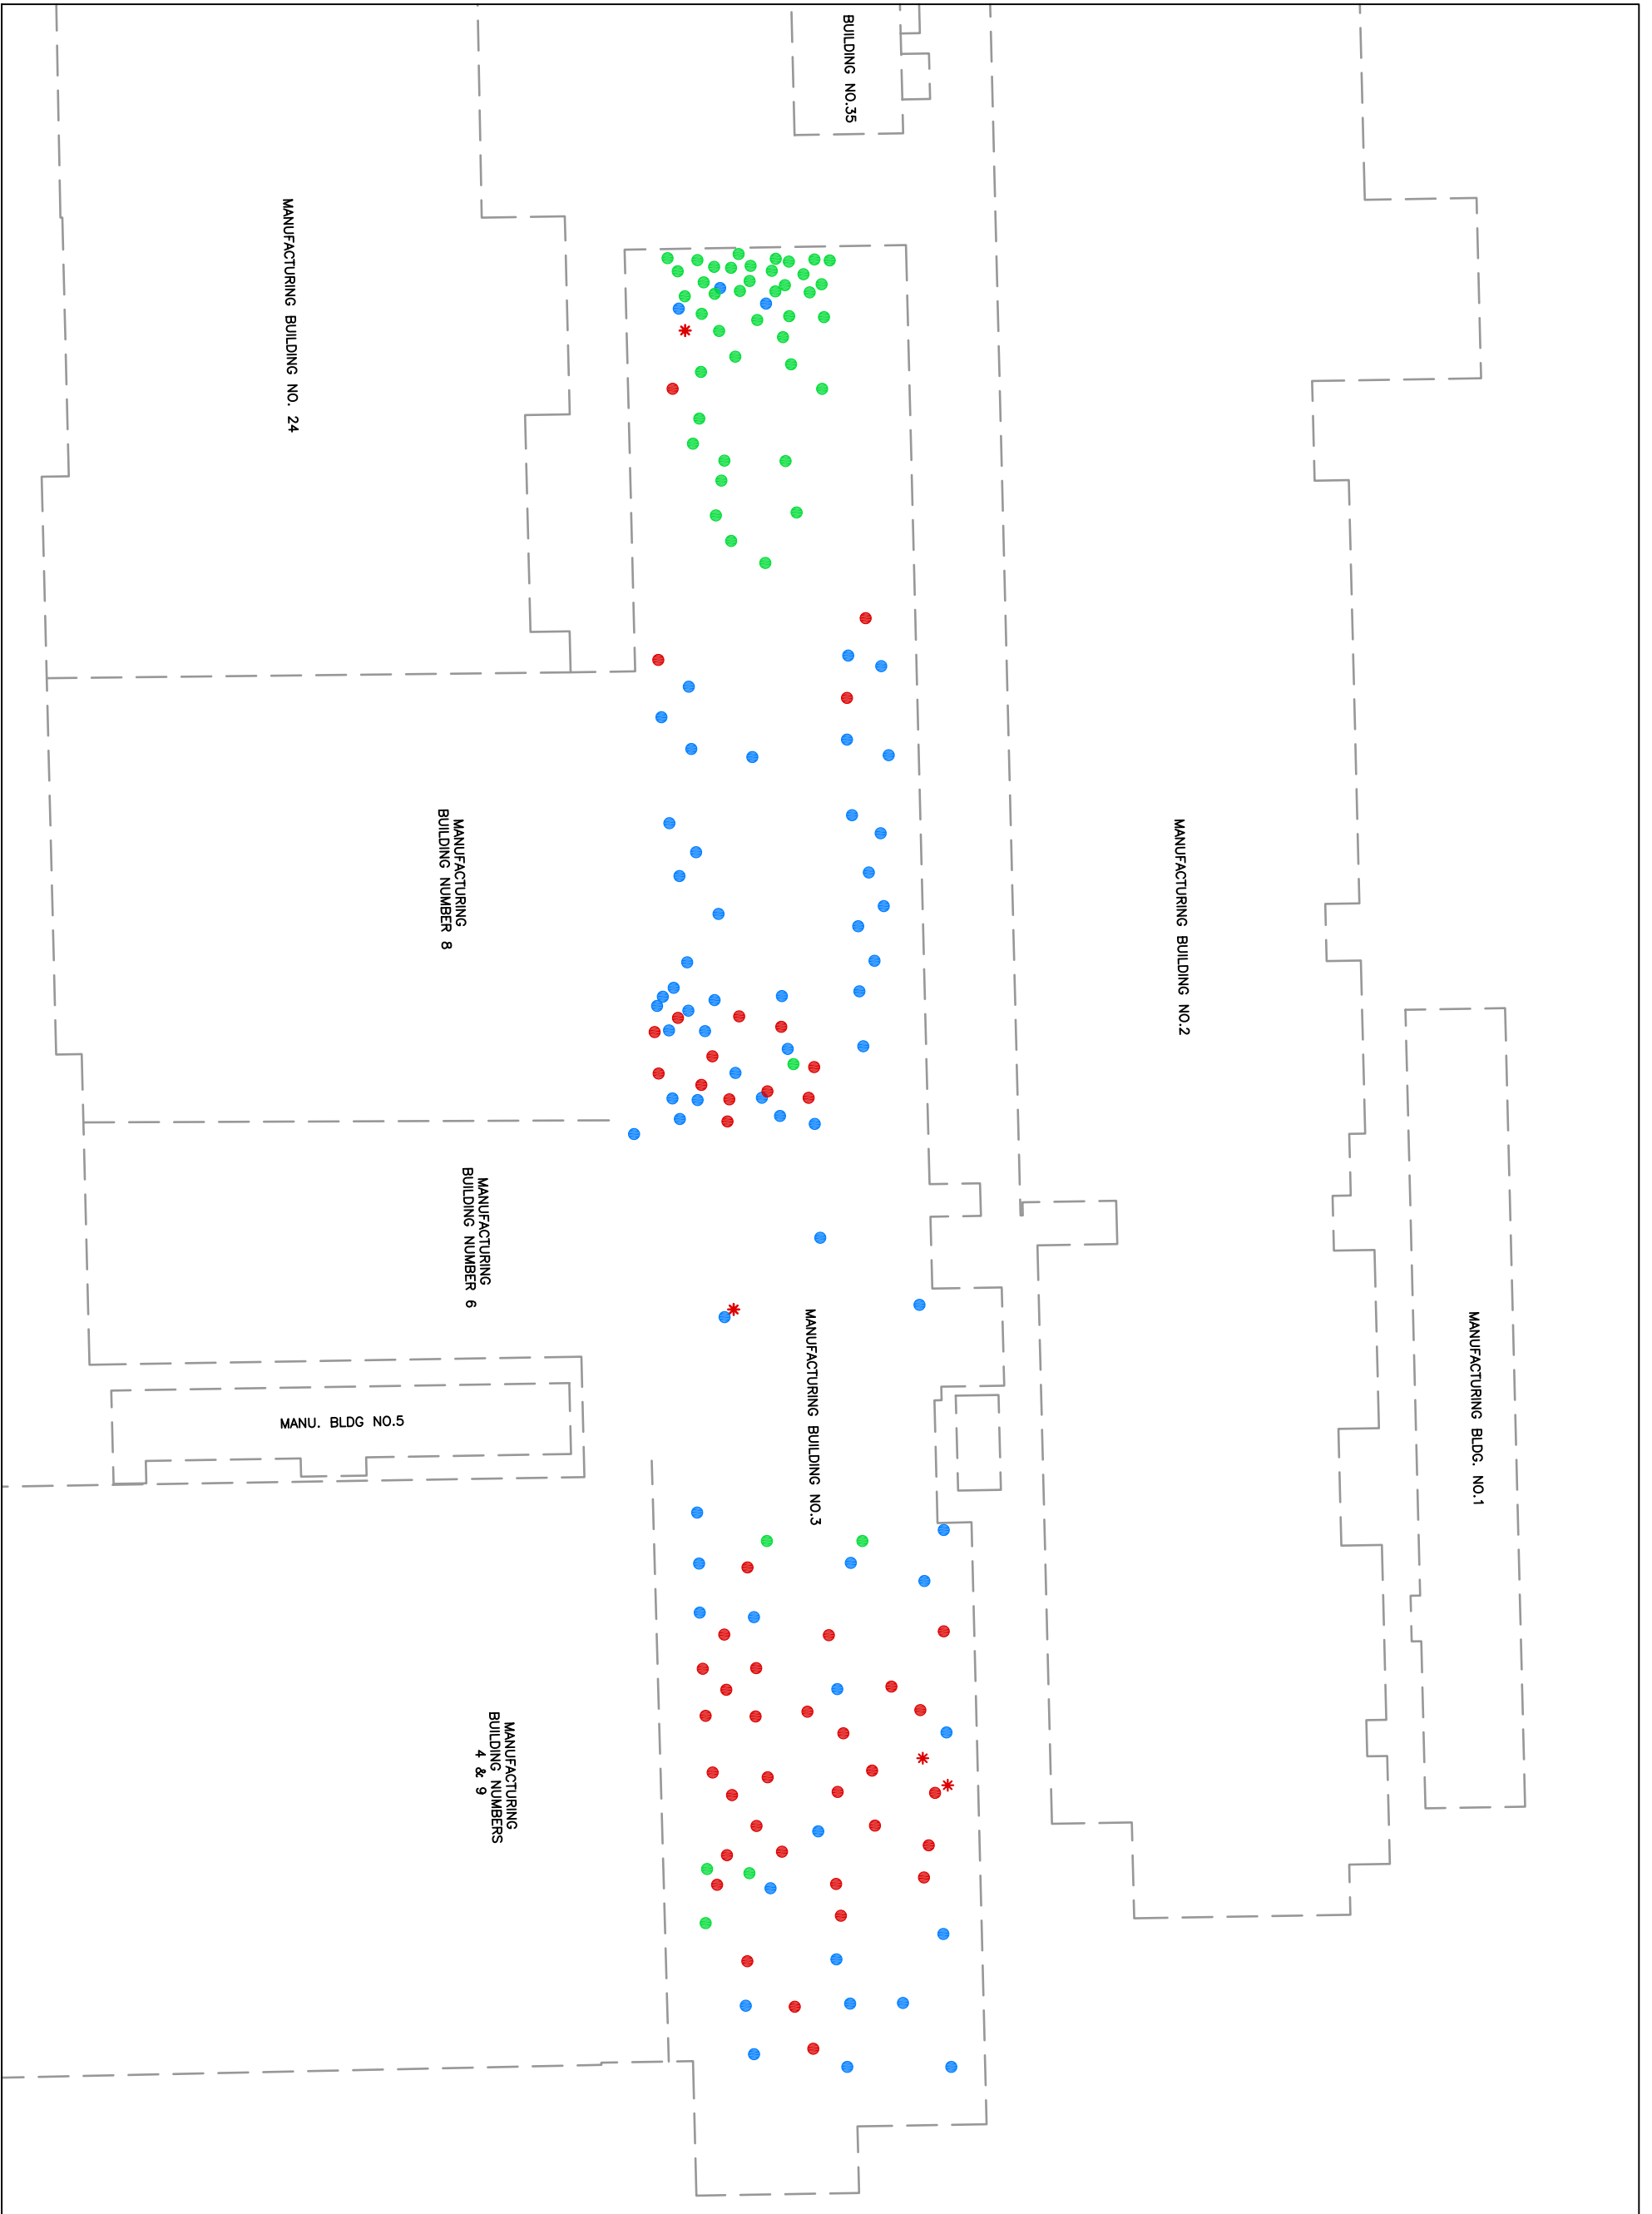
Figure No.: 4-34

MEASUREMENT/SAMPLING LOCATIONS

- >1,000 and ≤ 5,000 dpm/100 cm² β
- >5,000 and ≤ 15,000 dpm/100 cm² β
- >15,000 dpm/100 cm² β
- * >1,000 dpm/100 cm² α

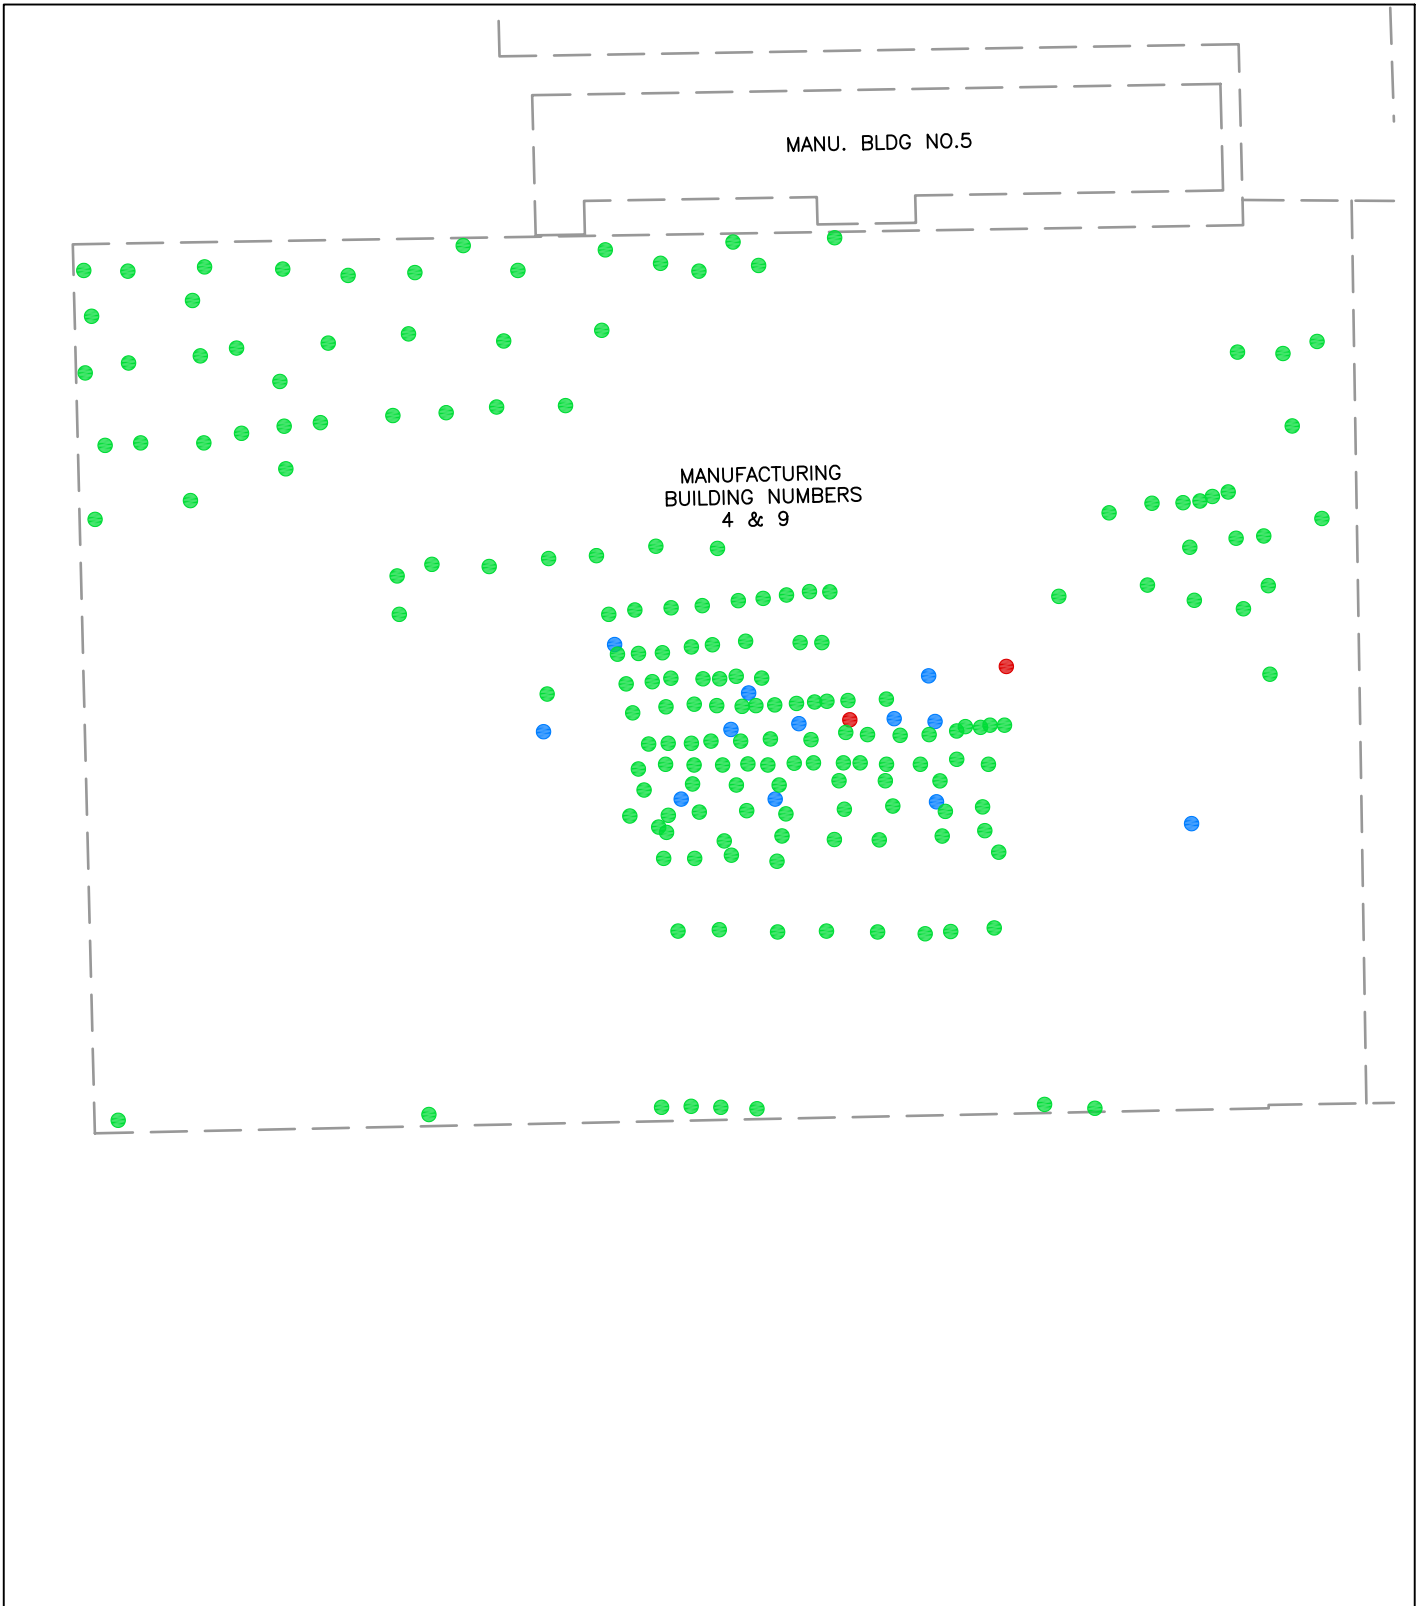
Figure No.:
4-35

MEASUREMENT/SAMPLING LOCATIONS

- >1,000 and ≤ 5,000 dpm/100 cm² β
- >5,000 and ≤ 15,000 dpm/100 cm² β
- >15,000 dpm/100 cm² β

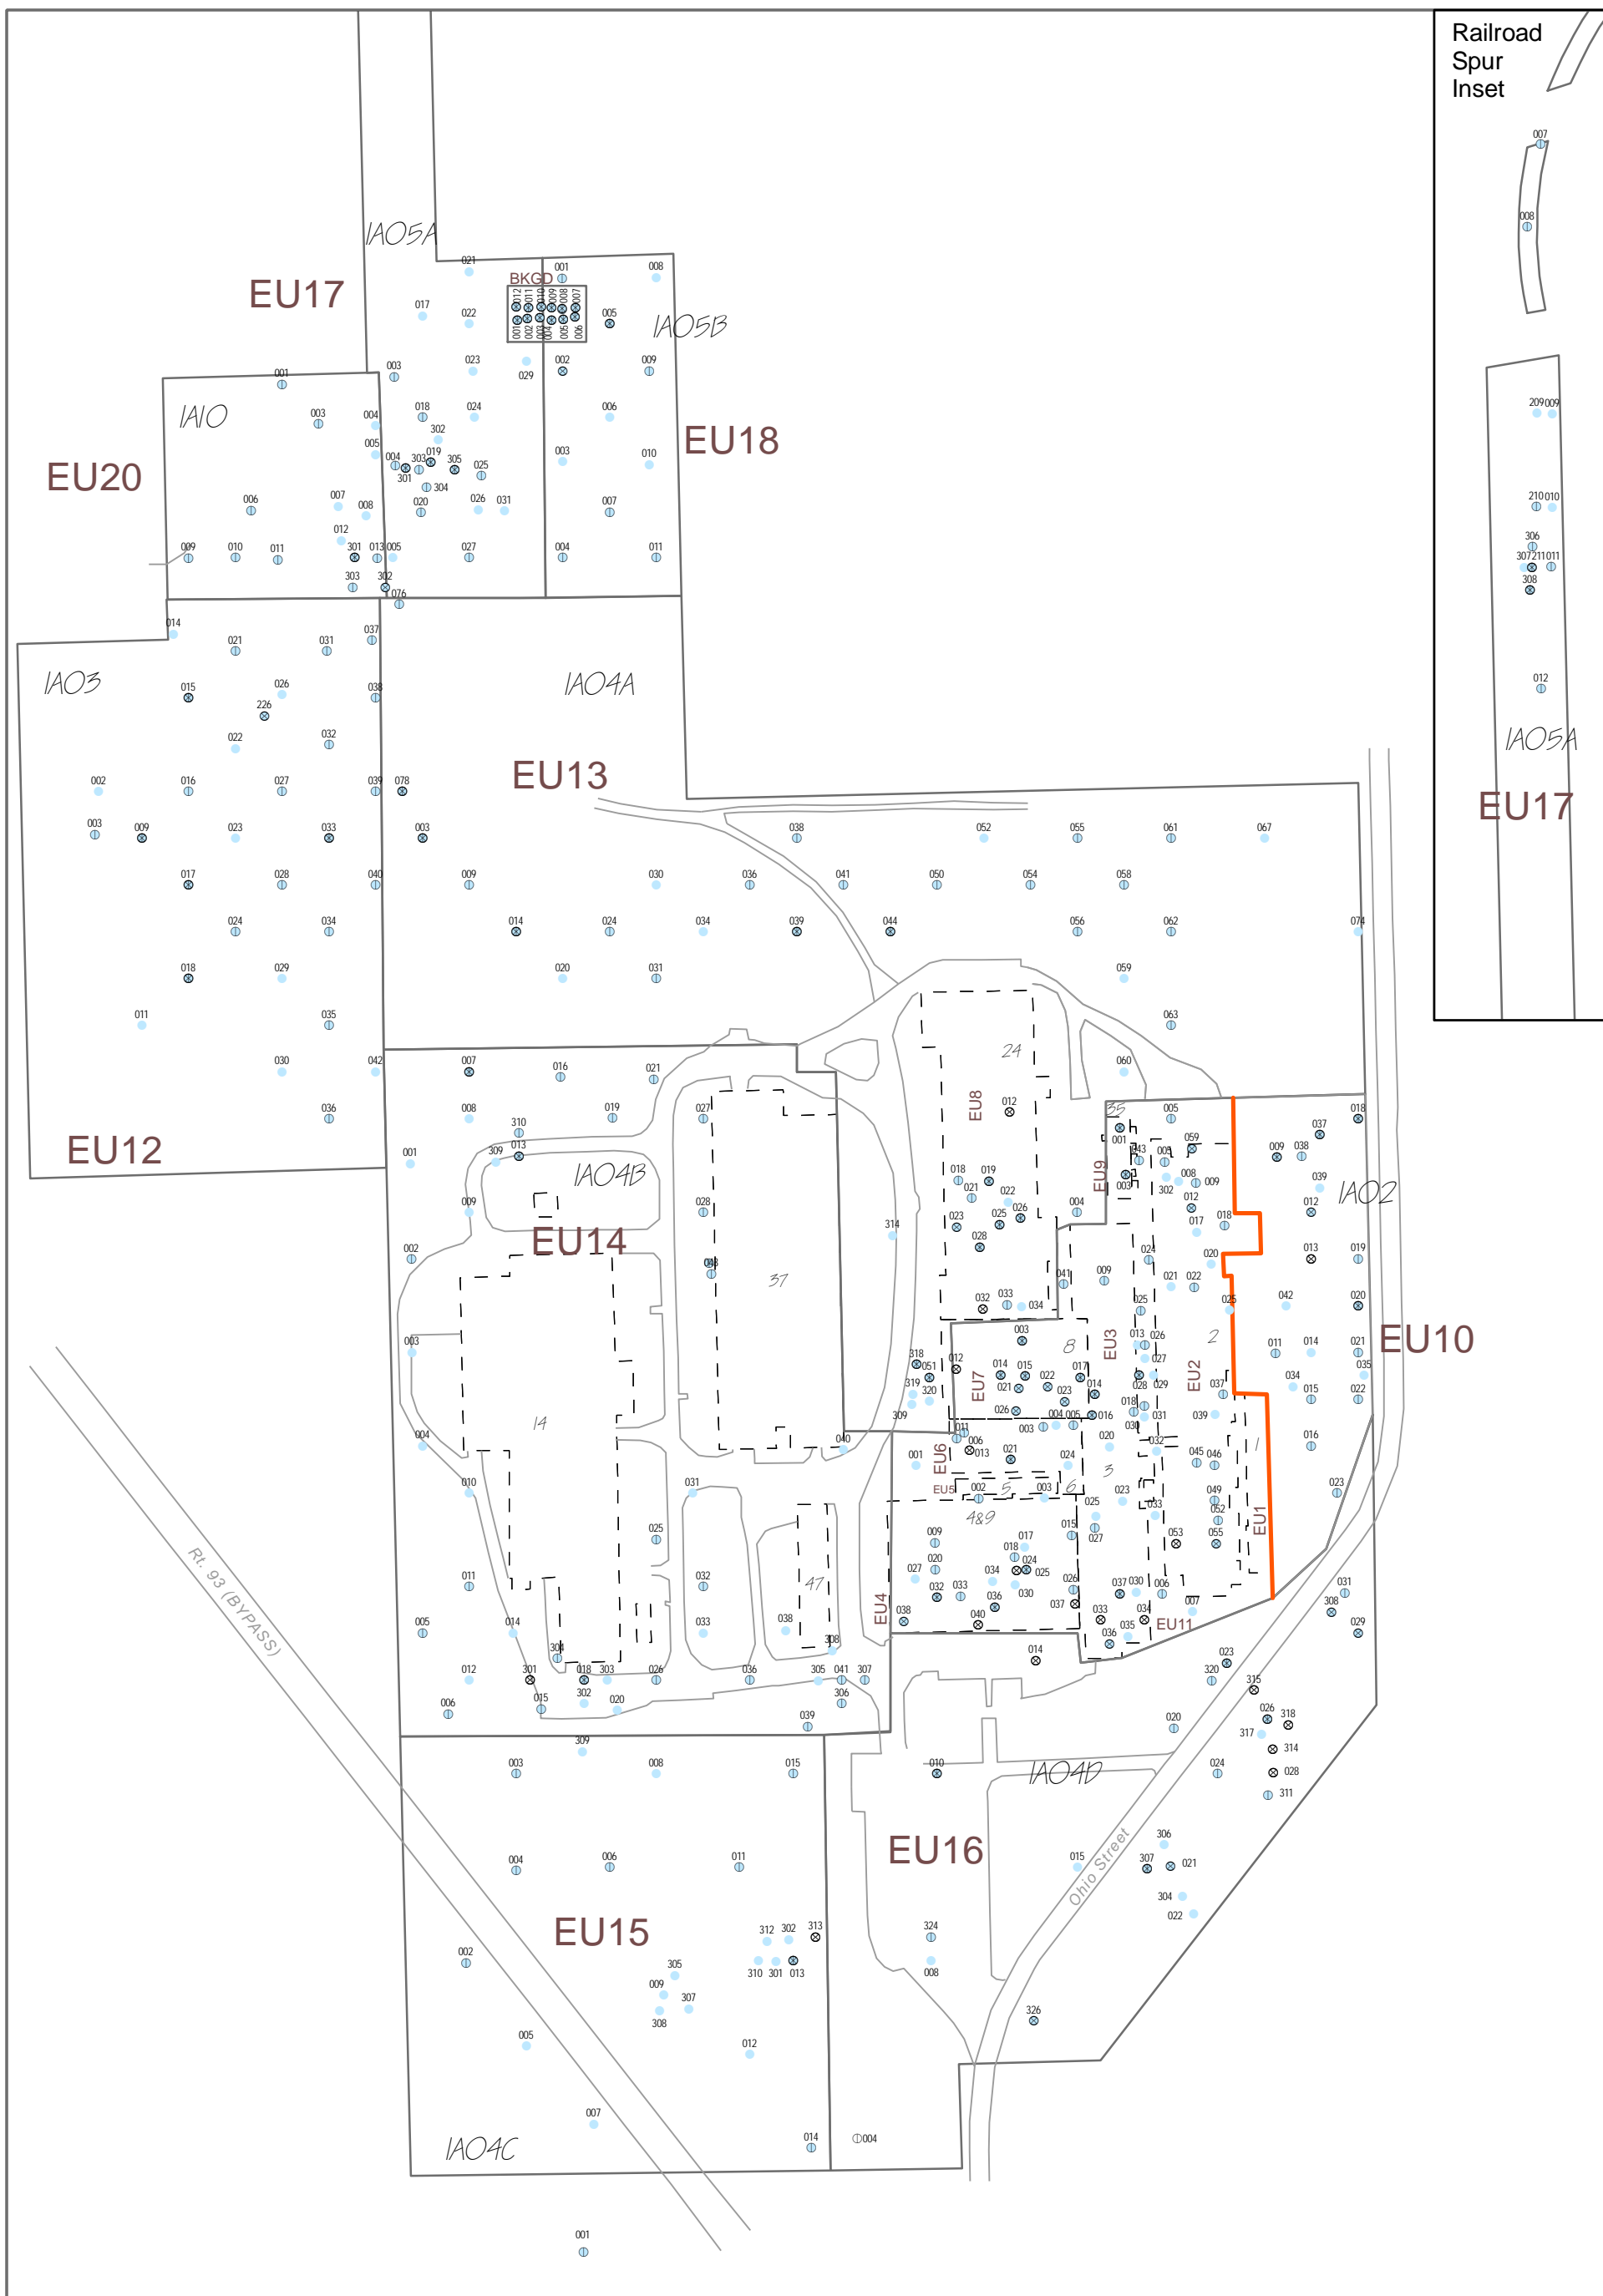
Date: 11/10/09 Scale: 1 inch = 120 feet Figure No.: 4-48

GROUNDWATER SAMPLE RESULTS -
NOVEMBER 2007

- ⊙ Radium Analysis
- ⊗ Gamma Spectroscopy Analysis
- Alpha Spectroscopy Analysis
- EU10-EU11 Boundary
- Paved Areas
- ⬜ Exposure Units (EU)
- ⬜ Guterl Buildings

Station IDs:
 IA-Station Number (e.g., A02-001)
 Building No.-Station Number (e.g., B24-008)
