Prepared by:  
AECOM  
Buffalo, NY  
60481767  
March 2021

# Five-Year Review Report (2016 to 2020), Former Carborundum Company, Hyde Park Facility Town of Niagara, Niagara County, NY NYSDEC Site No. 932036

Elm Holdings Inc.

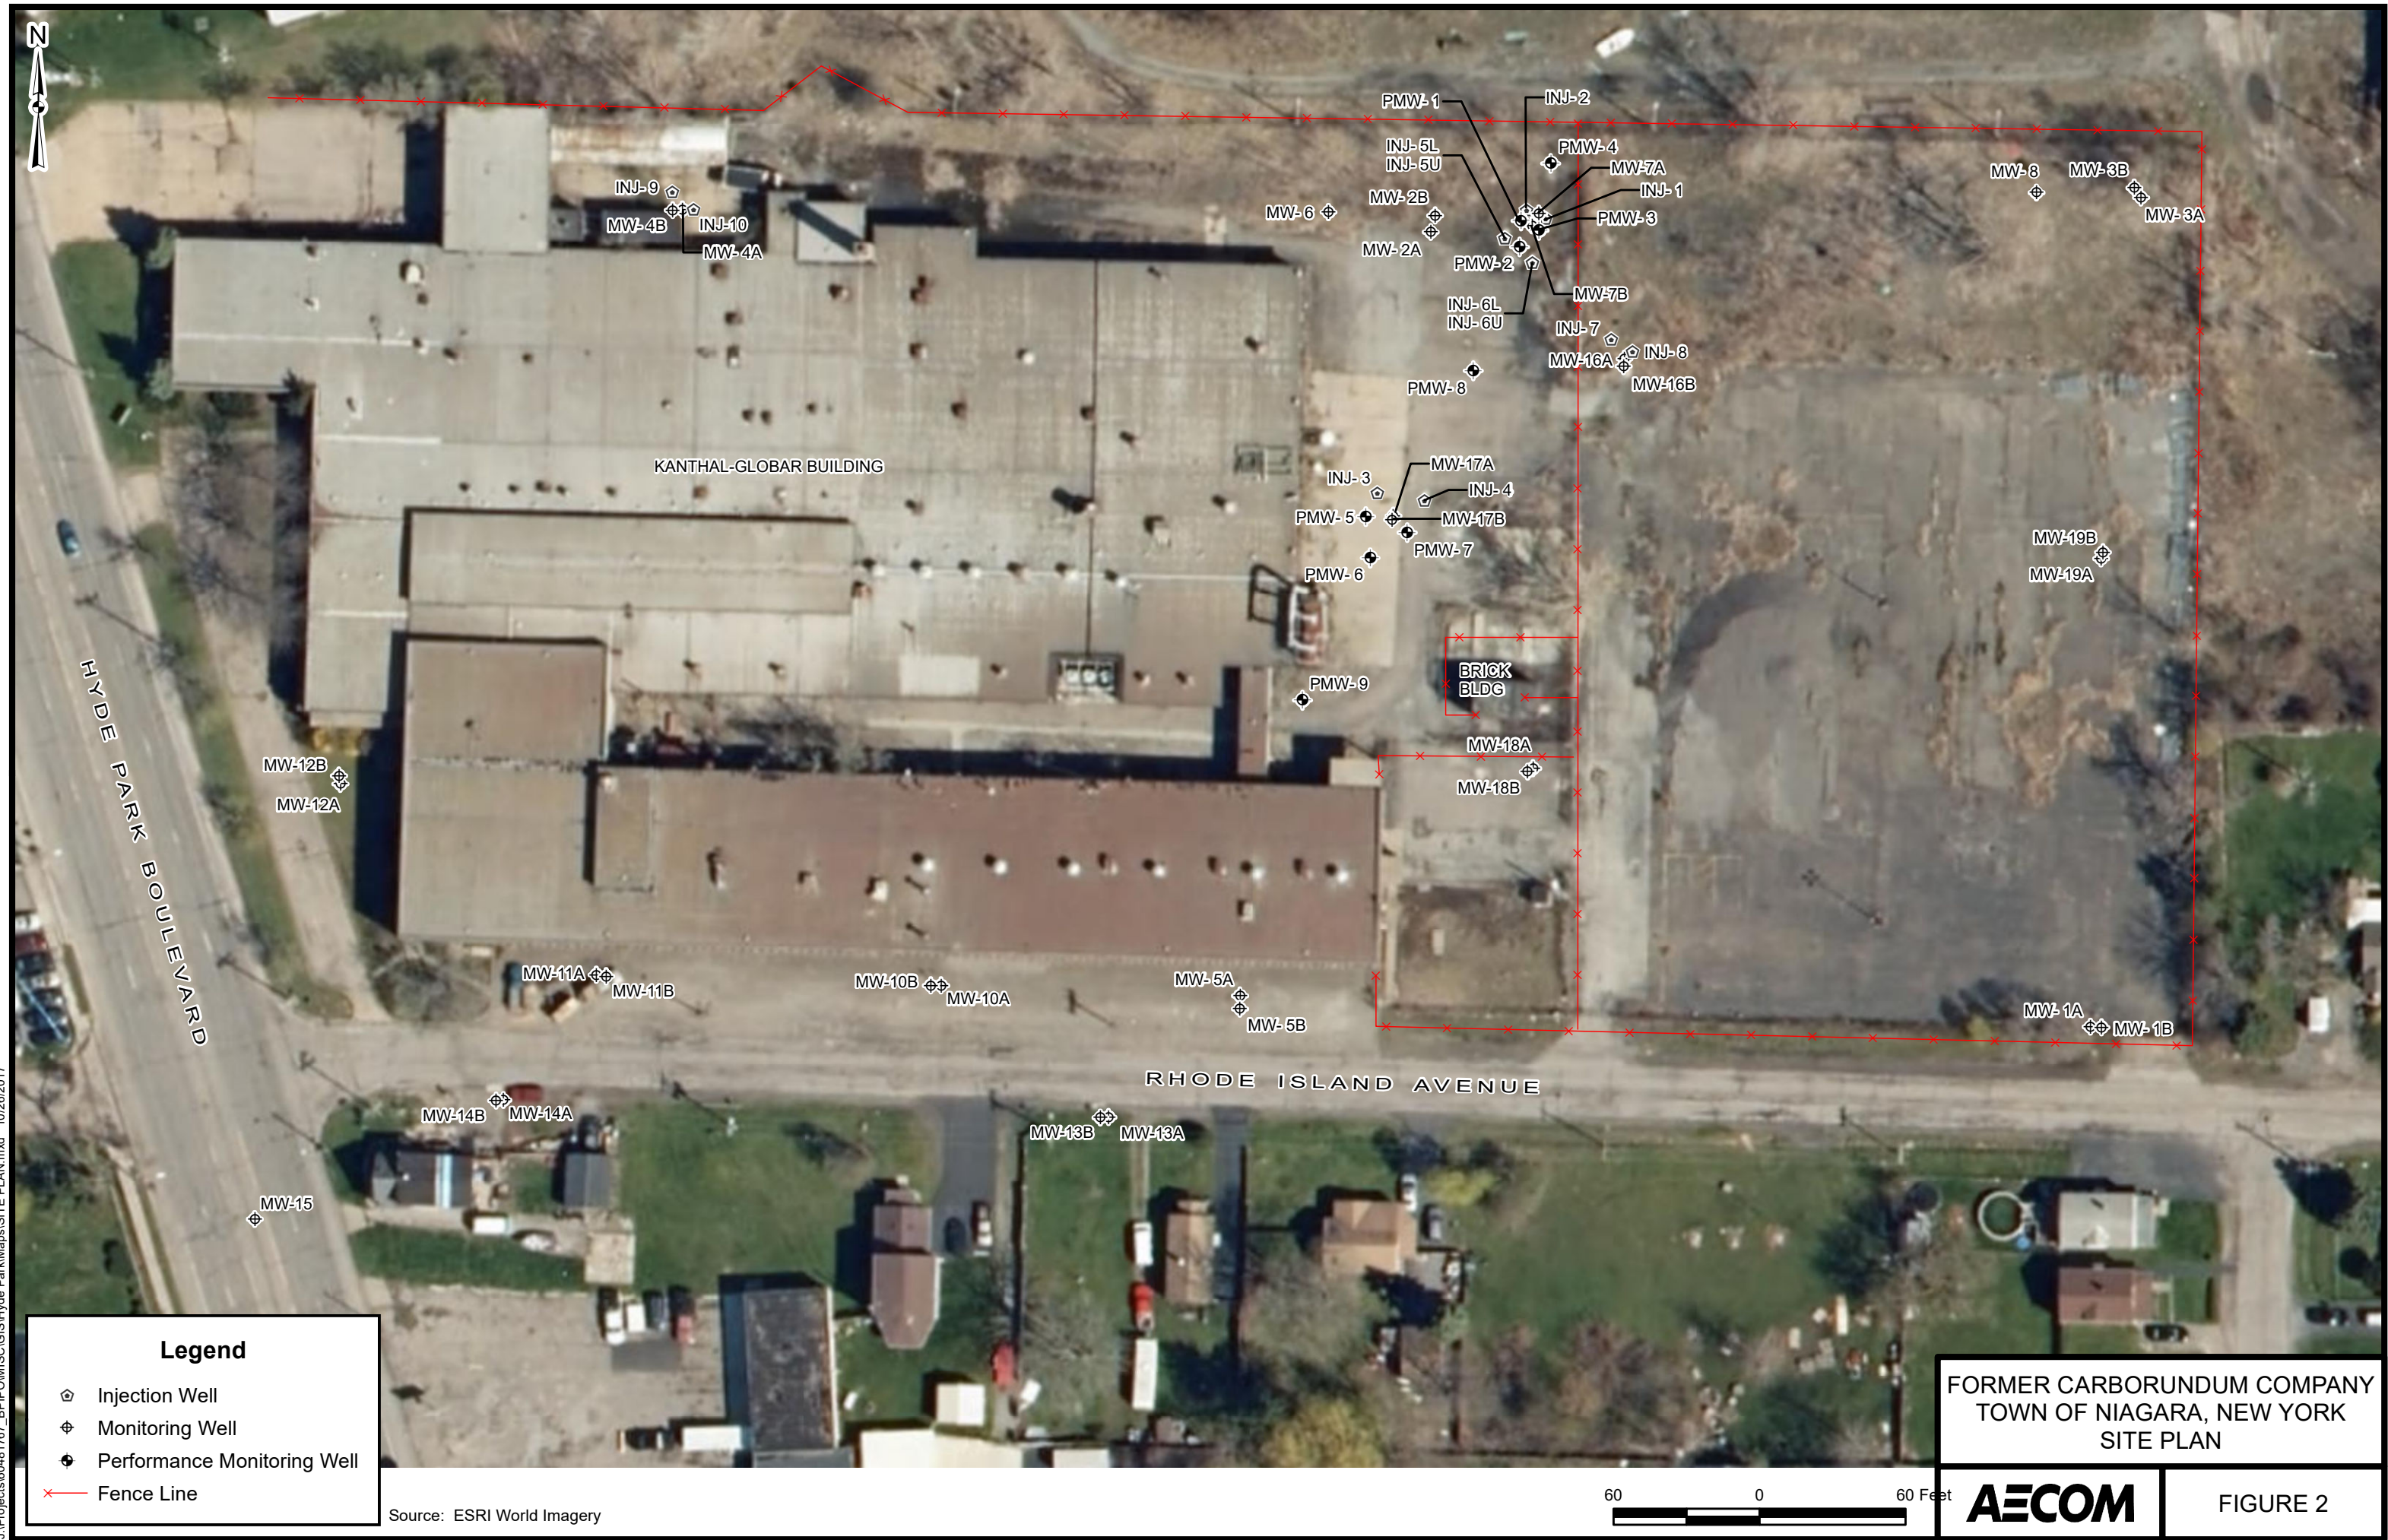
Figure 2 – Site Plan presents monitoring well locations, injection well locations, performance monitoring well locations, and site features.

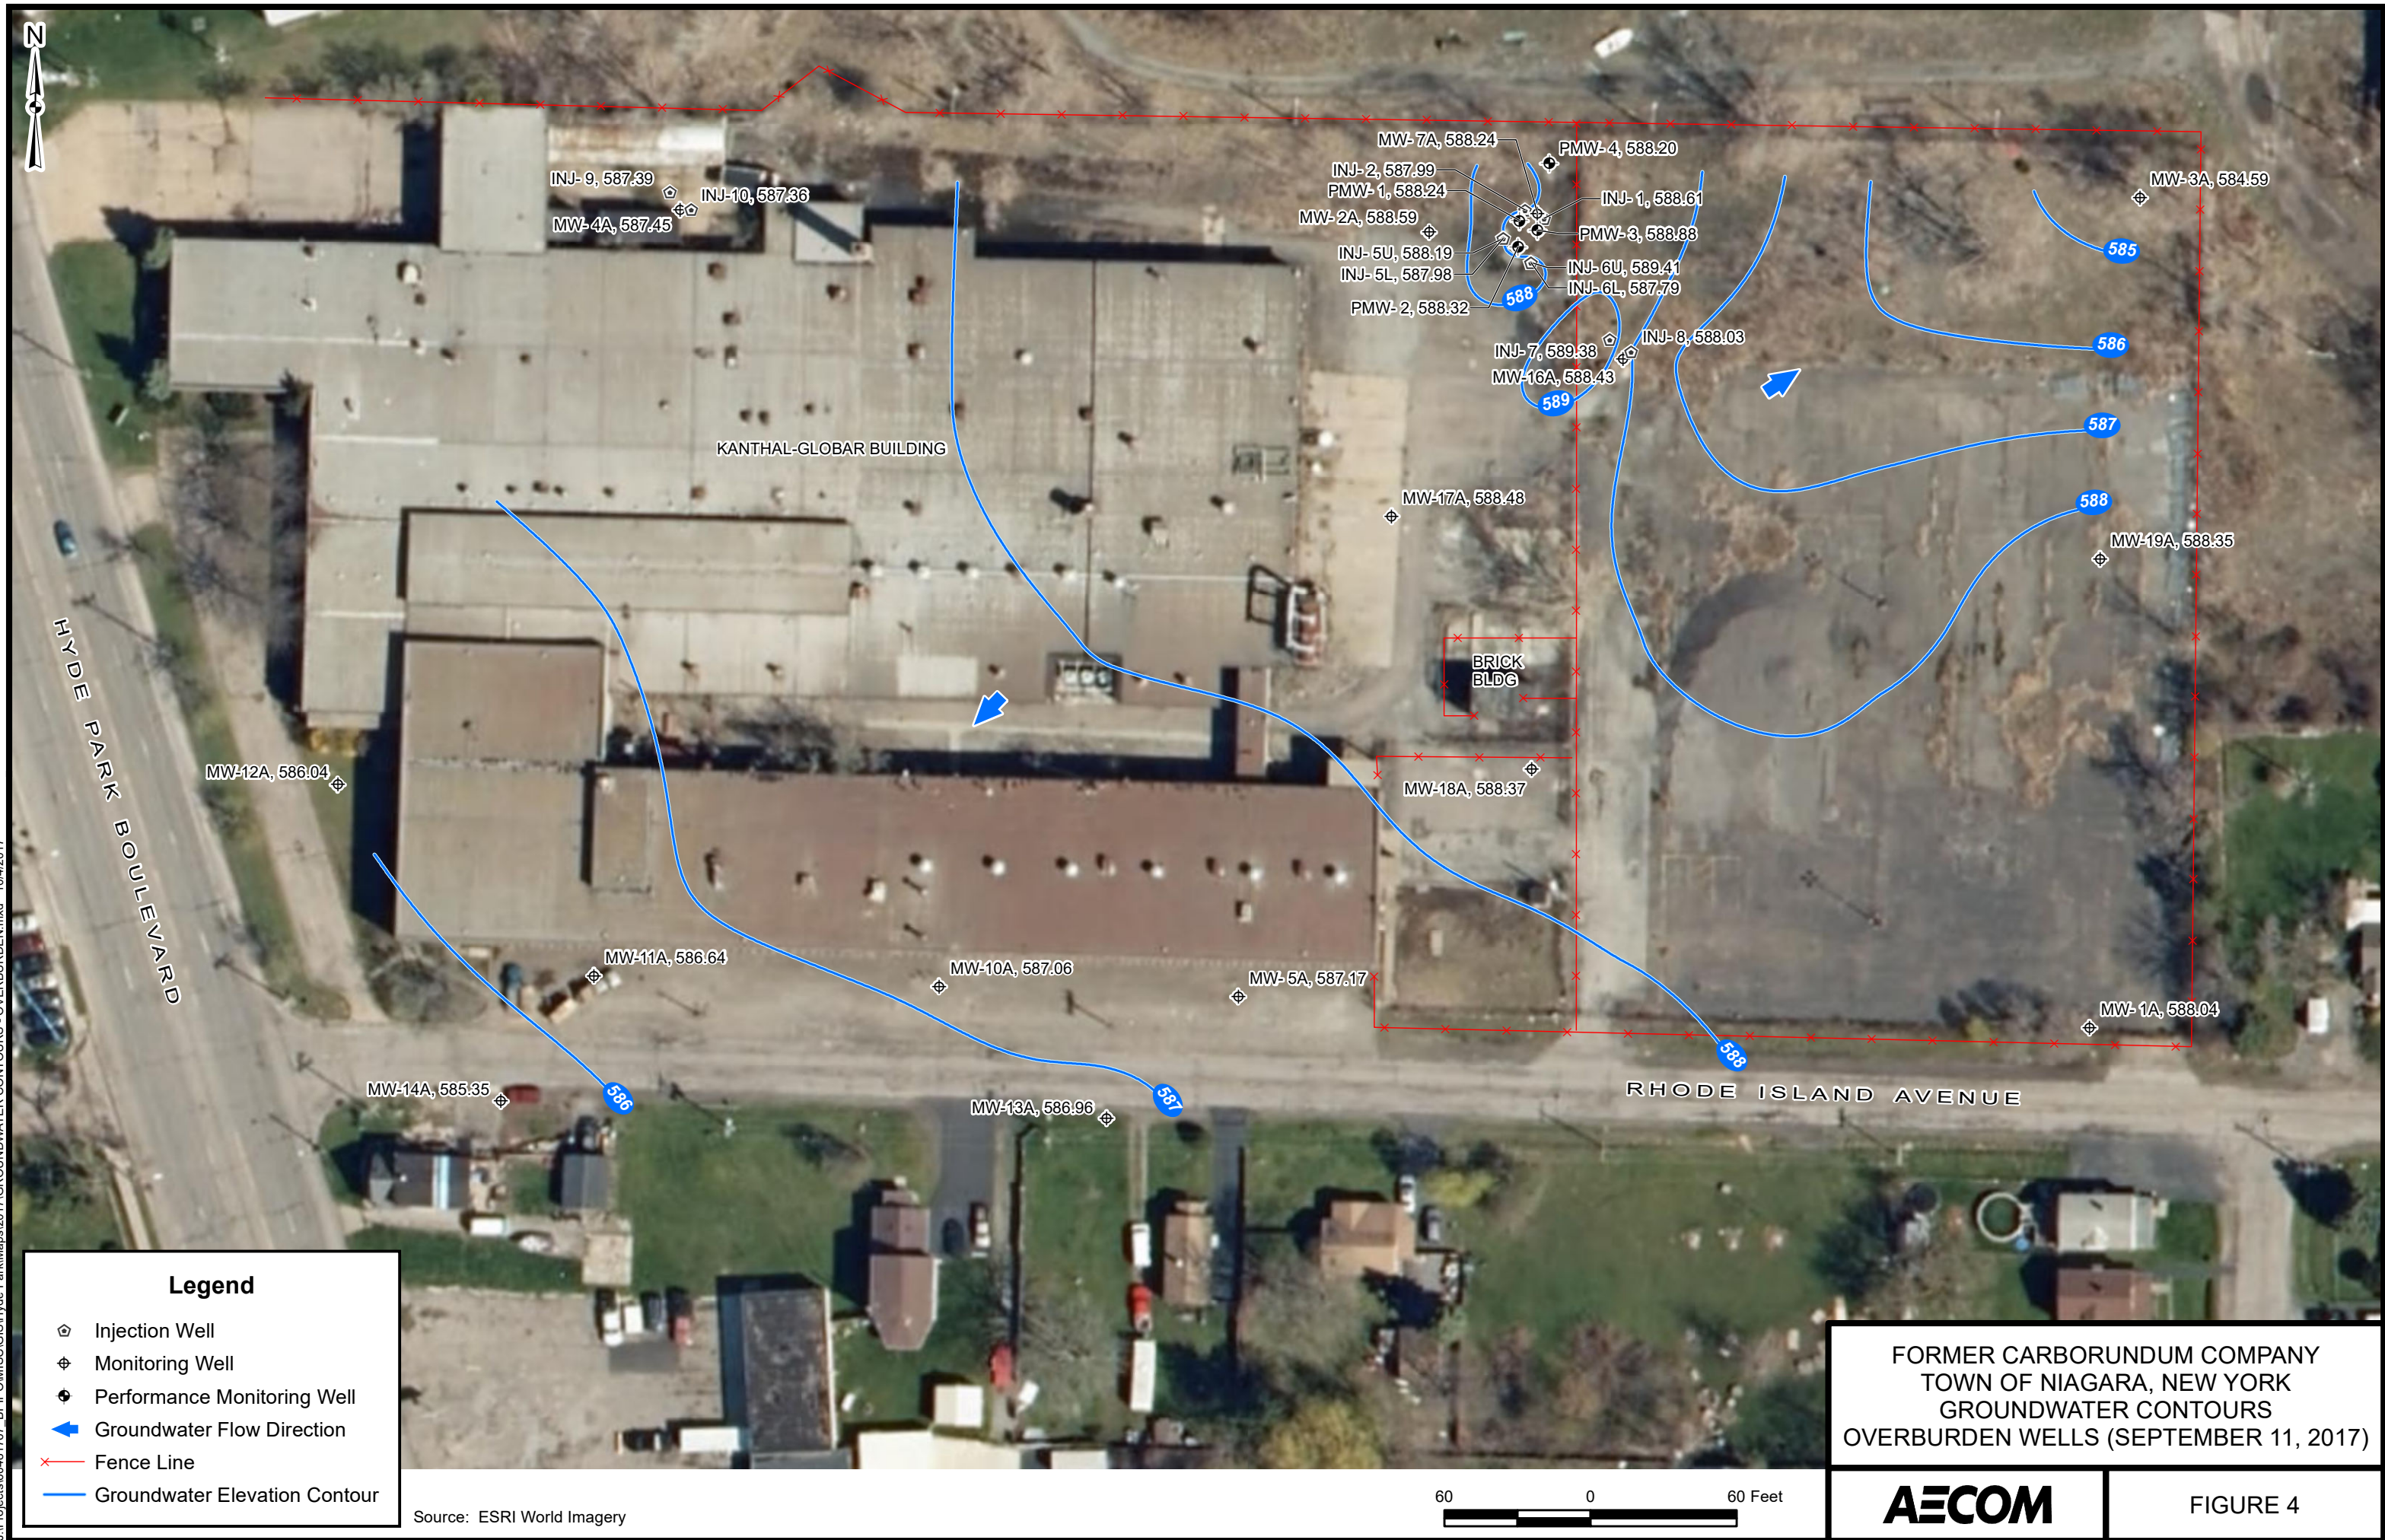
Figure 4 presents an overburden groundwater contour map based on the September 11, 2017 water level data. Overburden groundwater was measured at elevations between 589.41 ft AMSL (INJ-6U) in the north central portion of the Site to 584.59 ft AMSL (MW-3A) in the northeast corner of the Site. Overburden groundwater is mounded in the north central region of the Site as a result of the higher elevations observed in the area of MW-16A, INJ-6U, and INJ-7 as compared to MW-3A. As a result, groundwater flow is to the northeast toward MW-3A and to the southwest toward MW-11A off of this high with gently sloping gradients. With respect to the groundwater elevation at MW-3A, historically, the general groundwater flow trend is from the northeast (MW-3A) to the southwest (MW-11A) and water elevations in MW-3A, MW-7A, MW-16A, and MW-19A move in relative harmony; however, on 5 of 33 occasions since 2000, the elevation at MW-3A has been recorded lower than one or more of these three wells causing the apparent mound in the vicinity of MW-16A as observed during this event.

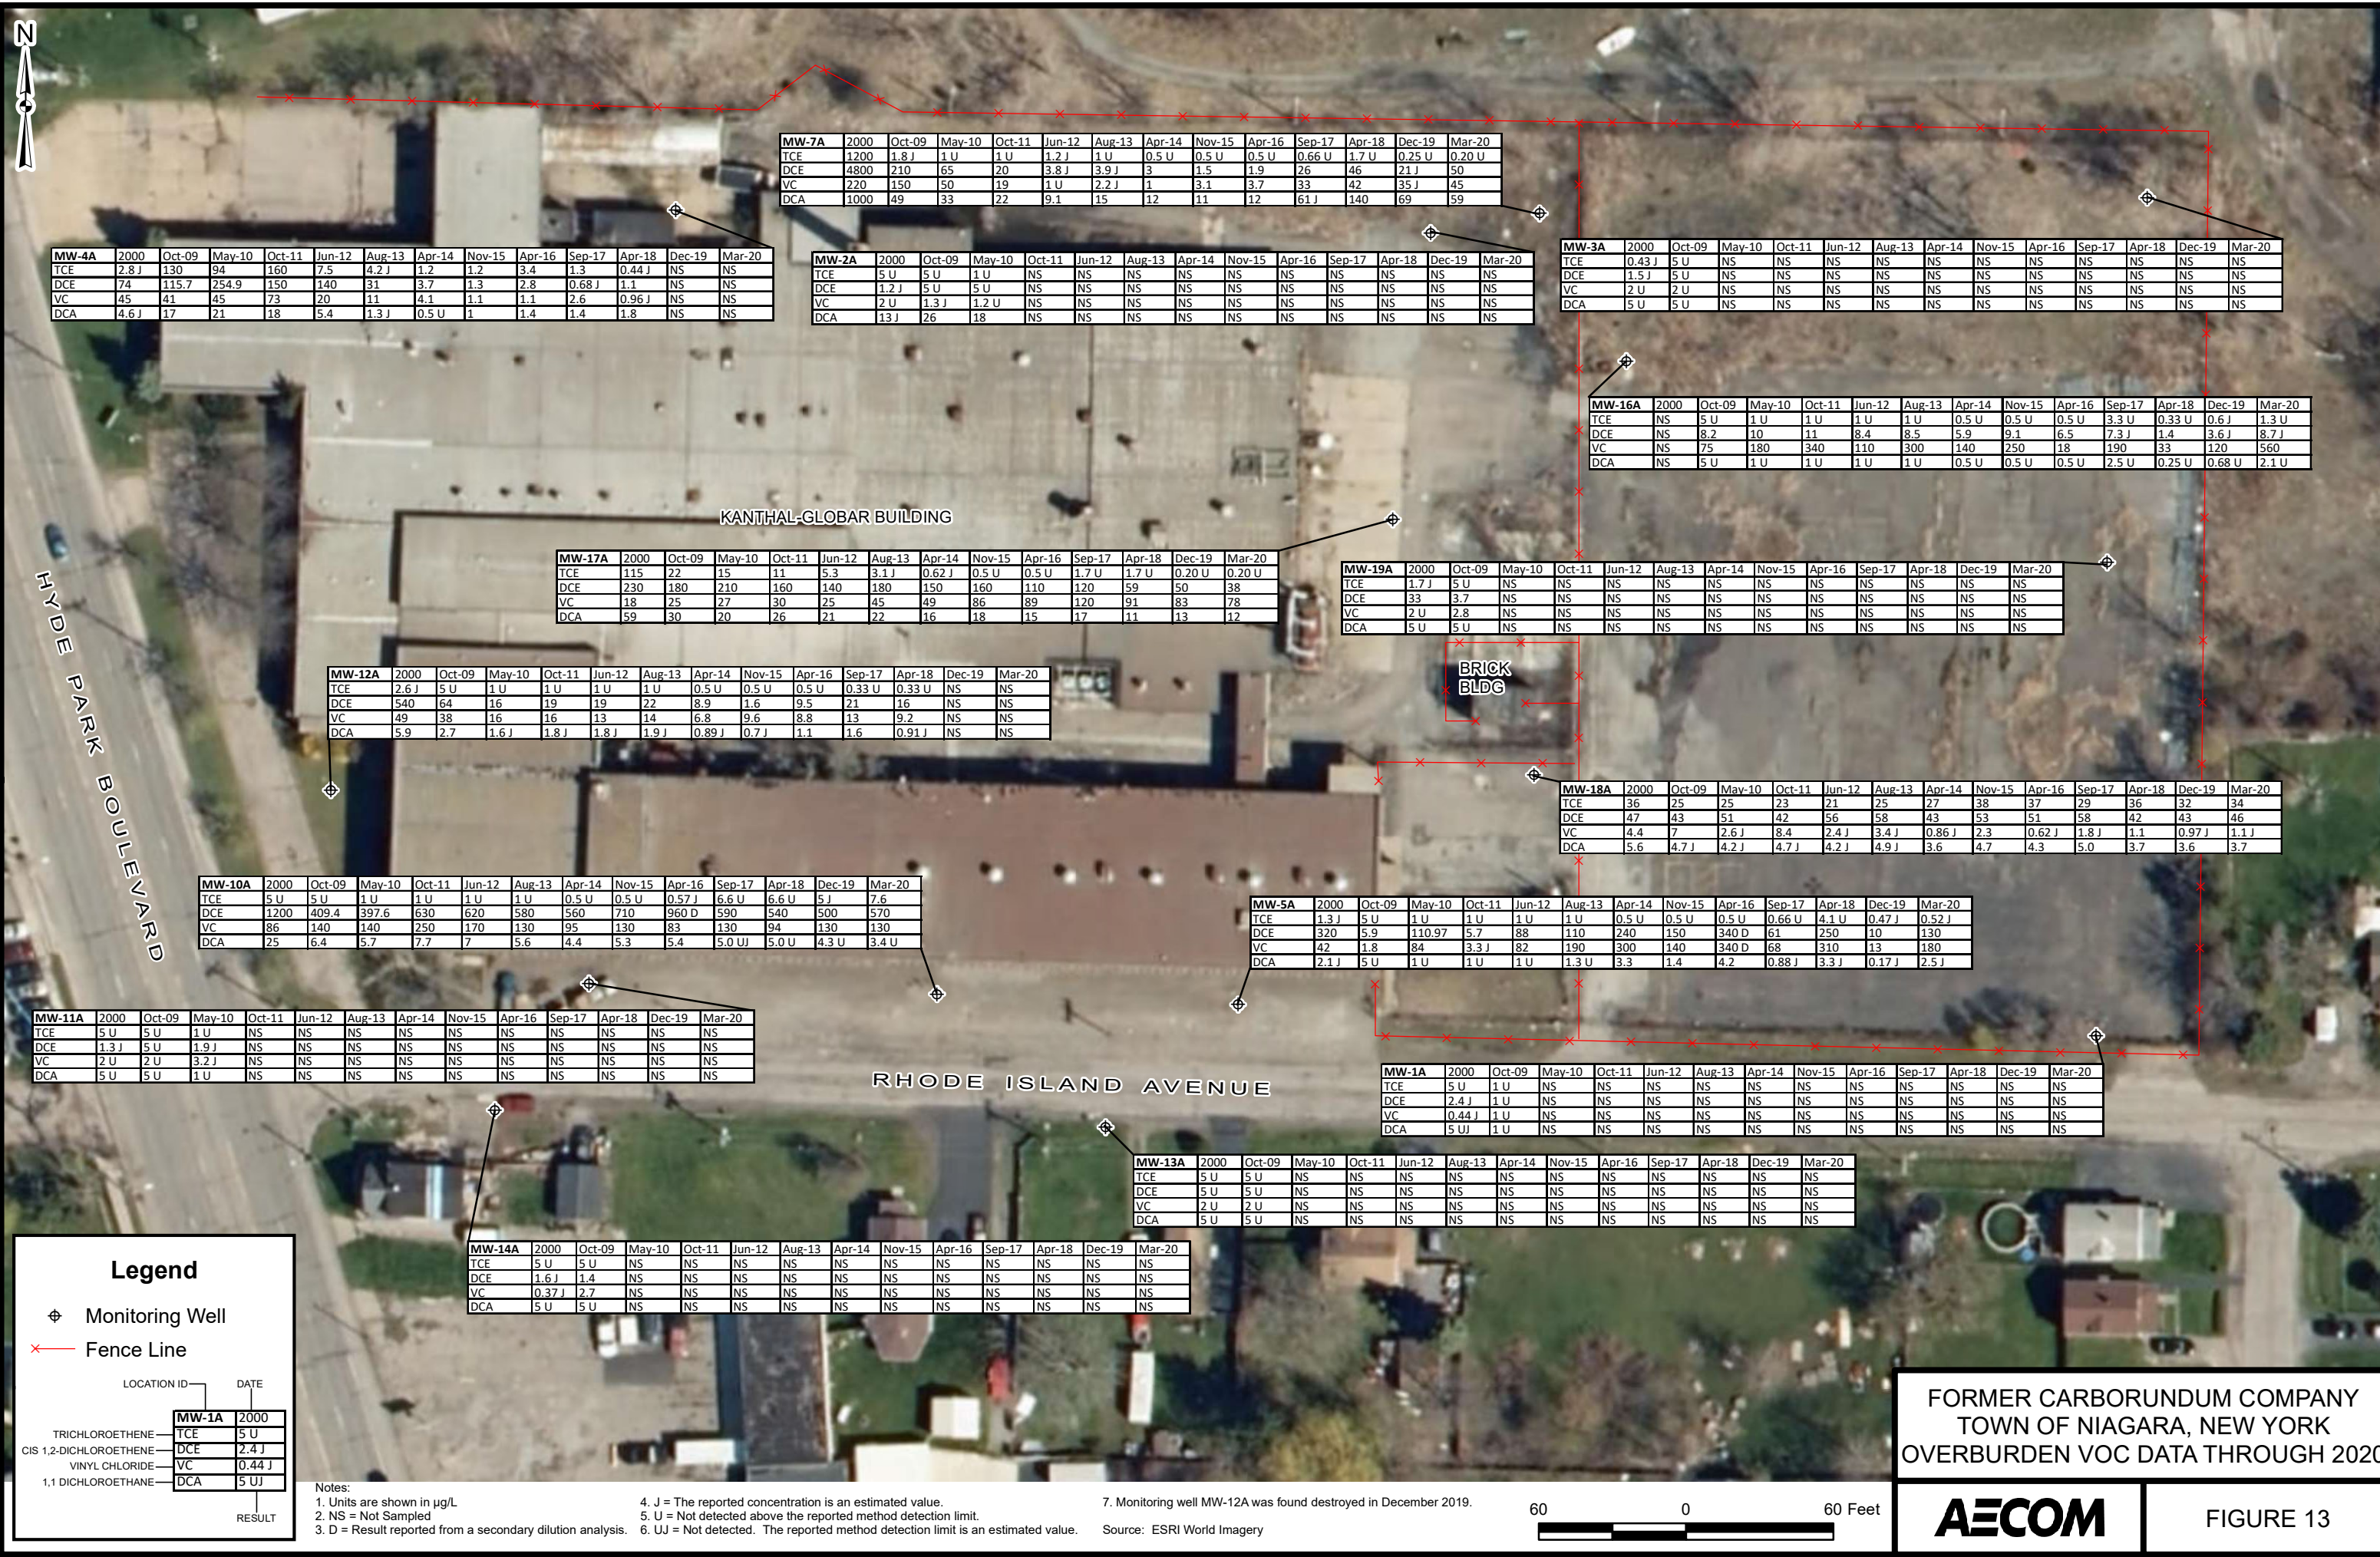
FIGURE 13

MW-5A, located south of the east end of the former facility building, showed sporadic increases and decreases in DCE and VC before and after substrate injections in 2009, 2011, and 2013 (Figure 13). This trend continued from Spring 2016 through Spring 2020 where concentrations of DCE, VC, and DCA fluctuated but remained within the mid-range of the historical average (Figure 17). There appears to be a direct relationship between degradation product concentrations and water level fluctuations in MW-5A. Furthermore, there is a consistent upward hydraulic gradient between the bedrock and overburden zones at this location. MW-5A will continue to be monitored as a part of the annual sampling program.

MW-10A is located central to and south of the former facility building. From 2016 through 2020, DCE and VC concentrations in MW-10A displayed changes suggestive of biodegradation, where DCE decreased from 960 µg/L to 570 µg/L, while VC increased from 83 µg/L to 130 µg/L (Figure 18). Over the same time period, TCE increased slightly from an estimated 0.57 µg/L to 7.6 µg/L, slightly above groundwater standard (5 µg/L). DCA was non-detect from 2017 through 2020. Groundwater elevation measurements indicate an upward hydraulic gradient between MW-10A and MW-10B (from bedrock to overburden). MW-10A will continue to be monitored as a part of the annual sampling program.

7. Monitoring well MW-12A was found destroyed in December 2019.
- Source: ESRI World Imagery
