Evaluation of Sediment Quality of the Erie Canal between the Niagara River and Rochester, New York

New York State Canal Corporation

January 2000

John R. Dergosits Principal Investigator

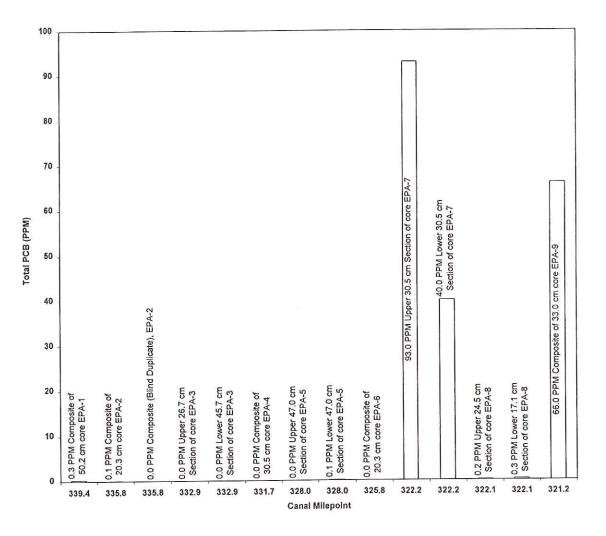
Figure # 4.1 Total PCB Concentration in Reach # 1

centimeter core was collected and composited. The concentration of PCB within this core, which represents a composite of the upper 33.0 centimeters of sediment, was 66 PPM. The geometry of the canal at this point is quite wide and there is little to no flow velocity during canal operations. Based on observations of this location on the canal during the navigation season, it appears that the increased sediment depth and the elevated total PCB concentrations found at this sampling location are due to the low flow velocities in this area. Based on the above results it appears that a source of the PCB contamination exists in the vicinity of milepoint 322.2.

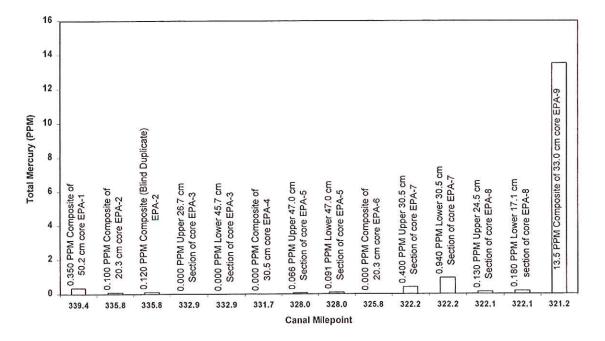
Figure # 4.3 Mercury Concentration in Reach # 1

Within this reach only three areas are of interest when one looks at mercury contamination in the sediments; there is an elevated level (0.350 PPM) at sample site EPA-1, most likely attributable to contaminants in the Niagara River. Elevated levels are also detected at sample site EPA-7. The upper section exhibits a level of 0.400 PPM while the lower core section contains 0.940 PPM mercury. The significant difference between upper and lower sections suggests that contaminant levels are decreasing in the more recent sediment deposits. The most surprising mercury contaminant concentration identified was at sampling site EPA-9 where the level of 13.5 PPM was identified within the top 33.0 centimeters of the sediment. It is unclear whether there is a supplemental source of mercury to the system or if the effects of low flow velocity have contributed to this elevated concentration. A third possibility is that the results of this sample may not accurately represent the mercury concentrations in the sediment in this area. Supplemental sampling is suggested to verify the presence of elevated Mercury levels. Figure # 4.3, below show levels of mercury contamination within the sediments plotted on an axis of canal milepoint.

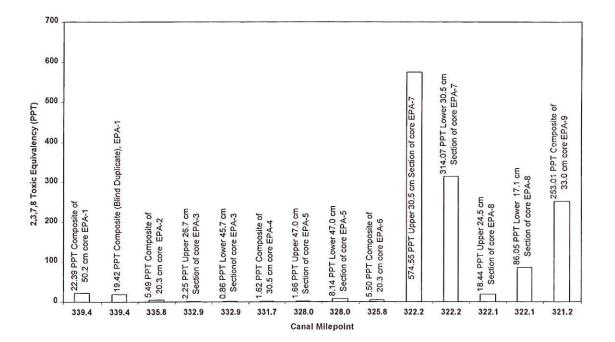
Figure # 4.4 Dioxin/Furan TEQ in Reach # 1

The results of the dioxin/furan analyses evaluated on a TEQ basis are similar to the trend seen in PCB contamination. There is a slight elevation of dioxin TEQs apparent at sample site EPA-1; the level appears to be consistent with the level of this contaminant encountered in numerous other locations along the canal in western New York. A significant TEQ concentration in the upper section at sample site EPA-7 of 574.55 PPT compares with a level of 314.07 PPT within the lower section of this core. Based on the above results, it appears that quite possibly the source of PCB contamination may also be the source of the dioxin/furan contamination in the vicinity of milepoint 322.2, near the Prospect Street Bridge. At sample site EPA-8 the trend reverses itself where the upper core section is at 18.44 PPT while the lower section is 86.05 PPT on TEQ basis. At sample site EPA-9, the levels of Dioxin/Furans on TEQ basis within the sediment composited from a 33.0 centimeter core is 253.01 PPT.

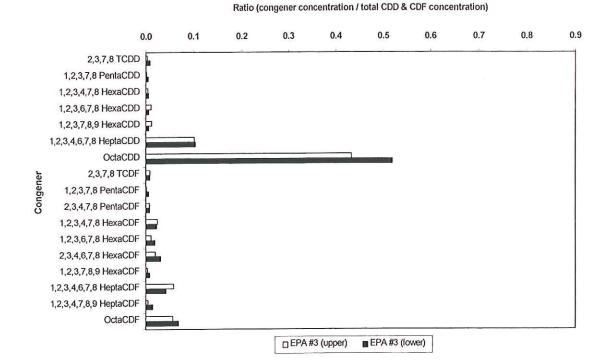
Figure # 4.6 Congener Profile Milepoint 332.9 (EPA #3)

Sample site EPA-3 has a different congener profile in both the upper and lower core sections than any of the other samples from this reach. There are significantly increased levels of 1,2,3,4,6,7,8 Heptachlorodibenzodioxin along with slightly elevated levels of all of the Pentachlorodibenzofurans and Hexachlorodibenzofurans and 1,2,3,4,7,8,9 Heptachlorodibenzofurans. There is about a 20 percent decrease in the percent of Octachlorodibenzodioxin within the sample results. It is currently unknown if this shift in congener pattern might identify a different source or quite possibly an area where biotic or abiotic degradation has caused a decrease in the more highly chlorinated congeners within the upper sediments. These sediments are also closer to the surface of the water column, hereby allowing for photo-degradation from sunlight (photolysis). Figure # 4.6 following, shows the congener patterns observed in core EPA-3.

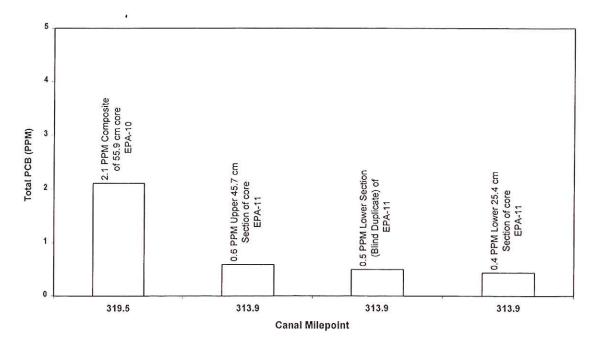
PCB levels in the composite obtained at sampling site EPA-10 were 2.1 PPM and the sample collected at EPA-11 showed surface levels in the range of 0.5 to 0.6 PPM.

The levels of PCBs in the lower section of the core contained PCBs in a concentration of 0.4 PPM as shown on Figure # 4.7, below.

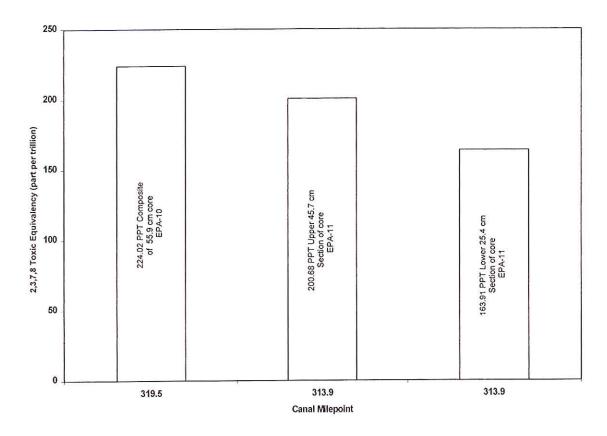
Figure # 4.8 Dioxin/Furan TEQ in Reach # 2

Dioxin/furan analyses evaluated on a TEQ basis trend downward as you move from Lockport eastward. The TEQ concentration measured in the composite of the core collected at sampling site EPA-10, 224.02 PPT is less than the TEQ levels encountered in the Lockport area. The upper section obtained at sample site EPA-11 of 220.68 PPT is only slightly elevated above the level of 163.91 PPT found in the lower section of this core. Dioxin/Furan TEQ concentrations are shown below on Figure # 4.8.

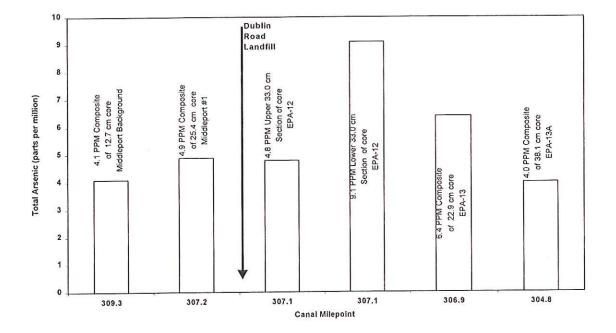
Figure # 4.9 Arsenic Concentration in Reach # 3

Within this reach 9 push cores were collected, many were small in length since there is limited sediment within the main channel of the canal. The levels of PCB encountered were 1.0 PPM or lower, many were non-detectable. Adjacent to the canal at milepoint 307.1 in the Middleport area, there is a landfill that has reportedly been used for the disposal of arsenic wastes from pesticide manufacture. Two background core samples were taken west of the landfill area. These samples were collected and composited, the first one was taken nearly 3 kilometers upstream of the site, and a second about 160 meters upstream. A core sample was taken immediately downstream of the landfill and visually sectioned into an upper 33.0 centimeter section and a lower 33.0 centimeter section. Core samples were collected about 320 meters further downstream and another was taken over 3.2 kilometers downstream of the landfill. The results of the analysis for arsenic is shown on Figure # 4.9, below. Downstream of the landfill, arsenic levels are higher than background concentrations in the deeper, older sediments. The arsenic concentrations within the more recently deposited surficial sediments return to background levels approximately 4.8 kilometers further downstream. Thus with no other inputs, one might speculate that the elevated arsenic found within the deeper sediments originated from the landfill.

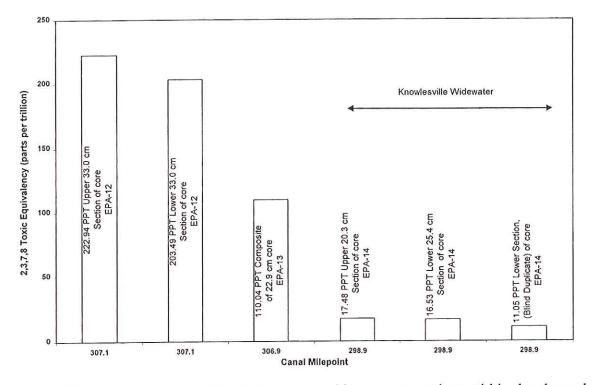
Figure # 4.10 Dioxin/Furan TEQ in Reach # 3

Dioxin/Furan TEQ levels in this reach trend downward as you move easterly. Core samples collected at sample site EPA-12, milepoint 307.1 are generally the same as the levels found in reach number 2. At this location there is little difference in TEQ concentration between the upper and lower sections of the core. A composite from sample site EPA-13, milepoint 306.9 is nearly half of the levels seen at milepoint 307.1. Samples collected at sample site EPA-14, milepoint 298.9 were collected in a very large widewater area. This location appears to have seen little contaminant impact due to its location. Figure # 4.10, below shows the TEQ concentrations encountered within this reach.

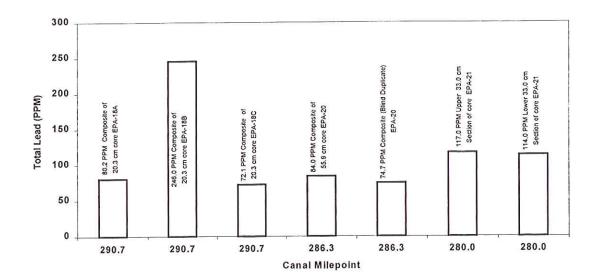
Figure # 4.11 Lead Concentration in Reach # 4

Within this reach 5 push cores were collected, 3 were taken from the upper 20.3 centimeters of sediment to evaluate the surface sediment quality adjacent to a bridge. The levels of PCB contamination encountered in the sediment were non-detectable within this reach. Sample sites at EPA-18A, milepoint 290.7 represents the conditions 33 meters upstream of the Orleans County Rote 11 Highway bridge, site EPA-18B was collected 2

meters from the downstream side of the bridge span and EPA-18C was collected 20 meters downstream. Many were small in length since there is limited sediment within the main channel of the canal. The elevated levels exhibited at sample sites EPA-20 and EPA-21 can not be accounted for since they are quite some distance from structures crossing the canal. It is hypothesized that the lead level detected may have been caused by the downstream transport of paint flakes. Figure # 4.11 shows the lead concentrations within this reach of the canal.

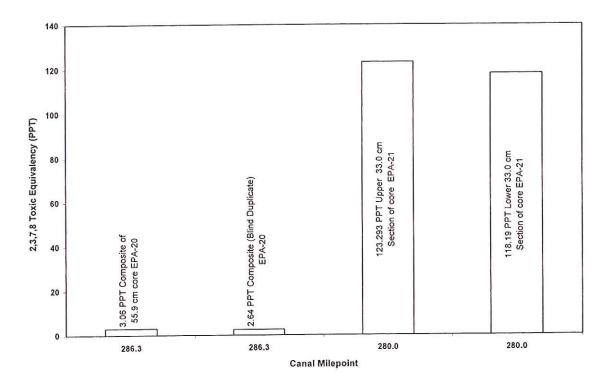
Figure # 4.12 Dioxin/Furan TEQ in Reach # 4

As discussed for reach number 3, the Dioxin/Furan TEQ levels are generally trending downward as one moves easterly. Core samples collected at sample site EPA-20, milepoint 286.3 show a level that is substantially lower than have been observed to the west. The location for this sample site was within an area of the canal of standard cross-section, where there would be little deposition of contaminants over time. Samples collected at sample site EPA-21, milepoint 280.0 were collected in a relatively wide area of the canal, on the outside of a curve. Dioxin/Furan TEQ levels are generally the same as those found in the western end of reach number 3. At this location there is little

difference in TEQ concentration between the upper and lower sections of the core. Figure # 4.12, below shows the TEQ concentrations encountered within this reach.

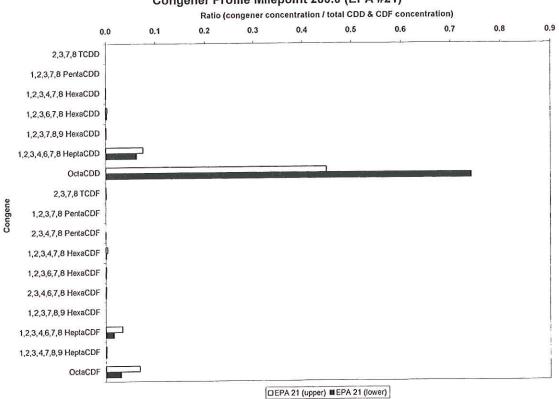
## Figure # 4.13 Congener Profile Milepoint 280.0 (EPA #21)

The composite core collected at sampling site EPA-20 and the lower core section of the core collected at sampling site EPA-21 exhibit the same congener profile, similar to the profile seen within all of the western canal reaches. In the upper section of sampling site EPA-21 there is a significant reduction in the Octachlorodibenzodioxin with a corresponding increase in the concentrations of 1,2,3,4,6,7,8 Heptachlorodibenzodioxin, 1,2,3,4,6,7,8 Heptachlorodibenzofuran and Octachlorodibenzodioxin. There is no known reason for this shift in congener pattern. Figure # 4.13 following, shows the congener patterns observed both the upper and lower sections of core EPA-21.

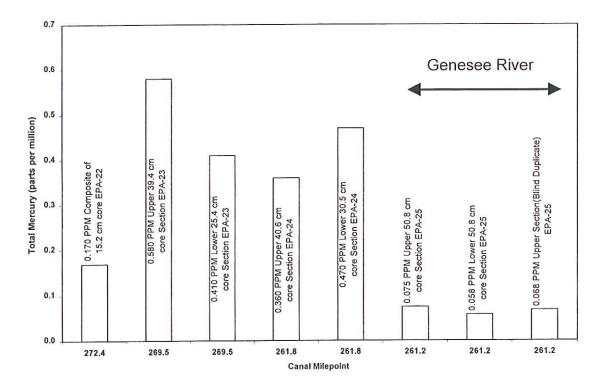
Figure # 4.14 Mercury Concentration in Reach # 5

Four push cores were collected within this reach, 3 were sectioned based on characteristics of the sediment while the fourth core was composited over its entire length. The levels of PCB contamination encountered in the sediment within this reach ranged from 1.05 PPM to non-detectable. The concentration of mercury in the sediment shows the dilution effects of the confluence of the canal with the Genesee River in Rochester. The levels of total mercury within the Genesee River downstream of the confluence are nearly an order of magnitude below the levels seen in the canal sediments. Since the flowrate in the canal represents only a small share of the combined flow, the dilution effects can be clearly seen in Figure # 4.14.

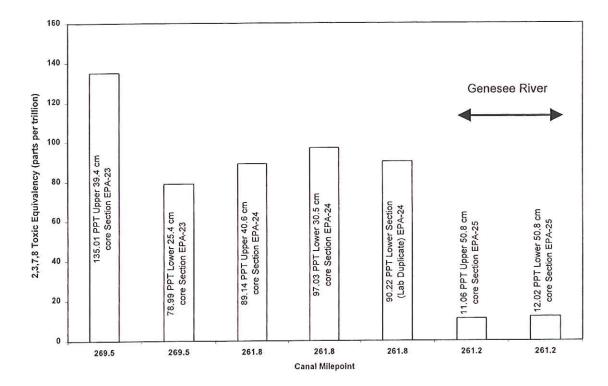
Figure # 4.15 Dioxin/Furan TEQ in Reach # 5

The dilution effects on the dioxin/furan TEQ concentrations are also evident by being nearly an order of magnitude less than the levels encountered in the canal sediments upstream of the confluence of the Genesee River. In sediments that were evaluated prior to the confluence the level of dioxin/furan TEQ continues to show the downward trend when moving from west to east along the canal. The levels within the sediment are approximately 1/5 of the TEQ levels found in the Lockport, New York area, with little change in the congener pattern. Figure # 4.15, below shows the dioxin/furan TEQ concentrations within this reach.

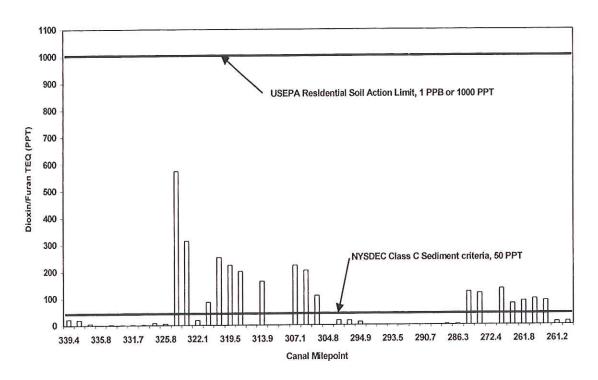
Figure # 5.1 2,3,7,8 Substituted Dioxin/Furan TEQ Levels in Sediments

Elevated levels of dioxin/furan contamination were encountered within the sediments under the Prospect Street Bridge in Lockport and are detectable in the sediments all the way to the Genesee River in Rochester. In some locations the 2,3,7,8 substituted TEQ levels exceed the NYSDEC Class C Sediment criteria of 50 ppt [6]. In no case does the level of 2,3,7,8 TCDD TEQ found in the sediment exceed the USEPA residential soil action limit of 1 PPB [8] or the NYSDEC Technical and Administrative Guidance Memorandum allowable soil concentration of 6 PPB [9].

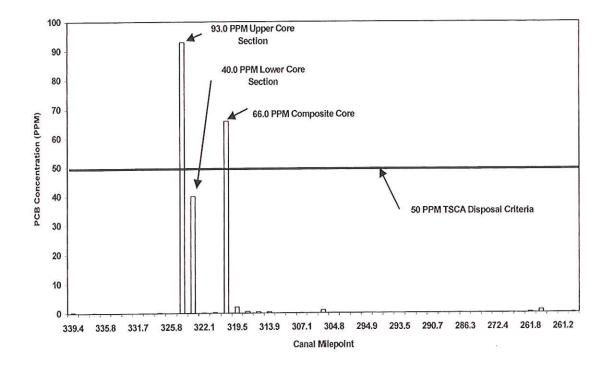
Elevated PCB levels are apparent in the Lockport area originating in the same area as the dioxin/furan contamination but do not seem to be spread as widely to the east.

Two locations showed levels of total PCB that exceeded the TSCA disposal criteria of 50 PPM. These two areas should be further sampled to determine the extent of the contaminated area.

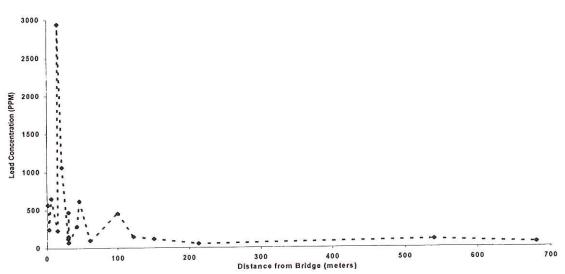
Distances downstream of structures have been obtained for numerous sediment cores over the past four years. By plotting the distance verses lead concentration, a general trend can be shown for the lead concentration in the canal sediments. Sampling that was conducted as recently as the Fall of 1999 at reconstruction project for the Exchange Street lift bridge showed visible flakes of lead based paint downstream of the bridge structure. Samples collected immediately upstream of the bridge did not exhibit visible paint flakes [Dergosits, unpublished data]. Based on the data, lead concentrations can be predicted from flaking or deteriorated paint as shown on Figure # 5.3.

Although the amount of data points that are used to prepare the above figure and analysis may be somewhat limited, it is clear that particulate lead has caused an impact on the canal sediments. Supplemental data collection will be continued to better define the trend in sediment contamination.

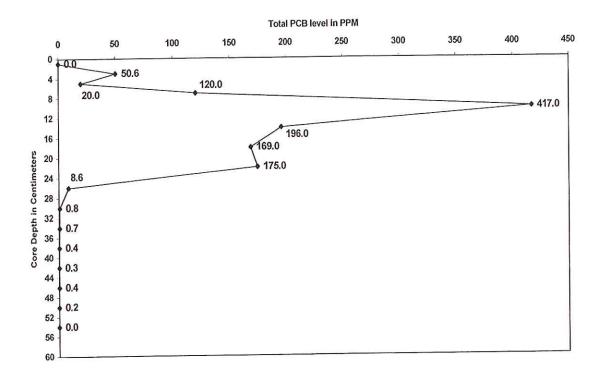
# Figure # 5.4 Core EPA 7 - Total PCB Profile

A second point that should be mentioned is that due to the limited volume of sediment that is contained in a 2-centimeter slice of a 5.1 centimeter diameter core, only an evaluation for PCB could be conducted at these sample locations. The vertical profile for PCB contamination within the core collected at site EPA 7 is shown below.

The information that is provided by this profile is quite dramatic, the initial detection of PCB that appears significant in the sediment appears in the 24 to 28 centimeter depth. Based on extrapolation this sediment horizon is estimated to have been deposited in approximately 1958. The low level of PCB detection that occurs in the 28 to 52 centimeter range are believed to be remnants of sediment from upper layers of the core, smearing within the core tube while the core is being pushed into the sediment. More significant discharges appear to have occurred in the 1961 to 1979 era with a more

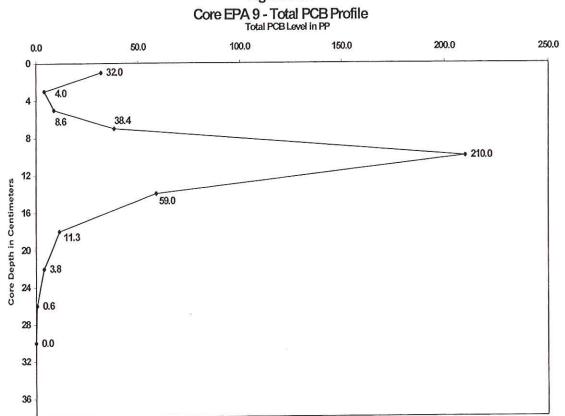
At site EPA 9 the peak contaminant levels have been reduced, most likely by mixing of the contaminants as they progressed over the vertical drop of the flight of Locks. Based on the Cs-137 profile in this area the deposition rates at this location are slower than were determined at site EPA 7, about 0.21 cm/year. This peak occurrence of Cs-137 appears in the duplicate sample analyzed in the 6 to 8 centimeter range.

The information provided by this profile does not readily coincide with the information found at site EPA 7. The initial detection of PCB that appears significant in the sediment appears in the 20 to 24 centimeter depth, with a peak concentration appearing in the core section at 8 to 12 centimeter depth. Based on extrapolation of the Cs-137 data, the initial occurrence of PCB would have appeared well before the historical use of this compound, before the turn of the century. The more significant peak discharge apparent in the 8 to 12 centimeter range would correspond to approximately 1948. Based on the wide difference between core EPA 7 and EPA 9 it is doubtful that the dating information in this core is accurate. It is possible that water diversions through the lock structure or the nearby hydroelectric facility may have increased turbulence in the water column leading to the questionable results in this core. What is interesting is the correlation between the depths of the peak contaminant levels in both core EPA 7 and EPA 9. Both cores show initial introduction of the contaminant in the 20 to 28 centimeter depth range. At core EPA 7 which is upstream, the initial contaminant depth is in the 24 to 28 centimeter range while at core EPA 9 the depth is in the 20 to 24 centimeter range. This would be consistent with the downstream flow of contamination over time. It is also interesting that the sediment depth for the peak contaminant level is consistent, at the 8 to 12 centimeter level in both cores.

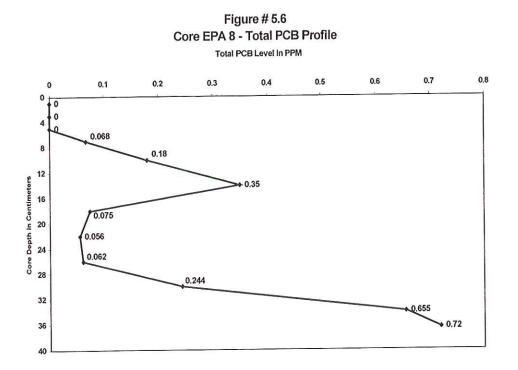
At sample site EPA 8 the turbulence caused by vessel propellers in this location might have mixed up the sediments so that a contaminant profile was not identifiable. This core was also subjected to an evaluation of the sediment by core slice for PCB. Generally, this core shows the wide range of PCB contaminant mixing throughout the

vertical core striation. It is interesting how significantly lower the PCB concentrations are at this core sampling location, the highest concentration is well below 1 PPM total PCB.

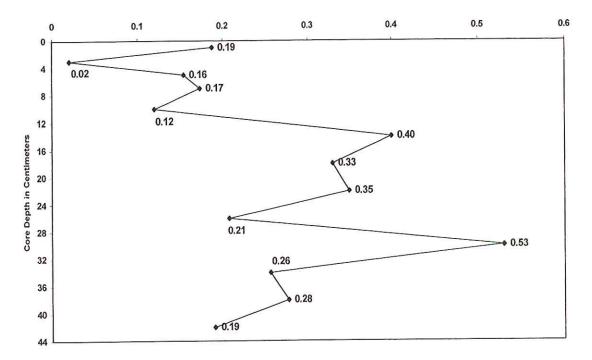
In Reach #4, the sample core collected at site EPA 21 exhibited a reasonable dating profile. This location was also evaluated for the vertical extent of PCB concentration. Peak occurrence of Cs-137 appears in the sample analyzed in the 24 to 28 centimeter range, based on this Cs-137 profile the deposition rates at this location are about 0.8 cm/year. The wide variation of PCB concentration through the core suggests that a relatively dilute source of PCB was discharging to the sediments over a long time frame. The peak concentration of PCB of 0.53 PPM would approximately equate to 1960, with a secondary peak of 0.40 PPM around 1980.

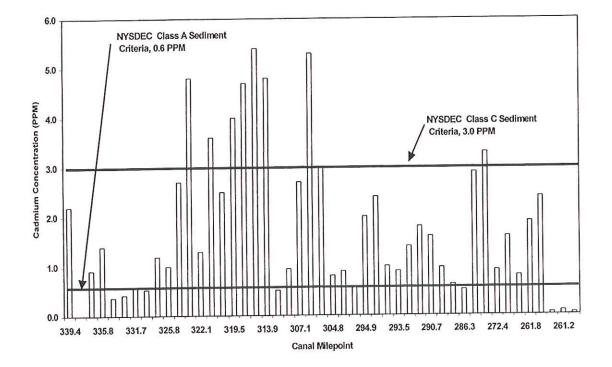
Figure # 5.8 Cadmium Concentration in Sediment

The levels of cadmium within the canal sediments appear to be elevated above the NYSDEC class C sediment criteria of 3.0 PPM starting within the City of Lockport in the vicinity of core EPA 7 and easterly to the Medina area, core EPA 13. The general trend is that the lower core sections, which represent the older sediments, are higher in cadmium contamination. This would appear to coincide with the potential for a historic discharges in the Lockport area. At core EPA 21 the cadmium level is 2.90 PPM, slightly below the 3.0 PPM threshold in the upper sediments. In the lower core section the cadmium concentration is 3.3 PPM, this suggests that mixing has played a role in the deposition of this contaminant.

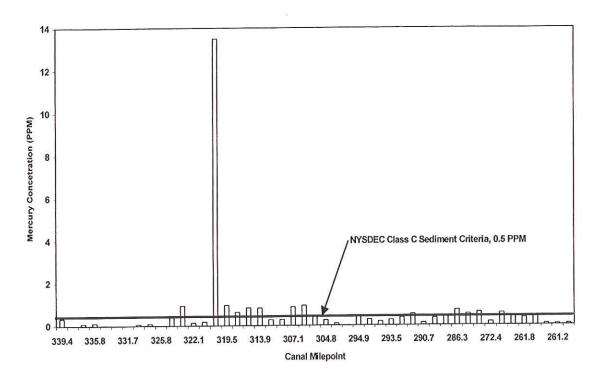
Figure # 5.9 Mercury Concentration in Sediments

The general trend of mercury contamination within the canal sediment appears to be close to the NYSDEC class C sediment criteria level of 0.5 PPM for most of the canal between Lockport and the Genesee River with one major exception. That exception was found in core EPA 9 which was collected below the flight of locks in Lockport where the mercury concentration was 13.5 PPM. The first elevated levels of mercury was found at core location EPA 7 where the lower older sediments showed mercury at 0.94 PPM while the upper, newer sediments were below the 0.5 PPM threshold.

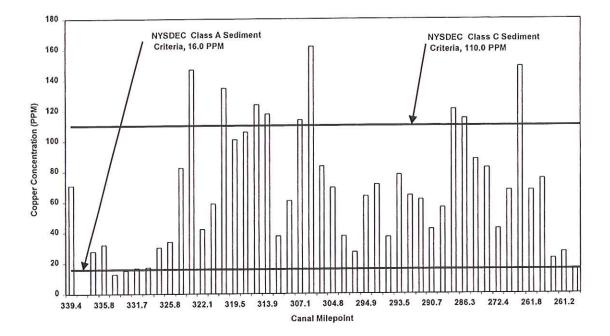
Figure # 5.10 Copper Concentration in Sediments

The concentration of copper within the sediments generally showed the same trend as the level of cadmium in the sediments. Lower core sections also showed higher copper concentrations than the upper more recent core sections.
