**Historical Summary:**

**The Union Ship Canal  
and  
The Hanna Furnace Corporation,  
Buffalo, Erie County, New York**

**Development Downtown, Inc.  
Buffalo, New York**

**June 2002**

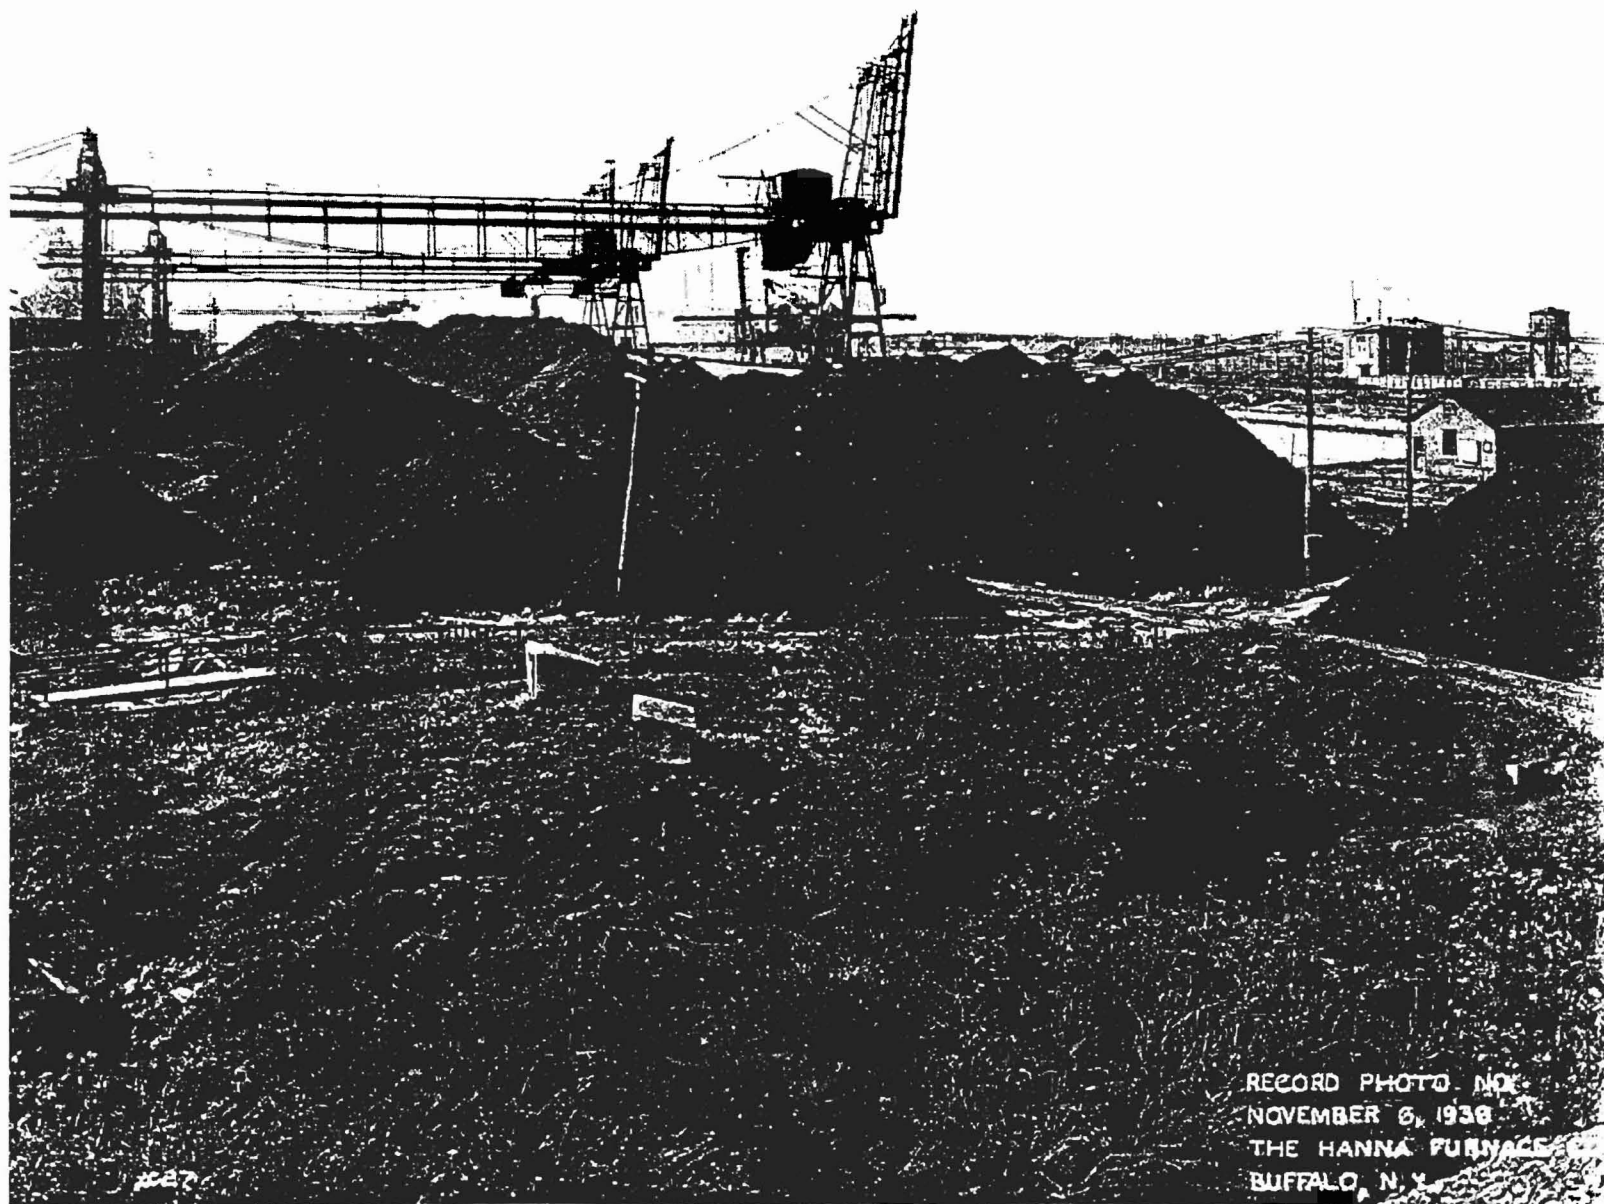
View of No. 4 Furnace, due southeast, with limestone storage and Union Ship Canal in the foreground.

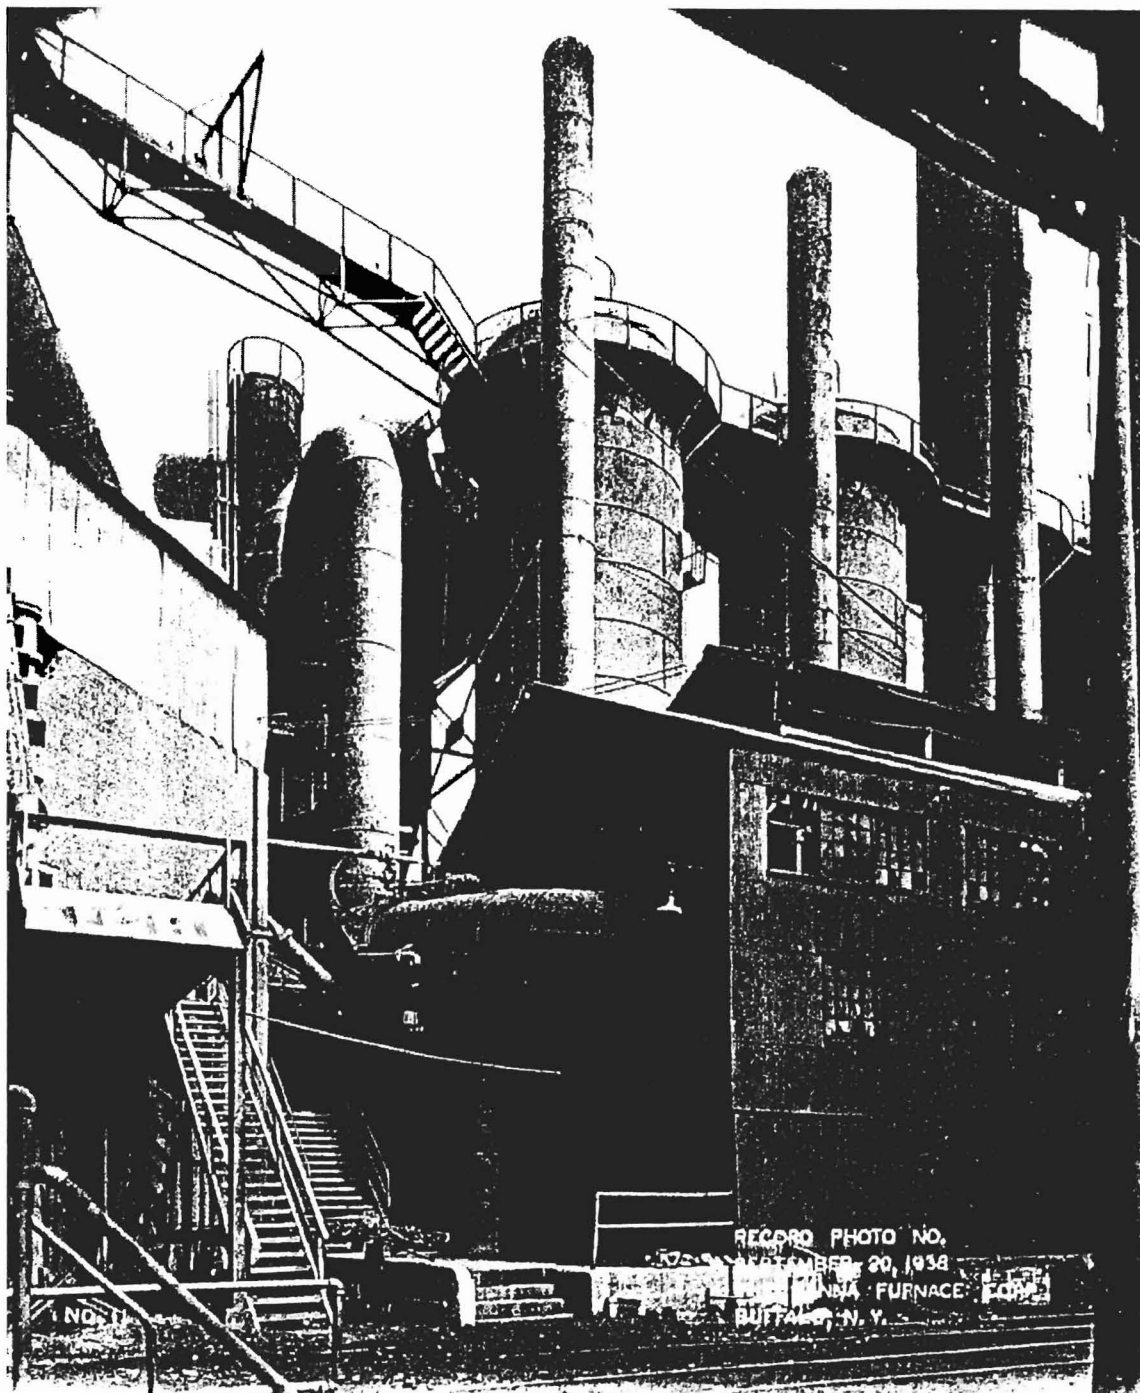
No. 1 Furnace with skip bridge, downcomer, dust catcher, washer and three stoves.  
Elevated trestle with a rail line in the foreground.

At the heart of the Hanna Furnace plant were four relatively large blast **furnaces** that were approximately 100 feet high and 25 feet in diameter (NSC nd: 22). Blast furnaces were cylindrical steel shells lined with fire resistant bricks (Photograph 5). These furnaces were erected on very strong concrete foundations that would support the enormous weight of the furnace and its charge and could also withstand side forces exerted by **skip bridges** and **downcomers** (Photograph 4)(See below).

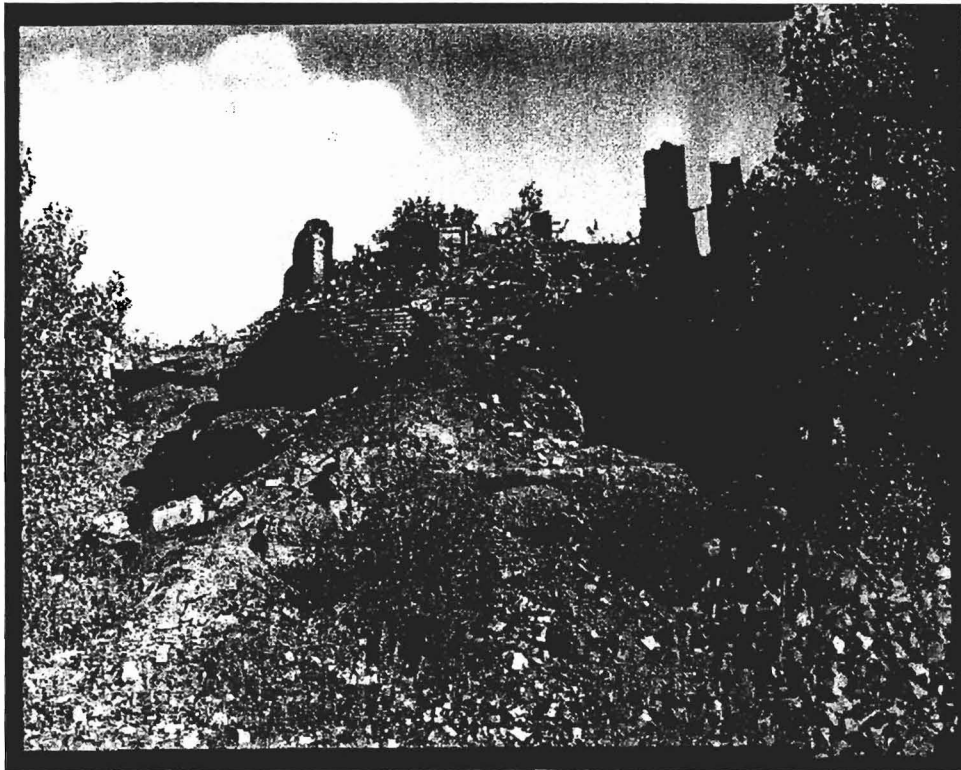
**Photograph 1. Southwest section of Hanna Furnace No. 4, facing north. Hanna Furnace Redevelopment Project, Buffalo, Erie County, New York (*PCI 2001*).**

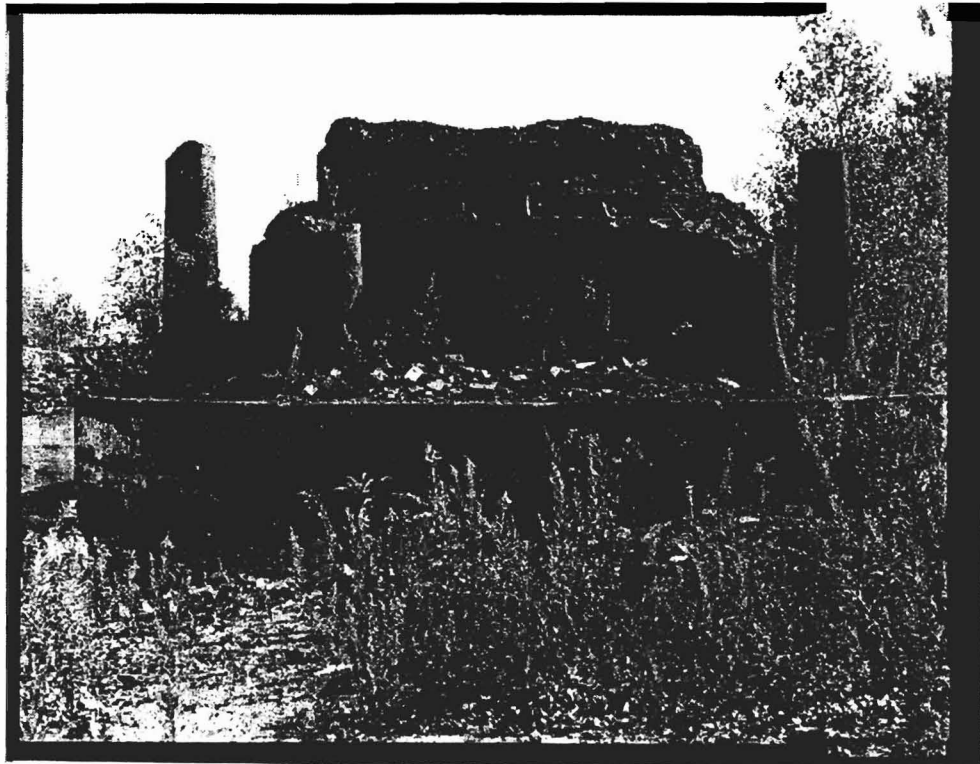
**Photograph 4. West elevation of Hanna Furnace No. 3, facing east. Hanna Furnace Redevelopment Project, Buffalo, Erie County, New York (PCI 2001).**

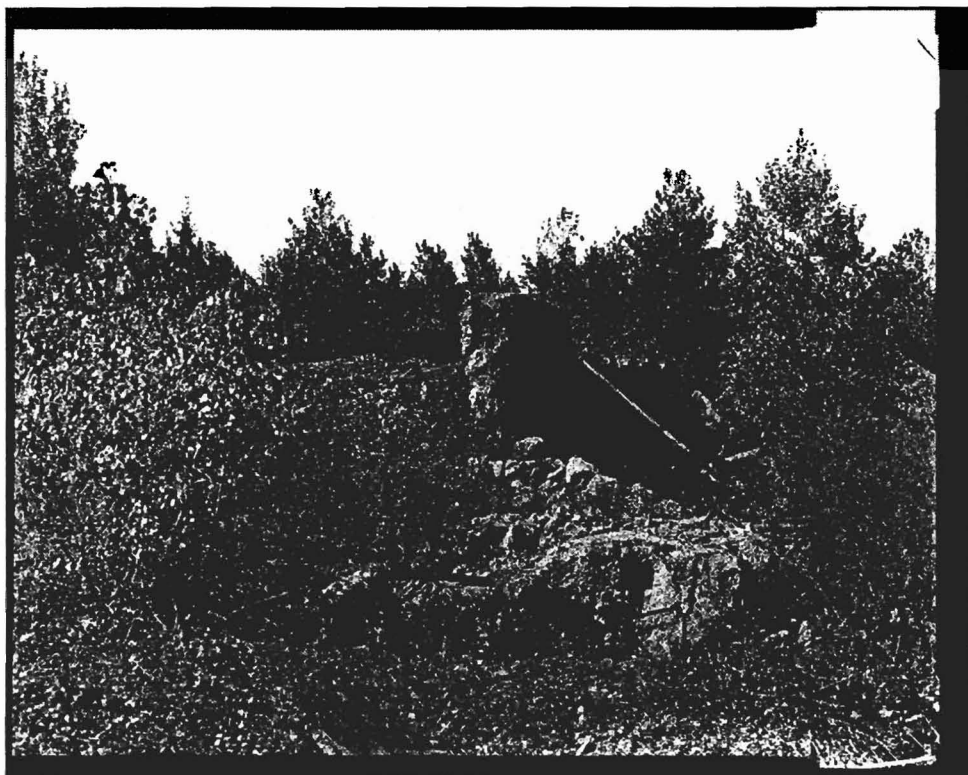
**Photograph 6. Hanna Furnace No. 1 with slag dump and drain, facing southwest. Hanna Furnace Redevelopment Project, Buffalo, Erie County, New York (*PCI 2001*).**

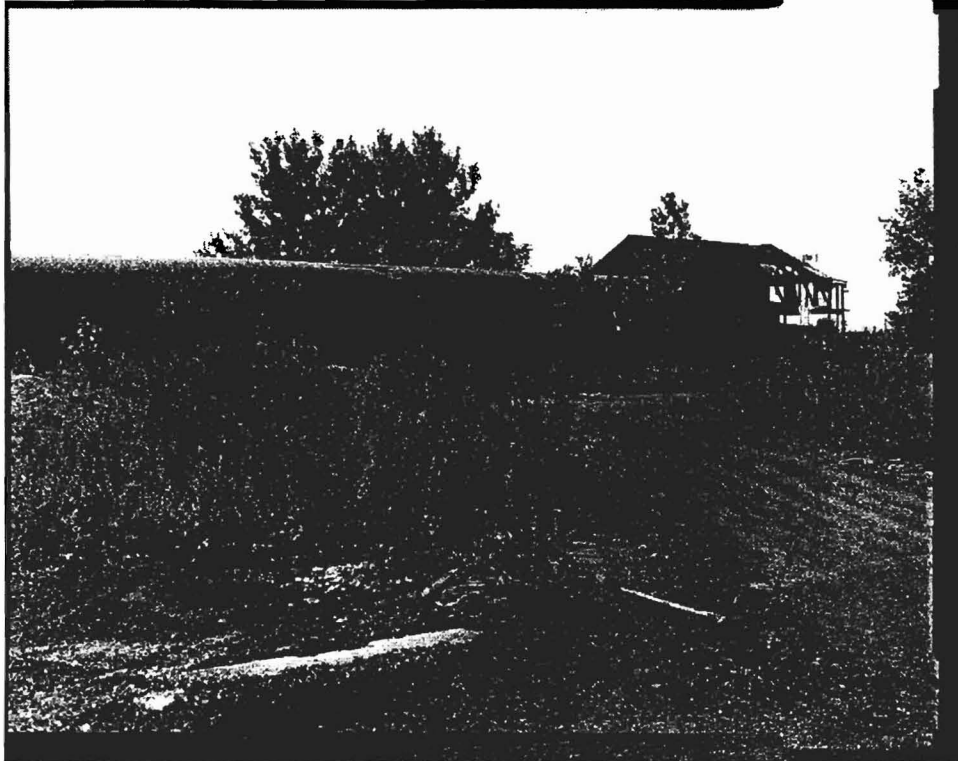
**Photograph 7. South and west elevations of Hanna Furnace Trestle Ramp, facing north-northeast. Hanna Furnace Redevelopment Project, Buffalo, Erie County, New York (PCI 2001).**

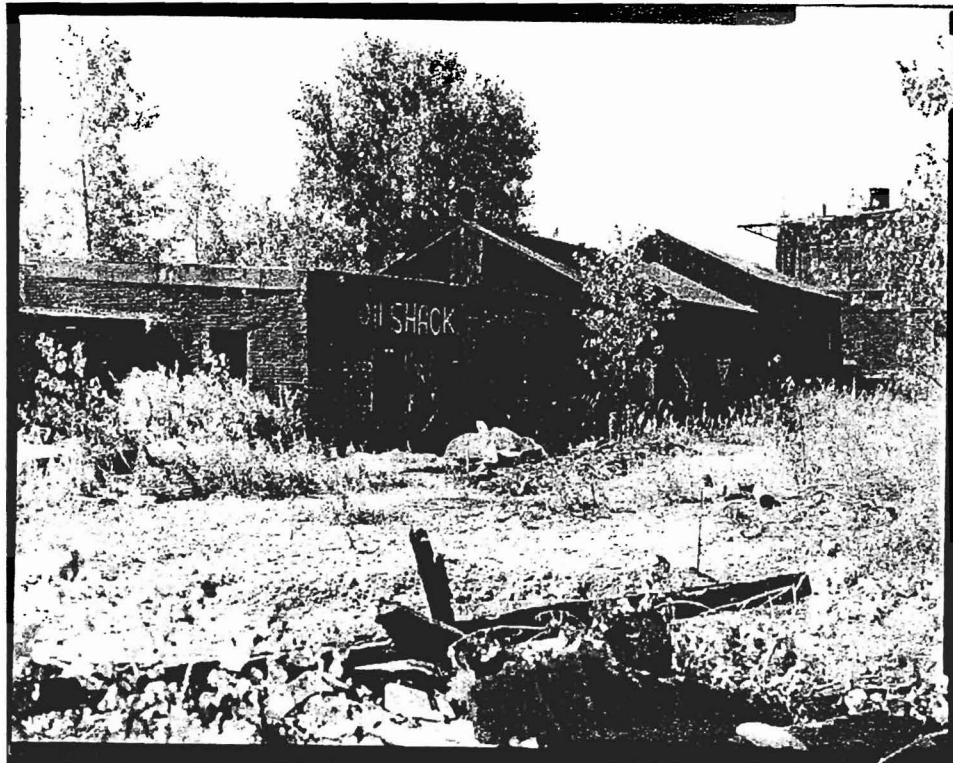
**Photograph 9. North and east elevations of Hanna Furnace Oil Shack and Coal Storage Building, facing southwest. Hanna Furnace Redevelopment Project, Buffalo, Erie County, New York (PCI 2001).**

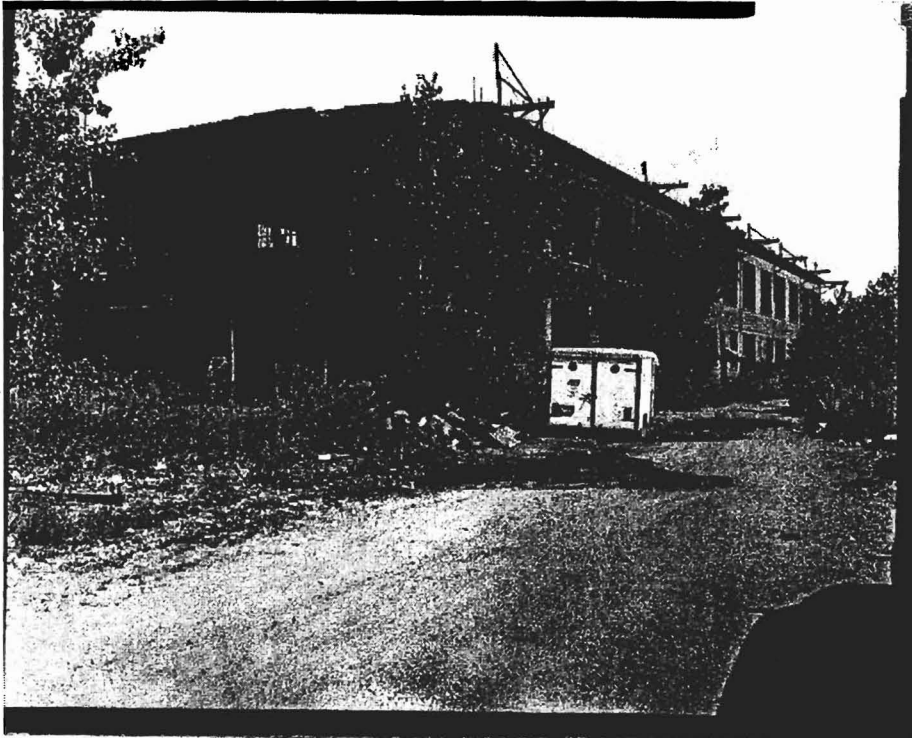
**Photograph 11. West and south elevations of Hanna Furnace Machine Shop, facing northeast. Hanna Furnace Redevelopment Project, Buffalo, Erie County, New York (PCI 2001).**

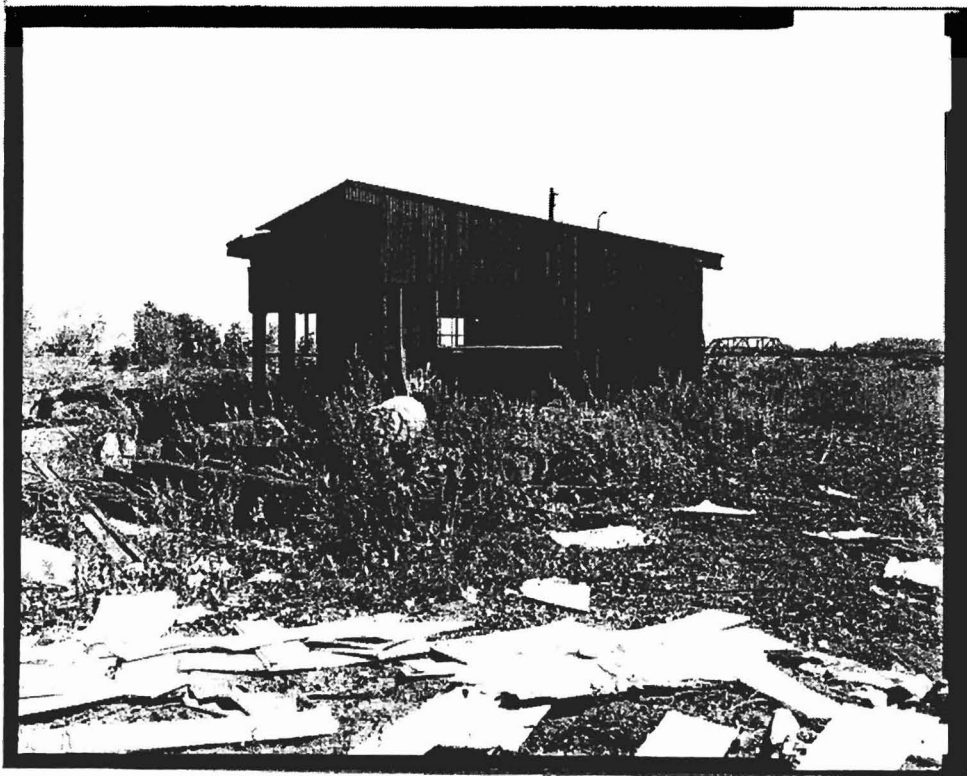
**Photograph 12. North and west elevations of Hanna Furnace Filter House, facing east. Hanna Furnace Redevelopment Project, Buffalo, Erie County, New York (PCI 2001).**

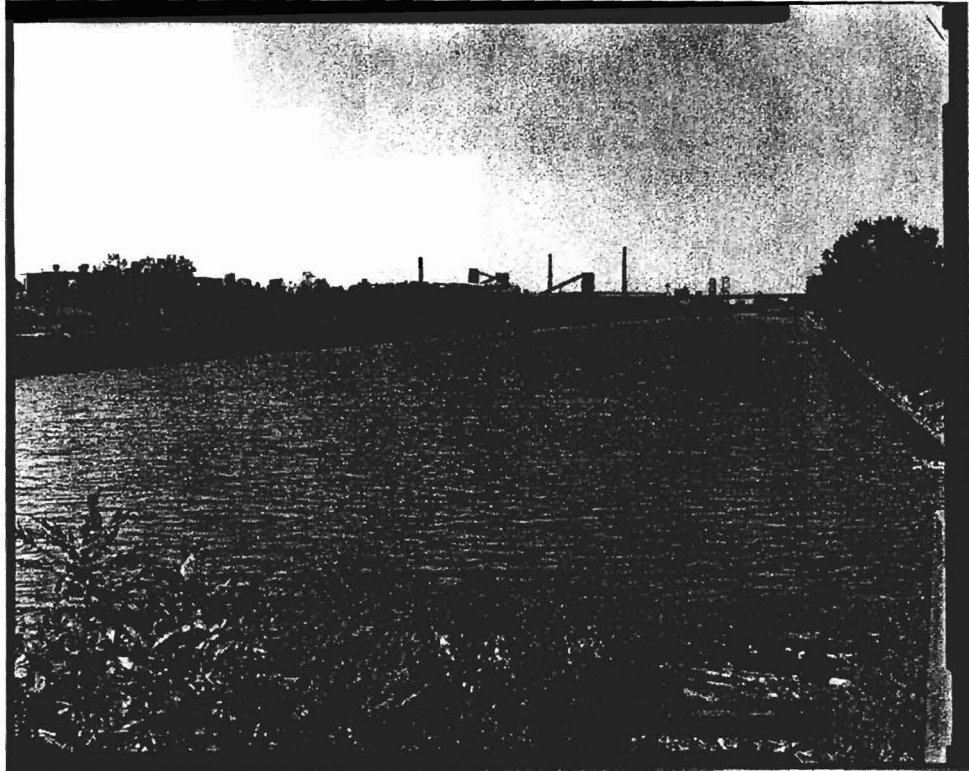
**Photograph 13. Union Ship Canal from the northeast corner of the canal, facing southwest. Note Hanna Furnace complex and Machine Shop to the left. Hanna Furnace Redevelopment Project, Buffalo, Erie County, New York (PCI 2001).**
