**Environmental Restoration  
Record of Decision  
Hanna Furnace-Subparcel 3 Site  
City of Buffalo, Erie County, New York  
Site Number B-00164-9**

**February 2005**

## **Hanna Furnace-Subparcel 3 Environmental Restoration Site City of Buffalo, Erie County, New York Site No. B-00164-9**

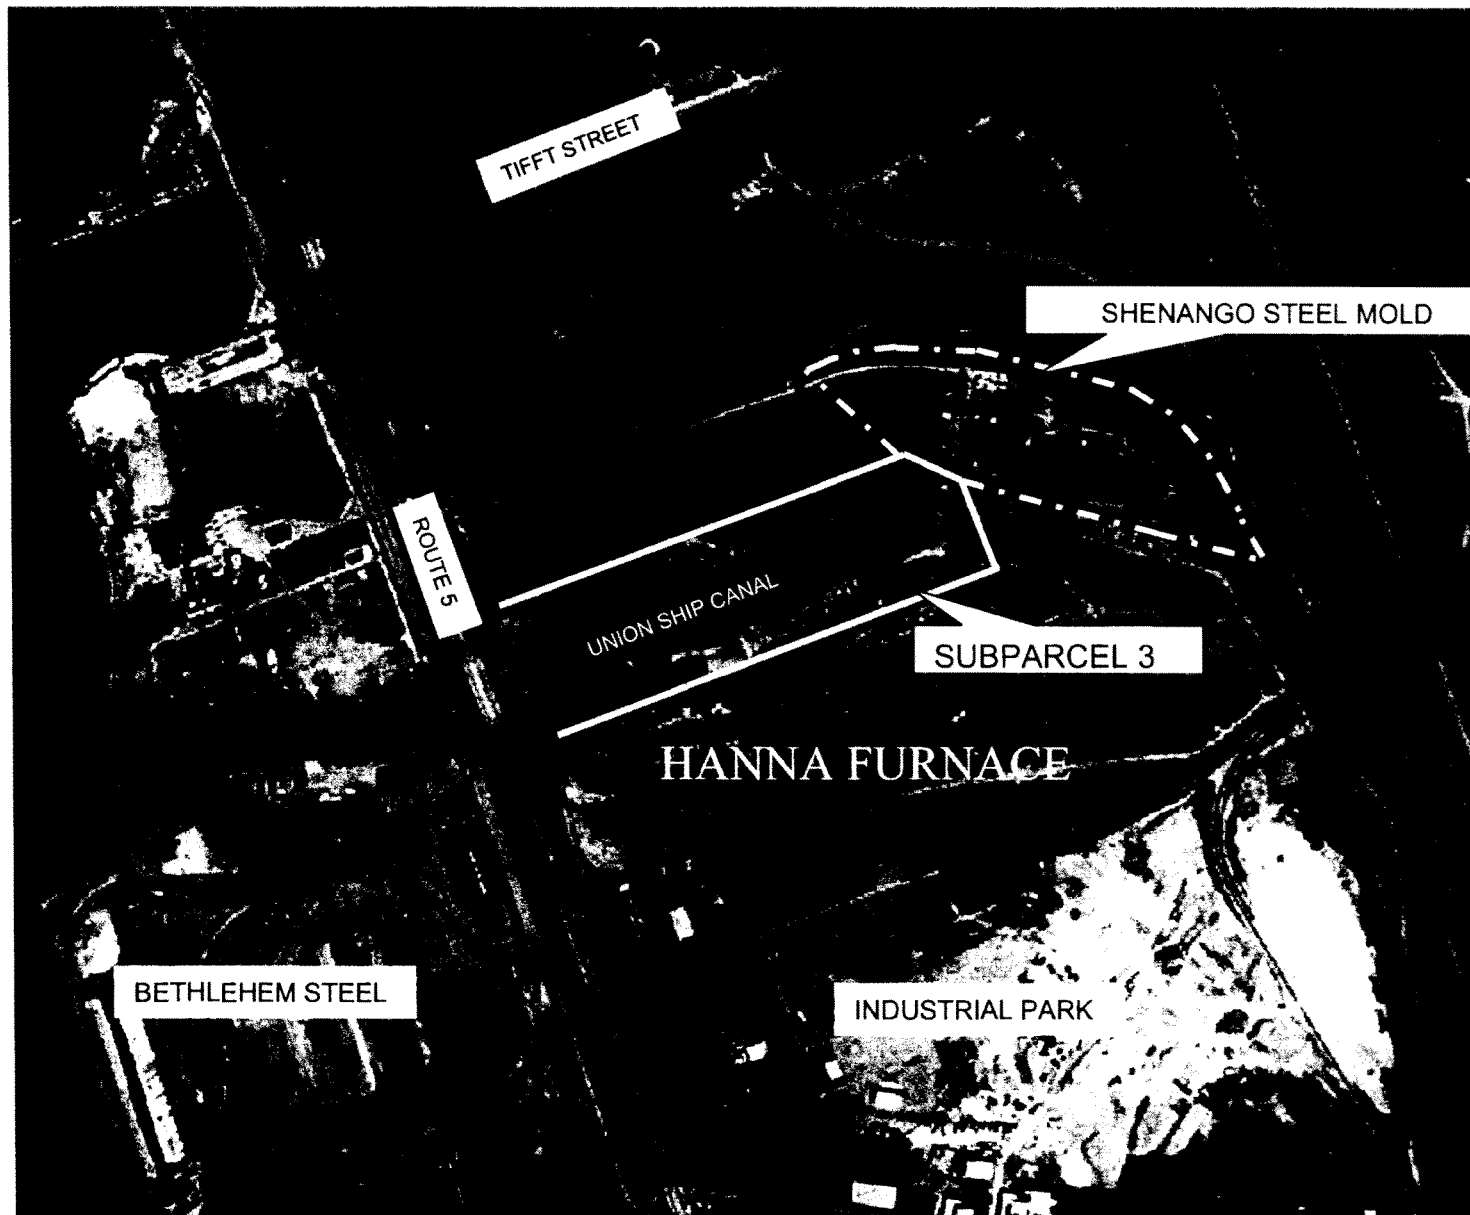
FIGURE 2 – HANNA FURNACE SUBPARCEL 3

- FORMER BUILDING LOCATION
- SURFACE WATER
- GRAVEL ROAD
- HANNA FURNACE SITE PROPERTY
- SHENANGO STEEL SITE PROPERTY
- SECTIONS WITHIN HANNA FURNACE SITE

Properties surrounding Hanna Furnace include the inactive hazardous waste disposal site known as Shenango Steel Mold (Site #915172) to the northeast, active railroad lines and wetlands to the north and east, NY State Route 5 and the former Bethlehem Steel Corporation facility to the west, and an industrial /commercial park to the south in the City of Lackawanna (Figure 2).

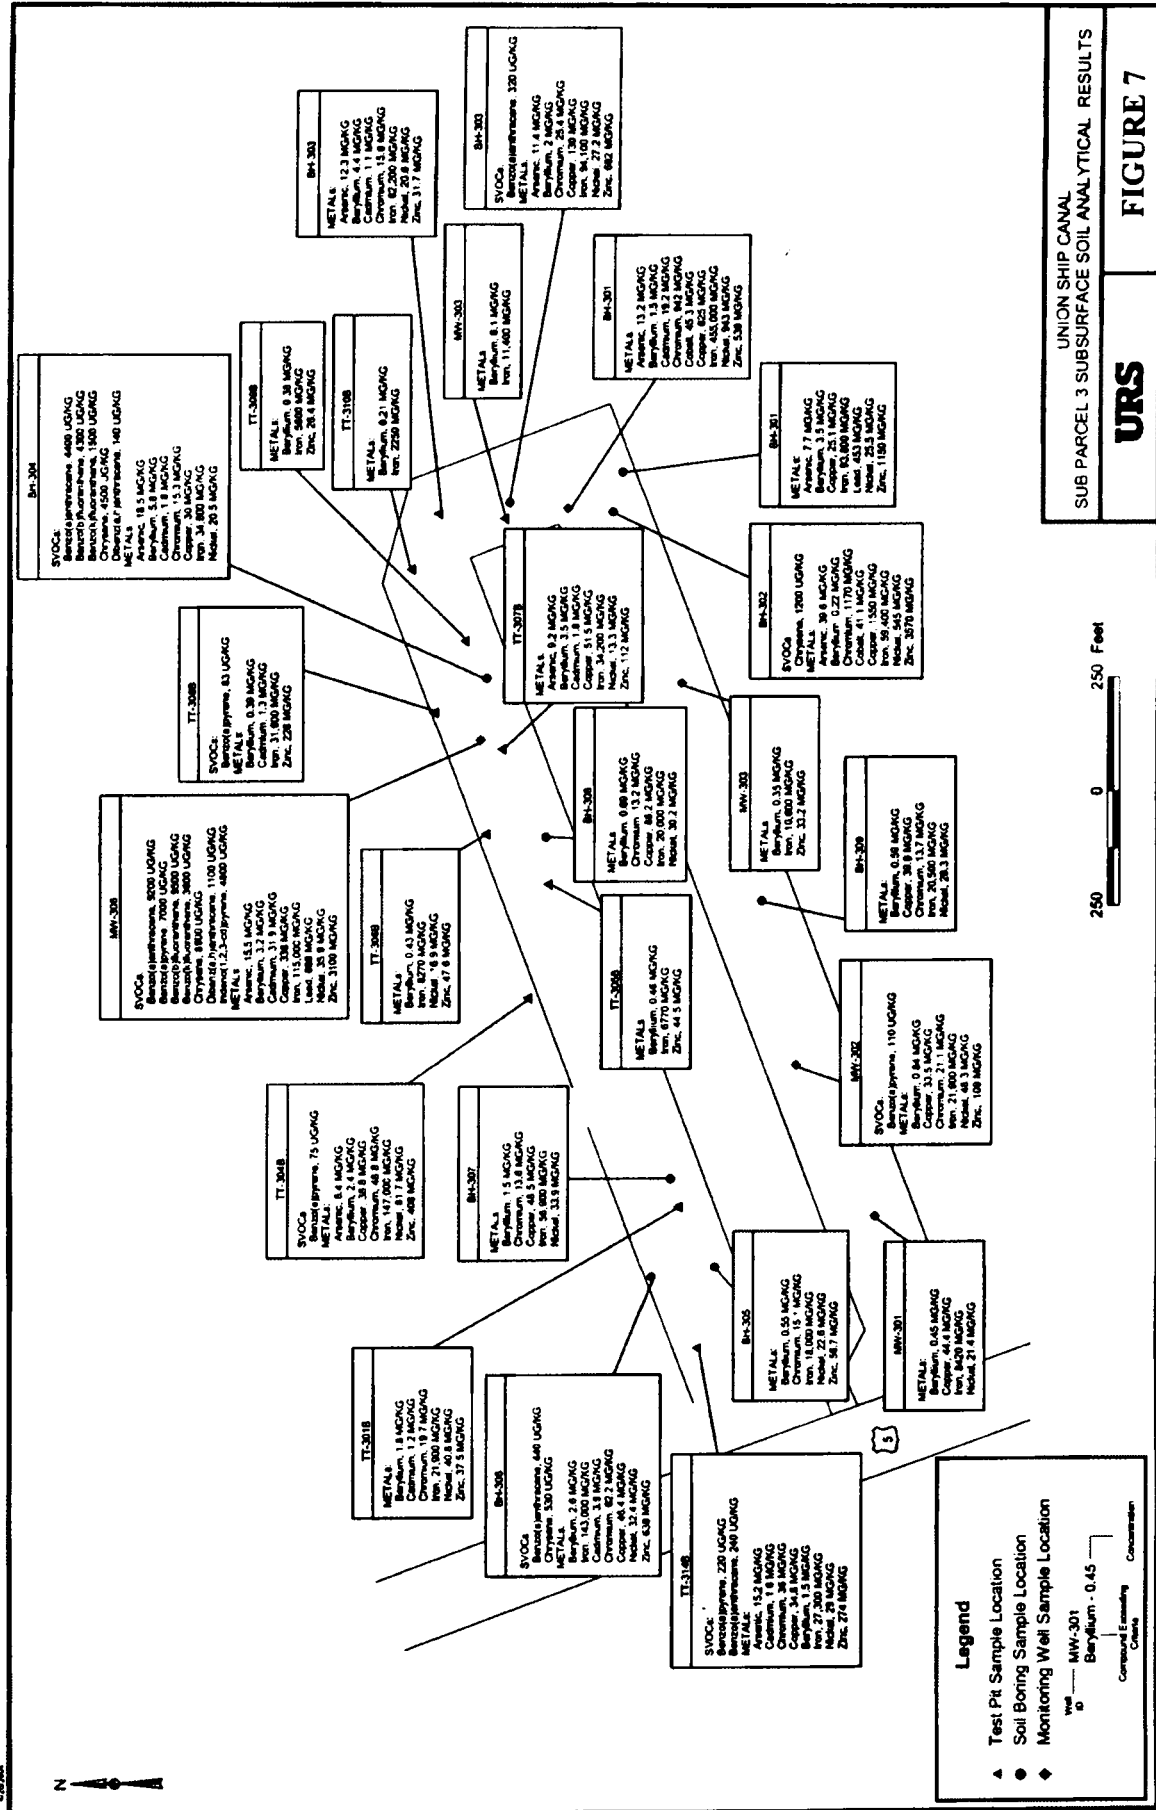
FIGURE 7

UNION SHIP CANAL  
SUB PARCEL 3 SUBSURFACE SOIL ANALYTICAL RESULTS

No VOCs were detected in any of the subsurface soil samples. SVOCs, consisting primarily of PAHs, were detected in twenty one of the twenty five samples. Concentrations exceeding SCGs were observed in eight of the twenty five samples analyzed. As with the surface soils, all of these occurrences were cPAHs. Similarly, only one or two cPAHs were detected in these samples. Again, the exception was the subsurface soils in the northeast portion of the site, near BH-304 and MW-306, the same area where elevated cPAH concentrations were found in the surface soils.
