**Re: Groundwater Sampling Report  
Former Darby Drugs – OUII (Off-Site)  
Rockville Centre, New York 11570  
NYSDEC BCP Number: C130140A**

EnviroTrac Ltd. (EnviroTrac) has prepared this report to document the results of groundwater sampling conducted during September 2021 at the above-referenced Site.

### **Photographic Documentation Monitoring Well Condition On September 9, 2021**

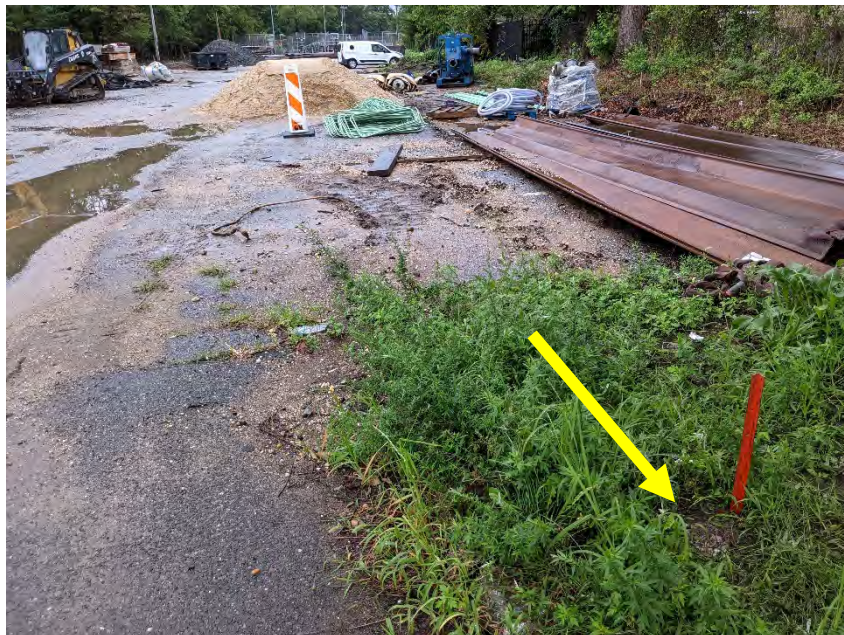
**Photograph 2:** View of the southeastern portion of the Site, where MW11 is located, which has been unimpacted by the construction.

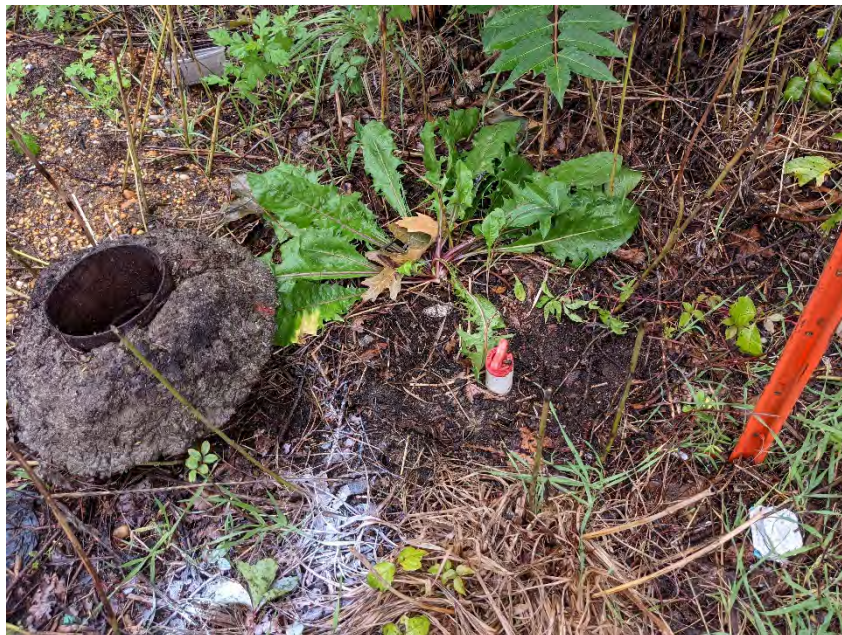
**Photograph 5:** View of the casing of MW12. Note displaced manhole cover.

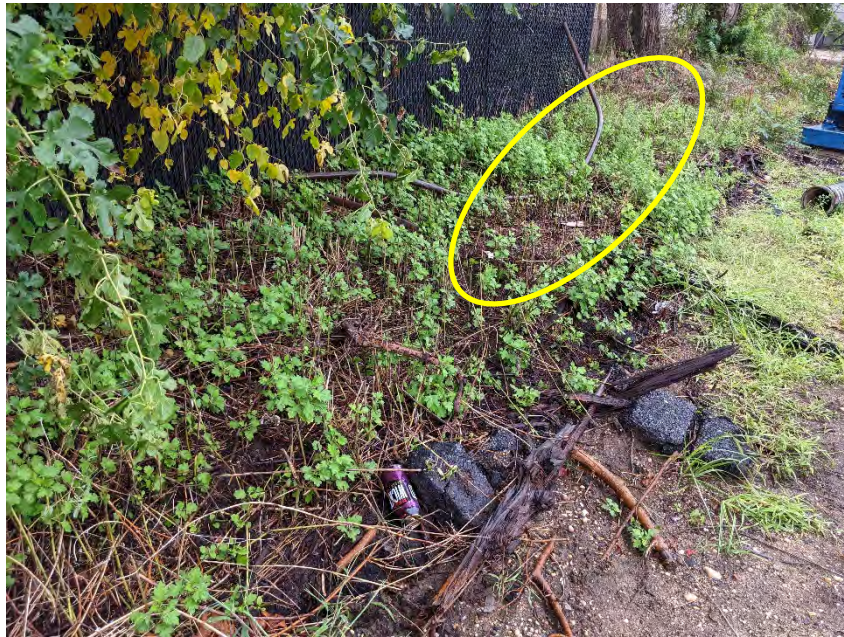
**Photograph 7:** View of the area where MW13 is located; however, it was not found during the site visit. The well cover appeared to be removed from this area.

Construction activities related to the regional flood control structure have resulted in damage/destruction of some existing monitoring wells. Wells that will require replacement by the Village of Rockville Centre include but are not limited to MW1, MW2 and MW13. The road box for well MW12 needs to be restored. This work should be conducted prior to the next semi-annual sampling event in March 2022. Recommended wells to be gauged include MW1, MW2, MW4, MW6 through MW9 and MW11 through

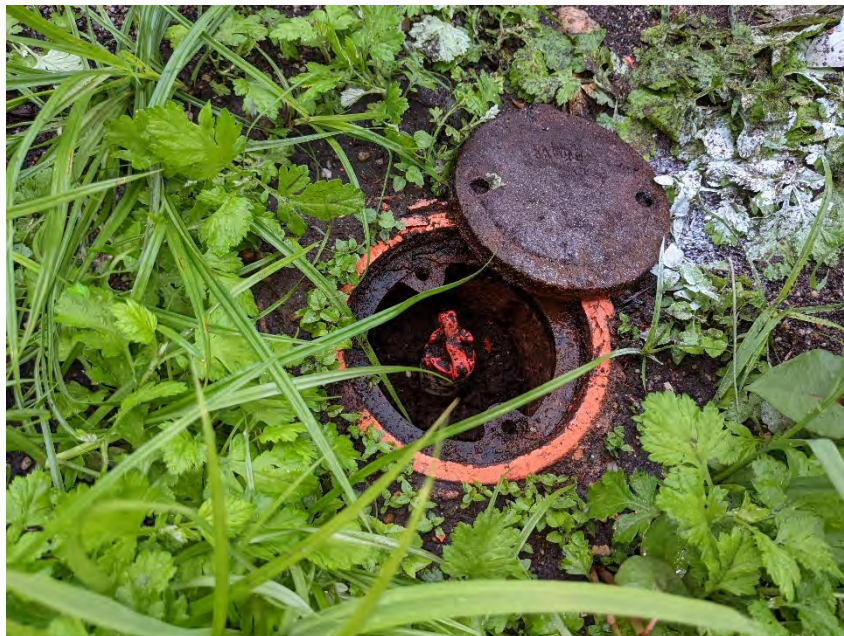
**Photograph 10:** View of the casing of MW14, which appeared unimpacted by the construction around Smith Pond.

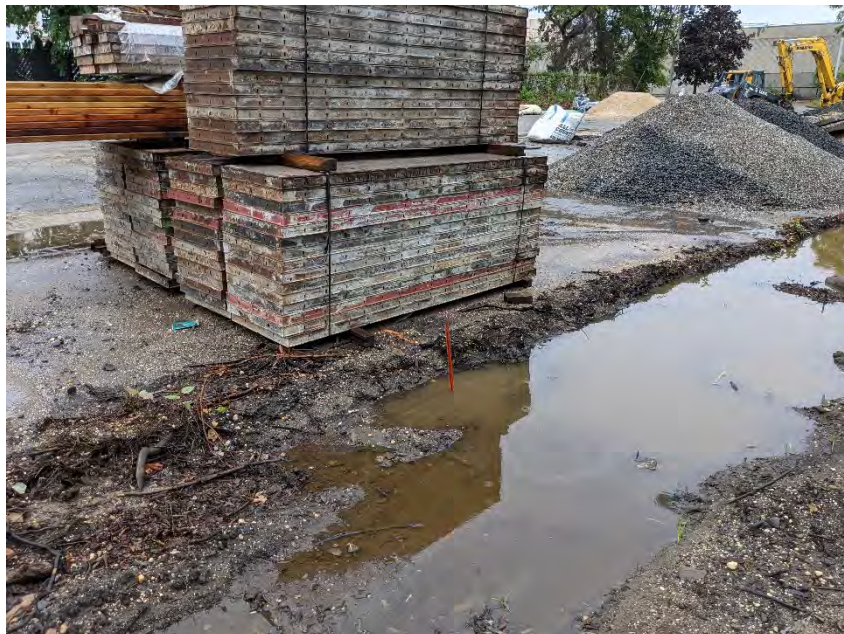
**Photograph 12:** View of the location of MW1, which was flooded over by the remnants of Hurricane Ida.

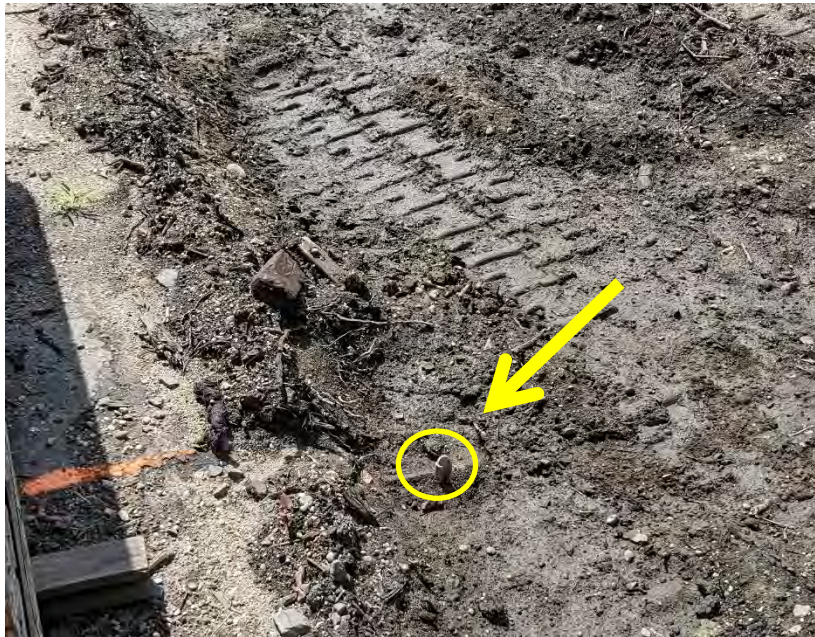
**Photograph 13:** View of the casing of MW1 during a previous visit on August 31, 2021, which was observed to be broken at the top.

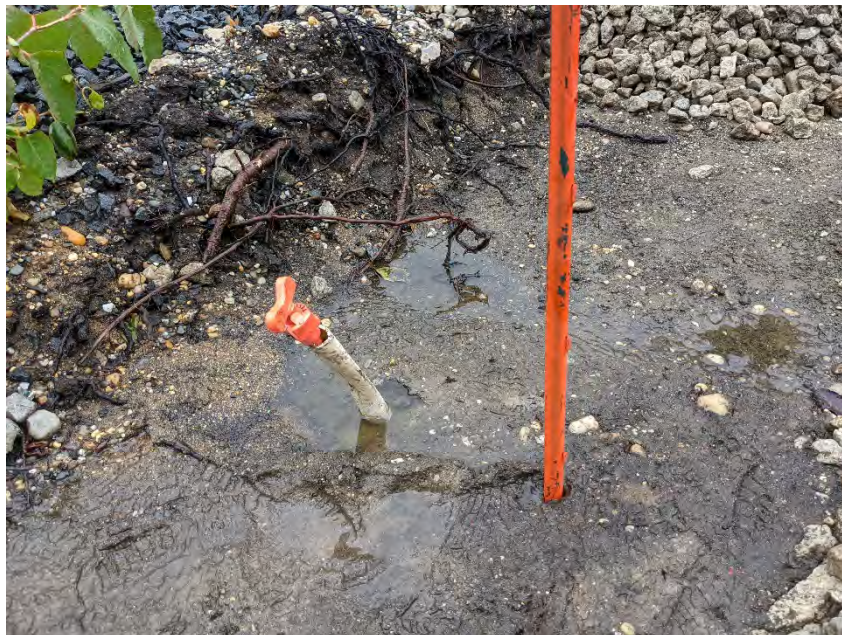
EnviroTrac personnel reported to the Site on September 9, 2021, to gauge monitoring wells MW2, MW4, MW6 through MW9 and MW11 through MW14 and sample monitoring wells MW2, MW9, and MW11 through MW14. MW2 had been damaged during the construction and could not be used. MW13 could not be located and is presumed to have been destroyed. The purpose of this work was to continue the assessment of shallow groundwater flow patterns and quality at OUII.

**Photograph 15:** View of the casing of MW2, which was pinched at the base. This damage prevented the well from being sampled or gauged.
