# SITE REMEDIATION WORK PLAN

**190 West Shore Road**

**Kings Point, New York**

NPV No. 21382

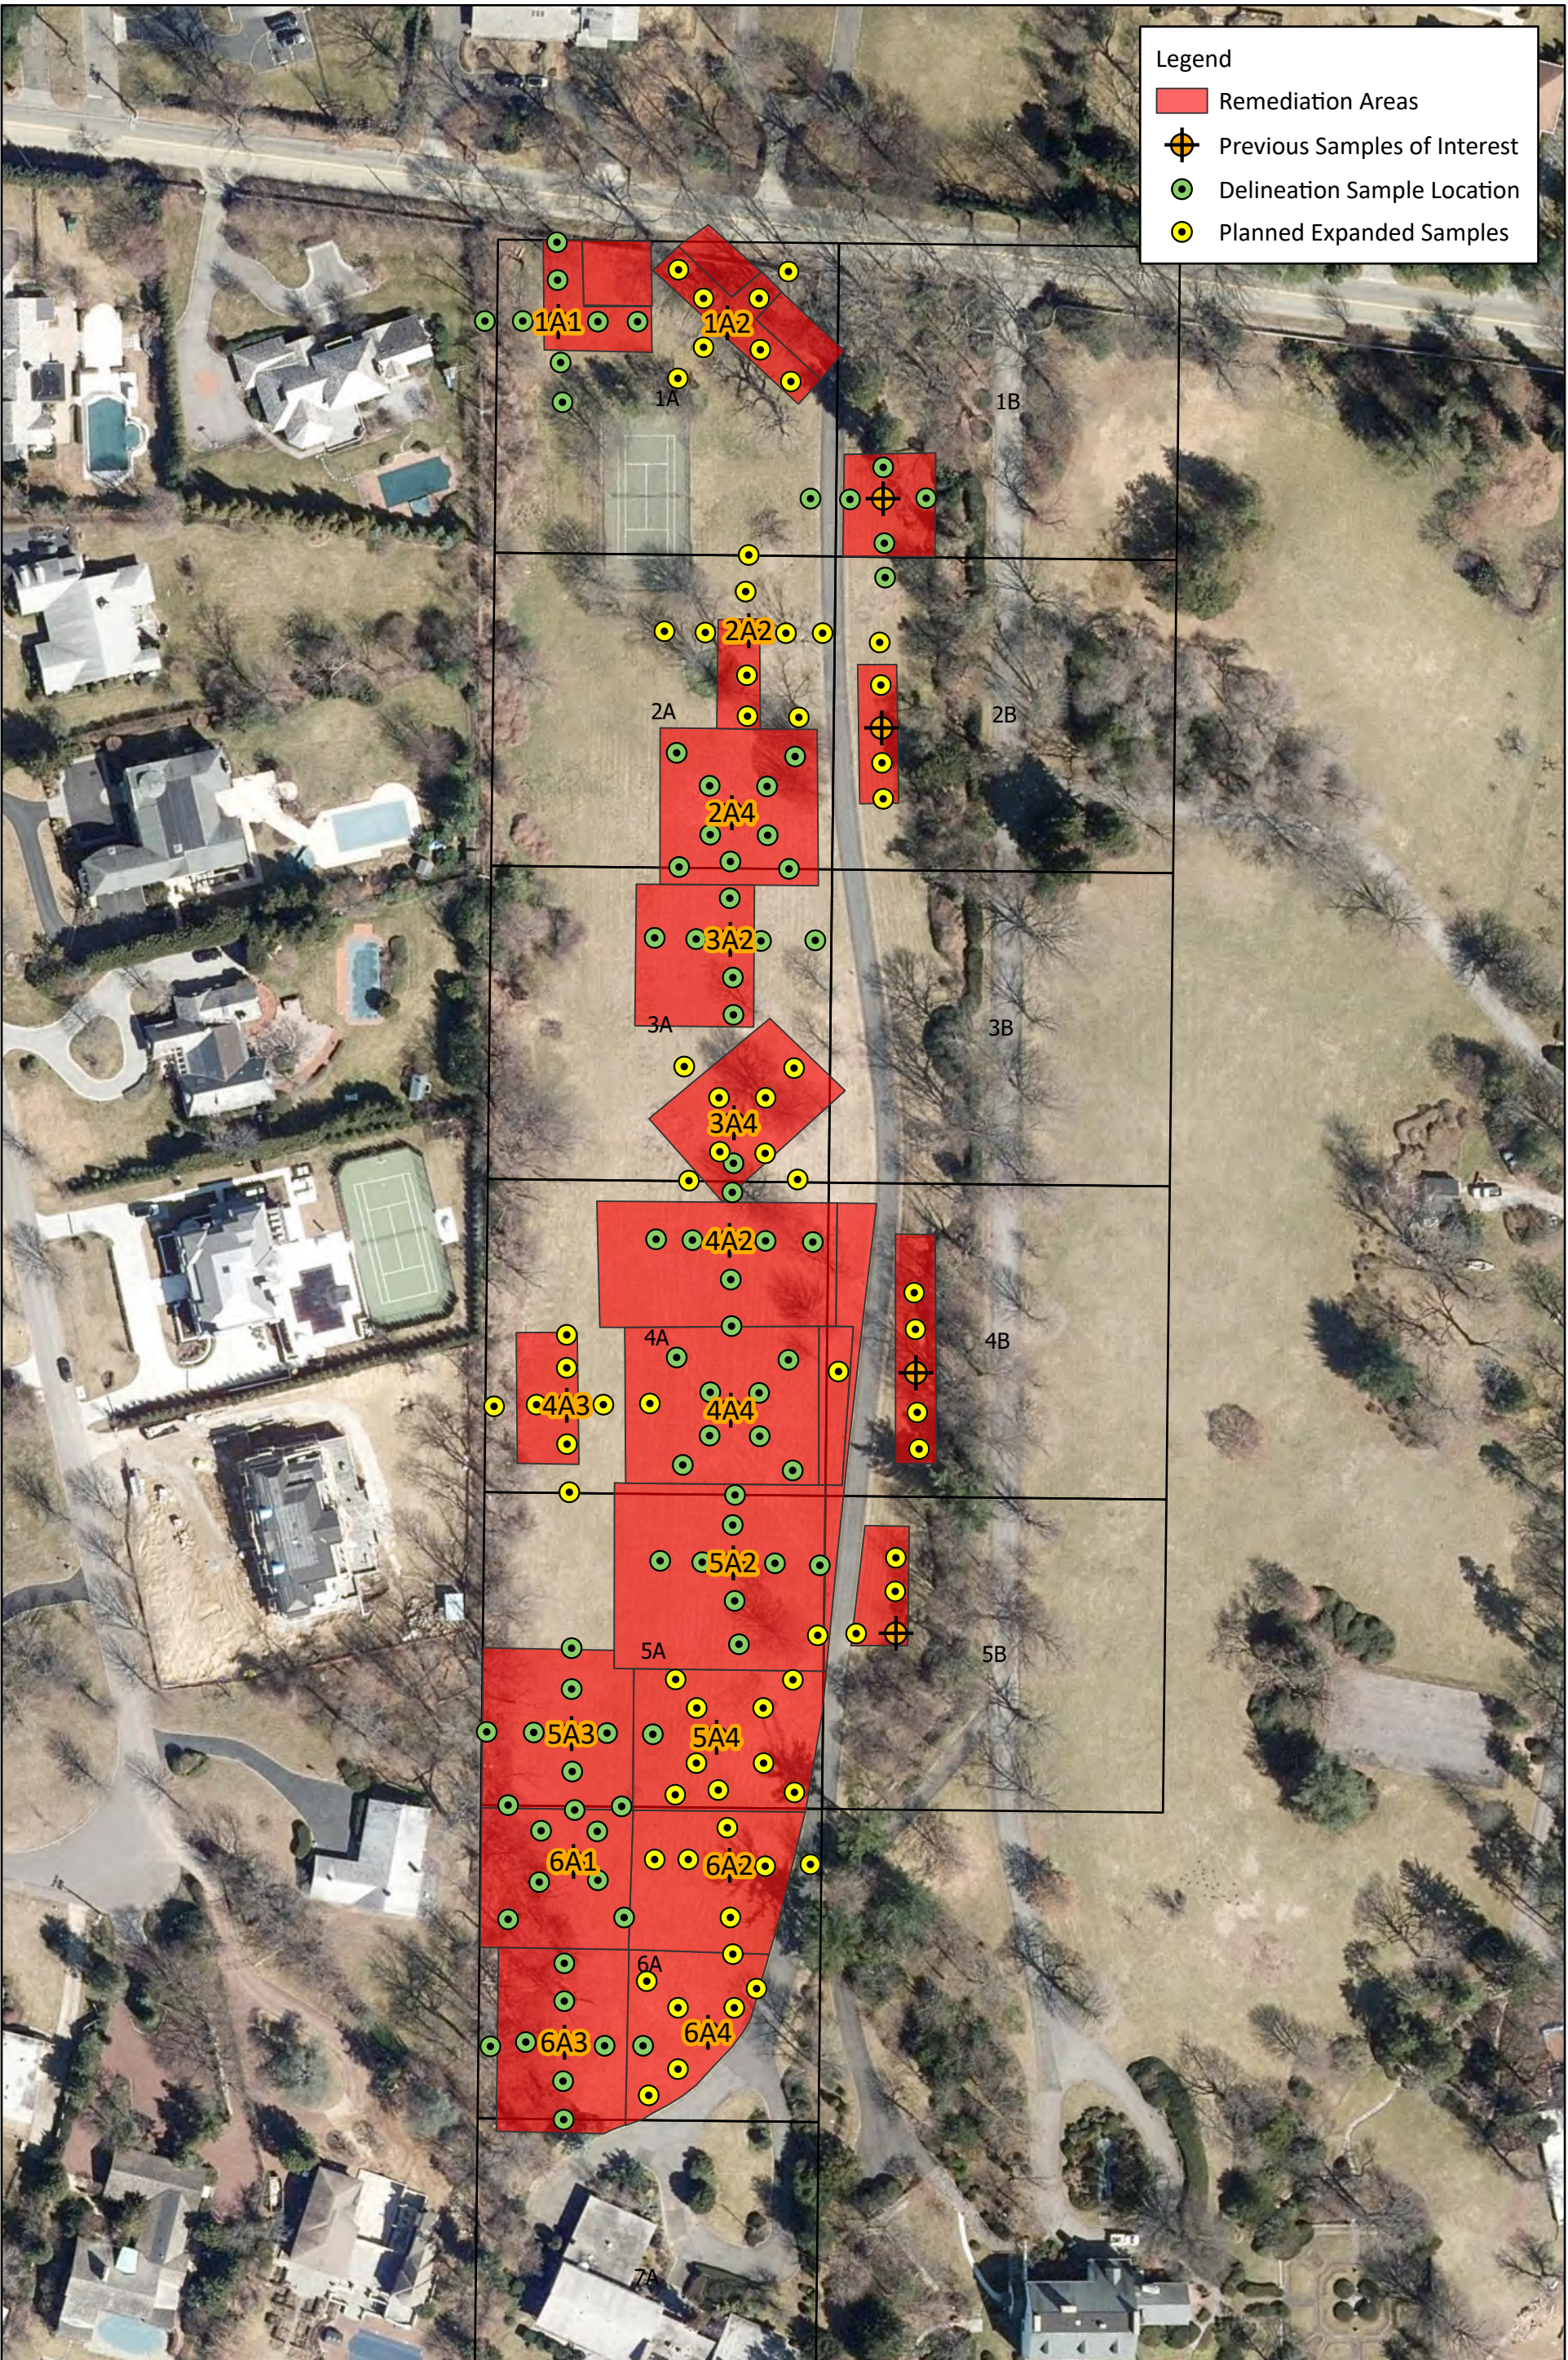
A depiction of the extent of the excavation has been included as **Figure 1**.

Each grid where central sample nodes were found to exhibit exceedances of NYSDEC Part 375 SCOs were divided into north, south, east and west quadrants where supplemental samples were collected to attempt to delineate the extent of contamination impacts. The entire area of each quadrant where exceedances of the NYSDEC Part 375 SCOs for residential use were recorded will be excavated to a depth ranging from ten (10) to fifty (50) inches bgs and will extend to approximately fifteen (15) feet past each exceeding delineation node.

A summary of the node locations to be excavated as well as direction, distance and depth ranges is provided in **Table 1**. Please note that some areas within the same grid will vary in depth based on the delineation sample results.
