235 Pinelawn Road  
Melville, New York

VERTEX Project No. 54600

VERTEX ENGINEERING, PC

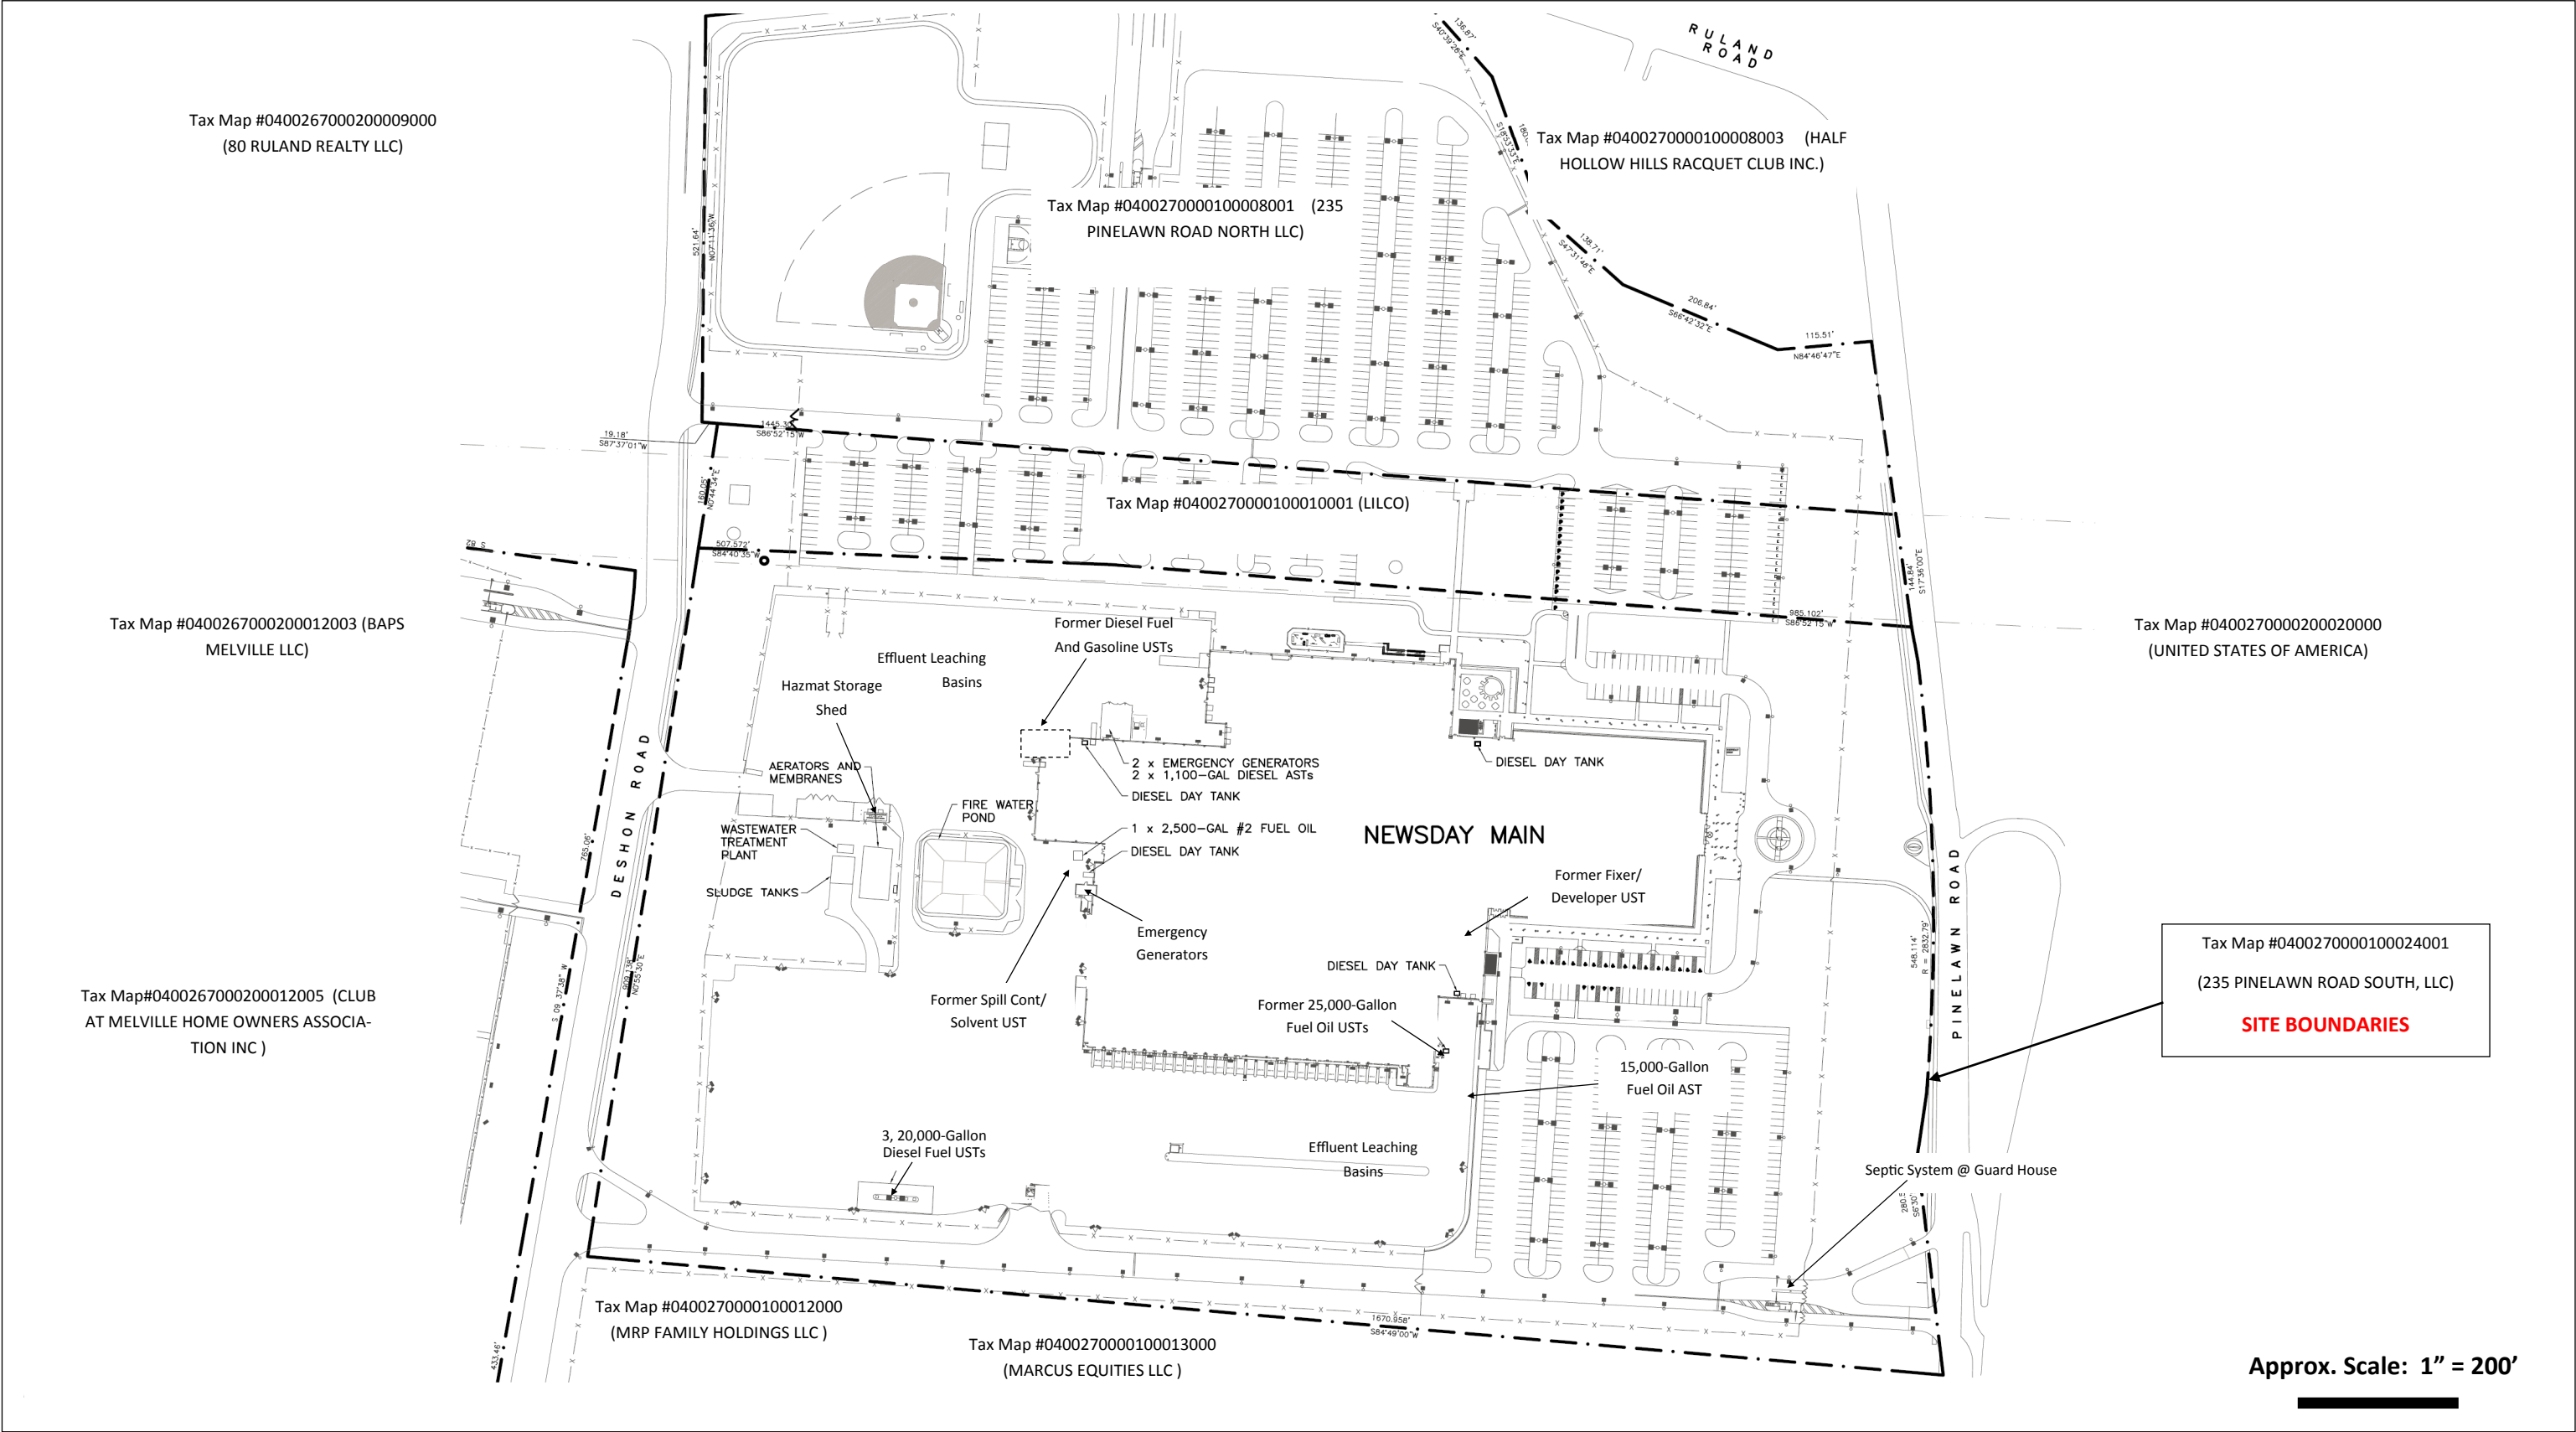
**FIGURE NO. 3**

**SITE SCHEMATIC**  
235 PINELAWN ROAD  
MELVILLE, NY

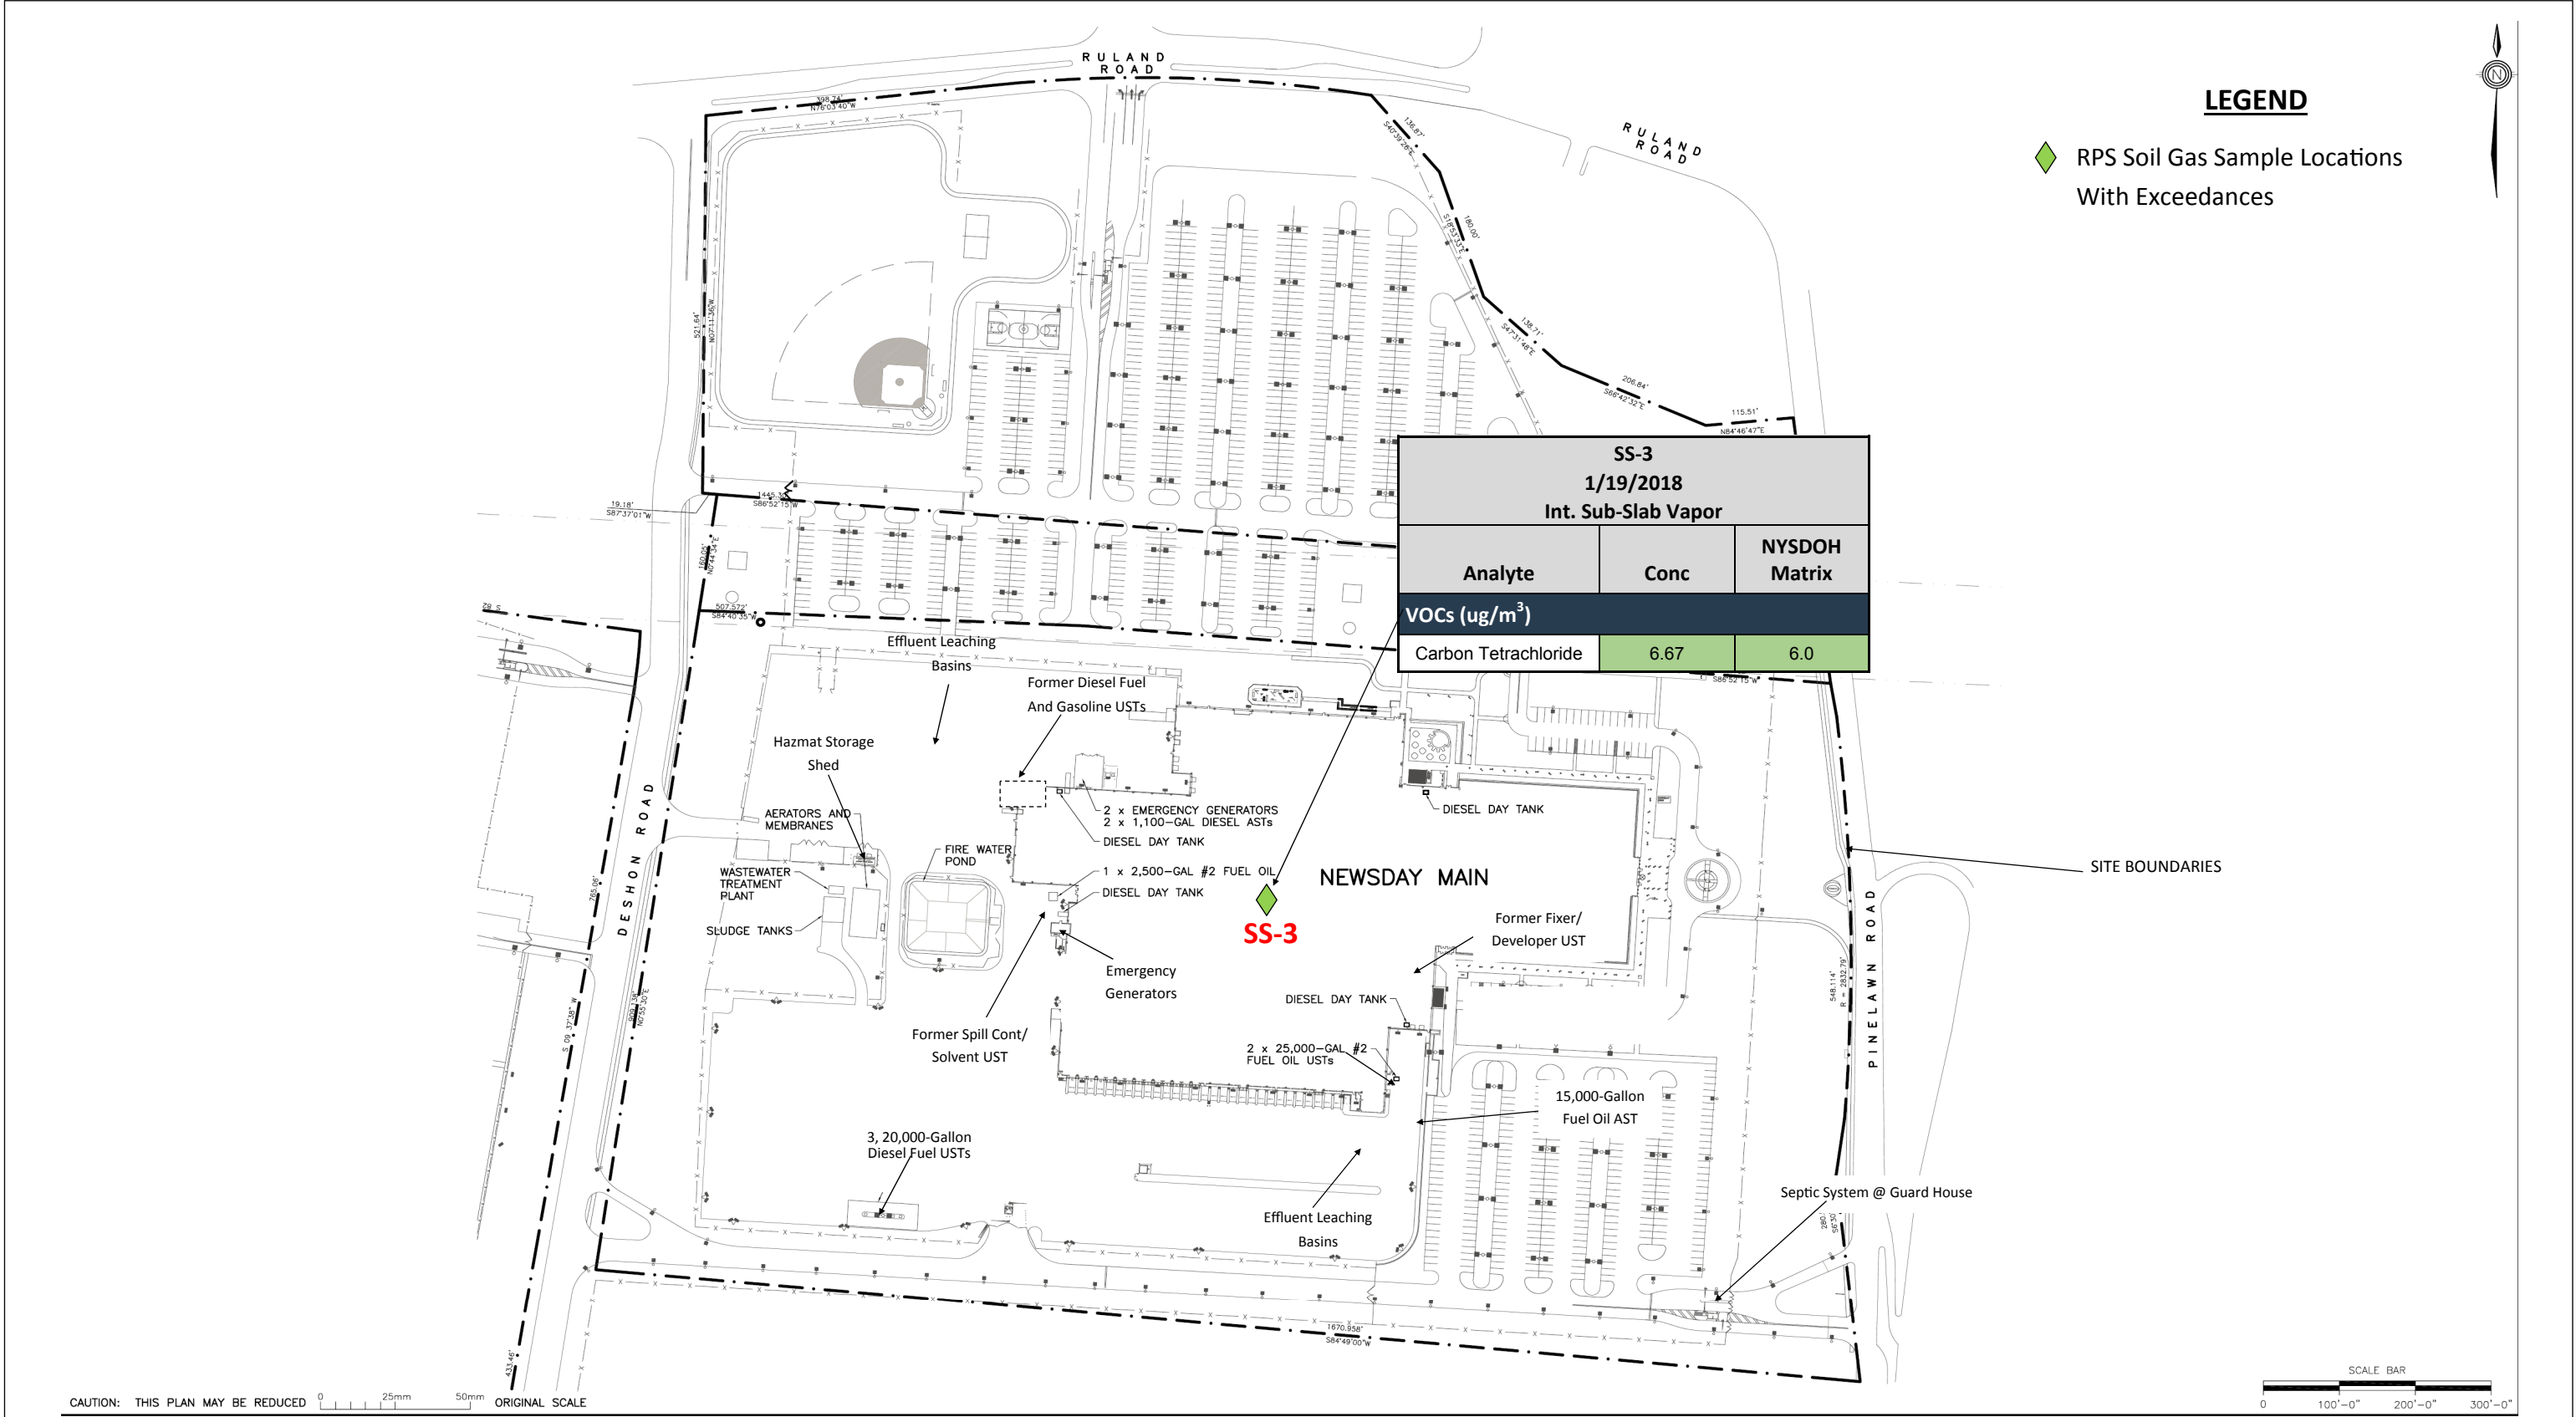
**FIGURE NO. 4**  
VERTEX Project No. 54600

**SOIL VAPOR RESULTS MAP (EXCEEDANCES ONLY)**  
235 PINELAWN ROAD  
MELVILLE, NY

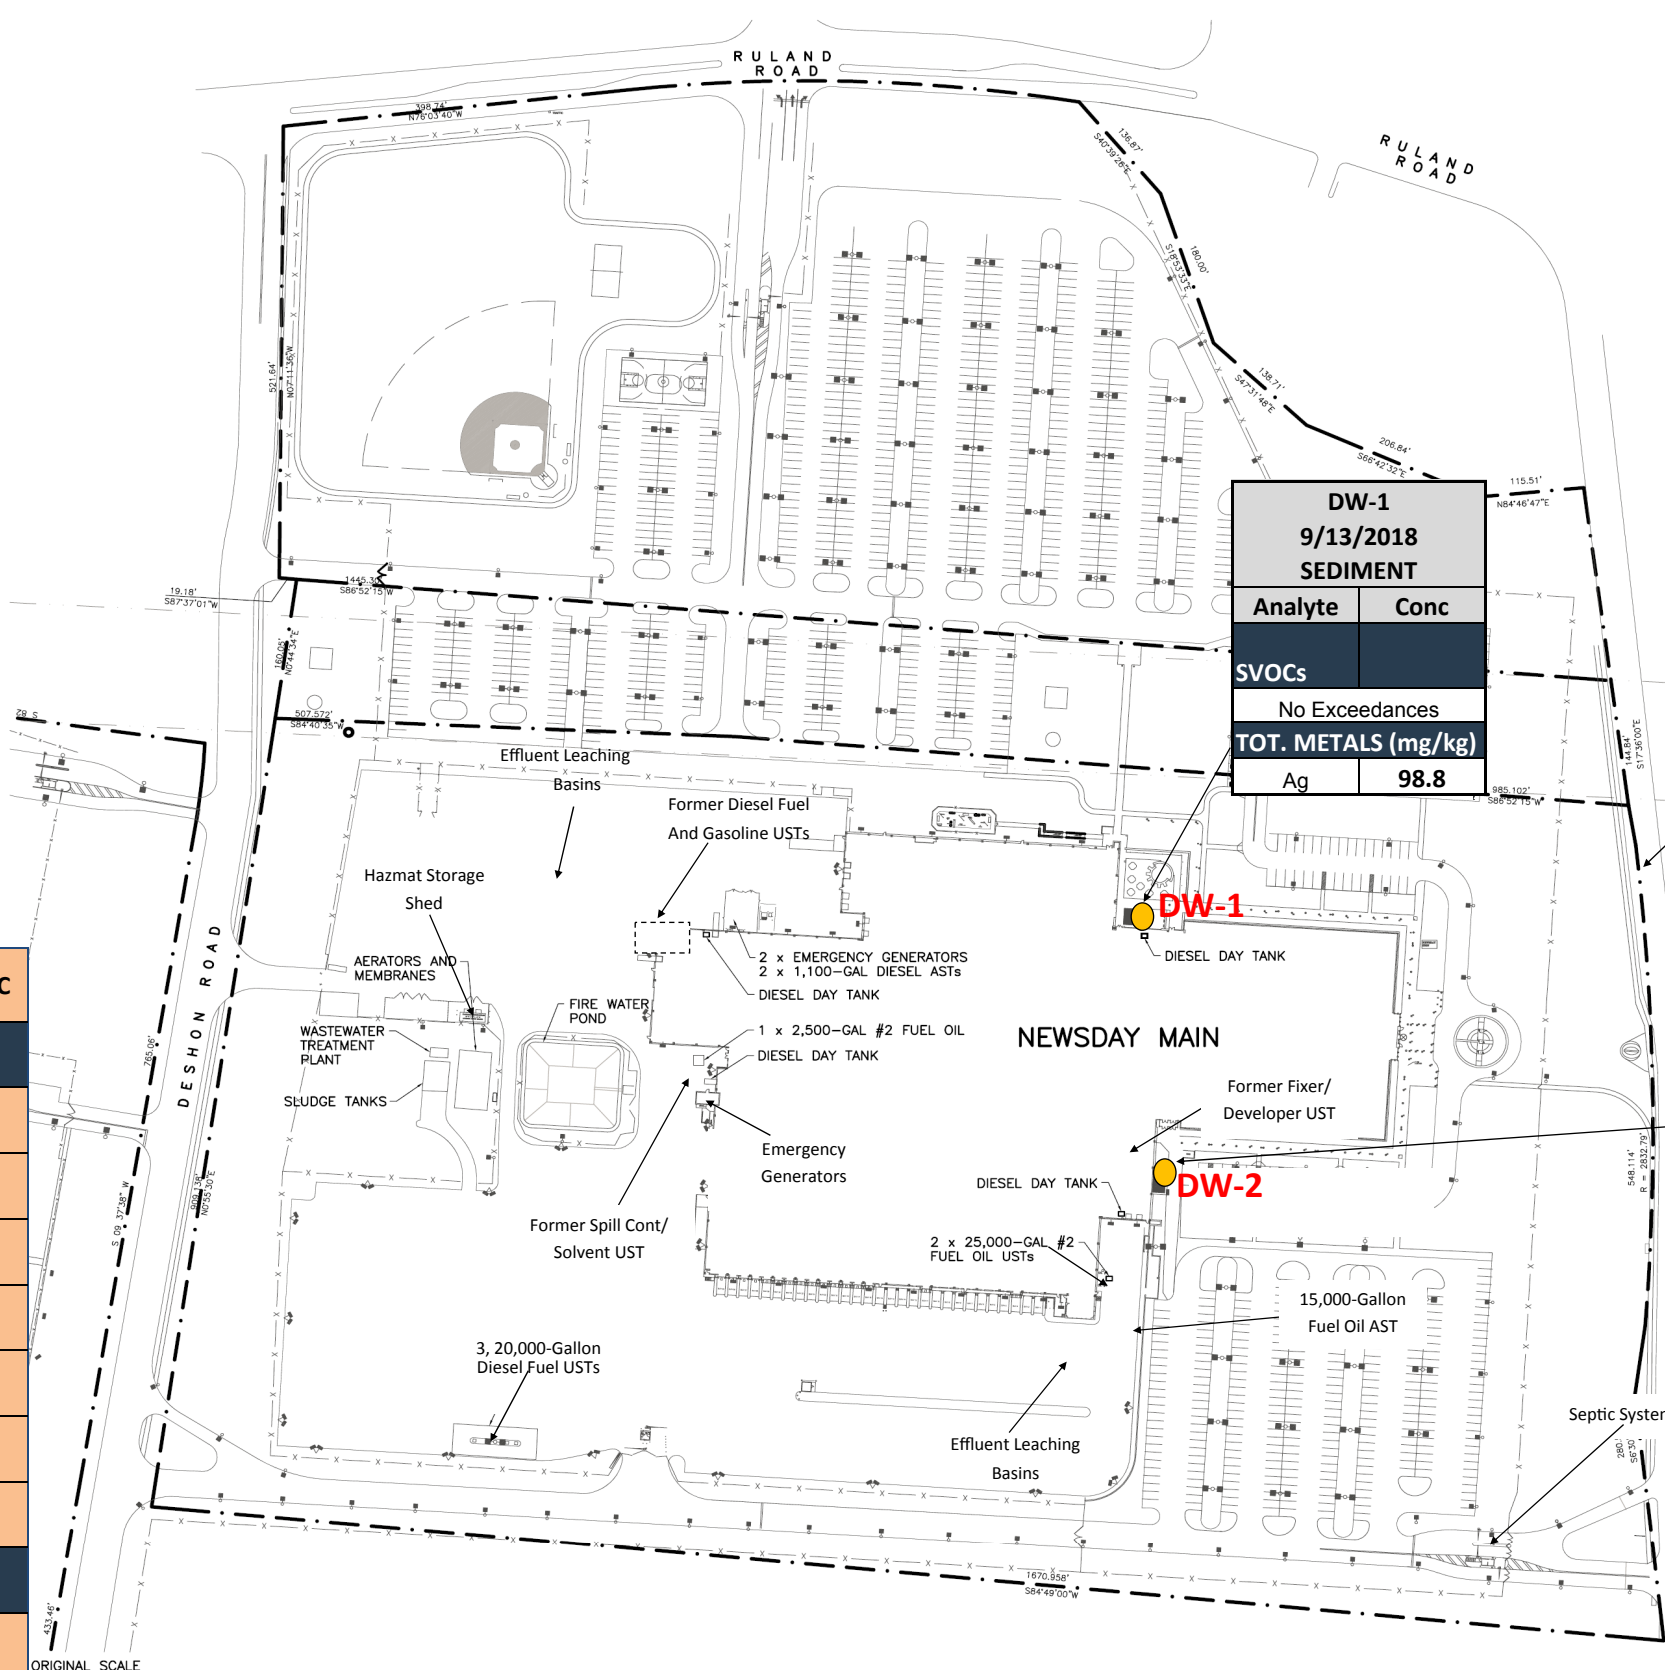
FIGURE NO. 5

| DW-1<br>9/13/2018<br>SEDIMENT | |
| Ag | 98.8 |

| DW-2<br>9/13/2018<br>SEDIMENT | |
| B(a)A | 3.1 |
| B(a)P | 3.7 |
| B(b)F | 5.2 |
| D(a,h)A | 0.62 |

SEDIMENT RESULTS MAP  
235 PINELAWN ROAD  
MELVILLE, NY

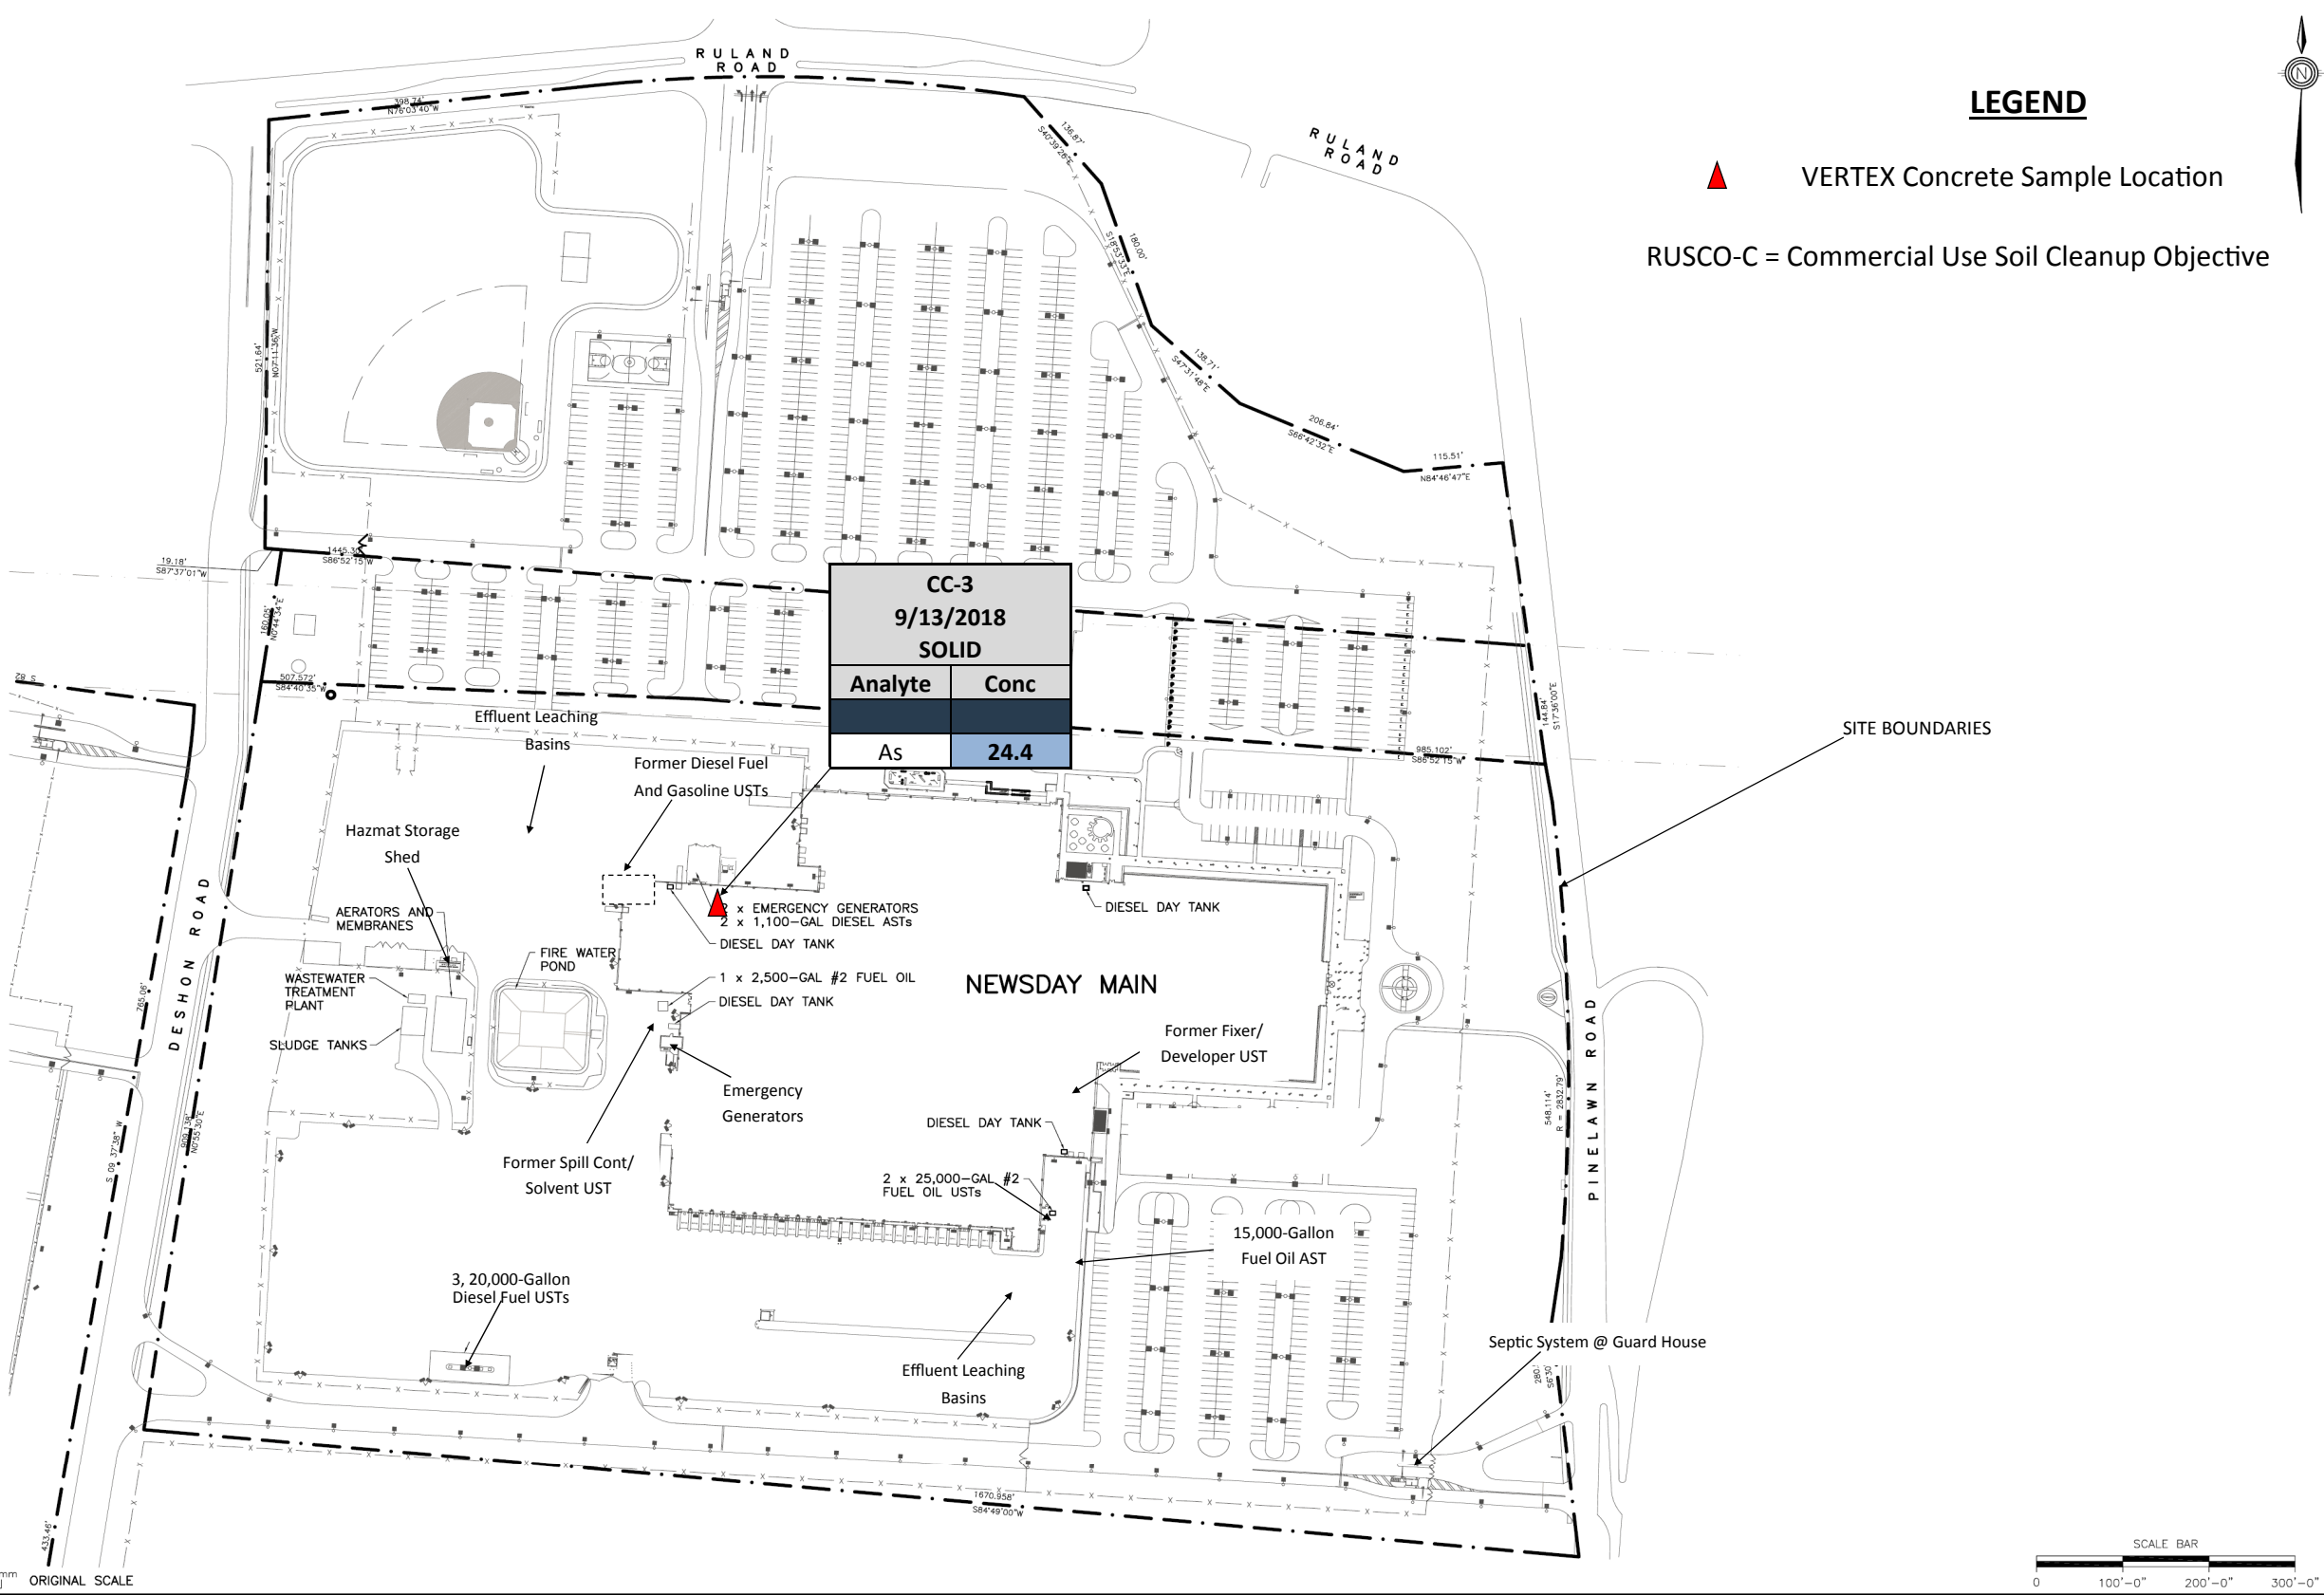
**FIGURE NO. 7**  
VERTEX Project No. 54600

**CONCRETE RESULTS MAP (EXCEEDANCES ONLY)**  
235 PINELAWN ROAD  
MELVILLE, NY
