Periodic Review Report 2022

**New Housing New York Legacy Project
700-730 Brook Avenue
Bronx, New York
Site # C203043**

May 2022

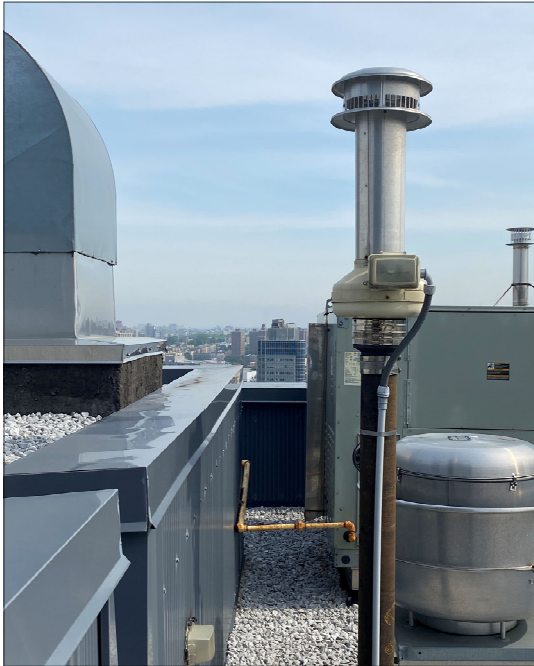
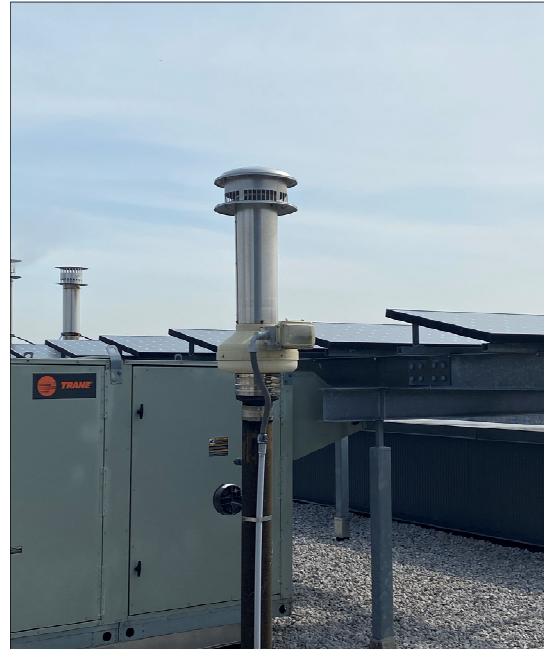
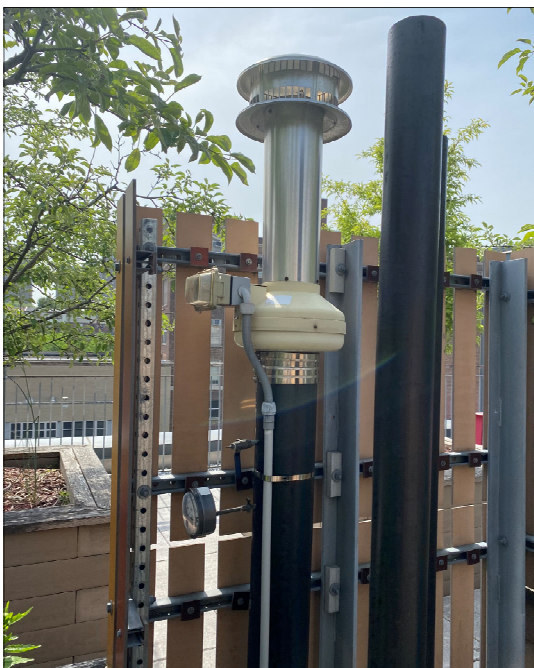
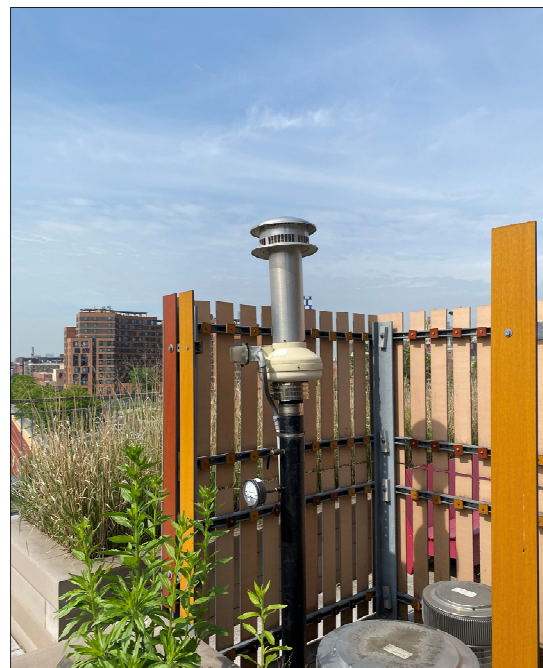
SSD System

It is noted that the SSD system was switched from active to passive mode in February 2019 for the performance of a vapor intrusion investigation. The system continues to operate in passive mode. The vapor intrusion investigation, summarized in CA RICH's Report dated May 8, 2019, did not result in the identification of a vapor intrusion issue requiring mitigation. As such, the system was allowed to remain in passive mode since it was shut down. Another round of testing was performed in November 2020, as summarized in CA RICH's Report Dated December 9, 2020. This second round of testing confirmed the findings of the initial round and, as such, it was subsequently agreed by NYSDEC and NYSDOH that the SSD system be permanently converted to a passive system. No repairs were needed at the time of the May 20, 2022 inspection. Future planned maintenance activities include removal of the fans.

The SSDS was started up in April 2012 and ran continuously up until it was deactivated in February 2019 (see section 4.1). Operations and maintenance visits were conducted in the frequency outlined in the SMP. In addition, monthly inspection of all of the fans by maintenance staff was performed to monitor the continued operation of the system. As discussed in Section 4.2, the system was found to be operating in passive mode, and no repairs were needed at the time of the May 20, 2022 inspection.

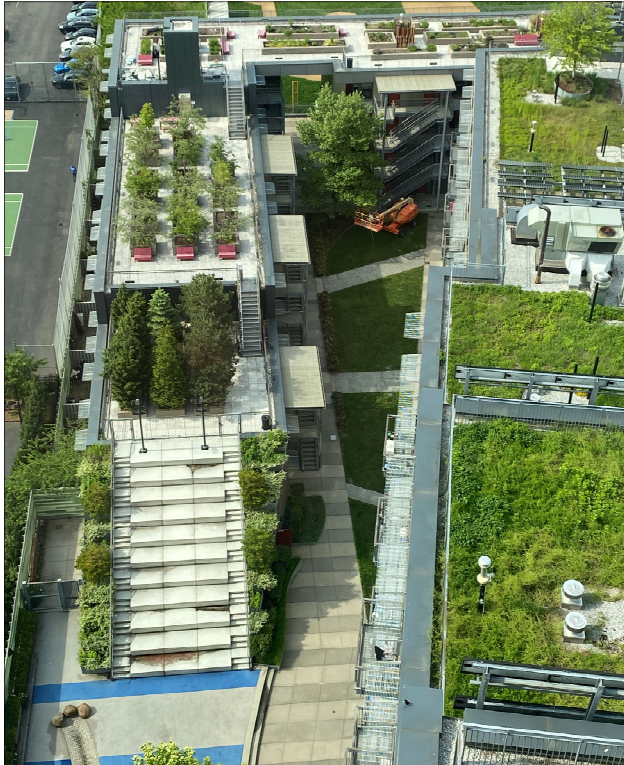
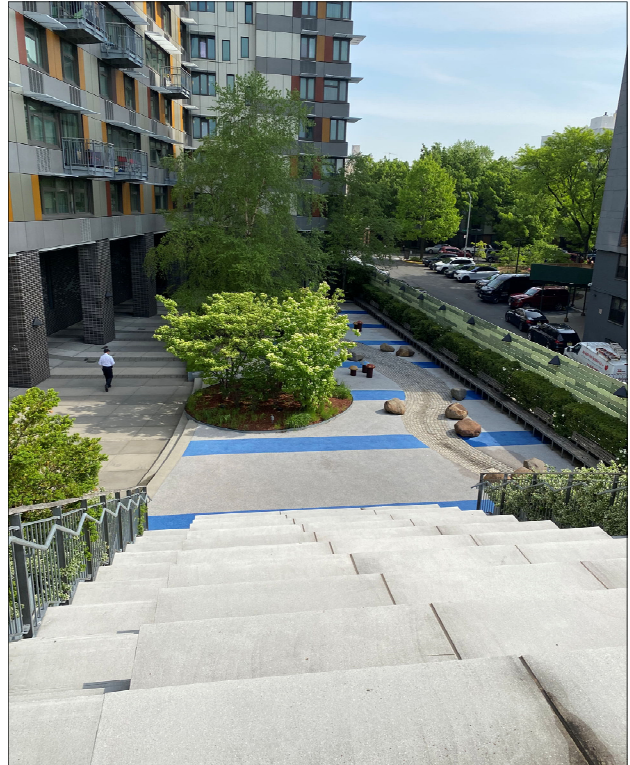
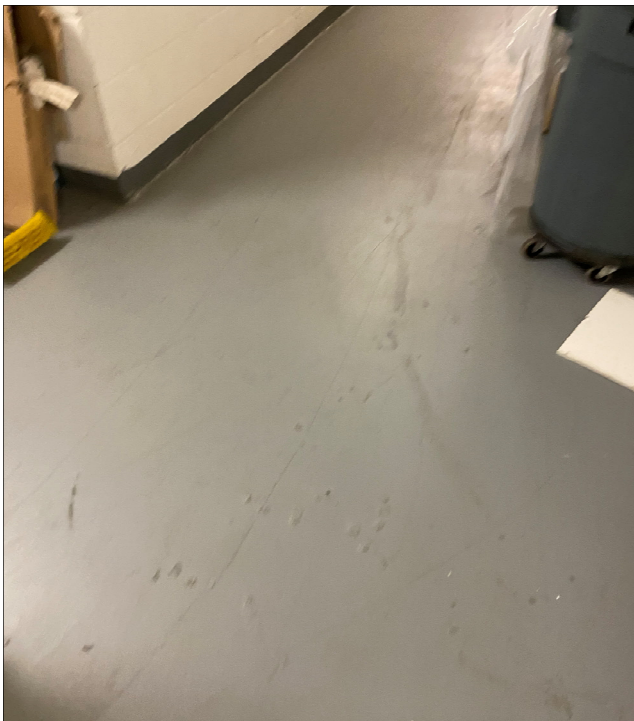
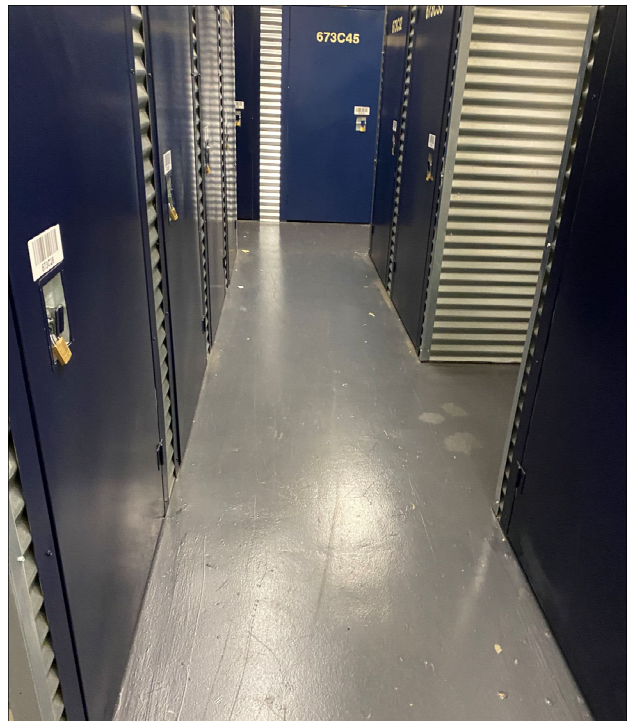
Composite Cover System

The Site inspection included a visual inspection of the composite cover system to determine if it was intact and free from damage that might render it unsuitable for its intended purpose. Ms. Proscia did not identify any areas where the cover system appeared impaired, compromised, or otherwise damaged. In addition, Mr. Colon indicated that there have been no breaches of the composite cover system since the completion of construction.
