3500 Park Avenue Apartments Site

Periodic Review Report

NYSDEC Brownfield Cleanup Program Site Number: C203096

MAY 2026

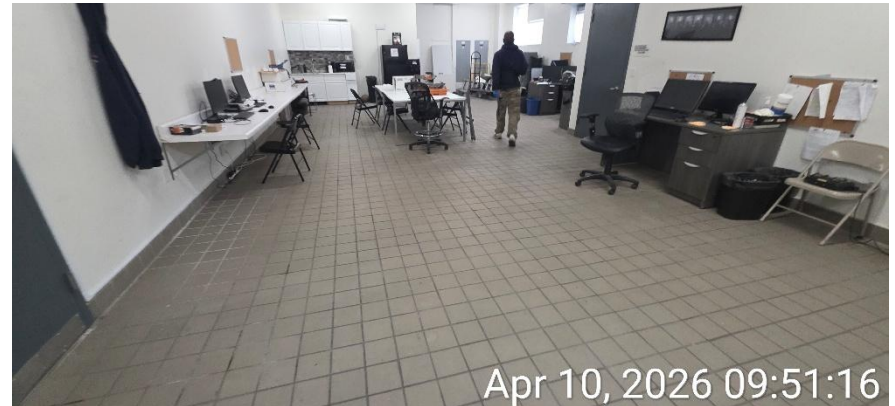
Photograph 4: The ground floor offices in the Track 4 portion of the Site, view facing northwest.
