Hunts Point Cooperative Market Redevelopment Plan

Final Engineering Report Site E Operable Unit 1

Bronx, NY

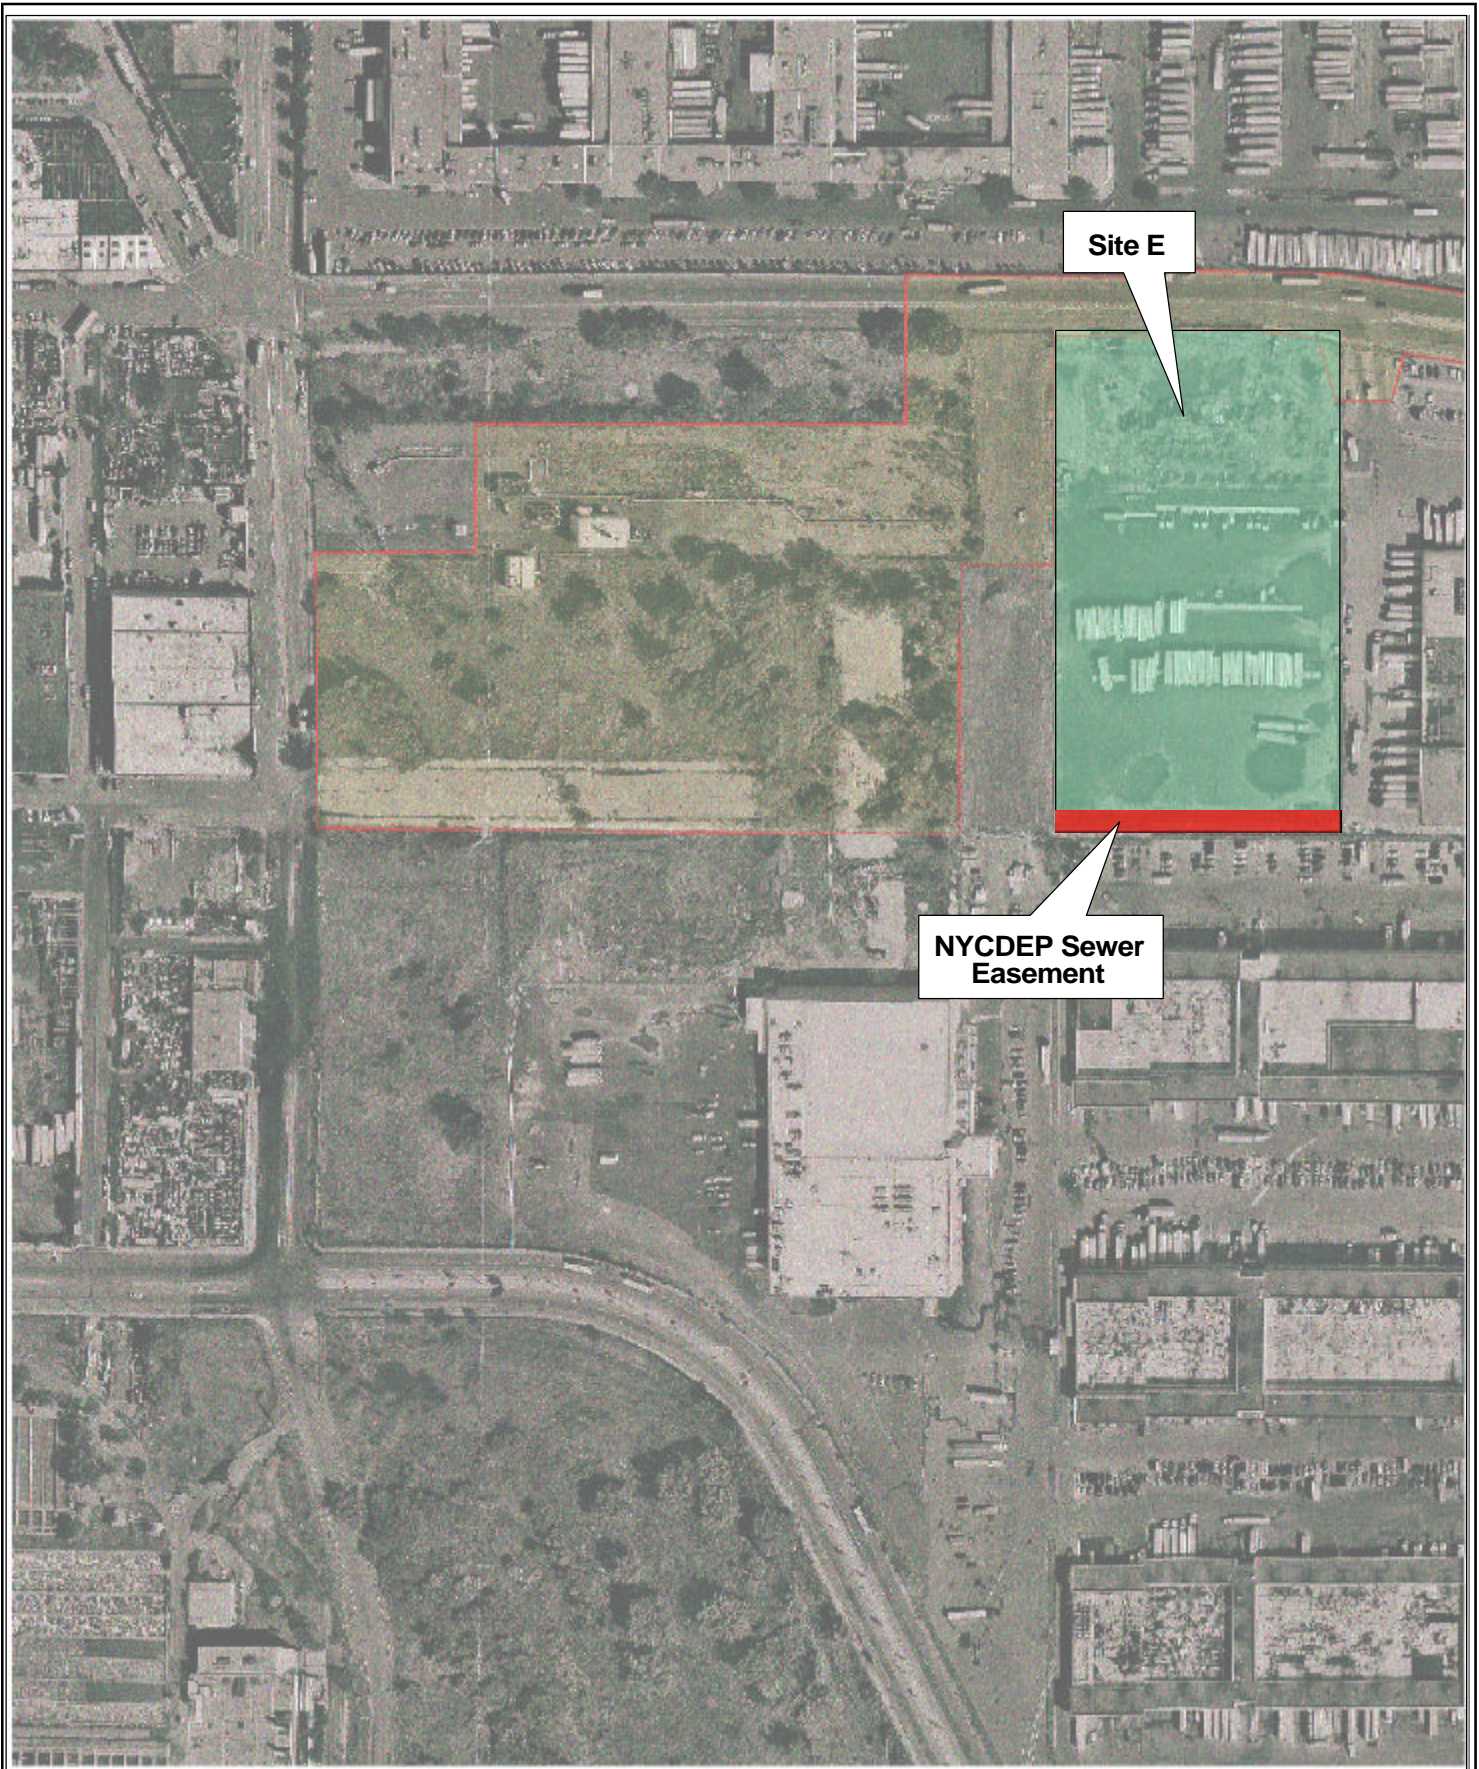
781 Hunts Pt Graphics\\AllSites\\Fig4 Site E and A BermRelocation.dsf

A strip of exposed material exists at the southern end of the Site, adjacent to the Meat Market parking lot (Figure 4). This strip of land is approximately 20 ft wide and runs along the fence line at the southern end of Site E. It is the location of a New York City Department of Environmental Protection (NYCDEP) easement for the sewer/stormwater system. LMS was informed by WA that NYCDEP requires this area to remain unpaved. The recommendations for this easement will be addressed later in this Report.

The strip of land at the southern end of the site was capped with a minimum of 1 ft of material that was imported to the Site from a NYSDEC Part 360 registered recycling

facility. Grass was not an option that was desired due to the inability to maintain it (watering, fertilizer and mowing), and the concern that erosion might be a problem.

The change from small open areas to a single solid parking lot and building requires no additional recommendations with respect to the existing parking lot and building. The area at the southern end of the Site that includes the NYCDEP sewer easement has been covered with 1 ft of material that will prevent contact with the underlying material. The end result is that the site does not have any exposed areas of fill.

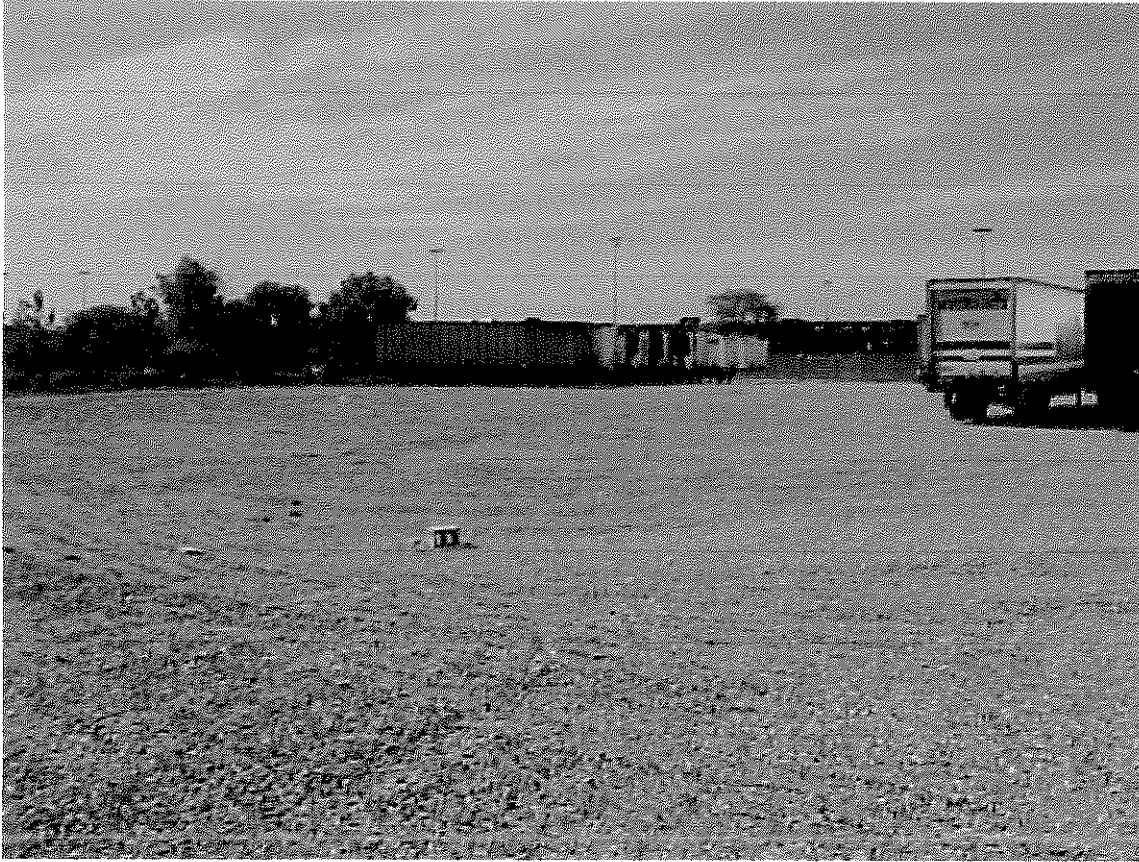
Photo 1 Site Looking Northwest - Pre-Construction

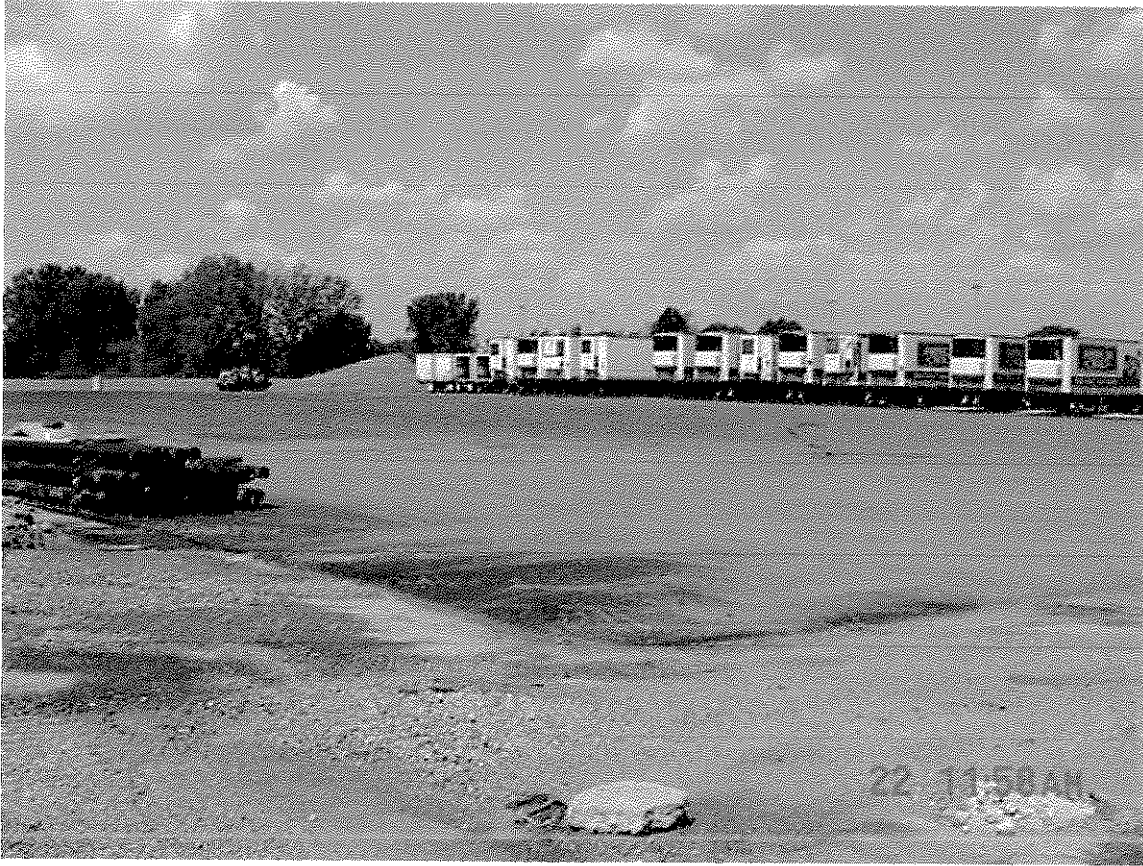
Photo 2 Looking Northwest - During Construction

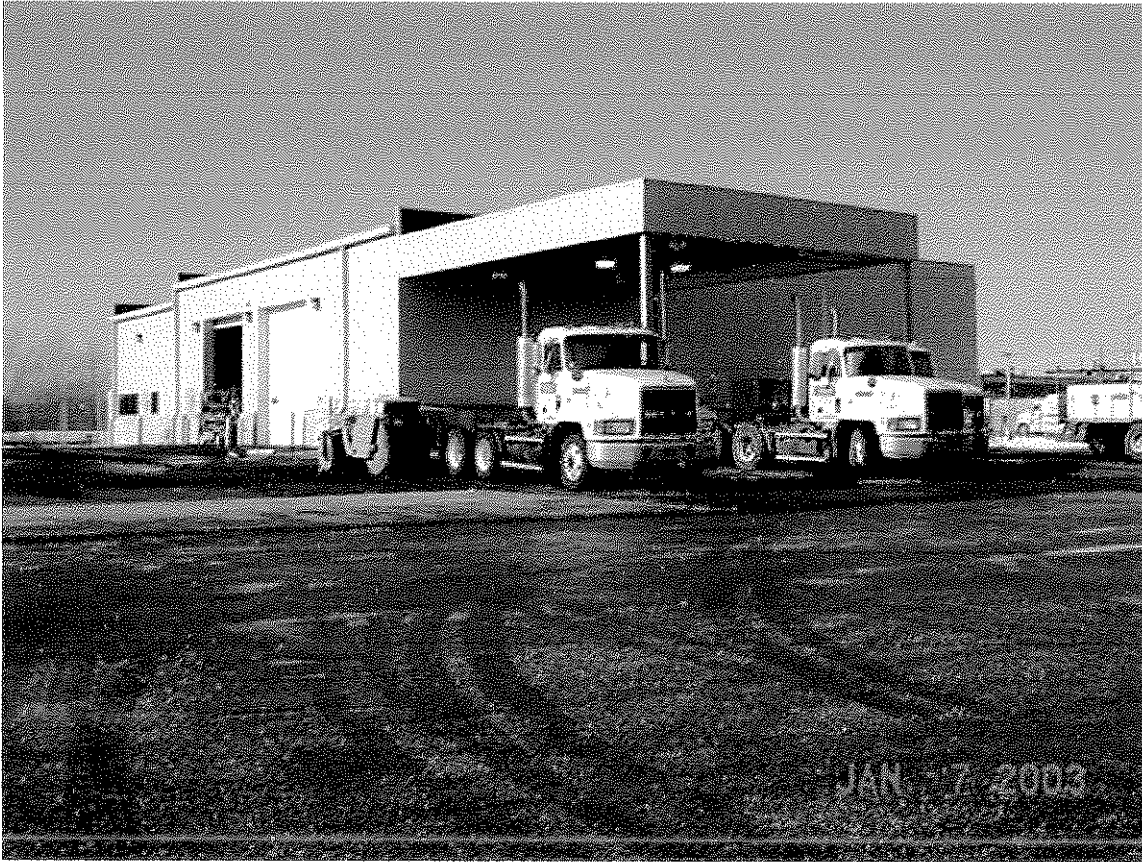
Photo 3 Looking Northwest - Post-Construction

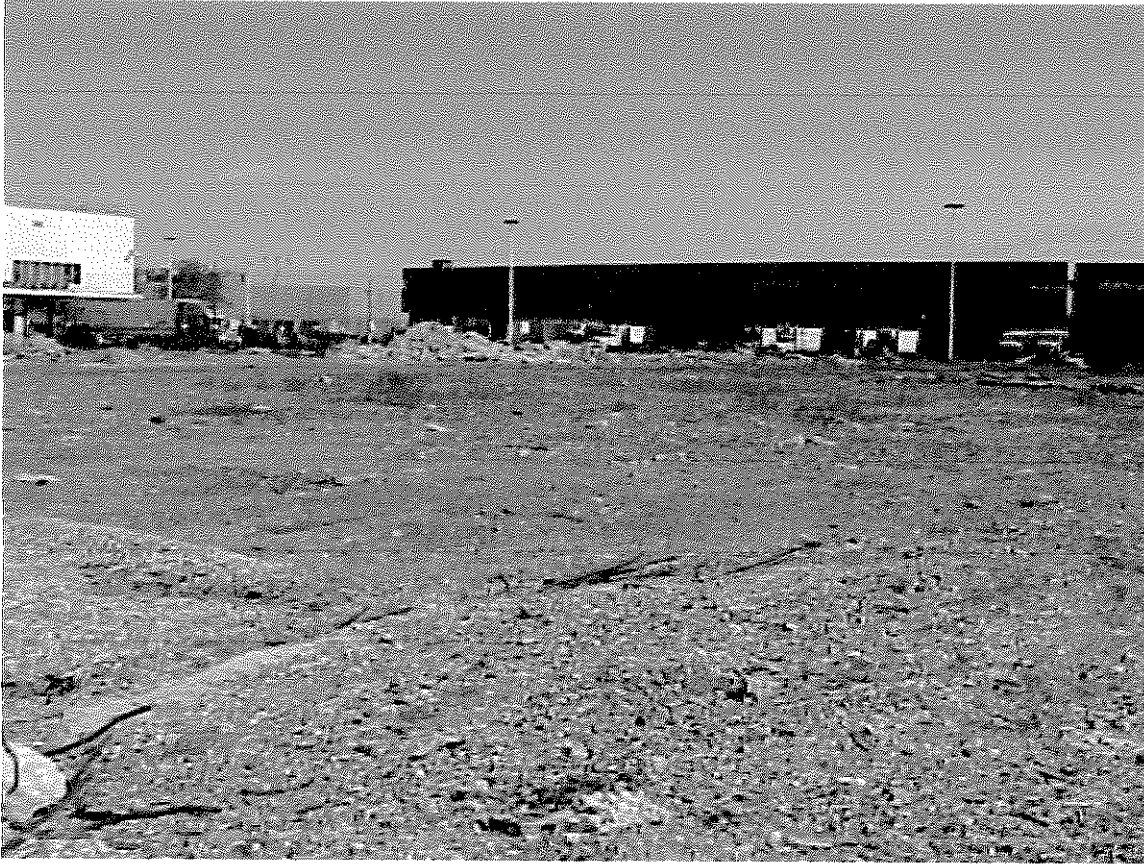
Photo 4 Looking Southeast - Pre-Construction

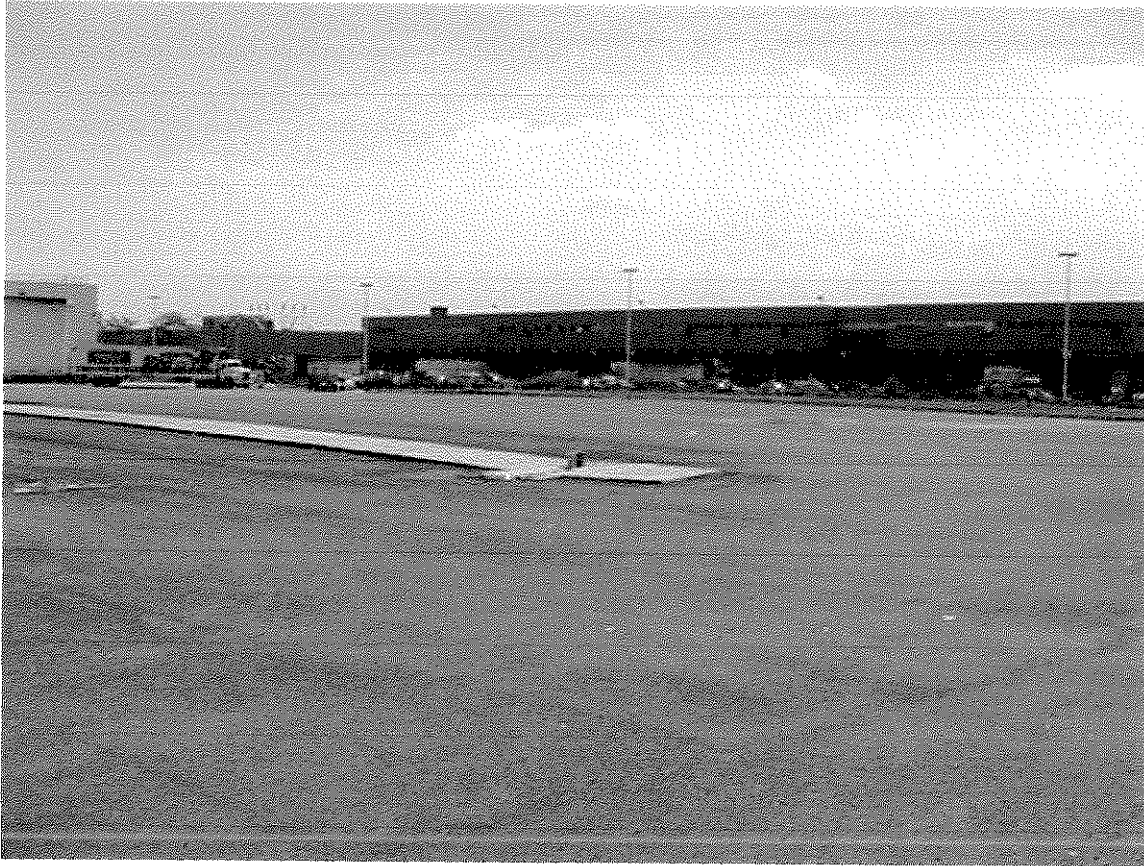
Photo 5 Looking Southeast During Construction

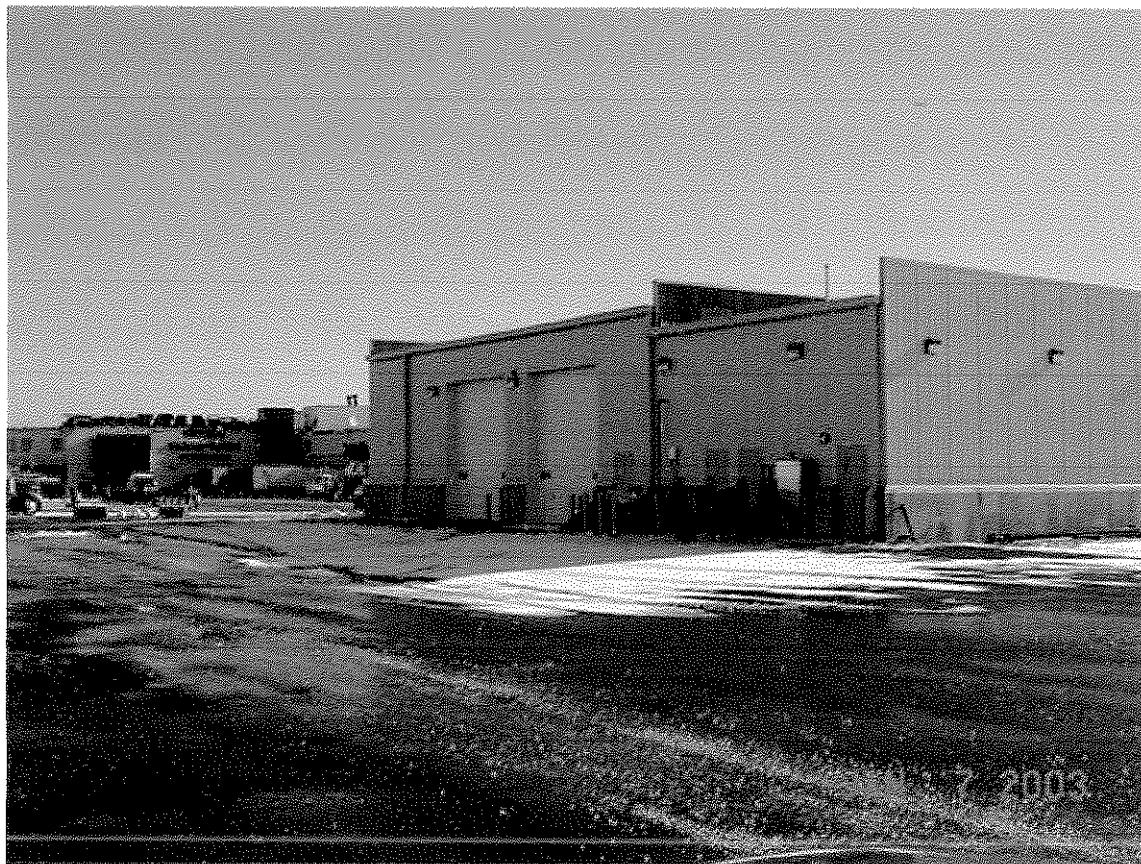
Photo 6 Looking Southeast Post-Construction
