# **PHASE I ENVIRONMENTAL SITE ASSESSMENT**

150 WALTON STREET  
BLOCK 2344 LOT 75  
BRONX, NEW YORK 10451

22-2681

MAY 23, 2022

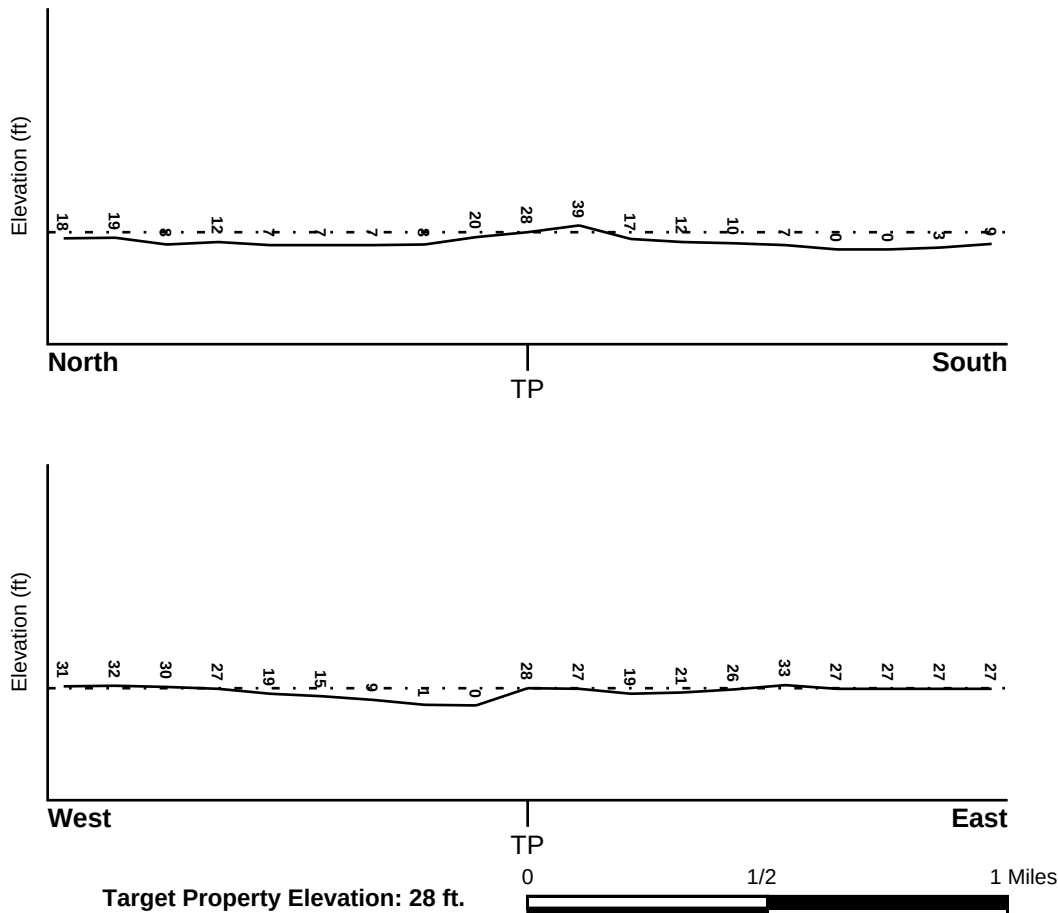
### SURROUNDING TOPOGRAPHY: ELEVATION PROFILES

Source: Topography has been determined from the USGS 7.5' Digital Elevation Model and should be evaluated on a relative (not an absolute) basis. Relative elevation information between sites of close proximity should be field verified.
