**SUPPLEMENTAL SITE CHARACTERIZATION  
WORK PLAN**

**1199 SUTTER AVENUE  
BROOKLYN, NEW YORK**

**Site ID # 224141  
NYSDEC SPILL NO. 0902686**

Revised January 16, 2014

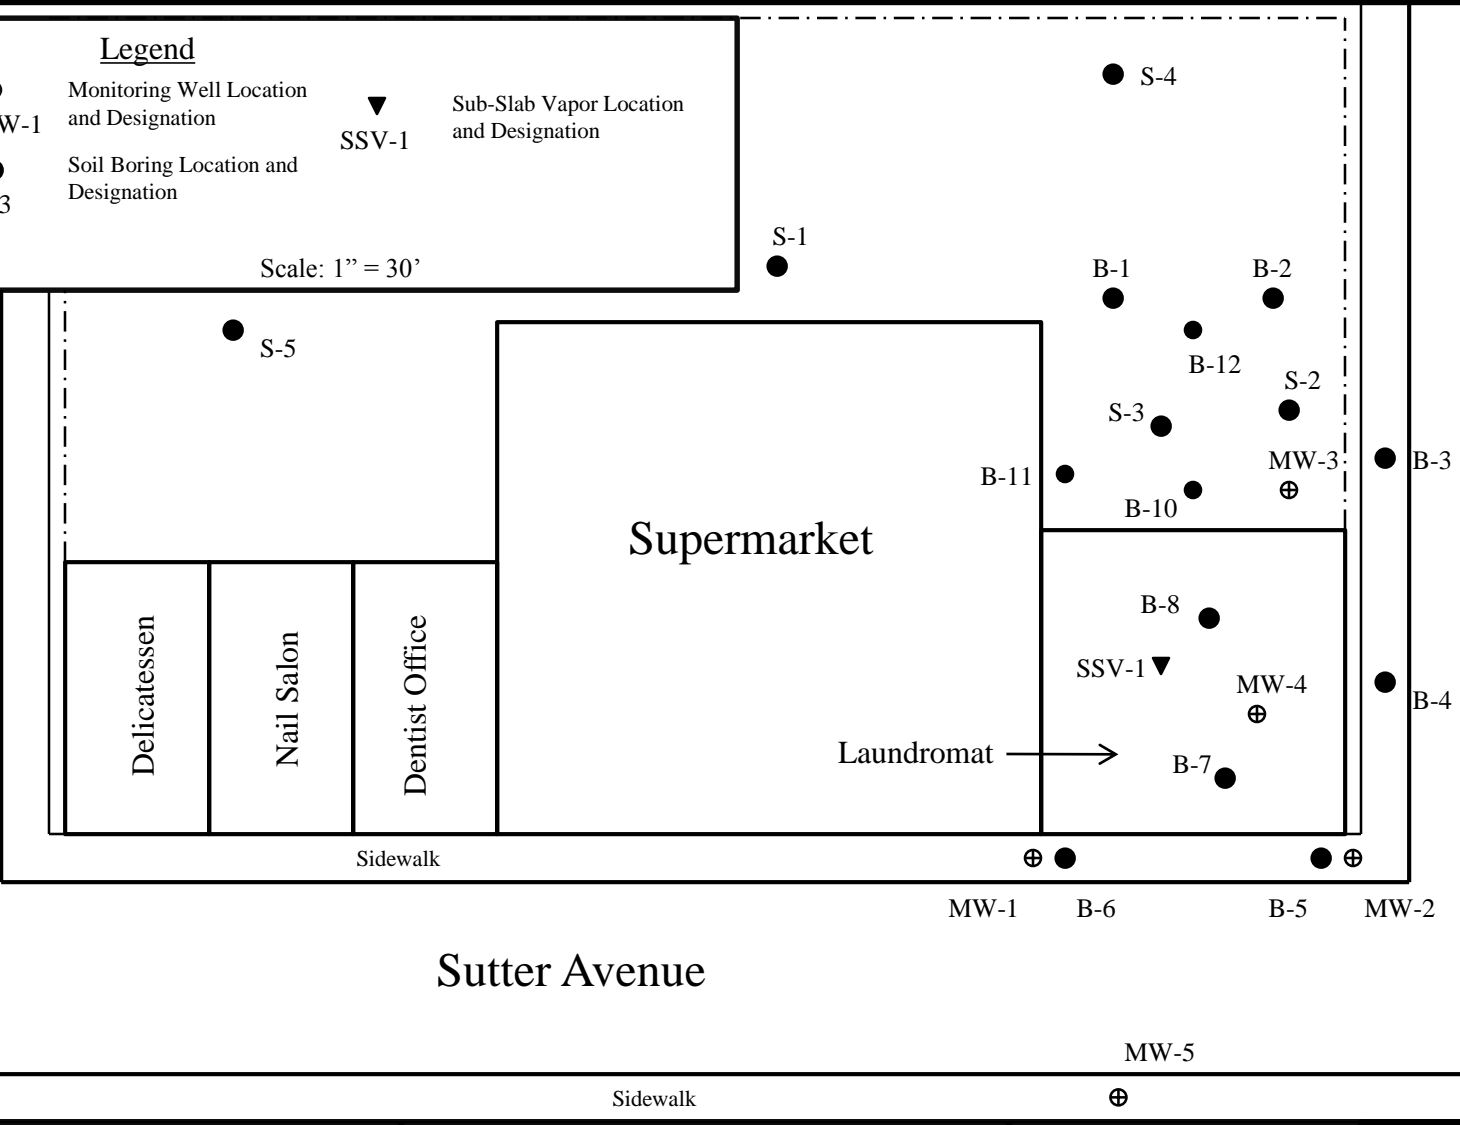
Figure 2  
Site Plan

The following section provides a description of the subject property and summarizes the previous investigations. A site plan of the property is provided on Figure 2.

The following section provides a brief description of prior environmental investigations conducted at the subject property, and summaries of the results and recommendations stemming from each investigation. The location and designation of the sample points associated with the previous investigations are provided on Figure 2. A summary of the previous investigation and remediation sample data is provided in Tables 1 and 2.
