MEMORANDUM

Subject: Monthly Progress Report
Former Cleaner Sales and Equipment Corp. NYSDEC Site No. 224177

Project No.: E051

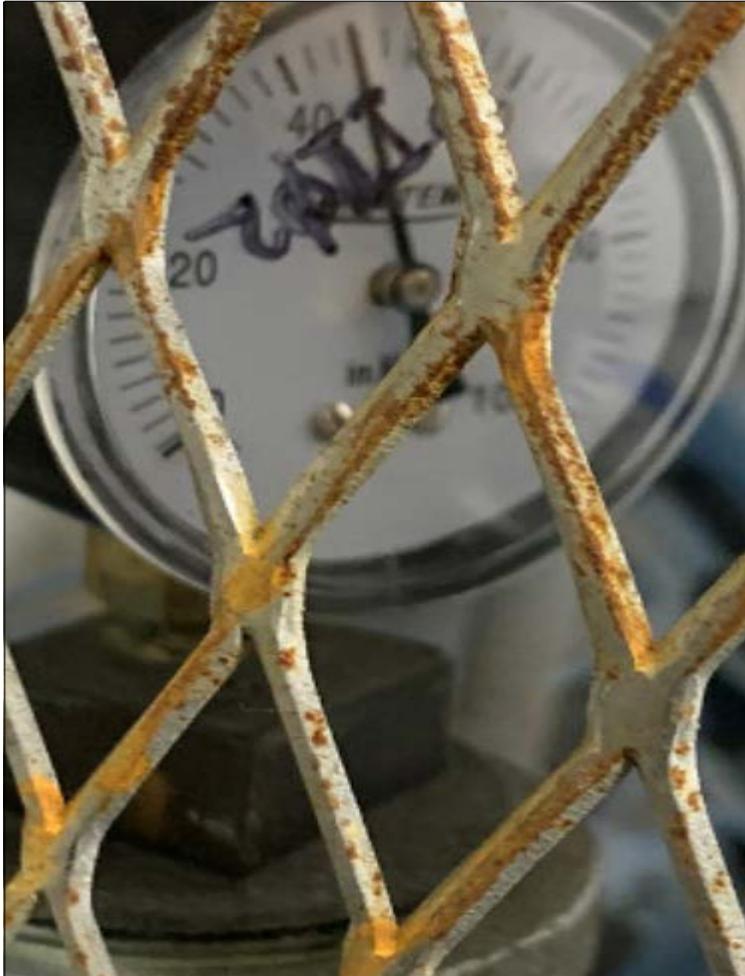
SSDS Pressure Gauge PI102
(Before Lead Carbon Treatment Drum)
Pressure = 46 inches of H₂O

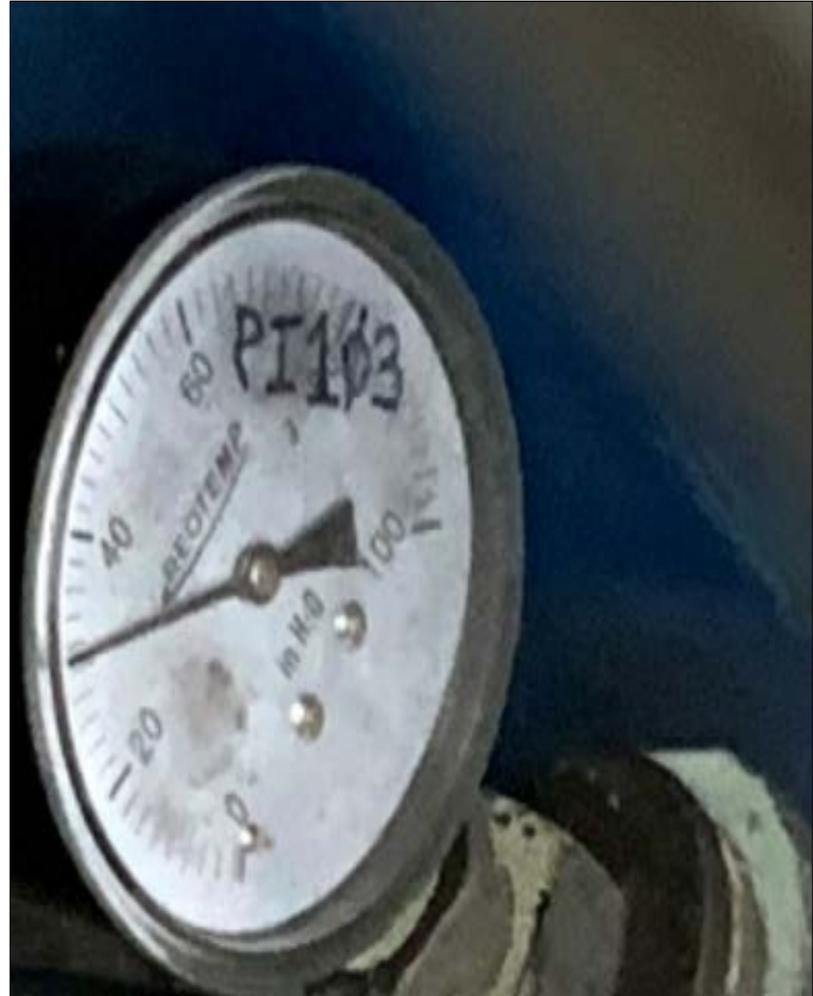
SSDS Pressure Gauge PI103
(After Lead and Before Lag Carbon Treatment Drum)
Pressure = 31 inches of H₂O

Notes:
Photographs taken by Raul Sillau on May 11, 2020.
