# DAILY FIELD REPORT

<b>Project</b>	Former A&A Brake Service Site	<b>Report No.</b>	81
<b>BCP Site</b>	NYSDEC BCP SITE C224372	<b>Date</b>	12/09/2024
<b>Location</b>	558 Sackett Street	<b>File No.</b>	0206384
<b>Client</b>	Sackett Heights LLC	<b>Temperature</b>	H: 51°F L: 41°F
<b>Contractor</b>	Blue Sky Builders, Blanco	<b>Wind Direction</b>	NE to SW, up to 15 mph
<b>Weather</b>	Moderate to light rain	<b>Personnel on Site</b>	George Poulton
<b>Humidity</b>	82%	<b>Time on Site</b>	6:30 am to 6:30 pm

## WEEKLY MONITORING REPORT

**Project Address:**  
558 Sackett Street,  
Brooklyn,  
Brooklyn NY 11215  
BBL:/443/55

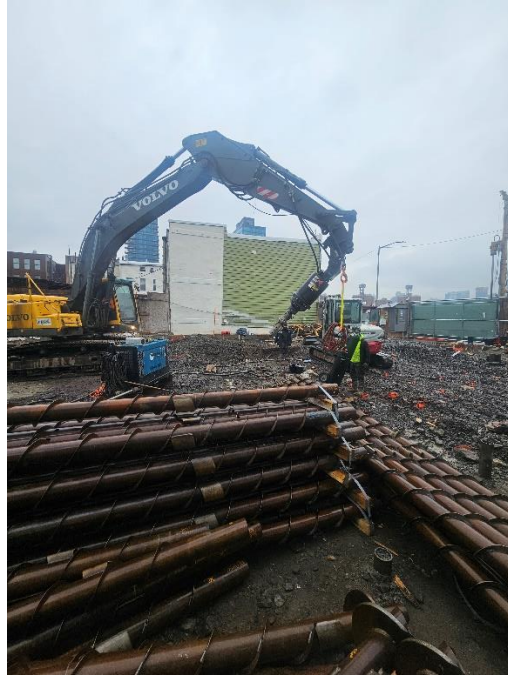
*Photo 1: View of Blanco installing structural pile, facing Northwest.*

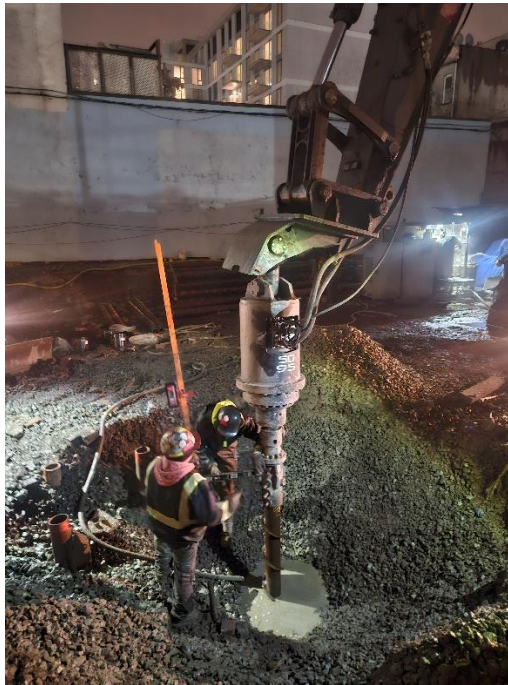
*Photo 2: View of Blanco installing structural pile, facing East.*

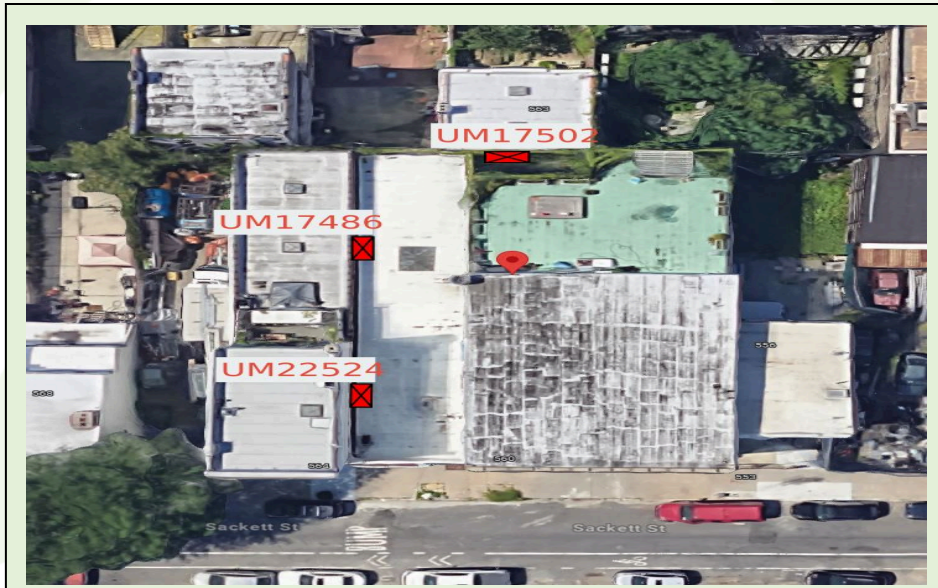
<p><b>QUIVER</b> MONITORING</p>	<p>Vibration Monitoring Layout 558 Sackett Street, Brooklyn Brooklyn NY 11215</p>	<p>Date of Installation MM/DD/YY 06/24/24</p>
---	---	---

1. **UM17486:** Is installed at the 564 Sackett Street Exterior, front.
2. **UM17502:** Is installed at the 563 Union Street Exterior.
3. **UM22524:** Is installed at the 564 Sackett Street Exterior, rear.

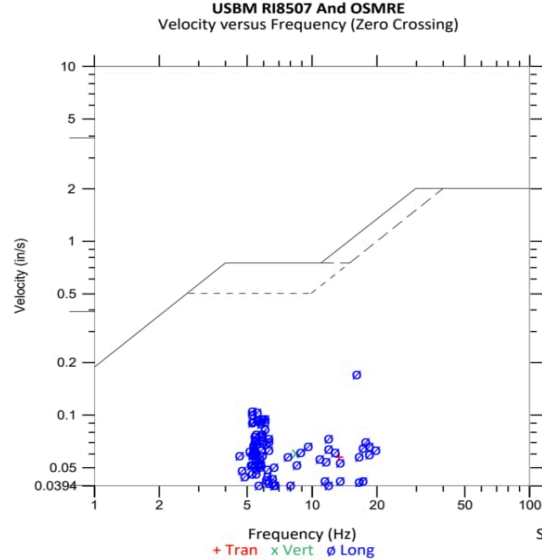
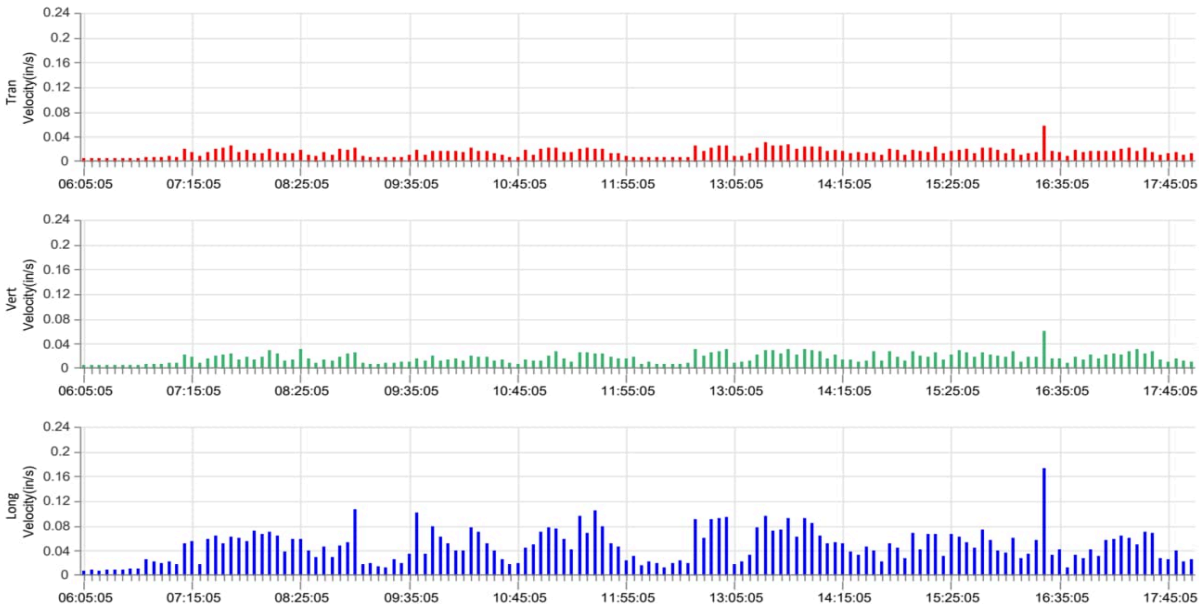
Geophone	Tran	Vert	Long
Peak Particle Velocity	0.0571 in/s	0.0614 in/s	0.1741 in/s
Zero Crossing Frequency	13.5 Hz	8.4 Hz	16.0 Hz
Date	Dec 9, 2024	Dec 9, 2024	Dec 9, 2024
Time	16:25:05	16:25:05	16:25:05
Sensor Check	✓ Passed	✓ Passed	✓ Passed
Frequency	7.3 Hz	7.3 Hz	7.3 Hz
Overswing Ratio	4.7	4.9	5.1
Peak Vector Sum	0.1778 in/s at December 9, 2024 16:25:05

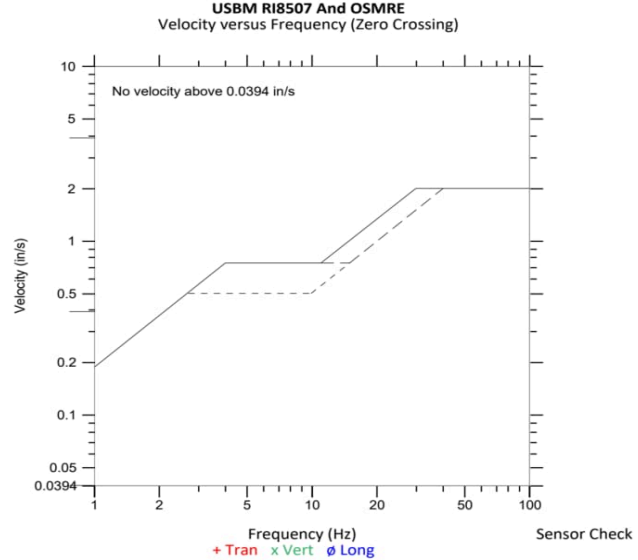
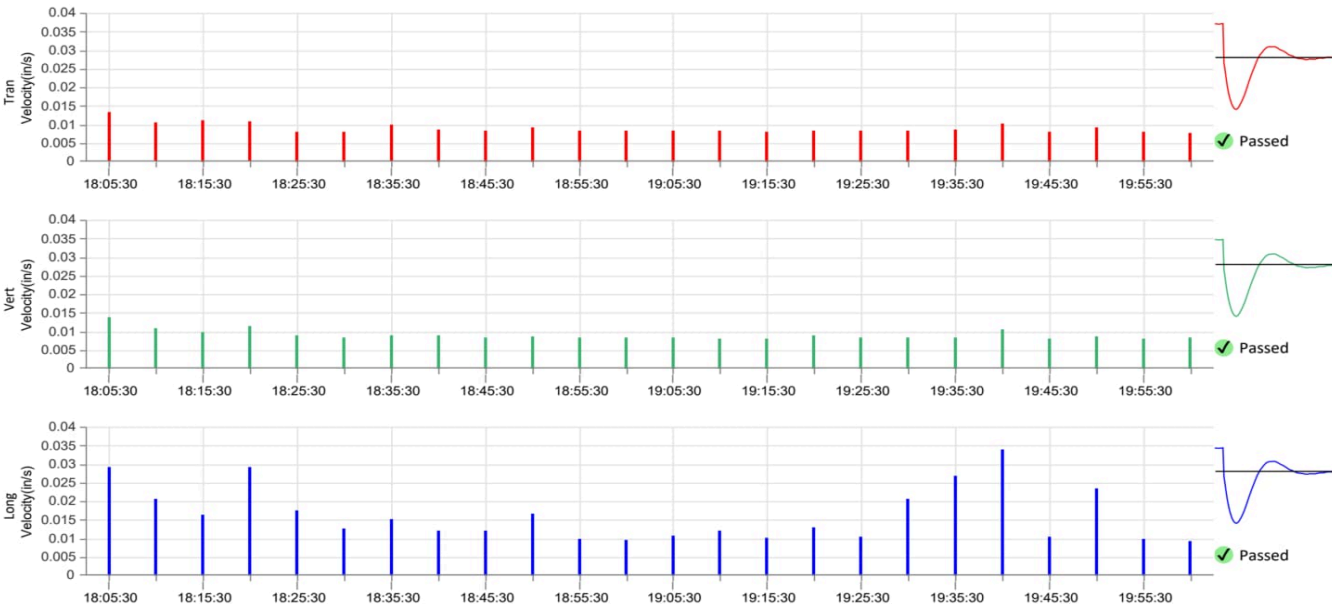
Geophone	Tran	Vert	Long
Peak Particle Velocity	0.0133 in/s	0.0140 in/s	0.0338 in/s
Zero Crossing Frequency	17.1 Hz	17.1 Hz	5.4 Hz
Date	Dec 9, 2024	Dec 9, 2024	Dec 9, 2024
Time	18:05:30	18:05:30	19:40:30
Sensor Check	✓ Passed	✓ Passed	✓ Passed
Frequency	7.5 Hz	7.3 Hz	7.3 Hz
Overswing Ratio	4.7	4.9	5.1
Peak Vector Sum	0.0351 in/s at December 9, 2024 19:40:30

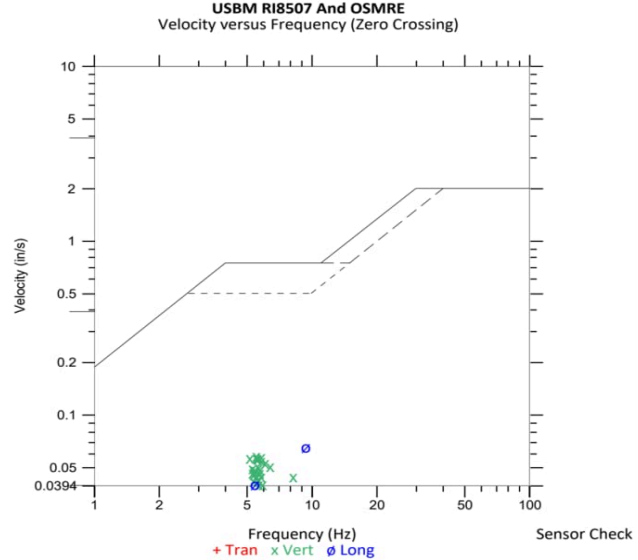
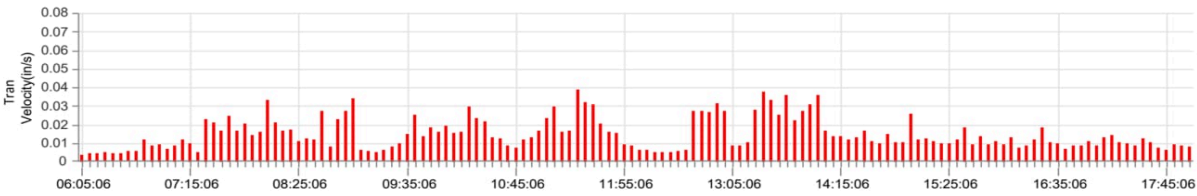
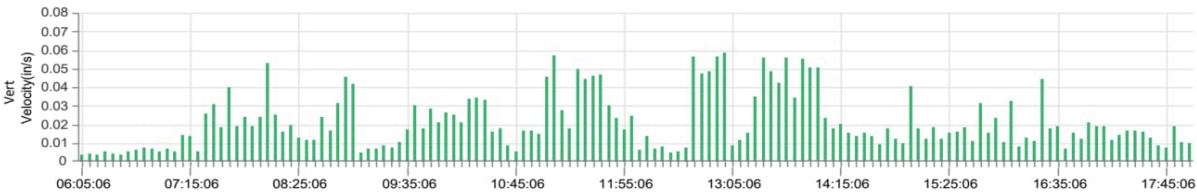
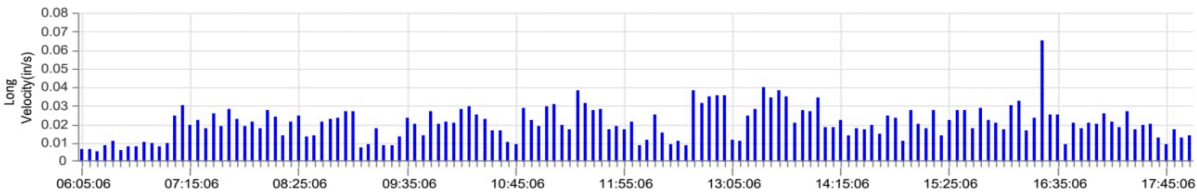
**UM17486**

Geophone	Tran	Vert	Long
Peak Particle Velocity	0.0385 in/s	0.0586 in/s	0.0655 in/s
Zero Crossing Frequency	5.1 Hz	5.6 Hz	9.3 Hz
Date	Dec 9, 2024	Dec 9, 2024	Dec 9, 2024
Time	11:25:06	13:00:06	16:25:06
Sensor Check	✓ Passed	✓ Passed	✓ Passed
Frequency	7.3 Hz	7.7 Hz	7.3 Hz
Overswing Ratio	4.2	3.9	4.4
Peak Vector Sum	0.0680 in/s at December 9, 2024 13:25:06

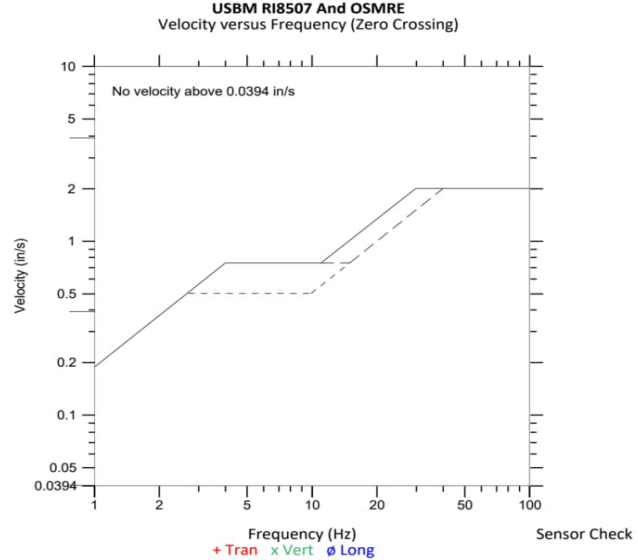
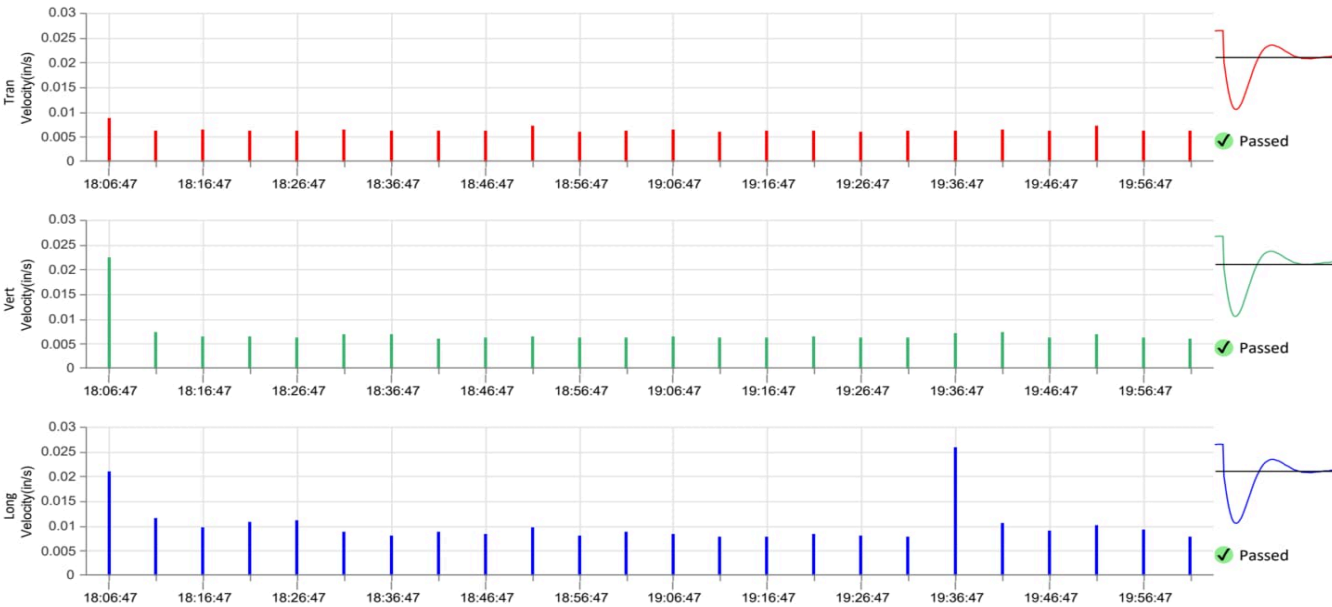
Geophone	Tran	Vert	Long
Peak Particle Velocity	0.0087 in/s	0.0223 in/s	0.0258 in/s
Zero Crossing Frequency	17.1 Hz	10.7 Hz	12.2 Hz
Date	Dec 9, 2024	Dec 9, 2024	Dec 9, 2024
Time	18:06:47	18:06:47	19:36:47
Sensor Check	✓ Passed	✓ Passed	✓ Passed
Frequency	7.3 Hz	7.7 Hz	7.3 Hz
Overswing Ratio	4.1	3.9	4.3
Peak Vector Sum	0.0259 in/s at December 9, 2024 19:36:47

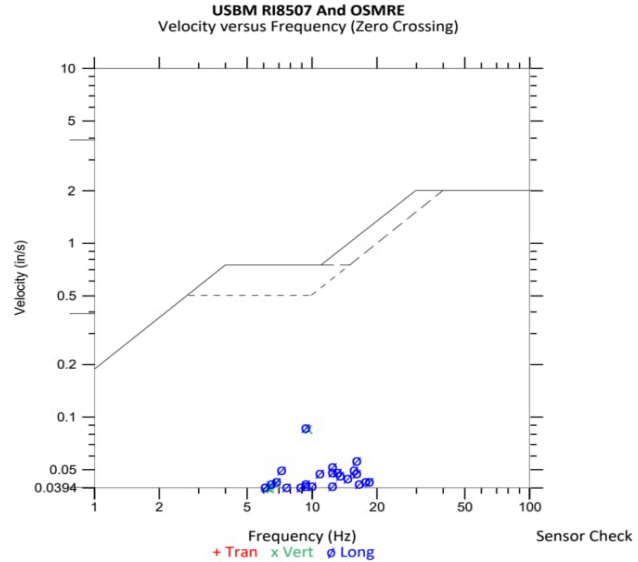
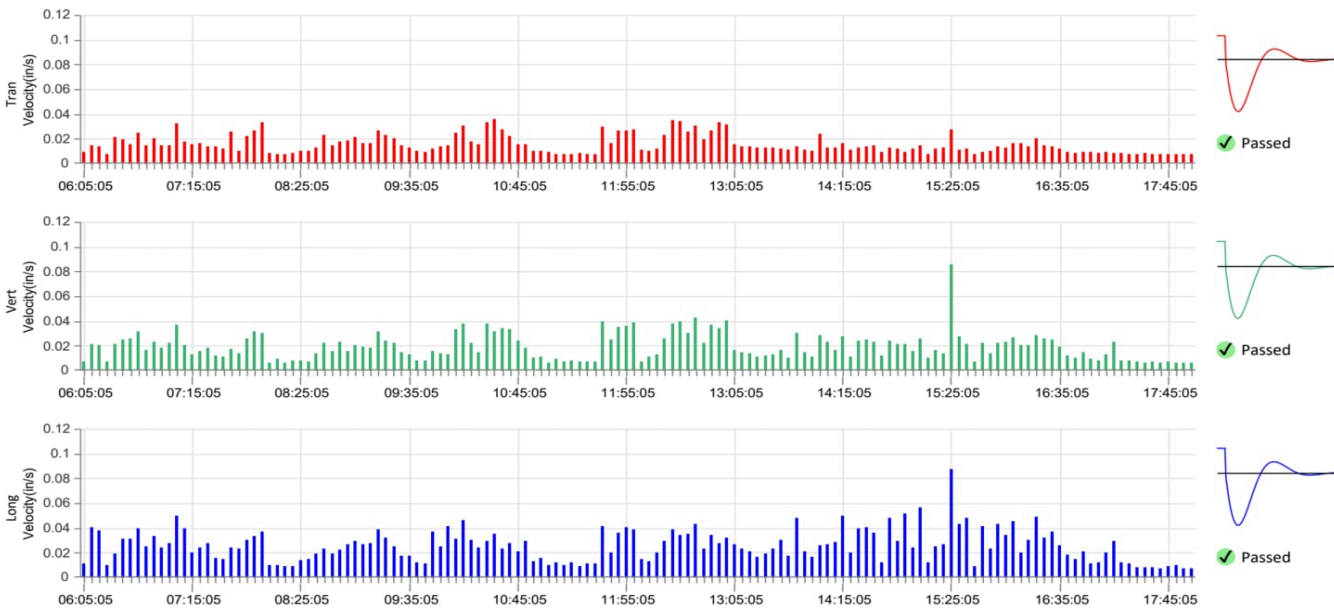
**UM22524**

Geophone	Tran	Vert	Long
Peak Particle Velocity	0.0363 in/s	0.0860 in/s	0.0878 in/s
Zero Crossing Frequency	5.2 Hz	9.7 Hz	9.3 Hz
Date	Dec 9, 2024	Dec 9, 2024	Dec 9, 2024
Time	10:30:05	15:25:05	15:25:05
Sensor Check	✓ Passed	✓ Passed	✓ Passed
Frequency	7.1 Hz	7.5 Hz	7.3 Hz
Overswing Ratio	4.9	4.7	4.4
Peak Vector Sum	0.1184 in/s at December 9, 2024 15:25:05

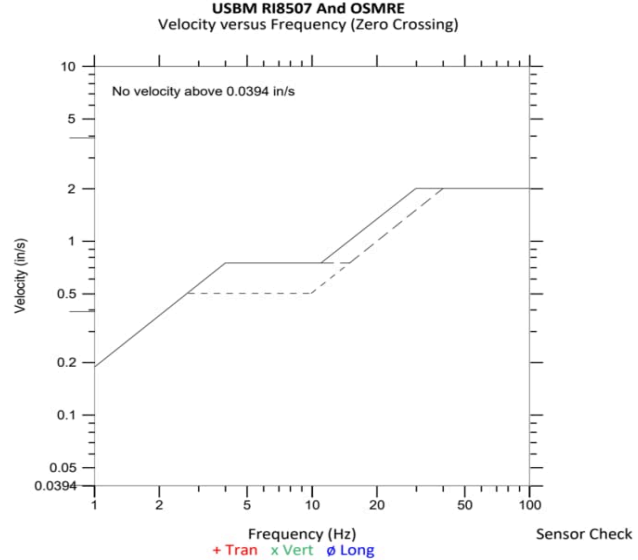
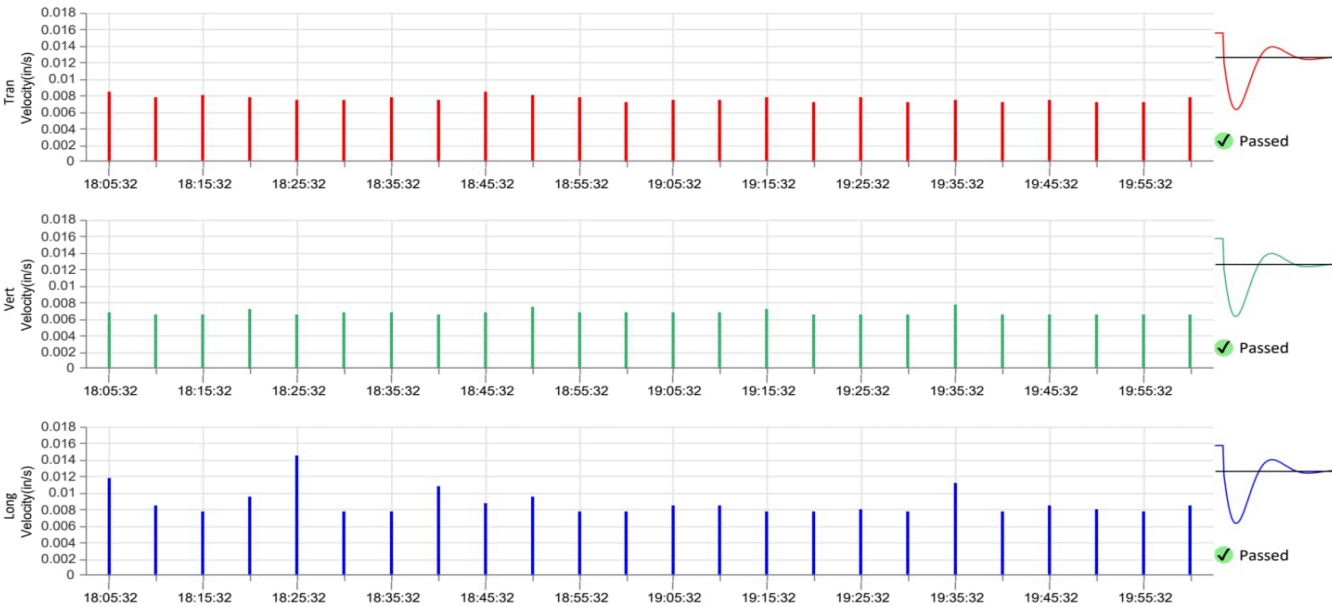
Geophone	Tran	Vert	Long
Peak Particle Velocity	0.0084 in/s	0.0078 in/s	0.0146 in/s
Zero Crossing Frequency	46.5 Hz	46.5 Hz	1.2 Hz
Date	Dec 9, 2024	Dec 9, 2024	Dec 9, 2024
Time	18:05:32	19:35:32	18:25:32
Sensor Check	✓ Passed	✓ Passed	✓ Passed
Frequency	7.1 Hz	7.3 Hz	7.3 Hz
Overswing Ratio	4.8	4.7	4.4
Peak Vector Sum	0.0161 in/s at December 9, 2024 18:25:32
