### SITE OBSERVATION REPORT

**PROJECT:** C224398 – 1709 Surf Avenue

**LOCATION:** 1709 Surf Avenue, Brooklyn, New York

Langan was present to oversee implementation of the November 20, 2024 Remedial Action Work Plan (RAWP) for Brownfield Cleanup Program (BCP) Site No. C224398 at 1709 Surf Avenue. Observed activities were as follows:

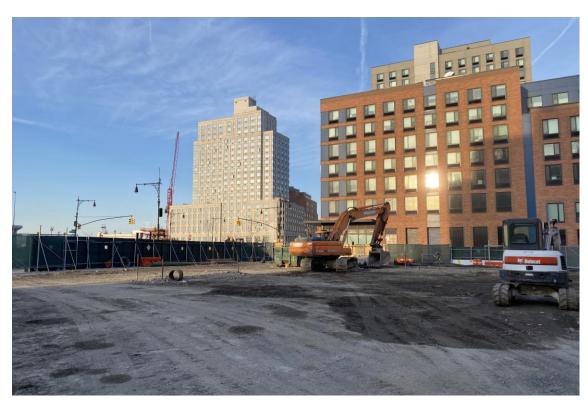
**Photo 1:** General view of the site (facing southwest).
