SITE NAME: Kingsbrook Estates

SECTION I: Property Information See Attachment A						
PROPOSED SITE NAME Kingsbrook Estates						
ADDRESS/LOCATION 585 Schenectady Avenue						
CITY/TOWN Brooklyn, NY				ZIP CODE 11203		
MUNICIPALITY (LIST ALL IF MORE THAN ONE) Brooklyn						
COUNTY Kings				SITE SIZE (ACRES) 2.13		
LATITUDE			LONGITUDE			
40	39	37.245	-73	55	58.116	
Provide tax map information for all tax parcels included within the proposed site boundary below. If a portion of any lot is to be included, please indicate as such by inserting "p/o" in front of the lot number in the appropriate box below, and only include the acreage for that portion of the tax parcel in the corresponding acreage column.						
ATTACH REQUIRED TAX MAPS PER THE APPLICATION INSTRUCTIONS.						
Parcel Address		Section	Block	Lot	Acreage	
585 Schenectady Avenue			4602	p/o 1	0.56	
86 East 49th Street			4602	p/o 5	1.61

Project
**KINGSBROOK
 ESTATES**
 BROOKLYN NEW YORK

ATTACHMENT E1: PROPERTY'S ENVIRONMENTAL HISTORY

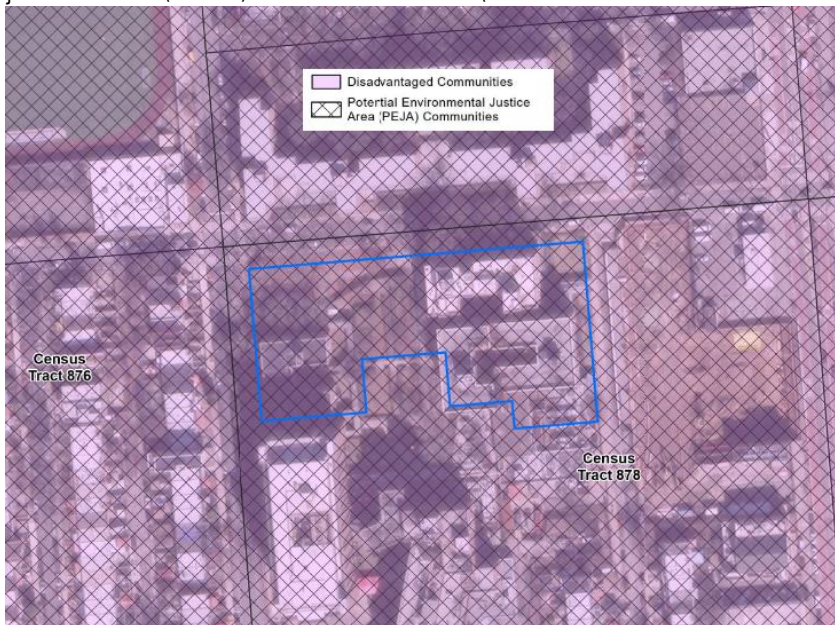
The site is located in a disadvantaged community (DAC) and potential environmental justice area (PEJA) as shown below (sourced from the DECInfo Locator)

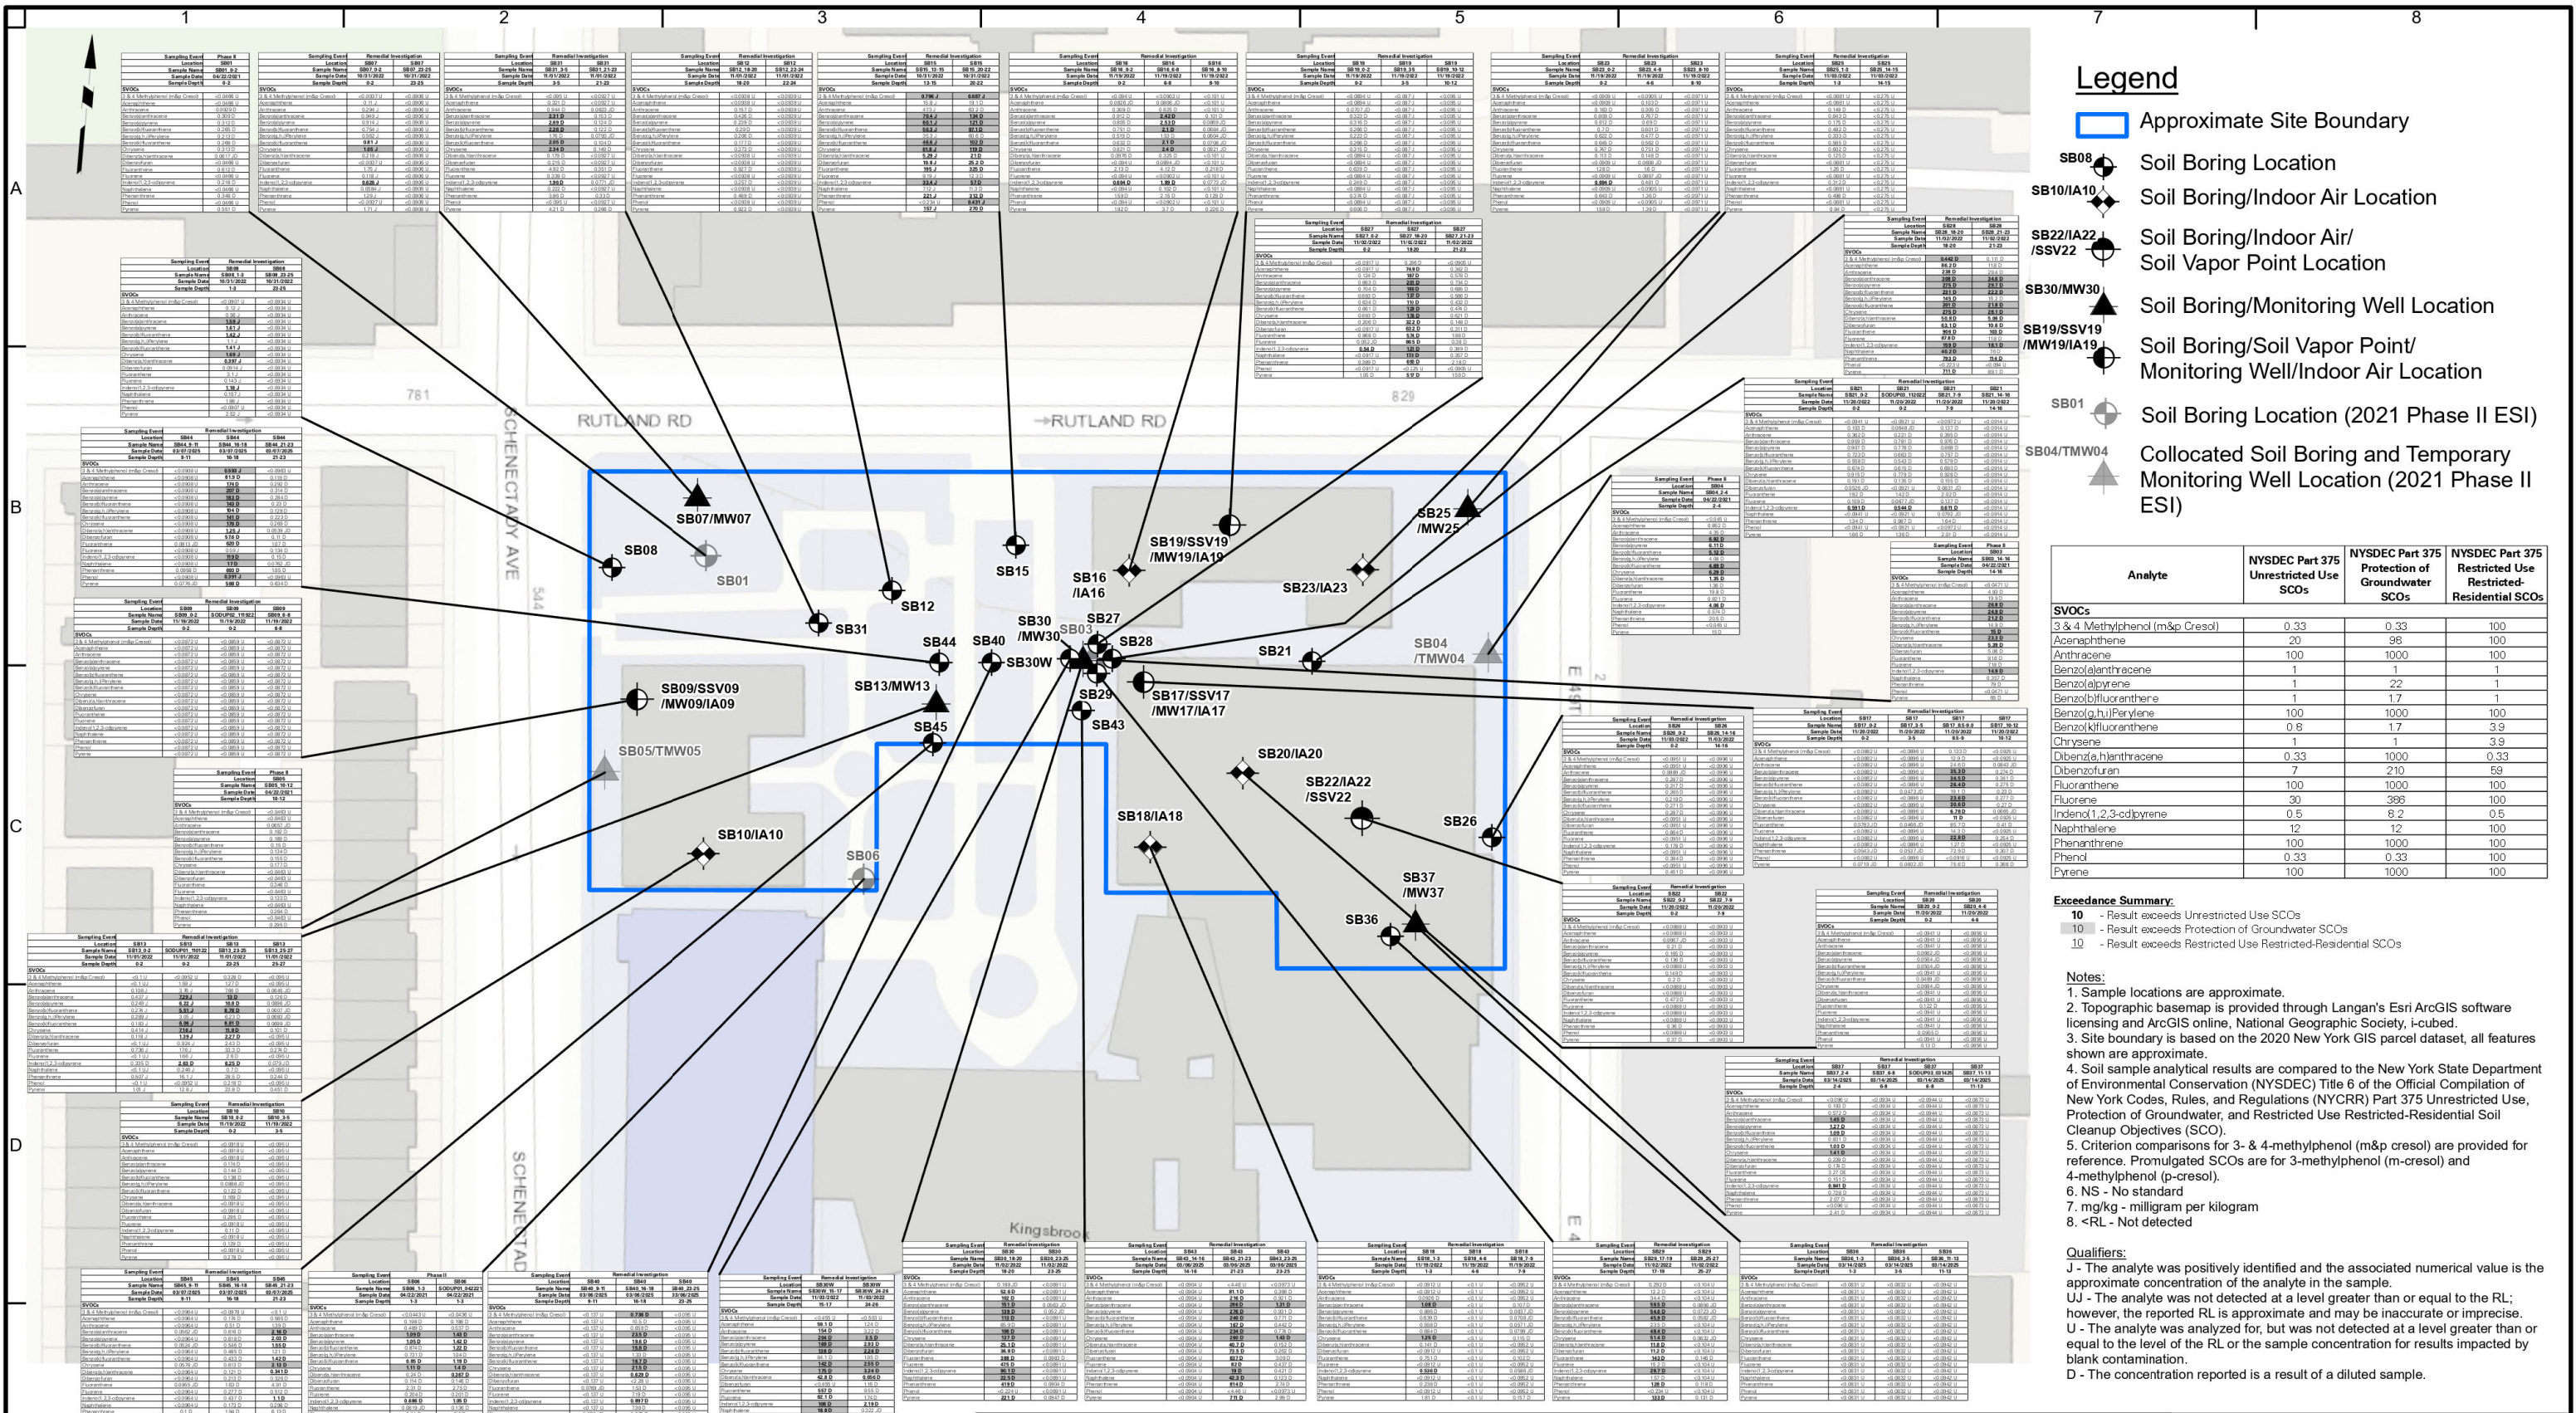
Project No.	170655401	Figure No.	E-1A
Date	8/27/2025		
Scale	1"=80'		
Drawn By	MG

- ### Legend
- Approximate Site Boundary
 - Soil Boring Location
 - Soil Boring/Indoor Air Location
 - Soil Boring/Indoor Air/ Soil Vapor Point Location
 - Soil Boring/Monitoring Well Location
 - Soil Boring/Soil Vapor Point/ Monitoring Well/Indoor Air Location
 - Soil Boring Location (2021 Phase II ESI)
 - Collocated Soil Boring and Temporary Monitoring Well Location (2021 Phase II ESI)

An SVOC hotspot with a chemical-like odor and staining was observed from about 8.5 to 25 feet bgs in the central part of the site. SVOCs were detected at concentrations two orders of magnitude above the UU, PGW and/or RURR SCOs in stained and odorous fill and native soil samples collected from this area. Sample depths with constituents that exceeded the UU, PGW and/or RURR SCOs ranged from surface grade to about 27 feet bgs. An unknown on-site release has been established as the source of SVOCs in soil and groundwater at the central part of the site.

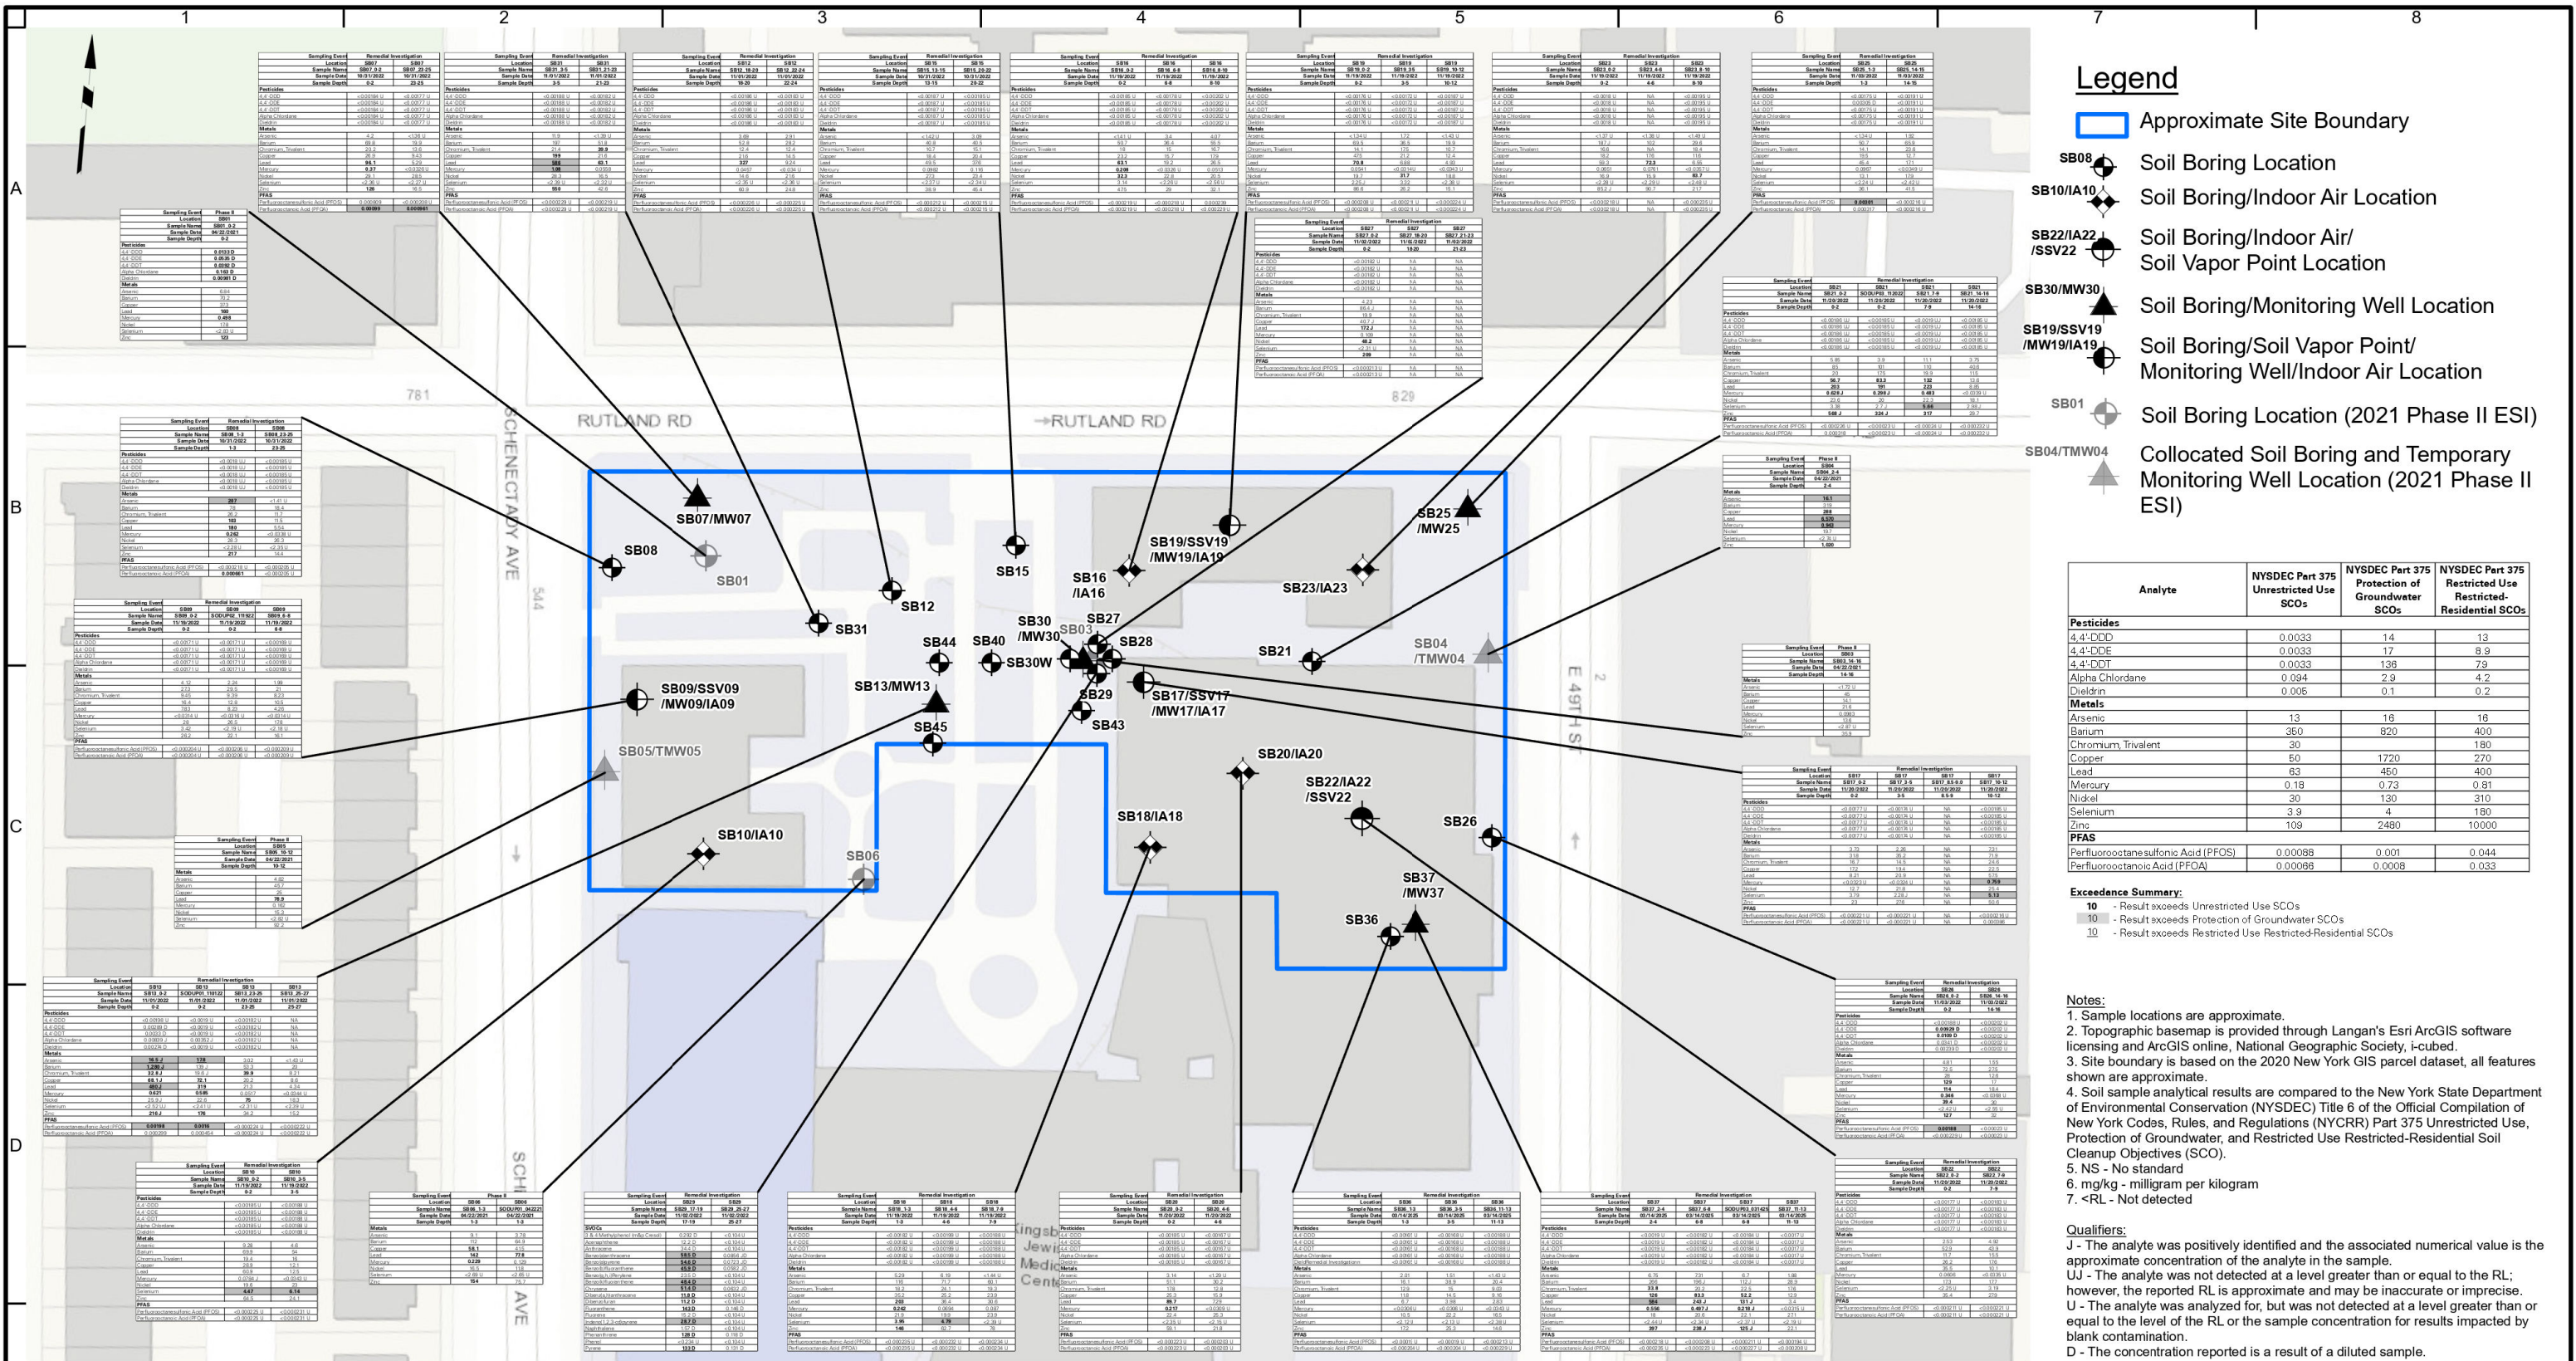
- ### Legend
- Approximate Site Boundary
 - Soil Boring Location
 - Soil Boring/Indoor Air Location
 - Soil Boring/Indoor Air/Soil Vapor Point Location
 - Soil Boring/Monitoring Well Location
 - Soil Boring/Soil Vapor Point/Monitoring Well/Indoor Air Location
 - Soil Boring Location (2021 Phase II ESI)
 - Collocated Soil Boring and Temporary Monitoring Well Location (2021 Phase II ESI)
