## SITE OBSERVATION REPORT

<b>PROJECT No.:</b> 170381202	<b>CLIENT:</b> 250 Seaport District, LLC c/o The Howard Hughes Corporation	<b>DATE:</b> Thursday, August 10, 2023
<b>PROJECT:</b> 250 Water Street		<b>WEATHER:</b> Partly Cloudy/Rain, 75 – 80° F Wind: NW @ 0.2 – 1.7 mph
<b>LOCATION:</b> New York, NY		<b>TIME:</b> 5:45am – 4:30pm
<b>BCP SITE ID:</b> C231127		<b>MONITOR</b> Jack Millman

Langan was present to document remediation activities in accordance with the NYSDEC-approved November 2021 Remedial Action Work Plan (RAWP) at the 250 Water Street site (NYSDEC Brownfield Cleanup Program [BCP] Site No C231127).

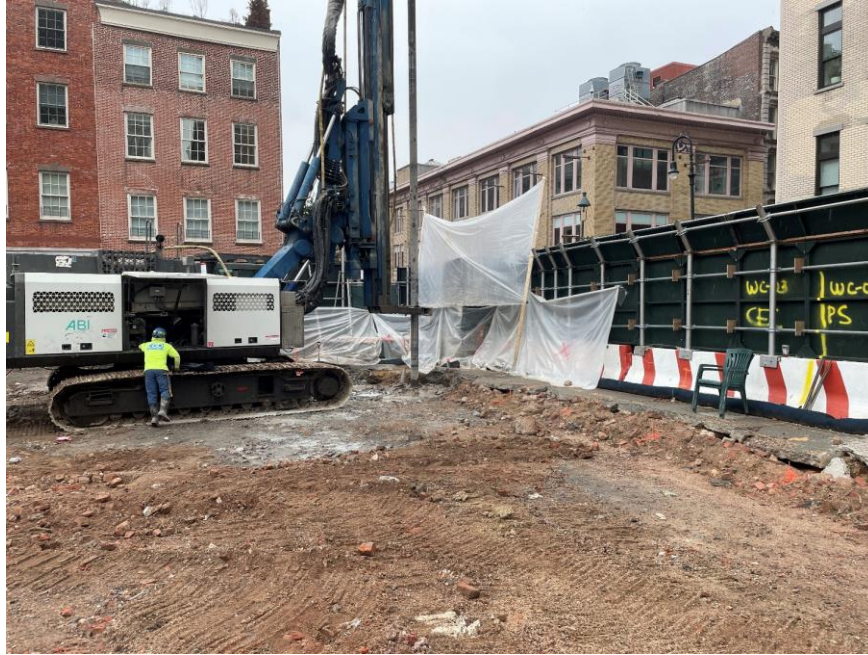
**Photo 1:** ECD installing a soldier pile in the southwest part of the site (facing southwest)

- ECD used an ABI Mobilram drill rig to install two soldier piles to about 35 feet below grade surface (bgs) for support-of-excavation (SOE) installation in the southwest part of the site (Beekman Street). ECD’s drill rig advanced a steel rod with a soil mixing paddle at the bottom of the rod, while concurrently injecting grout through the top of the paddle and spinning and advancing the paddle downward.

- No drilling spoils were generated during installation of the soldier piles.
  - Excess grout was contained within a temporary trench adjacent to the drilling area and will be managed as C&D debris at a later date.

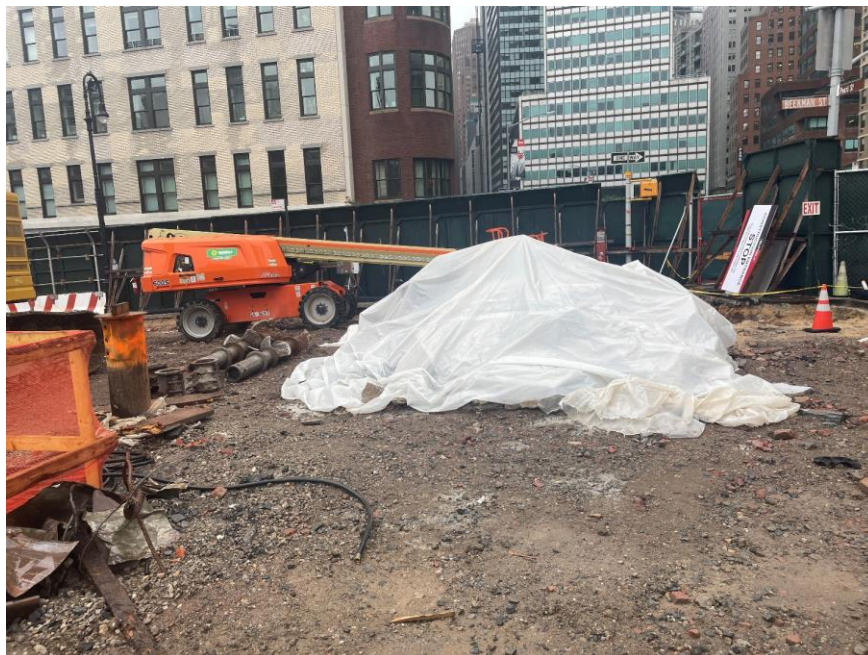
**Photo 2:** C&D stockpile on and covered with polyethylene sheeting in the northwestern part of the site (facing west)

- ECD demolished existing asphalt and concrete in the western part of the site. The construction and demolition (C&D) debris was temporarily stockpiled on and covered with polyethylene sheeting in the northwest part of the site pending future off-site disposal.
