## SITE OBSERVATION REPORT

<b>PROJECT No.:</b> 170381202  <b>PROJECT:</b> 250 Water Street  <b>LOCATION:</b> New York, NY  <b>BCP SITE ID:</b> C231127	<b>CLIENT:</b> 250 Seaport District, LLC c/o The Howard Hughes Corporation	<b>DATE:</b> Tuesday, September 26, 2023  <b>WEATHER:</b> Overcast/Rain, 54 – 60° F Wind: NW @ 0.2 – 2.2 mph  <b>TIME:</b> 5:45am – 6:00pm  <b>MONITOR</b> Jack Millman	
<b>EQUIPMENT:</b> CAT 335 Excavator CAT 328 Excavator Komatsu PC138 Excavator Delmag Drill Rig Bauer RTG RG 27S Bauer BG45 Drill Rig Casagrande M6A-1 Tieback Drill Rig Jerome J505 Mercury Vapor Analyzer RKI GX-6000 Photoionization Detector (PID) Aeroqual ASQ1 Air Monitoring Station	<b>PRESENT AT SITE:</b> <span style="float: right;"><b>Day 211</b></span> <b>Langan</b> (Environmental/Geotechnical) Jack Millman, Michael Cole, Pradeep Pandey <b>Suffolk Construction (Suffolk)</b> (General Contractor) Anthony Galu, Wyatt Favia <b>East Coast Drilling, Inc. (ECD)</b> (Foundation Contractor) Danny Rodgers <b>New York State Department of Environmental Conservation</b> <b>(NYSDEC)</b> Rafi Alam

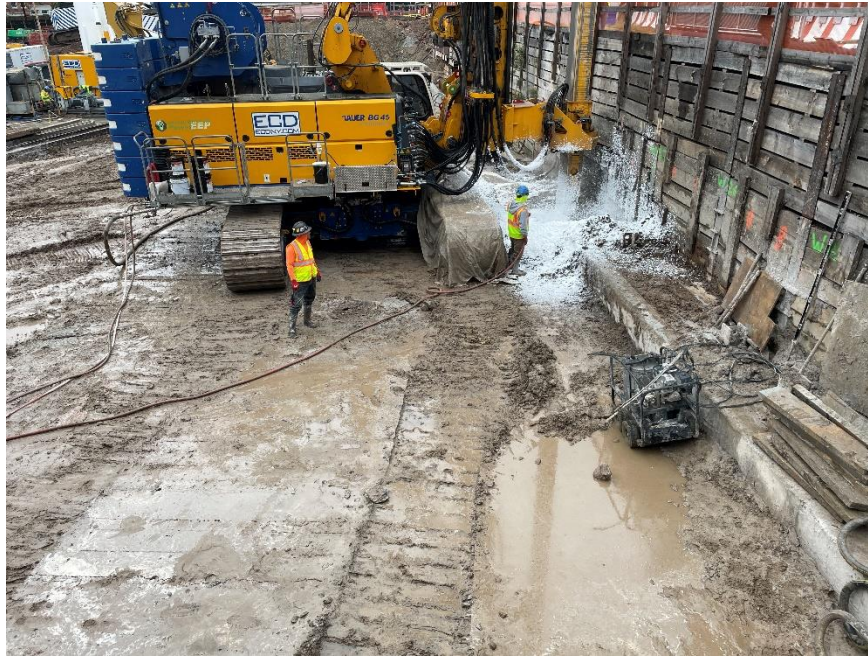
**Photo 1** Atmos® AC-645 odor/vapor suppressing foam proactively applied to soil/fill in the northern part of the site (facing west)

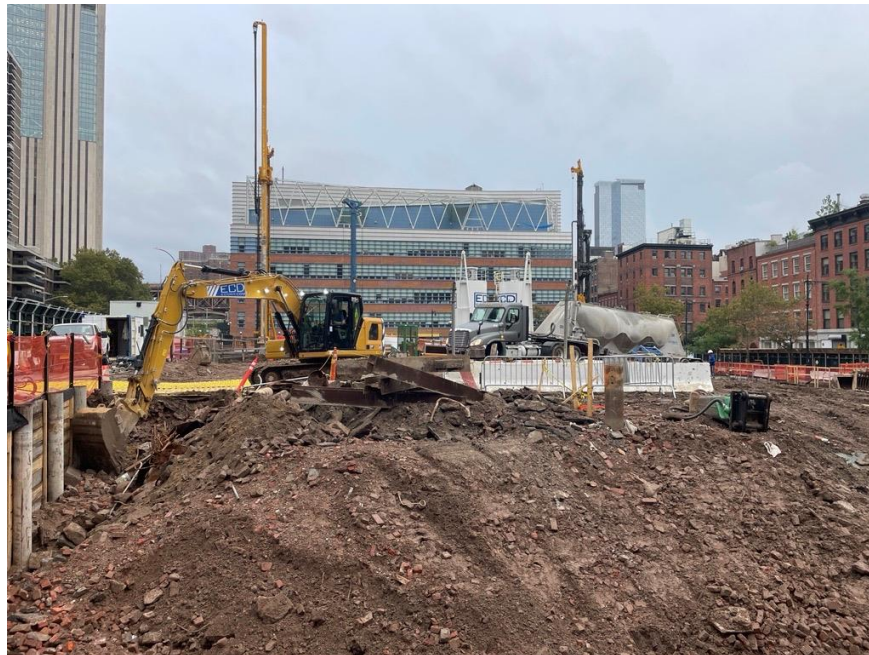
**Photo 2:** ECD excavating soil/fill in the northern part of the site (facing east)
