## SITE OBSERVATION REPORT

<b>PROJECT No.:</b> 170381202	<b>CLIENT:</b> 250 Seaport District, LLC c/o The Howard Hughes Corporation	<b>DATE:</b> Thursday, September 28, 2023
<b>PROJECT:</b> 250 Water Street		<b>WEATHER:</b> Overcast/Rain, 56 – 65° F Wind: NE @ 0.3 – 2.3 mph
<b>LOCATION:</b> New York, NY		<b>TIME:</b> 5:30am – 6:15pm
<b>BCP SITE ID:</b> C231127		<b>MONITOR</b> Jack Millman

Langan was present to document remediation activities in accordance with the NYSDEC-approved November 2021 Remedial Action Work Plan (RAWP) at the 250 Water Street site (NYSDEC Brownfield Cleanup Program [BCP] Site No C231127).

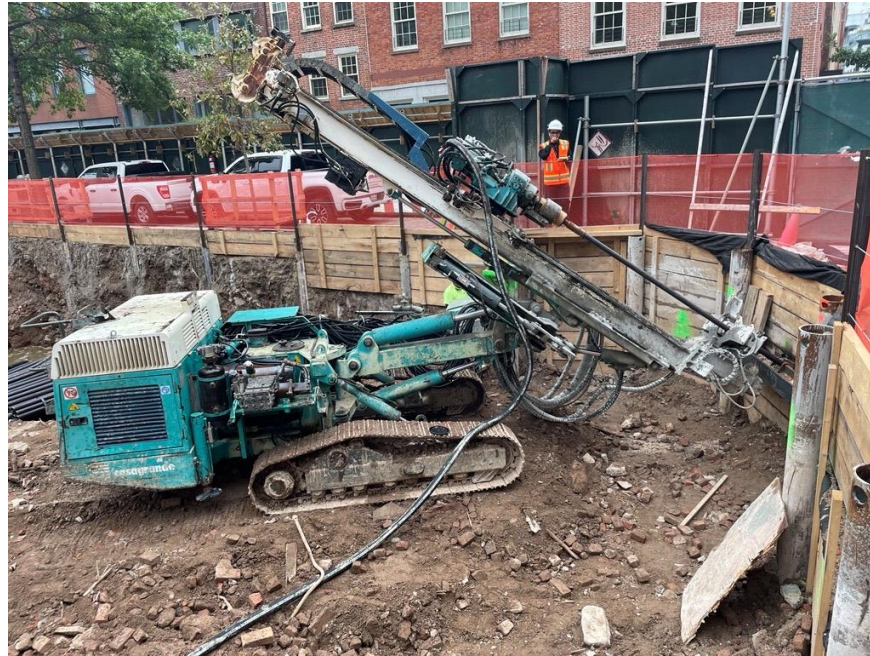
- ECD installed two tie-backs for the SOE system along the western perimeter of the site (Beekman Street).

**Photo 1:** ECD installing a tieback along the western perimeter of the site (facing south)

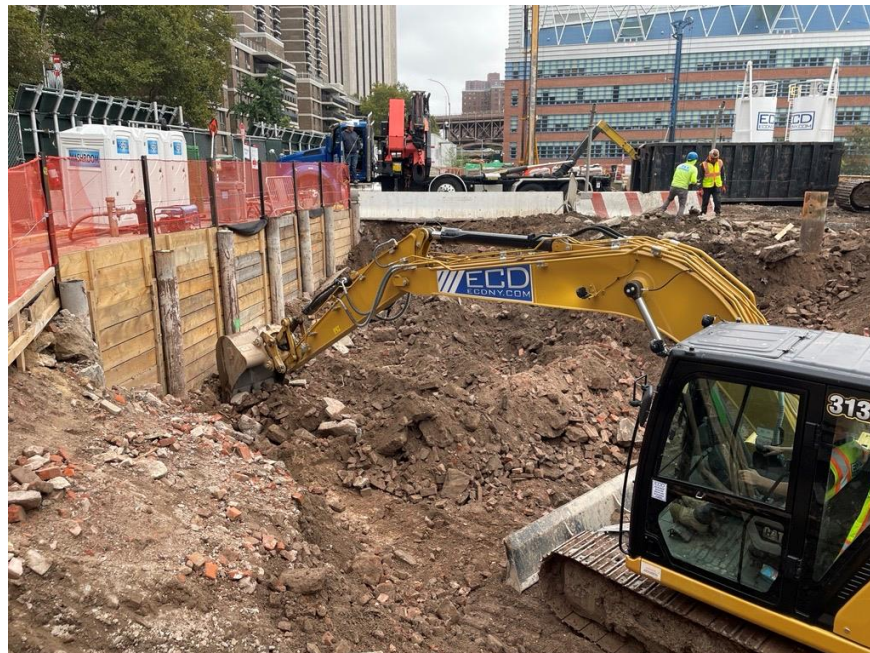
- ECD excavated an about 30-foot-long by 55-foot-wide area to a maximum depth of about 8 feet below the existing grade (about 8 feet below sidewalk grade [bsgl]) in the northwest part of the site (waste characterization cell WC01) to facilitate installation of tiebacks as part of the SOE system.

- Excavated soil/fill was screened for odors, staining, organic vapors, and mercury vapor using a handheld photoionization detector (PID) and handheld Jerome® J505 mercury vapor analyzer, respectively. Evidence of impacts was not observed and the excavated soil/fill was live-loaded into securely covered tri-axle dump trucks for off-site disposal.

**Photo 2:** ECD excavating soil/fill in the northwest part of the site (facing east)
