SITE OBSERVATION REPORT

<p>PROJECT No.: 170381202</p> <p>PROJECT: 250 Water Street</p> <p>LOCATION: New York, NY</p> <p>BCP SITE ID: C231127</p>	<p>CLIENT: 250 Seaport District, LLC c/o The Howard Hughes Corporation</p>	<p>DATE: Friday, November 3, 2023</p> <p>WEATHER: Sunny, 40 – 50 °F Wind: NE @ 0.2 – 2.1 mph</p> <p>TIME: 5:45am – 5:45pm</p> <p>MONITOR Sophia Misiakiewicz</p>
<p>EQUIPMENT: CAT 335 Excavator CAT 328 Excavator Komatsu PC210 Excavator Delmag Drill Rig Bauer RTG RG 27S Bauer BG 36H Drill Rig Bauer BG45 Drill Rig Casagrande M6A-1 Tieback Drill Rig Jerome J505 Mercury Vapor Analyzer RKI GX-6000 Photoionization Detector (PID) Aeroqual ASQ1 Air Monitoring Station</p>	<p>PRESENT AT SITE: Day 240 Langan (Environmental/Geotechnical) Sophia Misiakiewicz, Pradeep Pandey Suffolk Construction (Suffolk) (General Contractor) Anthony Galu, Wyatt Favia East Coast Drilling, Inc. (ECD) (Foundation Contractor) Daniel Rogers, Mike Brosnan New York State Department of Environmental Conservation (NYSDEC) Sydney Sobol</p>

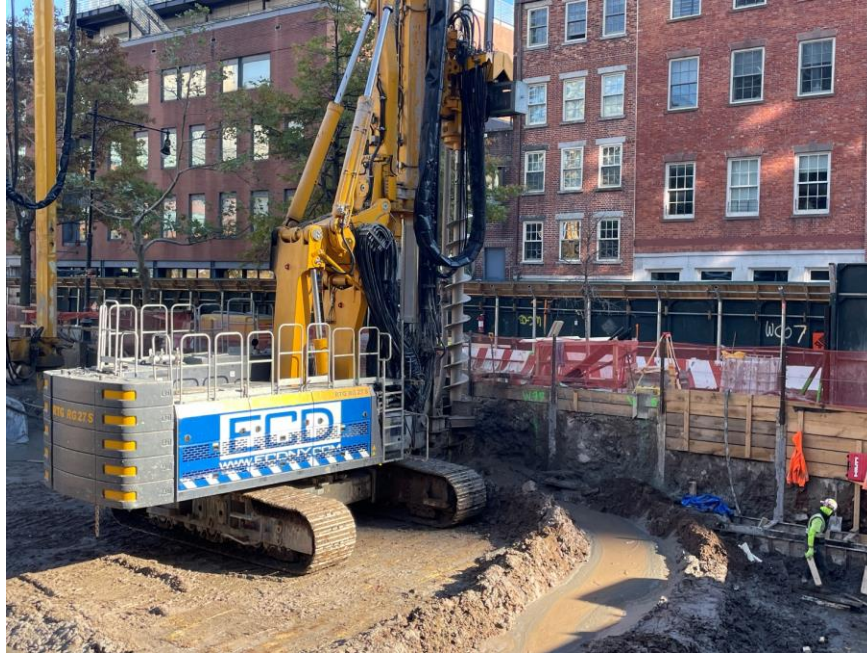
Photo 1: ECD pre-drilling a borehole for soil mix column installation along the southern site boundary (facing south)

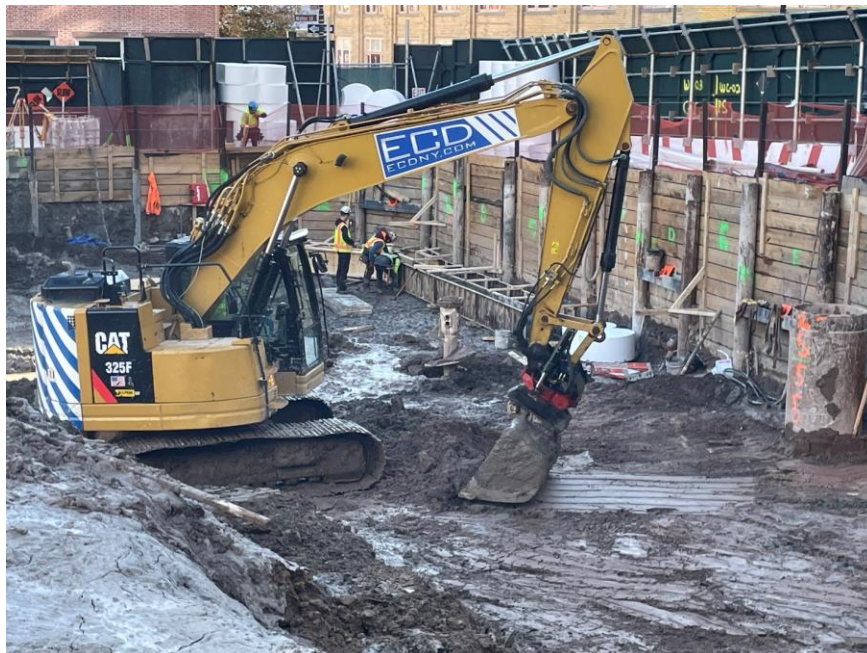
- Mercon-X® mercury vapor suppressant was actively applied to the soil/fill during excavation as a precautionary measure.
- ECD graded soil/fill in an about 30-foot-long by 20-foot-wide area in the central part of the site and an about 50-foot-long by 20-foot-wide area in the northwest part of the site to stabilize the surface for SOE system installation.

- Graded soil/fill was screened for odors, staining, organic vapors, and mercury vapor using a handheld PID and handheld Jerome® J505 mercury vapor analyzer, respectively. Evidence of impacts was not observed.

Photo 2: ECD grading soil/fill in the northwest part of site (facing southwest)
