**Progress Report No. 6
December 2024
Reporting Period: November 1 – November 30, 2024**

245 West 55th Street
Block 1027, Lot 7
New York, New York
Brownfield Cleanup Program Site #: C231157

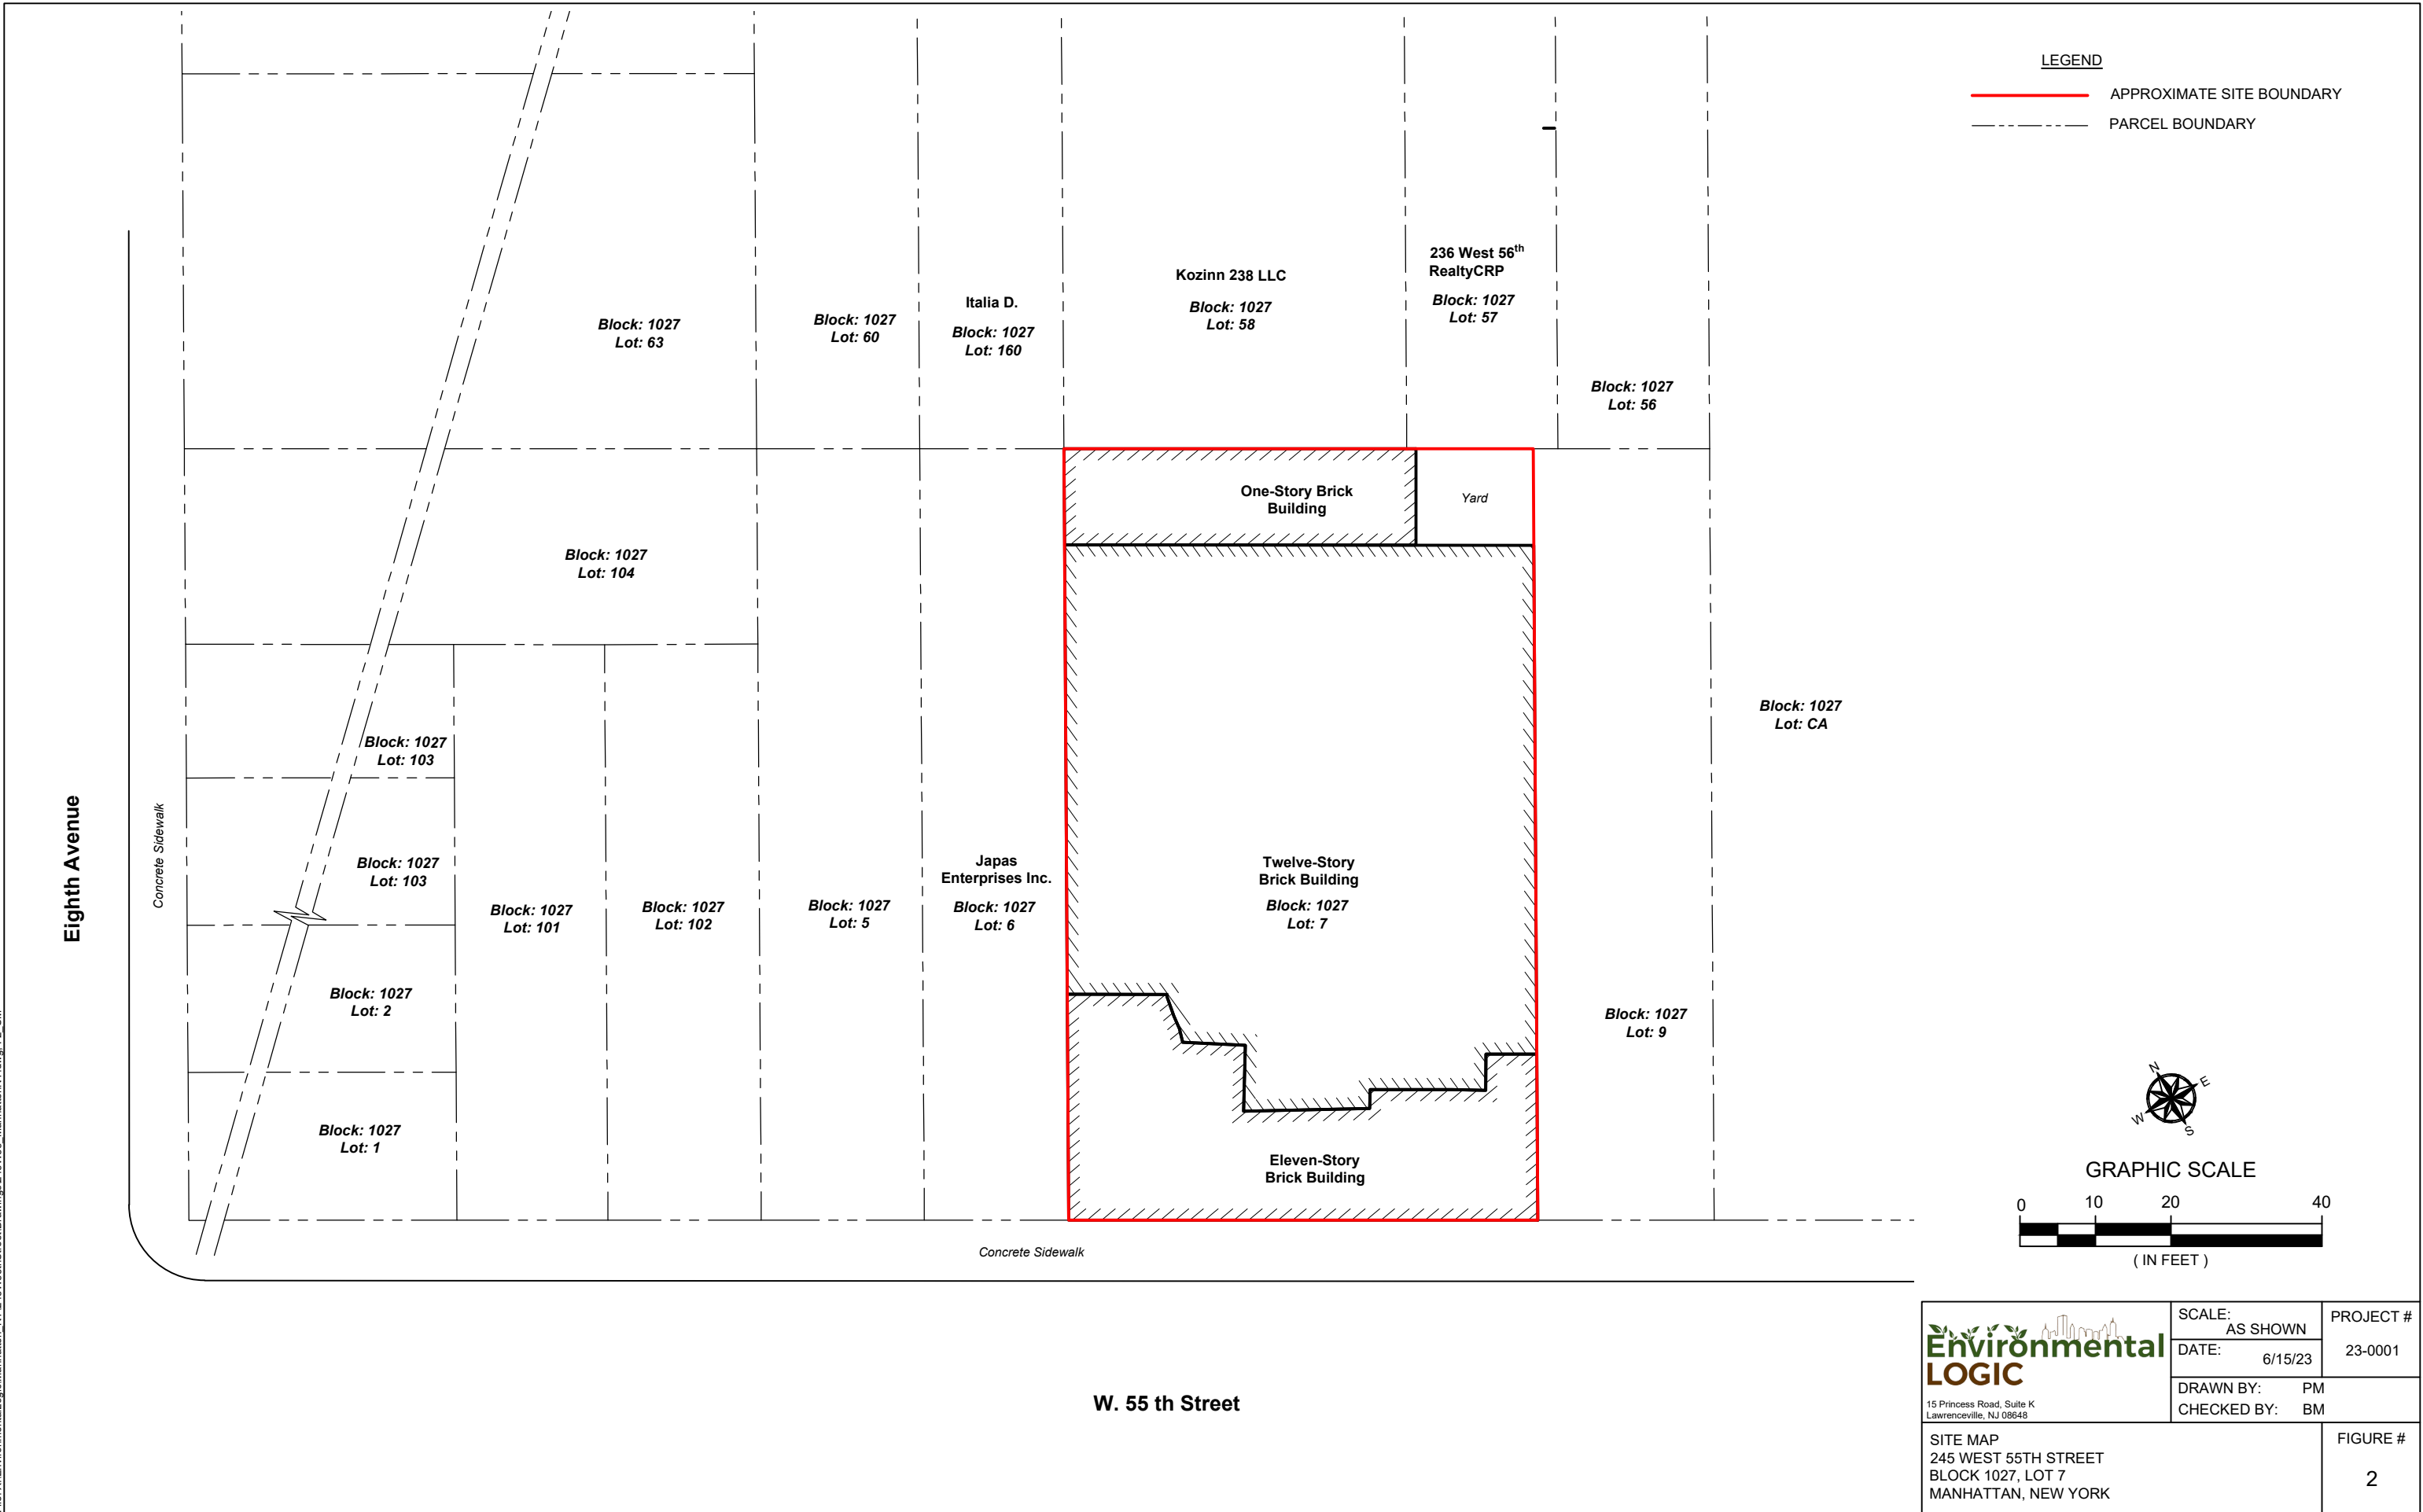
The Site was formerly owned and utilized by DuArt Media Services/DuArt Film Labs (DuArt) for cinematographic film cleaning and film processing from approximately 1922 through 2011. Film production including voiceover work, audio recording, and film editing continued to take place at the Site until 2021. A site plan is provided as **Figure 2**.

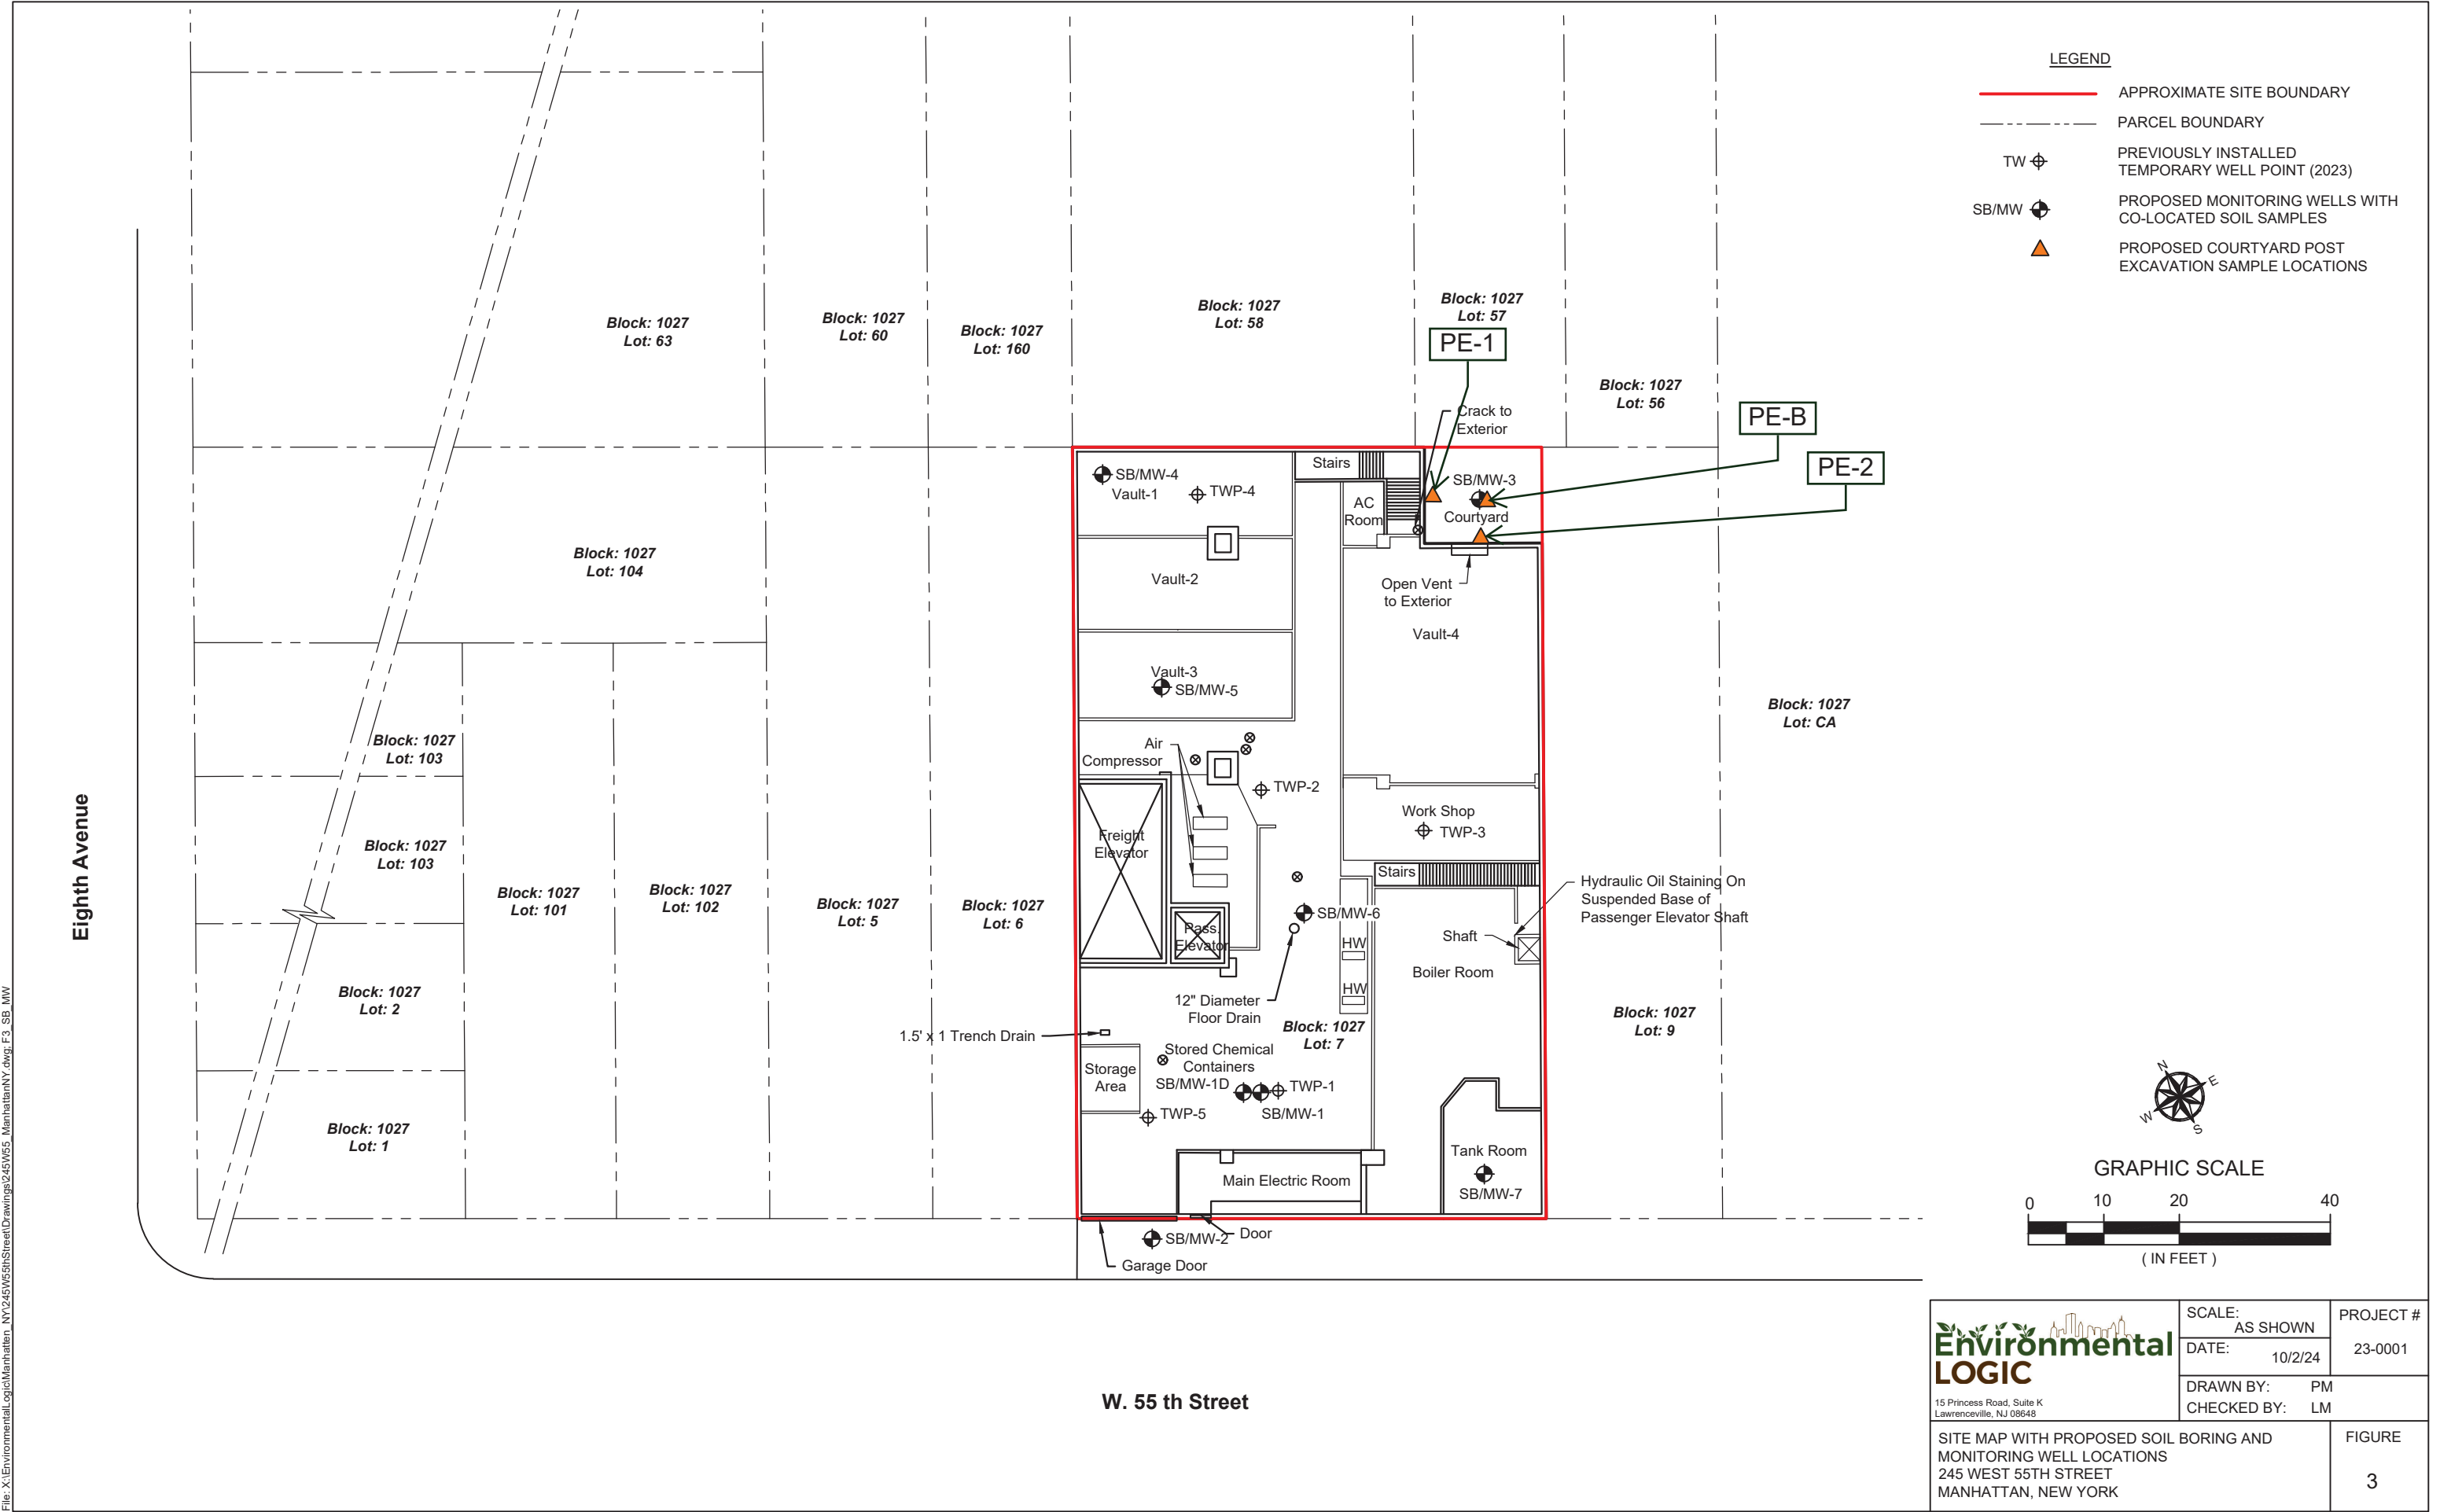
File: X:\Environmental\logic\Manhattan_NY\245W55thStreet\Drawings\245W55 ManhattanNY.dwg; F3 SB MW

As part of the remedial investigation, eight (8) collocated soil boring and monitoring well locations were proposed. EL mobilized to the Site, with a licensed drilling subcontractor on November 18, 2024. Between November 18 and 21, 2024, seven (7) of the soils borings (SB-1, SB-1D, and SB-3 through SB-7) were installed within the basement of the building on Site. The approximate sample locations are shown on **Figure 3**. The remaining proposed soil boring/monitoring well

A total of three (3) post-excavation soil samples, identified as PE-1, PE-2, and PE-B, were collected from the courtyard area on November 18, 2024. The approximate sample locations are shown on **Figure 3**. Samples PE-1 and PE-2 were collected from the western and southern sidewalls, and sample PE-B was collected from the bottom of the excavation. In accordance with the NYSDEC's October 2, 2024, comment letter, no post excavation samples were collected from the two side walls that run along the exterior site boundary (i.e., the northern and eastern sidewalls).

During soil boring installation activities, soils were field screened for evidence of impacts (i.e., staining, odors, or elevated Photoionization Detector (PID) readings) prior to sampling. Petroleum odors and staining were observed in the SB/MW-7 boring located in the Former Tank Room. Impacts were primarily observed just above the water table, between 8 to 10 feet below ground surface (ft bgs). Elevated PID readings (maximum reading - 169 ppm) were also observed in this boring. There was no evidence of impacts observed in the remaining soil boring locations (SB-1, SB-1D, and SB-3 through SB-6).
