Enclosure 2
NEW YORK STATE DEPARTMENT OF ENVIRONMENTAL CONSERVATION
Site Management Periodic Review Report Notice
Institutional and Engineering Controls Certification Form

Site Details	Box 1	
Site No. C241089			
Site Name Review Avenue Development I			
Site Address: 37-30 Review Avenue	Zip Code: 11101		
City/Town: Long Island City			
County: Queens County			
Site Acreage: 2.733			
Reporting Period: November 16, 2015 to March 31, 2017			
		YES	NO

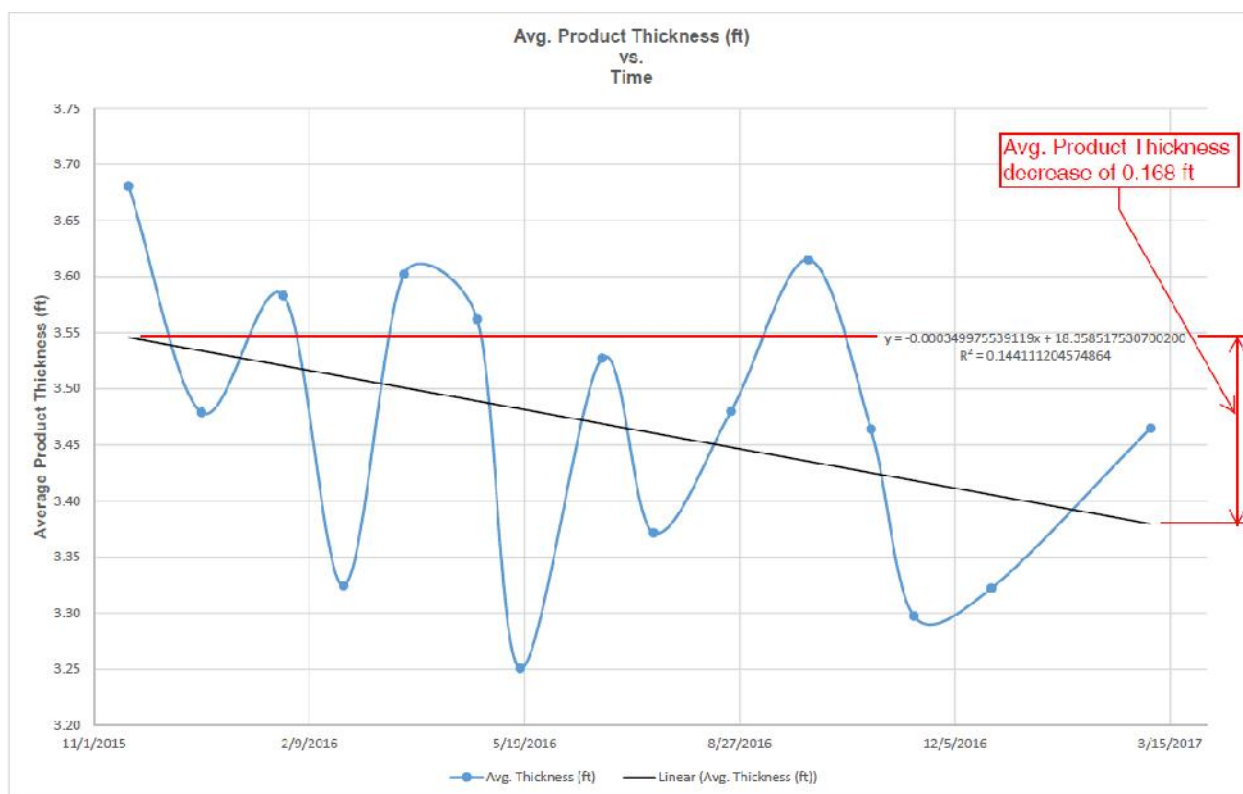
Monthly site wide LNAPL gauging events at thirty-three (33) on-site LNAPL monitoring wells (RAD I and RAD II) provide evidence that average LNAPL thickness is trending downwards across the site and has decreased by an average of approximately 0.17 feet as illustrated in the plot and linear curve fit below. This demonstrates the LNAPL Recovery System is effective.

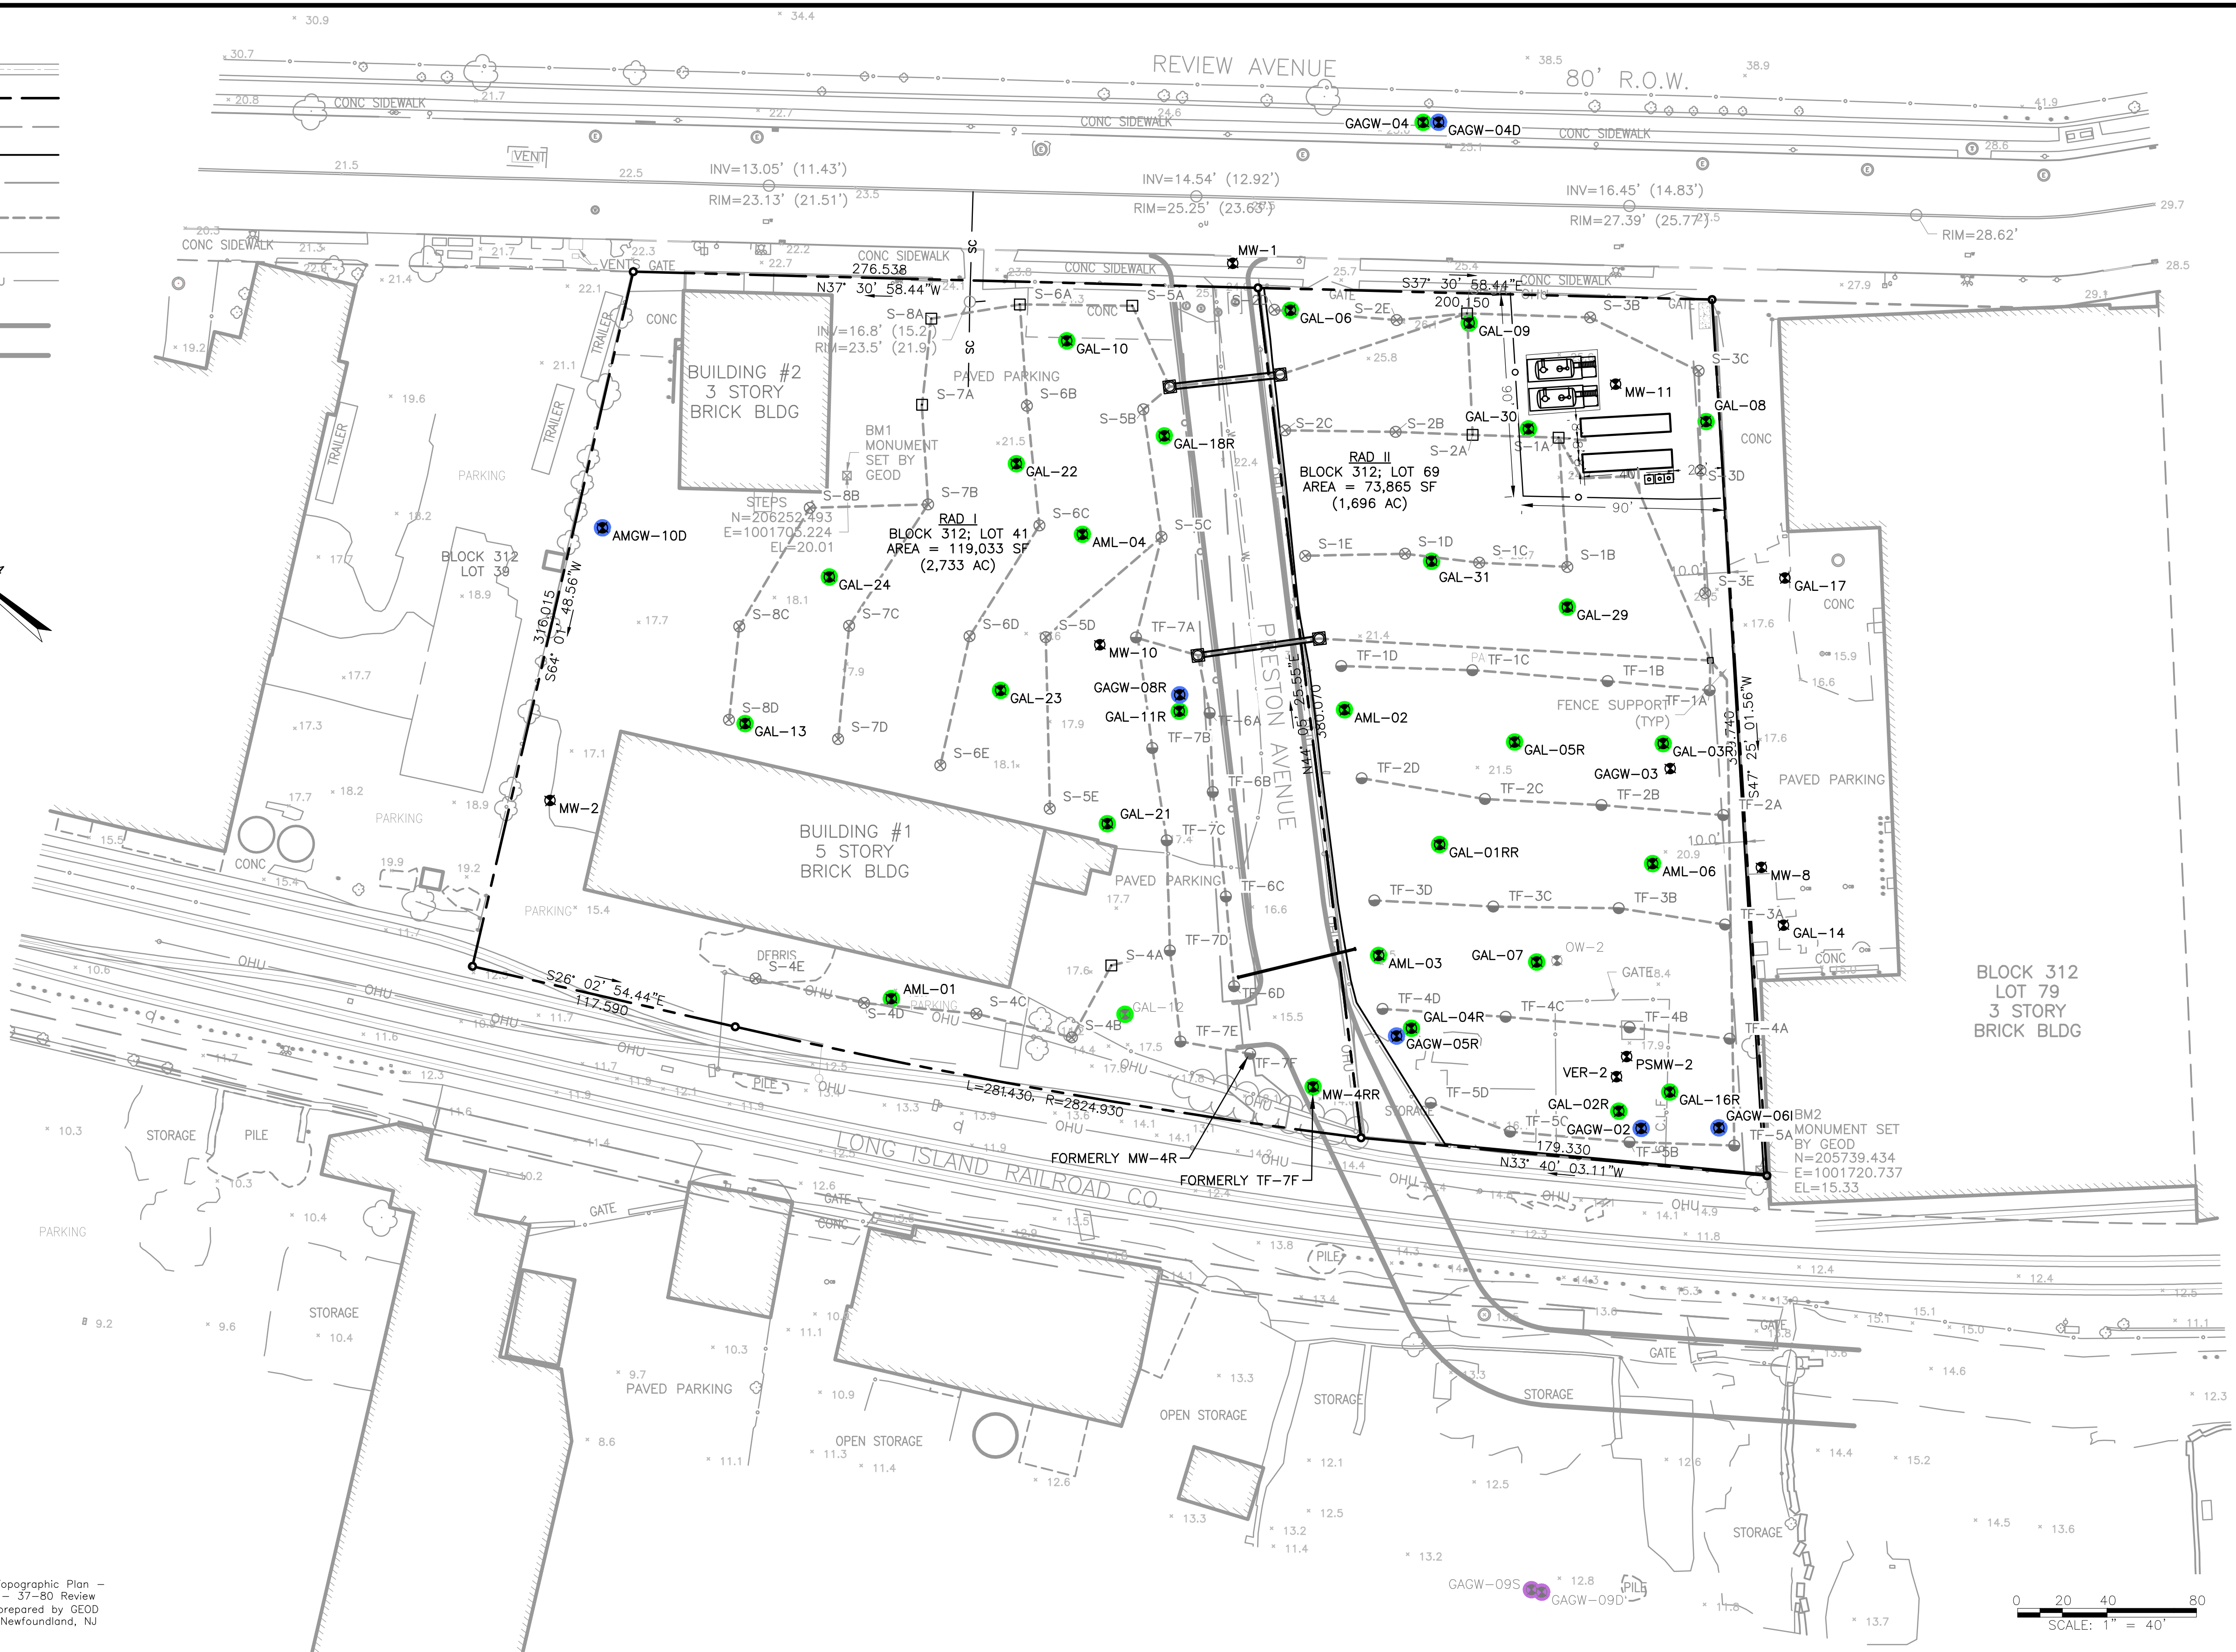
- MONITORING WELL NOTES:**
- 1) Suffixes:
 - Where a well is designated with the suffix "R", that well is a replacement for a previous well at that location.

- Where a well is designated with the suffix "RR", that well is a replacement for a previous replacement well at that location.
 - 2) MW-# are monitoring wells that were installed prior to the Remedial Investigation.
