131-24 AVERY AVENUE
QUEENS COUNTY
FLUSHING, NEW YORK

SITE MANAGEMENT PLAN

NYSDEC Site Number: [C241229]

YU & Associates Engineers, P.C.
200 Riverfront Boulevard
Elmwood Park, NJ 07407
201-791-0075

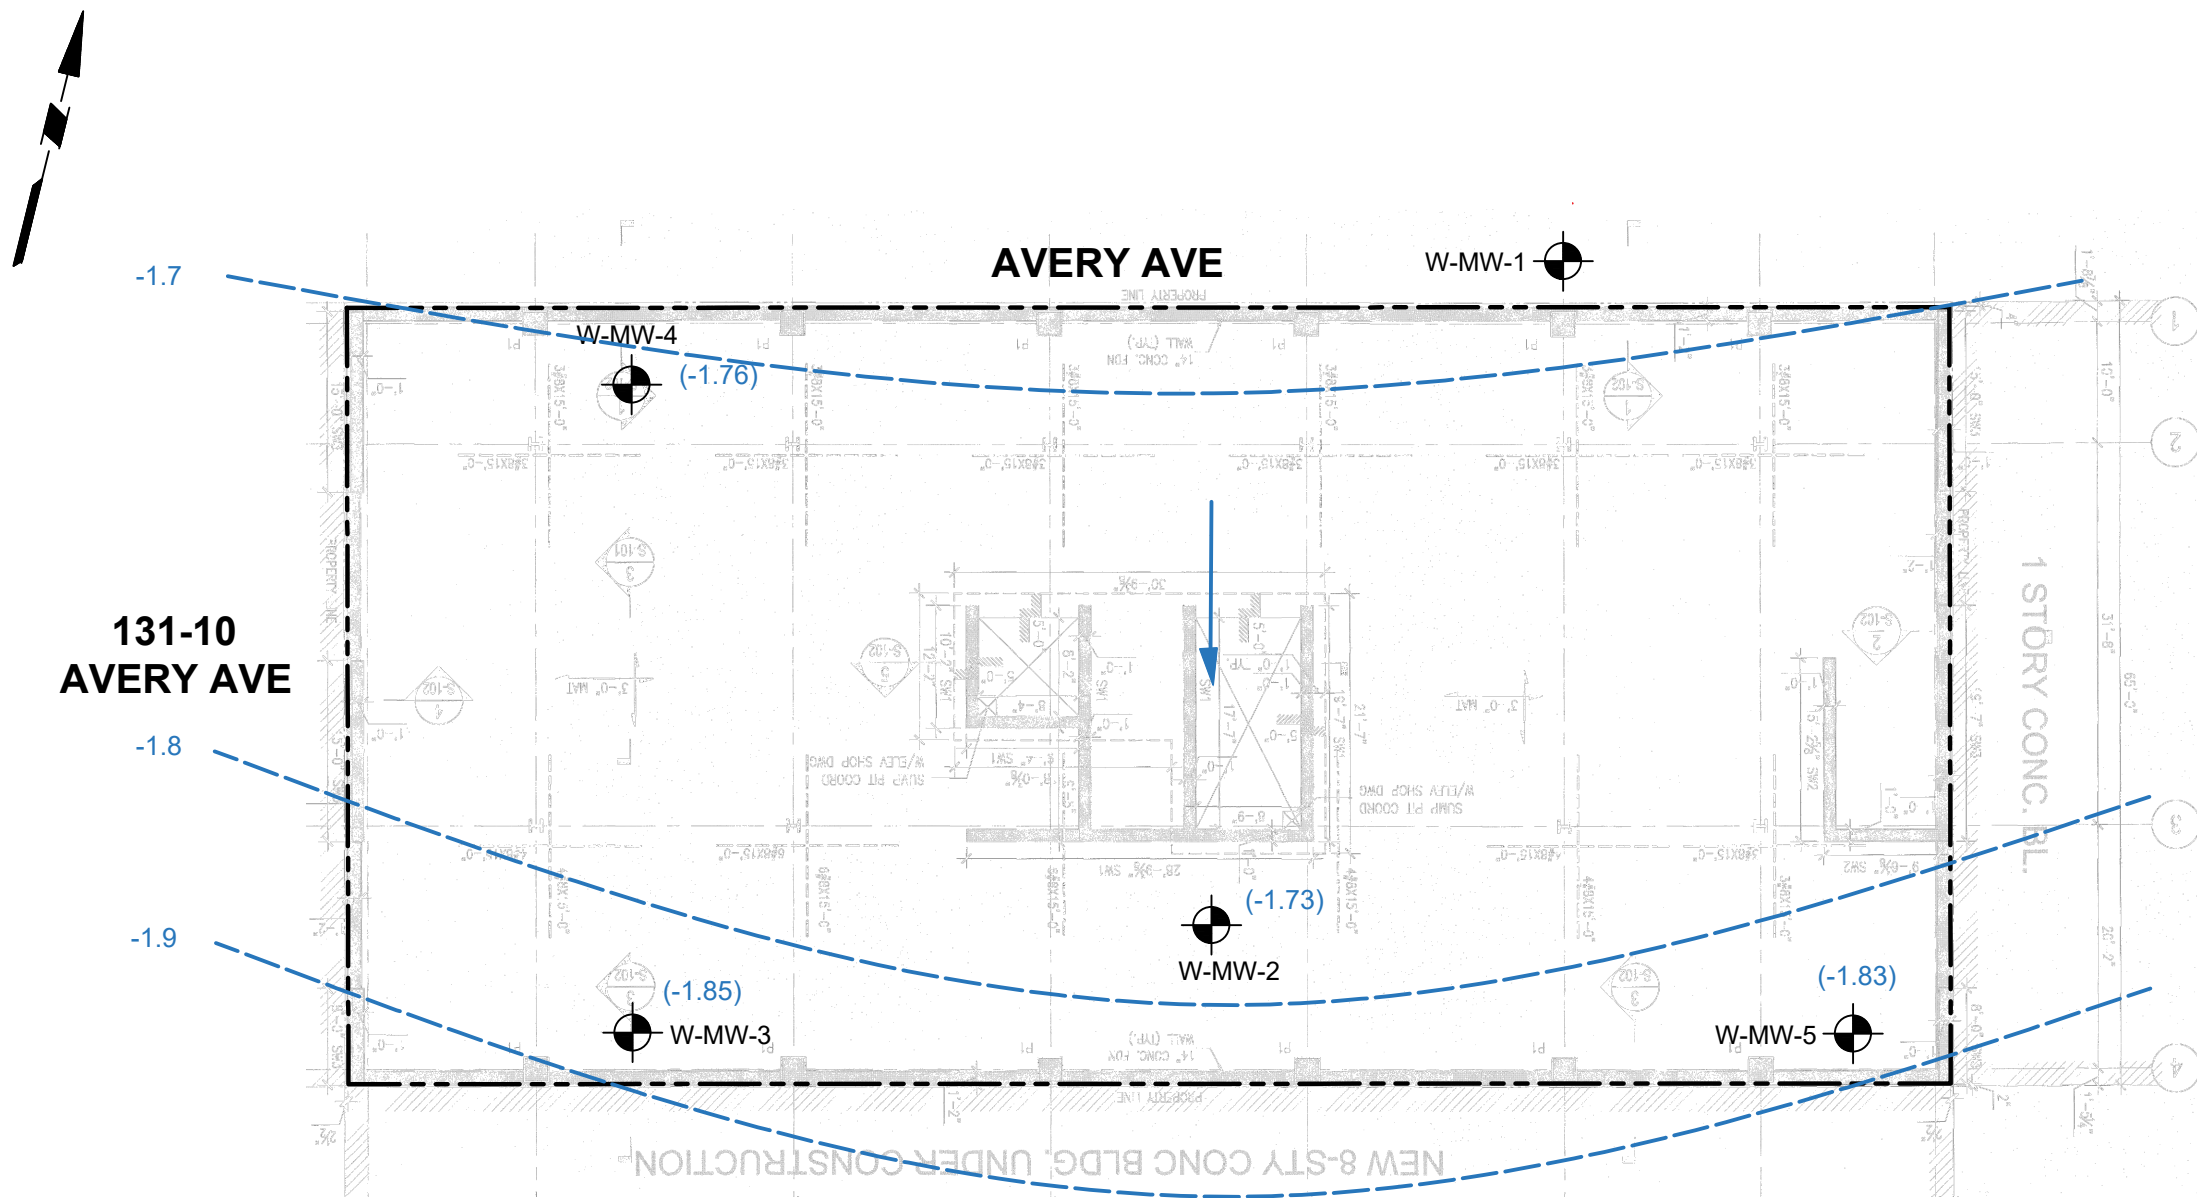
FIG. 4

- AS-BUILT MONITORING WELL LOCATIONS/GROUNDWATER INJECTION LOCATIONS AND DESIGNATION NUMBER
- SITE BOUNDARY
- GROUNDWATER ELEVATION (FEET)
- GROUNDWATER CONTOUR LINE
- GROUNDWATER FLOW DIRECTION

1. THE BASE MAP IS EXTRACTED FROM THE FOUNDATION PLAN FOR 131-22 AVERY AVENUE PREPARED BY TIMES BUILDINGS PC ON MAY 2019.
2. THE ELEVATIONS REFER TO THE NORTH AMERICAN VERTICAL DATUM OF 1988 (NAVD1988).
3. GROUNDWATER ELEVATIONS ARE BASED ON THE GAUGING INFORMATION ON SEPTEMBER 27, 2019.

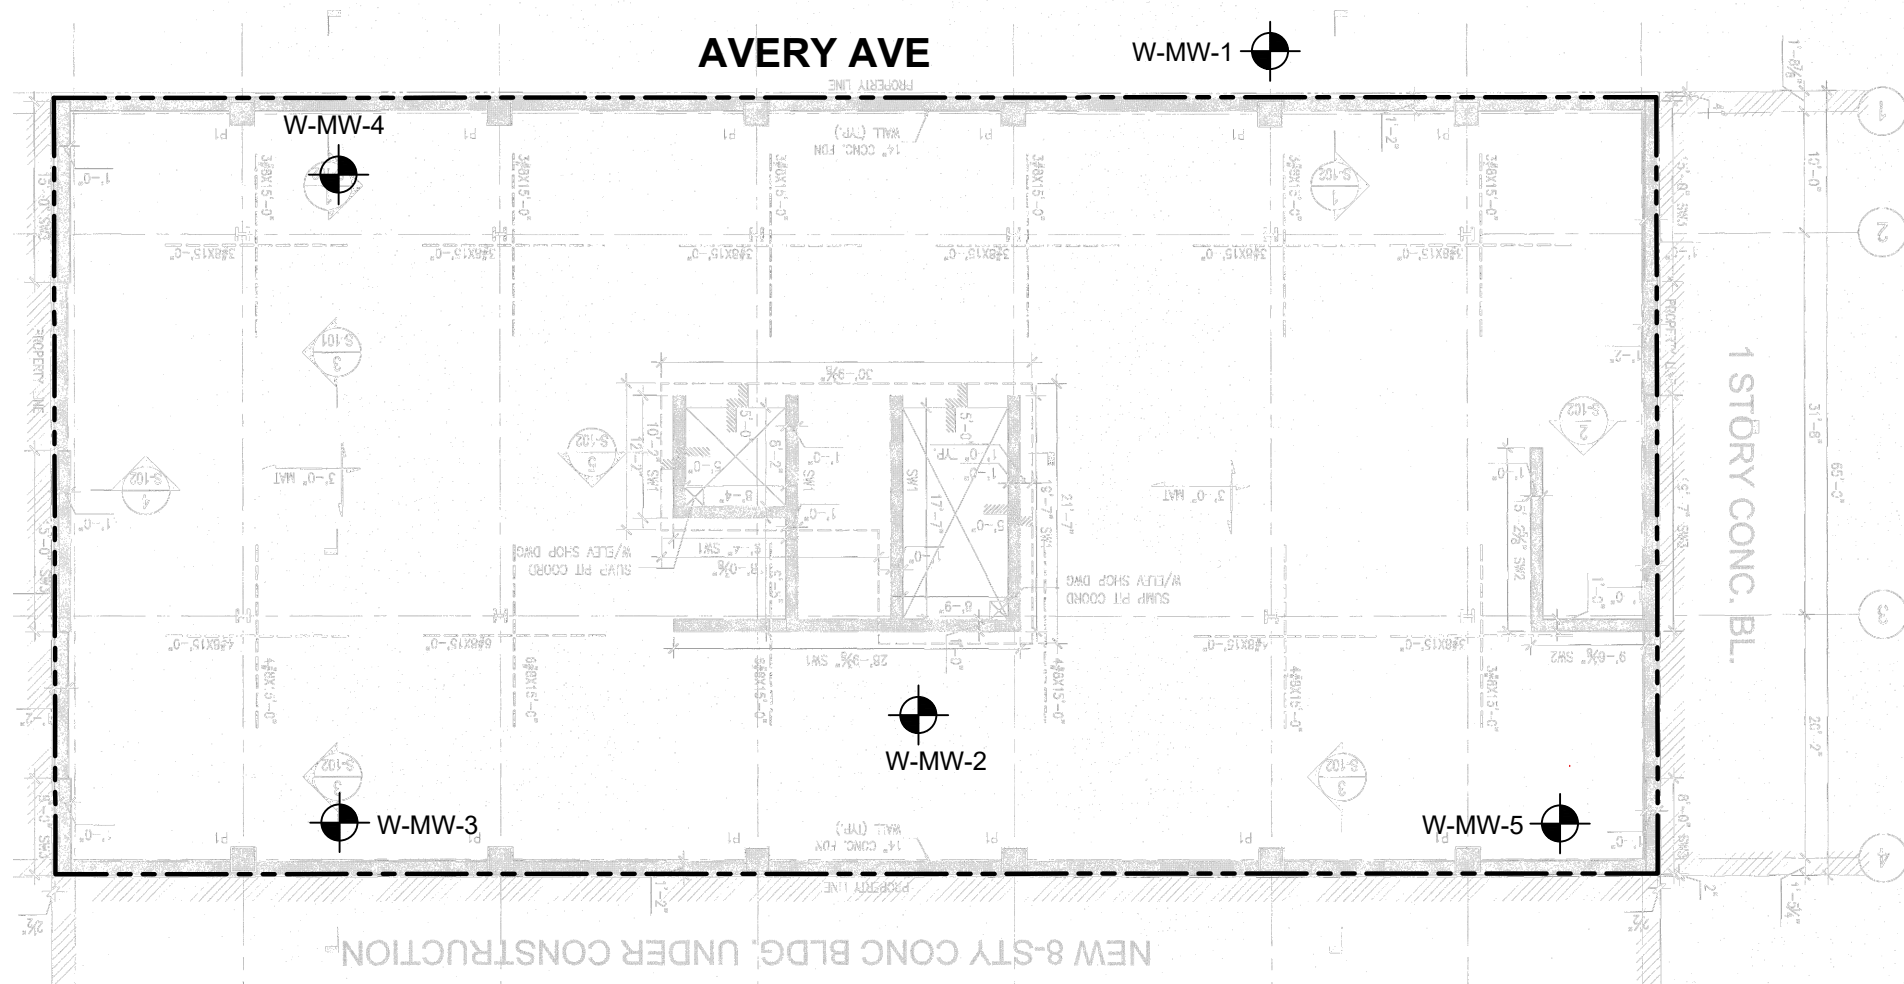
FIG. 7

AS-BUILT MONITORING WELL
LOCATIONS/GROUNDWATER
INJECTION LOCATIONS AND
DESIGNATION NUMBER

Chlorinated VOCs (CVOCs) and PCBs levels in groundwater have been monitored after mixing the ZVI powder into the groundwater and the installation of permeable reactive barriers (PRB) along the perimeters of the Site. A network of five new groundwater monitoring wells are used to monitor up-gradient, on-site, side-gradient, and down-gradient groundwater conditions at the Site. The location of the five monitoring wells is shown in Figure 7. A monitoring plan for groundwater is included in the section 4 of the SMP.

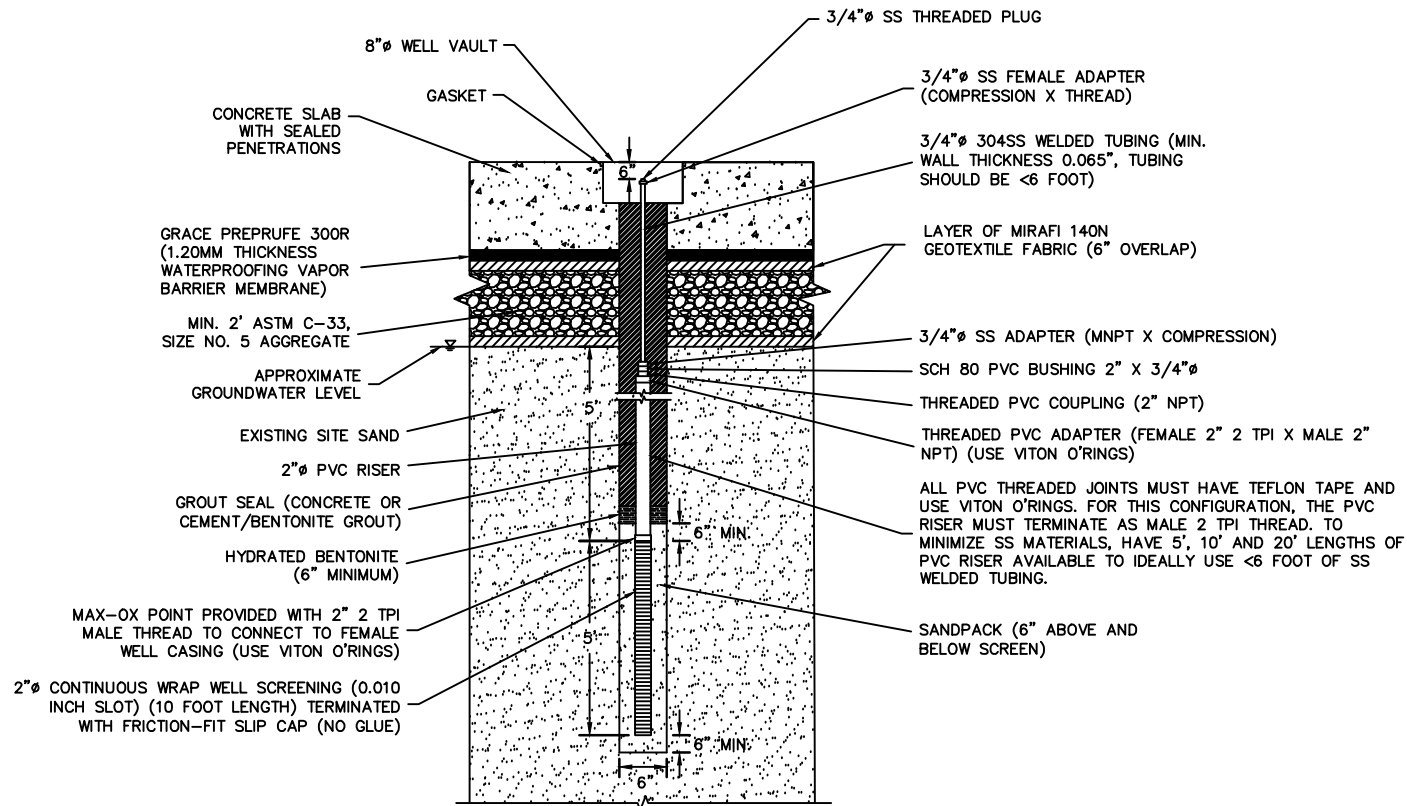
GROUNDWATER MONITORING/INJECTION WELL (N.T.S.)

All monitoring wells are also constructed as injection wells. The construction detail of the monitoring well is shown in Figure 8. Typically, the monitoring/injection well is consisted of a 5-foot long 2-inch continuous wrap well screening, a 5-foot long PVC riser, and a 6-foot long stainless-steel welded tubing. Monitoring well construction logs are included in Appendix D of this document. Monitoring well network is shown in Figure 7. Based on the well gauging data, the groundwater elevation at the Site ranges from el. -1.73 to el. -1.85, and the groundwater flow is generally described as southeastern direction.
