Phase 1 Report: 6819 Woodhaven Blvd., Queens New York

This report presents the findings of a Phase 1 Environmental Site Assessment of 68-19 Woodhaven Blvd., Queens, New York Avenue, **Block 3148– Lot 2.** This report was prepared by Dr. James M. Cervino, QEP, owner of Restoration and Conservation Advisement Group, LLC., for Damien Smith, President of First Standard Construction. This Phase 1 site reconnaissance was performed by Dr. James M. Cervino on May 1, 2019 and again on May 4, 2019. Damien Smith was present during the site reconnaissance and provided site-specific information about the property.

Phase I: Environmental Site Assessment 68-19 Woodhaven Blvd., Rego Park Queens New York Restoration and Conservation Advisement Group, LLC

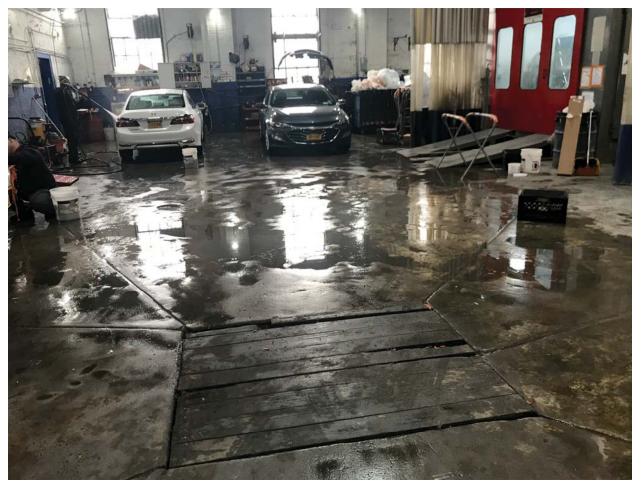
Figure (6)

due to the inability of getting close enough to the foundation walls that can otherwise compromise the adjoining buildings.

The target property, 68-19 Woodhaven Blvd., Rego Park Queens, NY, **Block 3148– Lot 2** is not an E-Designated area – a Phase II must be conducted by an Qualified Environmental Person and Phase 2 Environmental Remediation Report must be provided, which includes and in-depth sampling event of the following locations one See **Figure (7)** below; which indicates indoor and all outdoor suspected AOC locations at all strategic locations within and surrounding the property (**Appendix 7** Site Survey).
