Daily Activity Report					
	Magnolia Gardens					
	39-03 College Point Boulevard, Queens, NY BCP Site No. C241273					
General Site Information						
Date:	Thursday, May 30, 2024					
Weather:	57-72°F, Mostly Sunny					
Wind Direction/Speed (towards):	N @ 10 mph					
AKRF Personnel on Site:	Isabella Legovich					
AKRF Equipment on Site:	Mini RAE 3000 Photoionization Detectors [(PID) x3] and DustTrak Aerosol Monitors (x3)					
Visitors:	None					
Contractor Information						
Subcontractor						
Archstone Builders LLC				General Contractor (GC)		
Capstone Contracting Corp.				Foundation Contractor		
Description and Location of Work Activities Performed						
Excavation and grading occurred in Grids WC-3 and WC-5. As part of the SOE, installed lagging and tiebacks in Grids WC-1 and WC-5. No soil stockpiles were generated.						
Contractor installed rebar in the southwestern portion of the Site as part of the foundation construction.

Soil Waste Classification Grid Plan

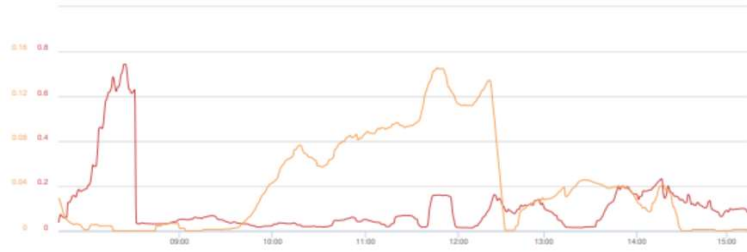
Upwind CAMP Station Data

Maximum Particulate Level (mg/m ³) 15-min avg:	0.7434			0.0660		
CAMP Response Actions: An elevated particulate reading was recorded at the Upwind CAMP Station when a site worker relocated the equipment. The elevated reading was not attributed to the remedial work.						
Additional Information						
Planned Work Activity for Next Day/Week:	Continued SOE work and begin SSDS installation.					
Comments:	None.

Mass Conc. Total mg/m³ AVG 15m <small>mg/m³</small> DustTrak 8530 <small>miniRAE</small>			VOC ppm AVG 15m <small>ppm</small> miniRAE 3000 <small>miniRAE</small>		
MIN	AVG	MAX	MIN	AVG	MAX
0.014	0.1085	0.7434	0	0.0404	0.1455

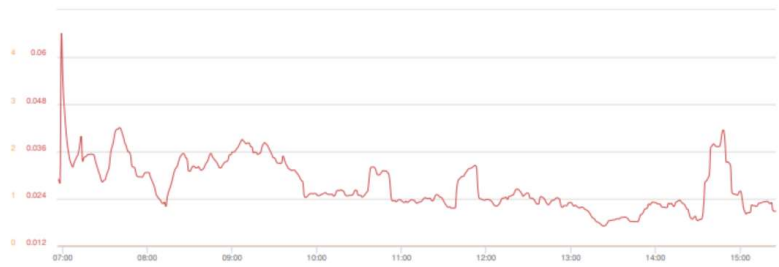
Downwind CAMP Station Data

Mass Conc. Total mg/m³ AVG 15m <small>mg/m³</small> DustTrak 8530 <small>miniRAE</small>			VOC ppm AVG 15m <small>ppm</small> miniRAE 3000 <small>miniRAE</small>		
MIN	AVG	MAX	MIN	AVG	MAX
0.0171	0.0275	0.066	0	0	0

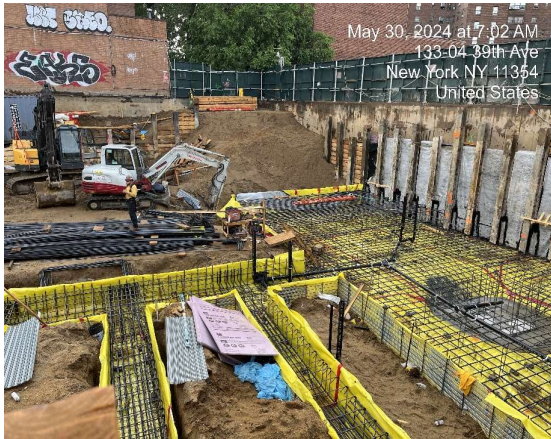
Photograph 2 -
Contractor installed
rebar in the
southwestern portion
of the Site as part of
the foundation
construction.

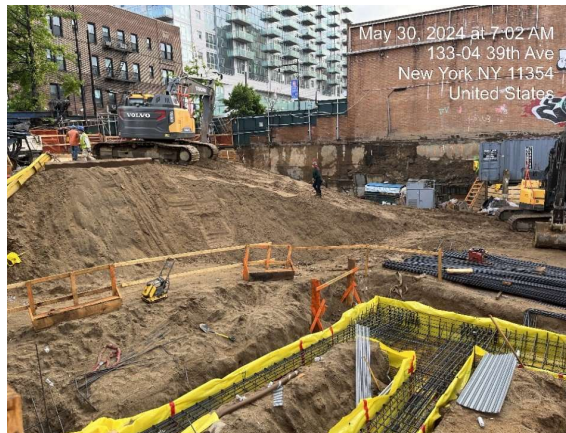
Photograph 3 -
General Site
conditions, facing
north
