**Remedial Investigation Work Plan
Former Belle Cleaners Site
38-40 Purchase Street
Rye, New York
Site Number 3-60-086**

January 2014

**Prepared for Submittal to
The New York State Department of Environmental Conservation**

**CA RICH CONSULTANTS, INC.
17 Dupont Street
Plainview, New York 11803**

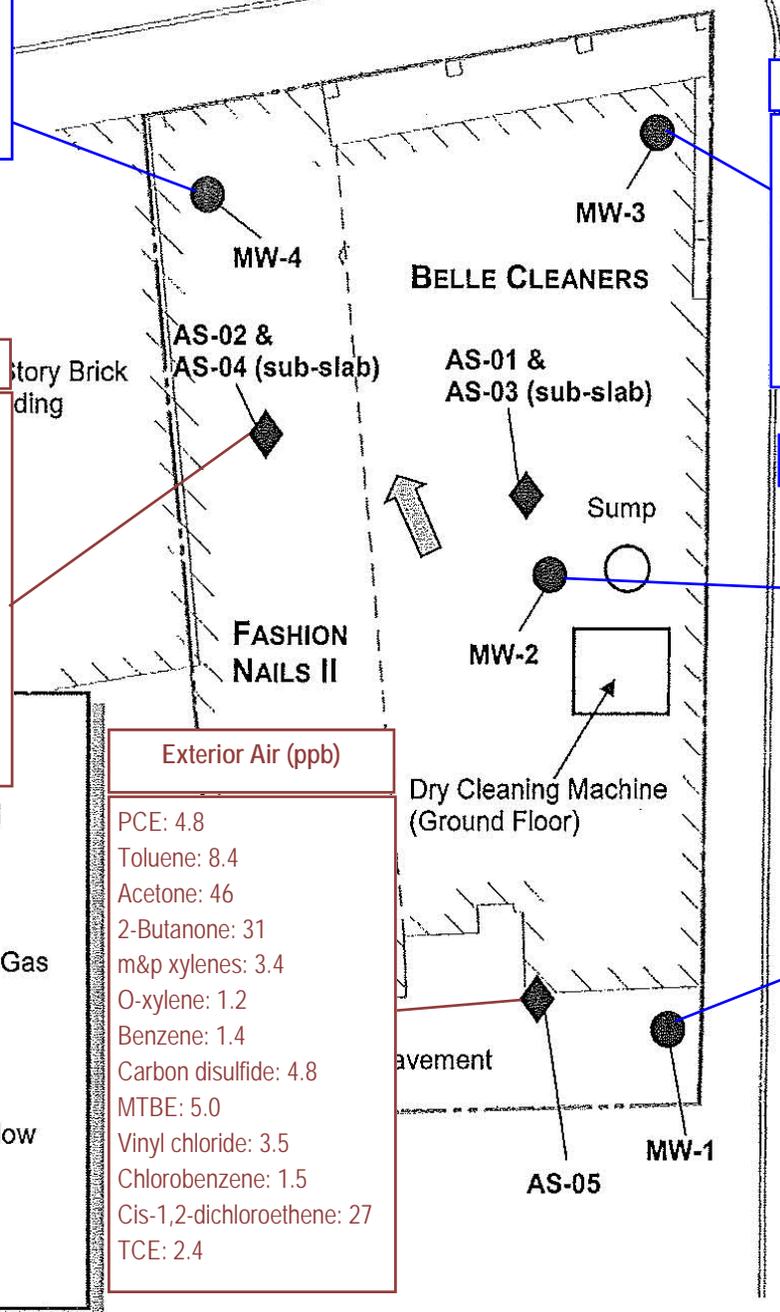
TITLE: Analytical Detections in Sub-Slab Vapor Ambient Air & Groundwater in 2005		DATE: 1/17/14
FIGURE: 3		SCALE: AS SHOWN
DRAWING: Belle Cleaners & Laundry Rye, NY		DRAWN BY: JC
		APPR. BY: RJI

Results of this Phase II investigation indicate the presence of low levels of volatile organic compounds (VOCs) in sub-slab soil gas and groundwater underlying the building at concentrations and an areal extent indicative of residual impacts from low-level historical releases or waste handling practices. No indoor air quality impacts or soil

impacts at or above limitation standards were observed. Analytical detections in sub-slab vapor and ambient air as well as groundwater results in excess of limitation standards are presented on Figure 3. Original soil, vapor/air and groundwater data tables are included in Appendix A.

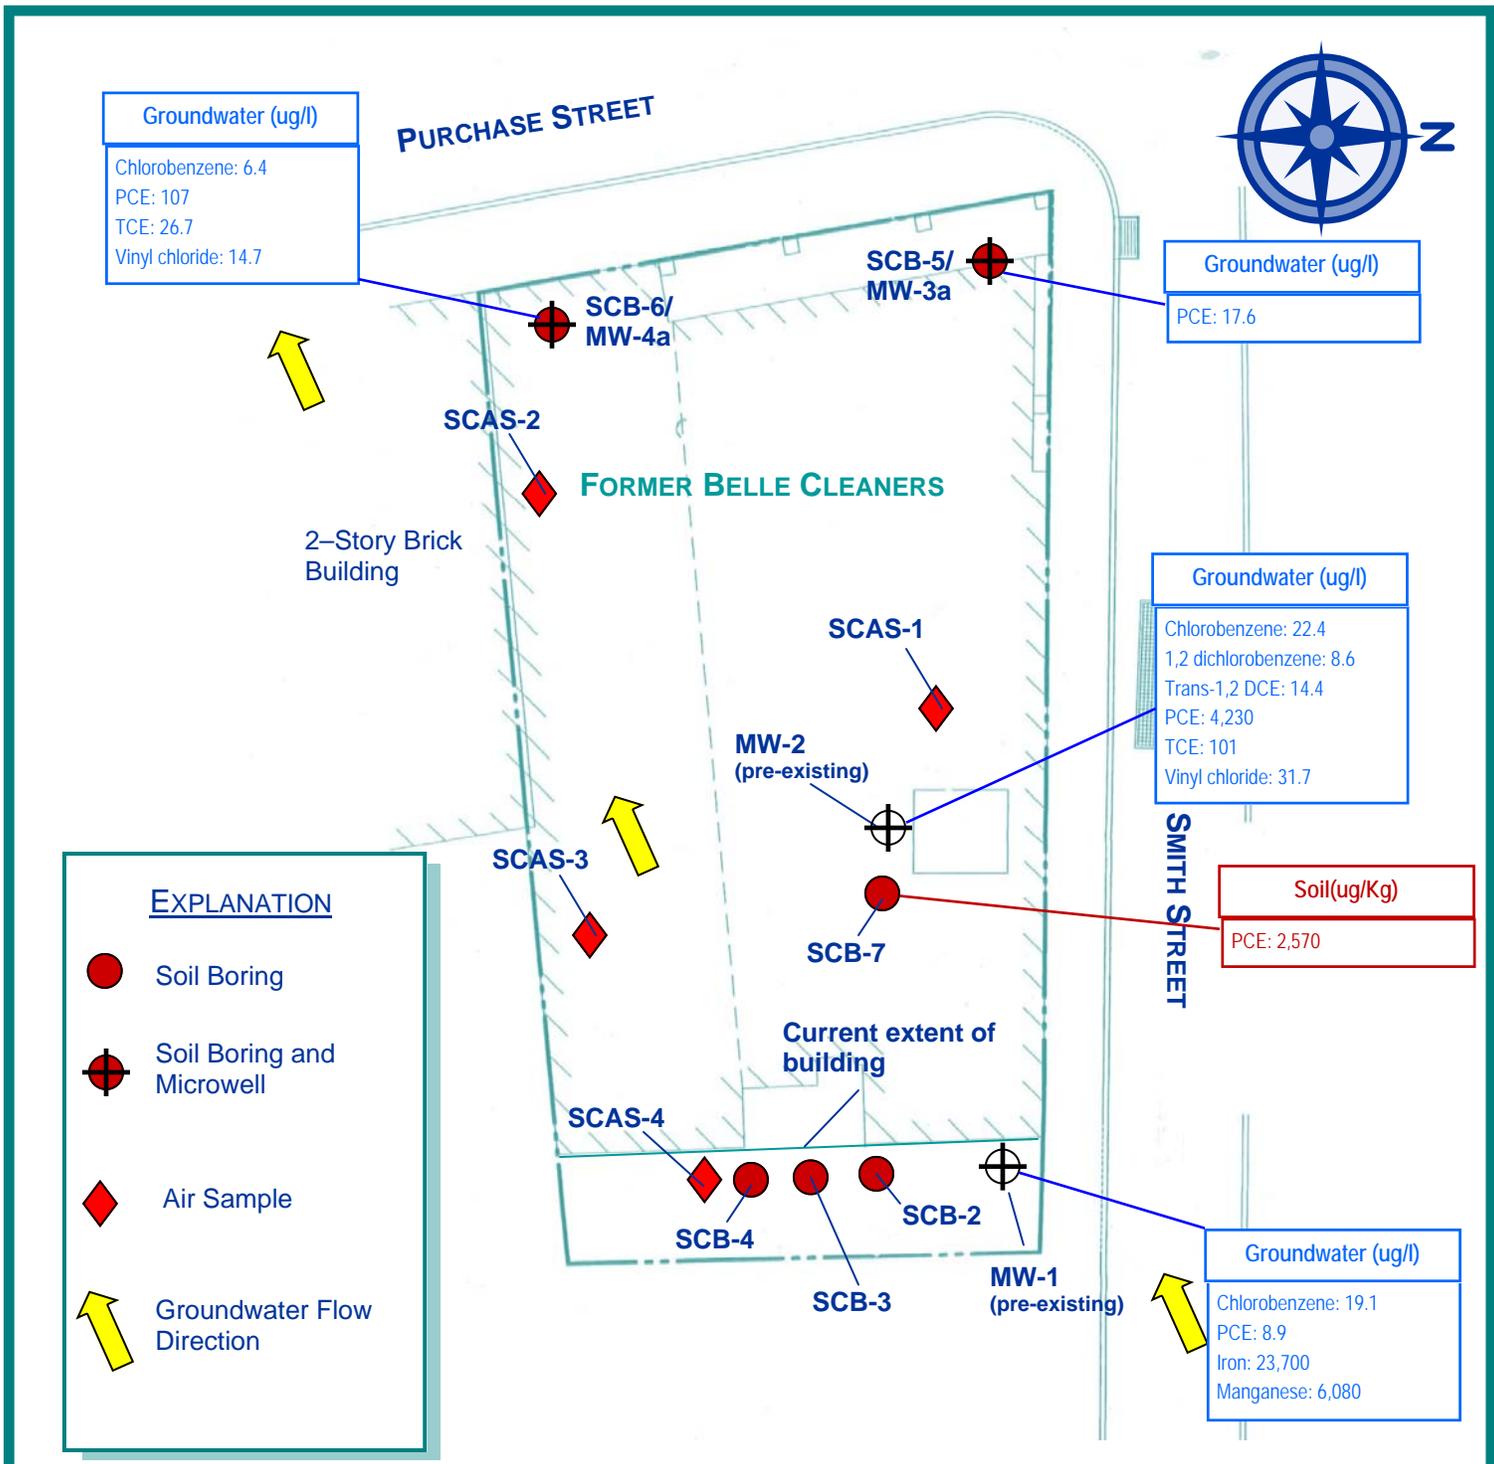
TITLE:		DATE:
Proposed Well/Boring Locations		1/7/14
FIGURE: 5		SCALE:
Former Belle Cleaners 40 Purchase Street Rye, NY		AS SHOWN
DRAWING:	DRAWN BY:	
	JC	
	APPR. BY:	
	RJI

A total of six interior soil borings are proposed for this investigation. The soil borings will be installed using a remote Geoprobe, direct push drilling system. Macro core samples will be collected continuously from immediately beneath the slab surface to the depth at which bedrock is encountered (anticipated to be 6-8 feet below the basement slab). These boring will be installed around and downgradient (presumed) of the soil boring and microwell locations that identified elevated soil/groundwater concentrations of PCE during the 2012 Site Characterization. The proposed boring locations are illustrated on Figure 5.

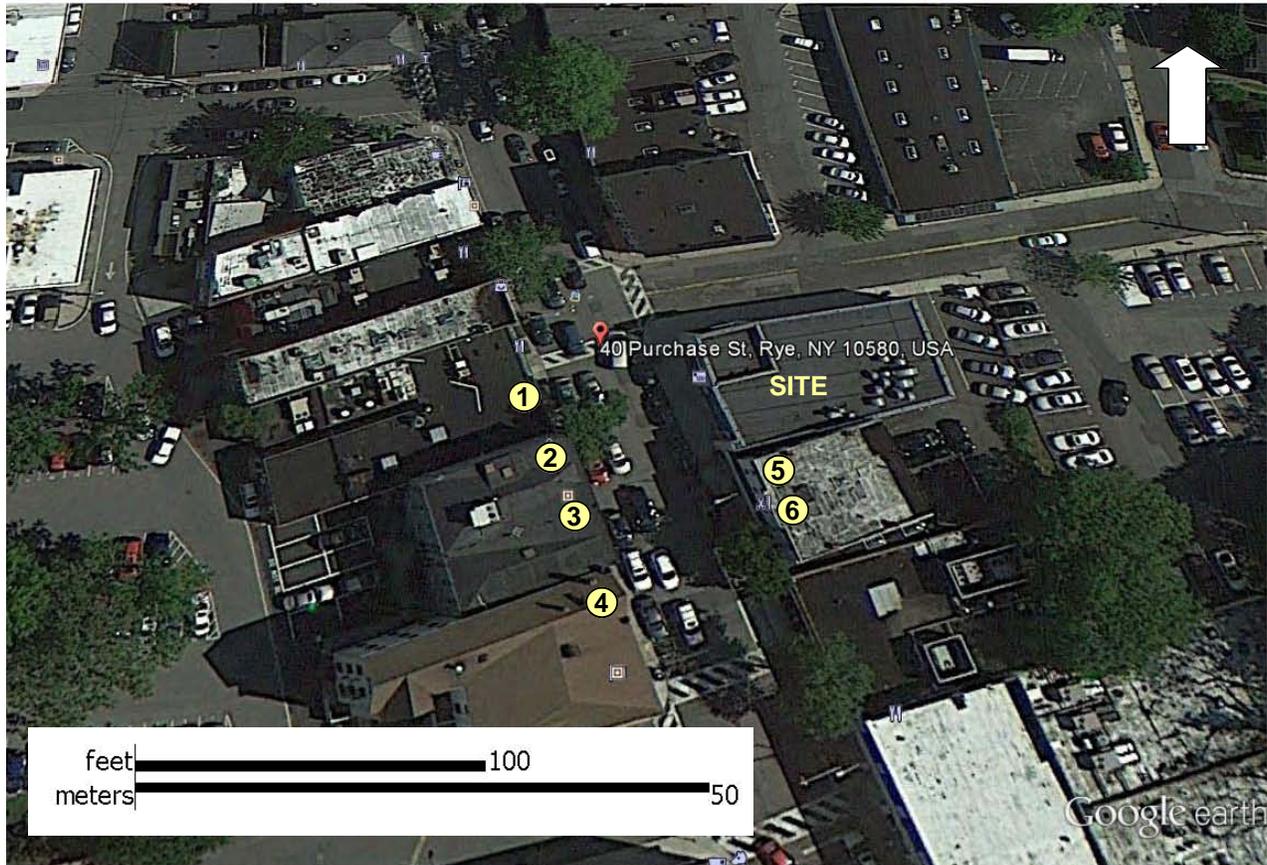
FIGURE 6
Proposed Off-Site Vapor Intrusion Testing Locations
Former Belle Cleaners Site
40 Purchase Street, Rye, NY
January 2014

Vapor intrusion sampling is proposed in and below building foundations for six off-site properties. This includes four properties across Purchase Street from the Site and two immediately adjacent.

One temporary sub-slab soil vapor point will be installed through the basement floor in each of the 6 off-site locations. The soil vapor point will be installed using hand tools and will consist of a 3-inch long stainless steel screen connected to ¼-inch stainless steel tubing extended just below the concrete slab. The annular space around the stainless steel screen will be packed with coarse sand and finished with a bentonite or beeswax seal. Once all six points are installed, CA RICH will return to collect a sub-slab soil vapor sample from each of the newly installed soil vapor points in accordance with NYSDOH's "Guidance for Evaluating Soil Vapor Intrusion in the State of New York" dated October 2006.
