Site Management Plan

**Brownfield Cleanup Program No. C360115
1-5 Holland Avenue
White Plains, NY
14206 / 65459**

DECEMBER 2014
(Updated FEBRUARY 2018)

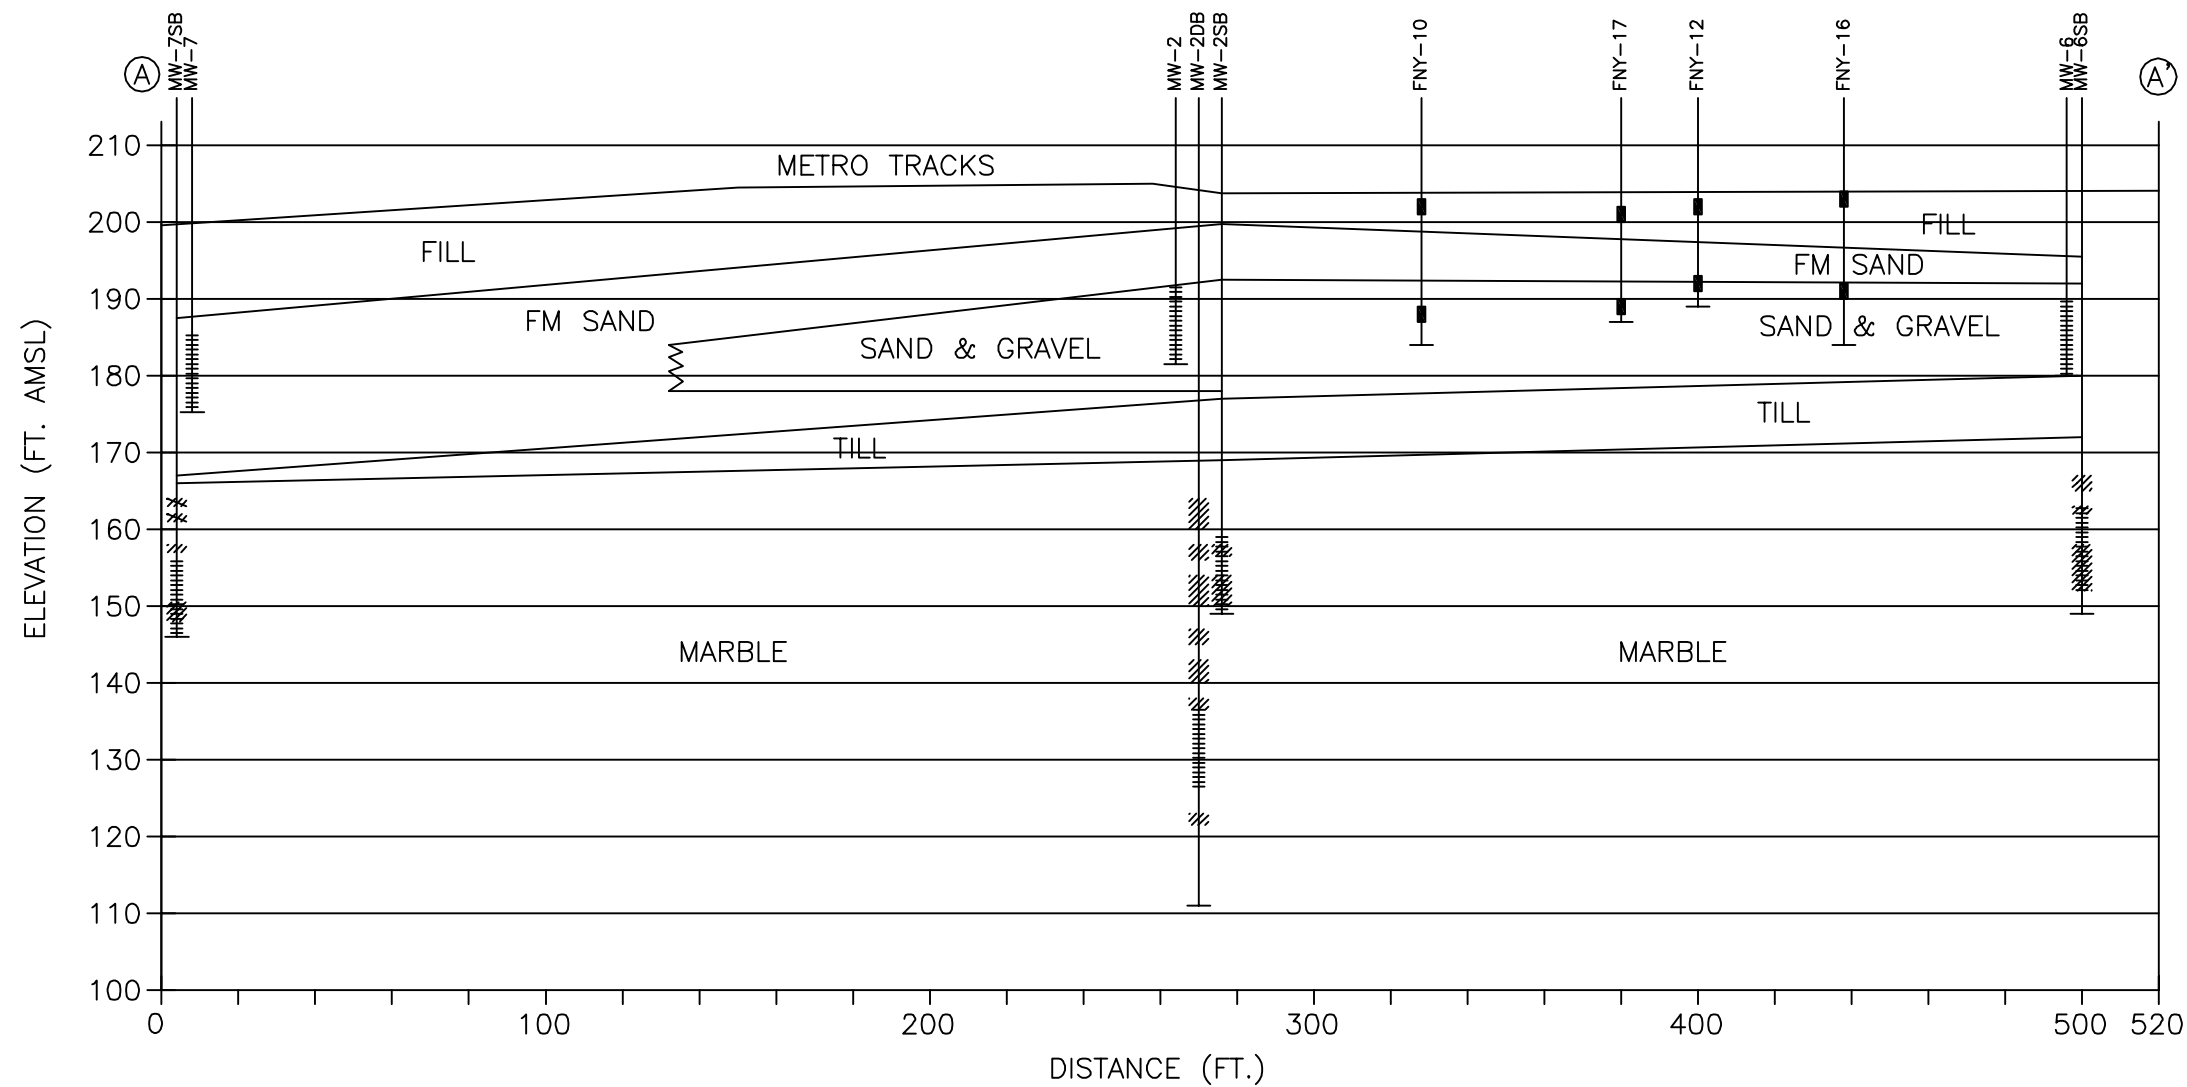
FIGURE 4b

CROSS SECTION
TRANSECT A-A'

The Site is underlain by 0.5 feet to 5 feet of sandy fill followed by a well sorted fine to medium grained sand to a depth between 15 and 17 feet below grade surface (bgs). A poorly sorted sandy-gravel believed to be till is present below this depth. Bedrock (Inwood Marble) is encountered between 20 and 24 feet bgs and is characterized as a calcitic-dolomitic marble with majority of fractures occurring in the upper 10 feet. These fractures act as the principal pathway for horizontal groundwater flow through the bedrock. Bedrock becomes increasingly competent and unfractured with depth. A geologic section location plan is shown in Figure 3. Three geologic sections have been provided in Figures 4a through 4c.

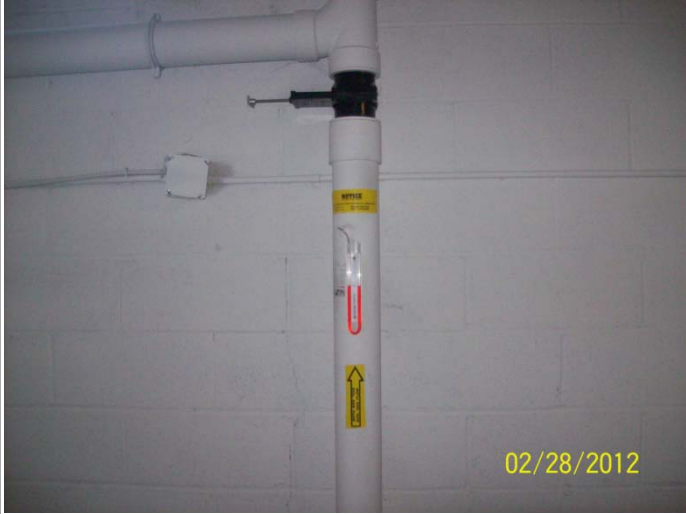
CLIENT NAME: 1-5 Holland Ave.		SITE LOCATION: White Plains, NY	PROJECT NO. 47376
PHOTO NO. 3	DATE: 2/28/12

DESCRIPTION SSP 4B-A, balancing valve and U-tube manometer. U-tube manometer shown indicates System is inoperable.			
AREA ID Interior wall on East side of Building.

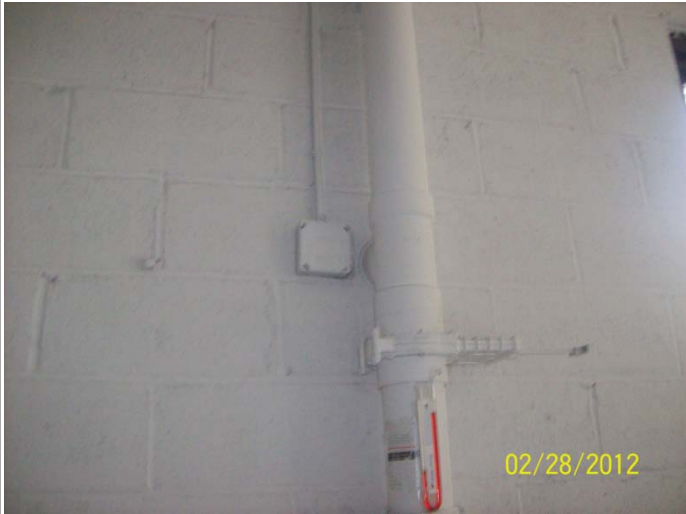
CLIENT NAME: 1-5 Holland Ave.		SITE LOCATION: White Plains, NY	PROJECT NO. 47376
PHOTO NO. 4	DATE: 02/28/12

DESCRIPTION SSP 3B-A, balancing valve and U-tube manometer. U-tube manometer shown indicates System is functioning.			
AREA ID Rear wall on West side of Building.

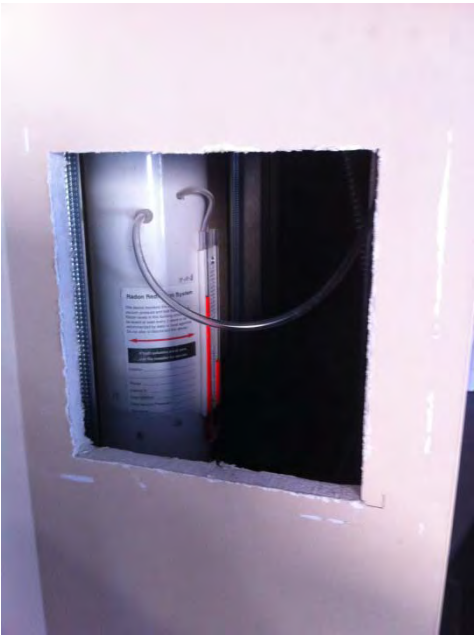
CLIENT NAME: 1-5 Holland Ave.		SITE LOCATION: White Plains, NY	PROJECT NO. 47376
PHOTO NO. 6	DATE: 01/23/14

DESCRIPTION SSP 2A-B behind false wall.			
AREA ID Northwest portion of Building.

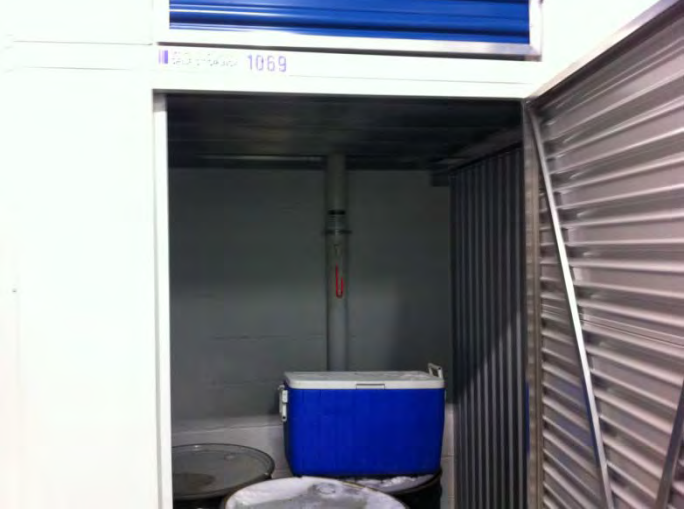
CLIENT NAME: 1-5 Holland Ave.		SITE LOCATION: White Plains, NY	PROJECT NO. 47376
PHOTO NO. 7	DATE: 01/23/14

DESCRIPTION SSP 4B-C located in locker 1069. Horizontal penetration through wall is not visible in this photo.			
AREA ID Interior wall on East side of Building.

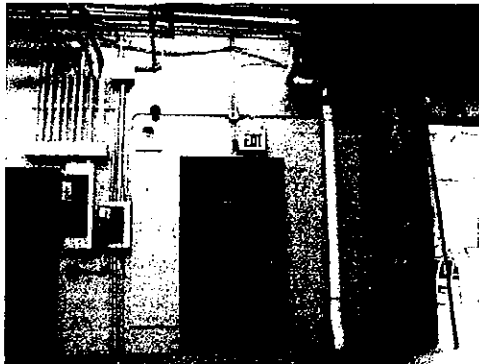
Photo 3 is a view showing a typical valved interior suction point (#4A-B) in Building #4.
