Geophysical Investigation Report

316 Huguenot Street 8 Westchester Place 64 Centre Avenue New Rochelle, NY (AGInc. Job No. 1919577)

September 24th, 2020

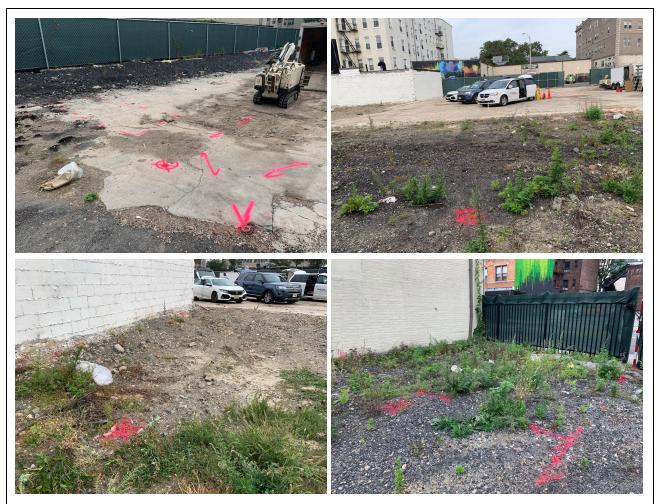
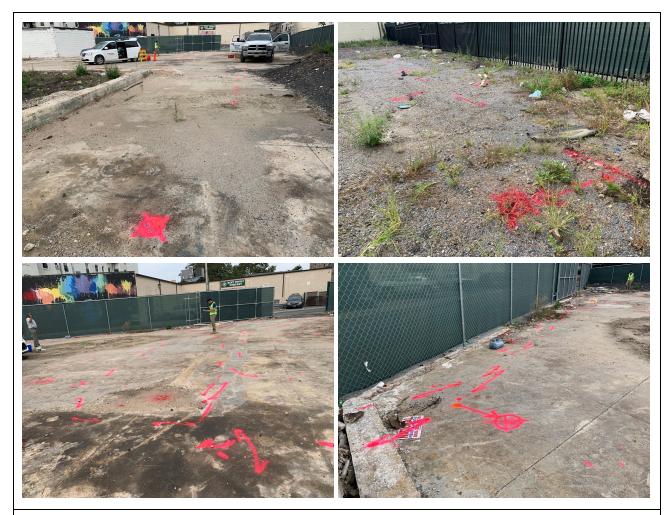
Fig. 1: Images of the areas investigated at 8 Westchester Place, with detected anomalies and utilities in pink paint, and the proposed boring locations marked as circles with an X inside.

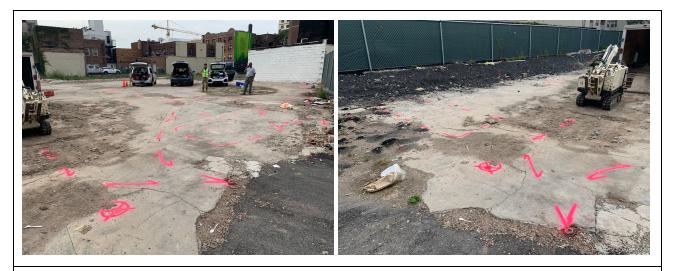
Fig. 2: Images of the detected metallic subsurface anomalies.

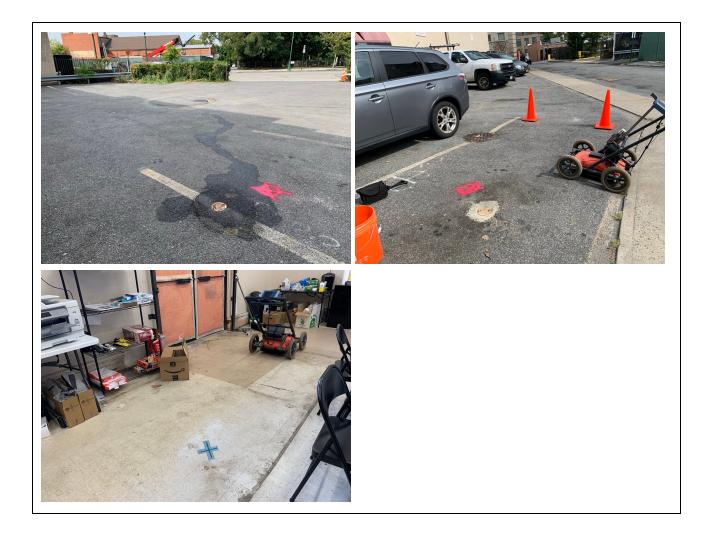
Fig. 3: Images of the areas investigated at 64 Centre Avenue (first picture, store parking lot), 316 Huguenot Street (second picture, store back lot), and the inside location, with detected anomalies and utilities in APWA coded colors.
