Geophysical Investigation Report

**White Plains Mall
200 Hamilton Avenue
White Plains, NY 10601
(AGInc. Job No. 1919933)**

**SESI Consulting Engineers
12A Maple avenue
Pine Brook, NJ 07058**

March 26th and 29th, 2021

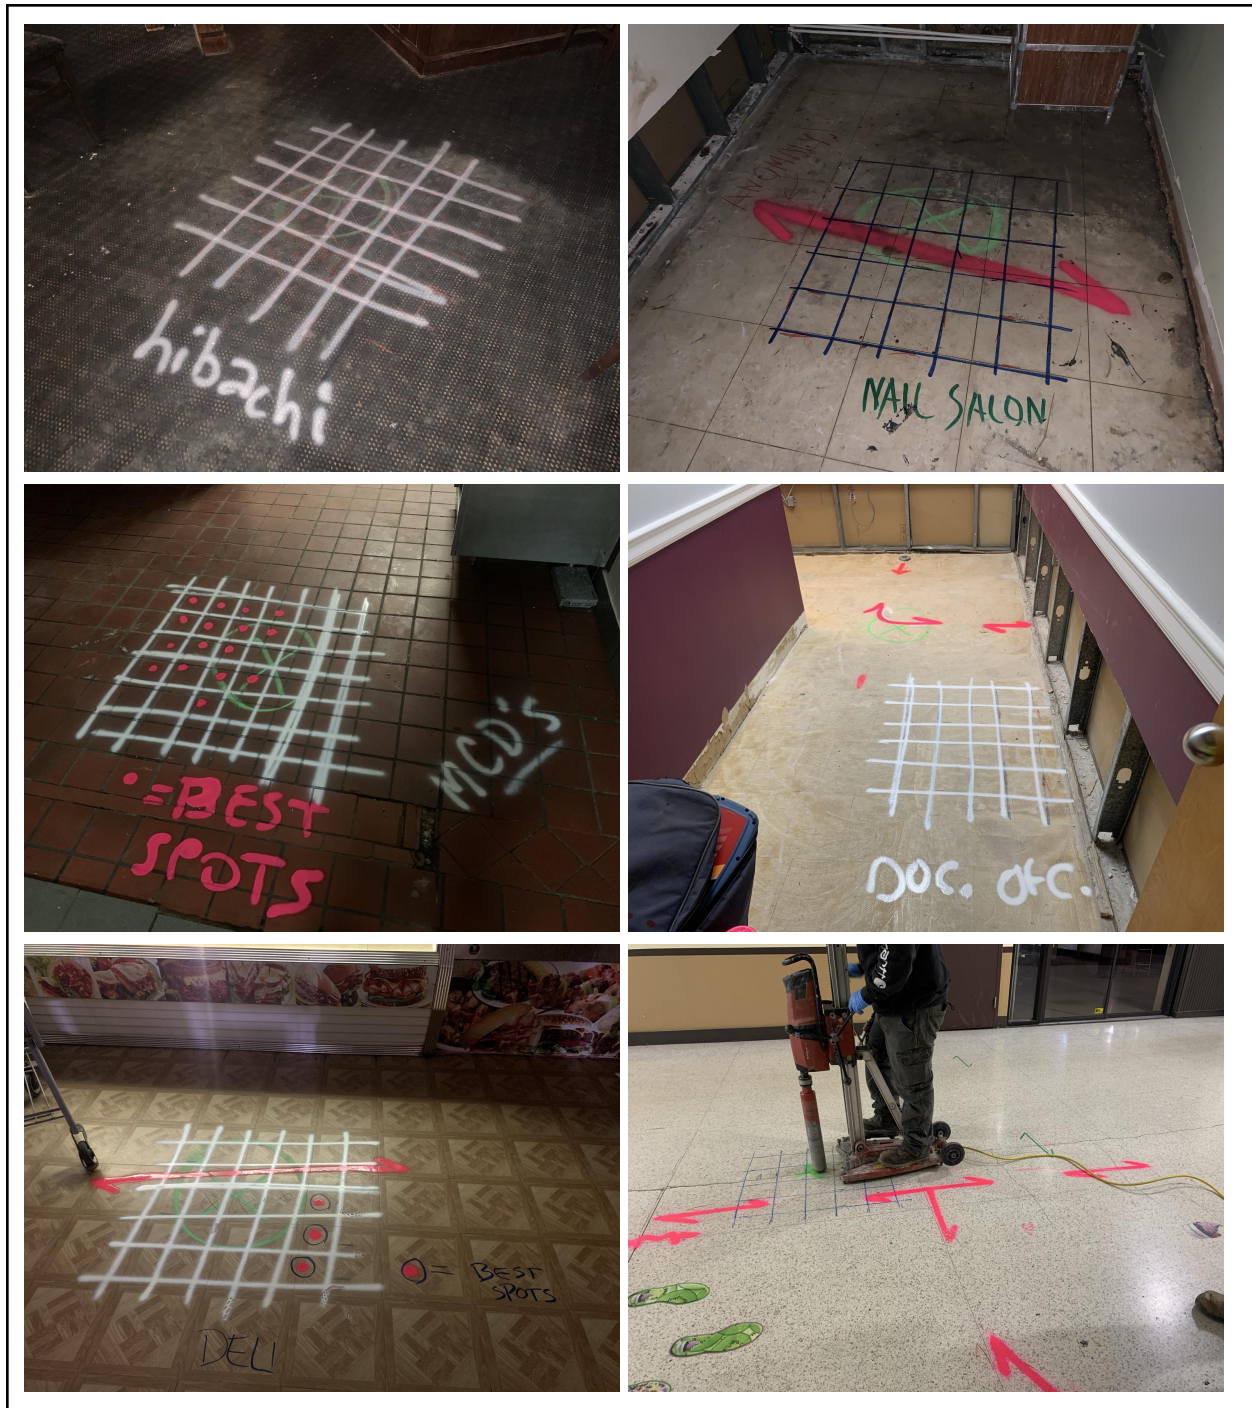
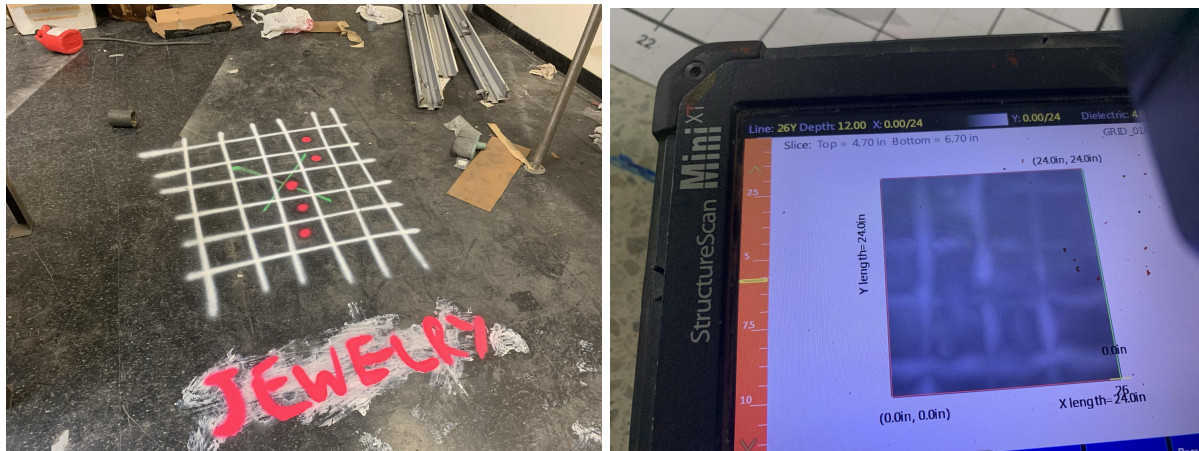
- 1) All detected reinforcement in the concrete was marked with white paint or blue crayon. All detected anomalies in the concrete were marked with pink paint.
- 2) The slab thickness estimated ~ (6-12 inches) and was slab on grade.

Fig. 1: Images of the interior locations investigated.

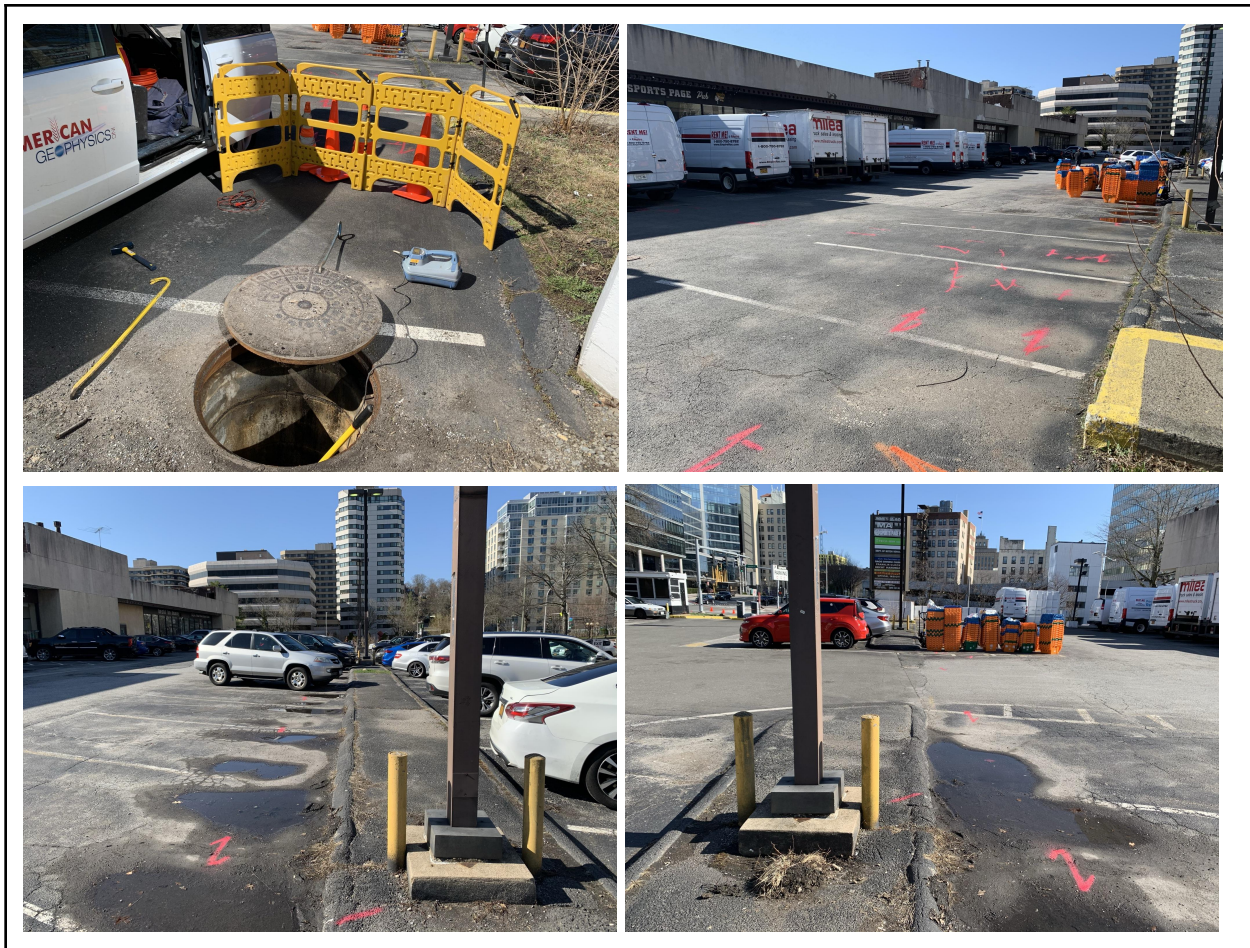
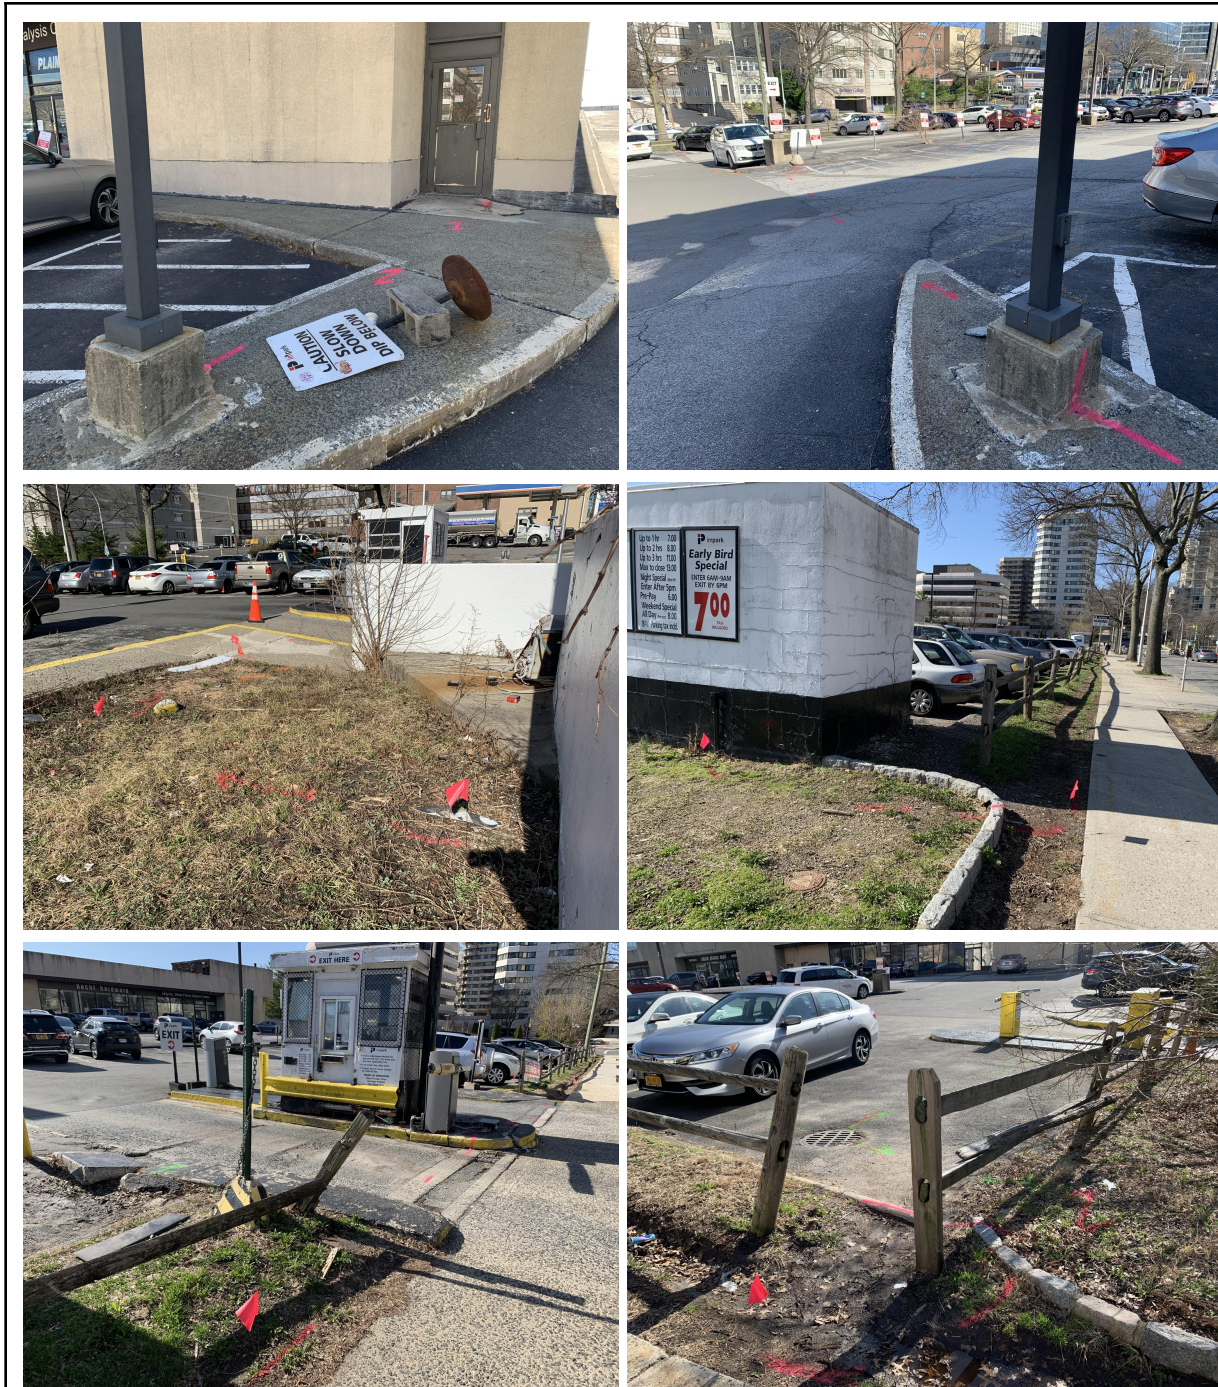
- 3) An electric vault on the south side of the parking lot was opened and induced to. All electric was marked with red paint and flags, at depths ~(2-4ft) below ground surface (BGS).

Fig. 2: Images of the electric detected around the parking lot.

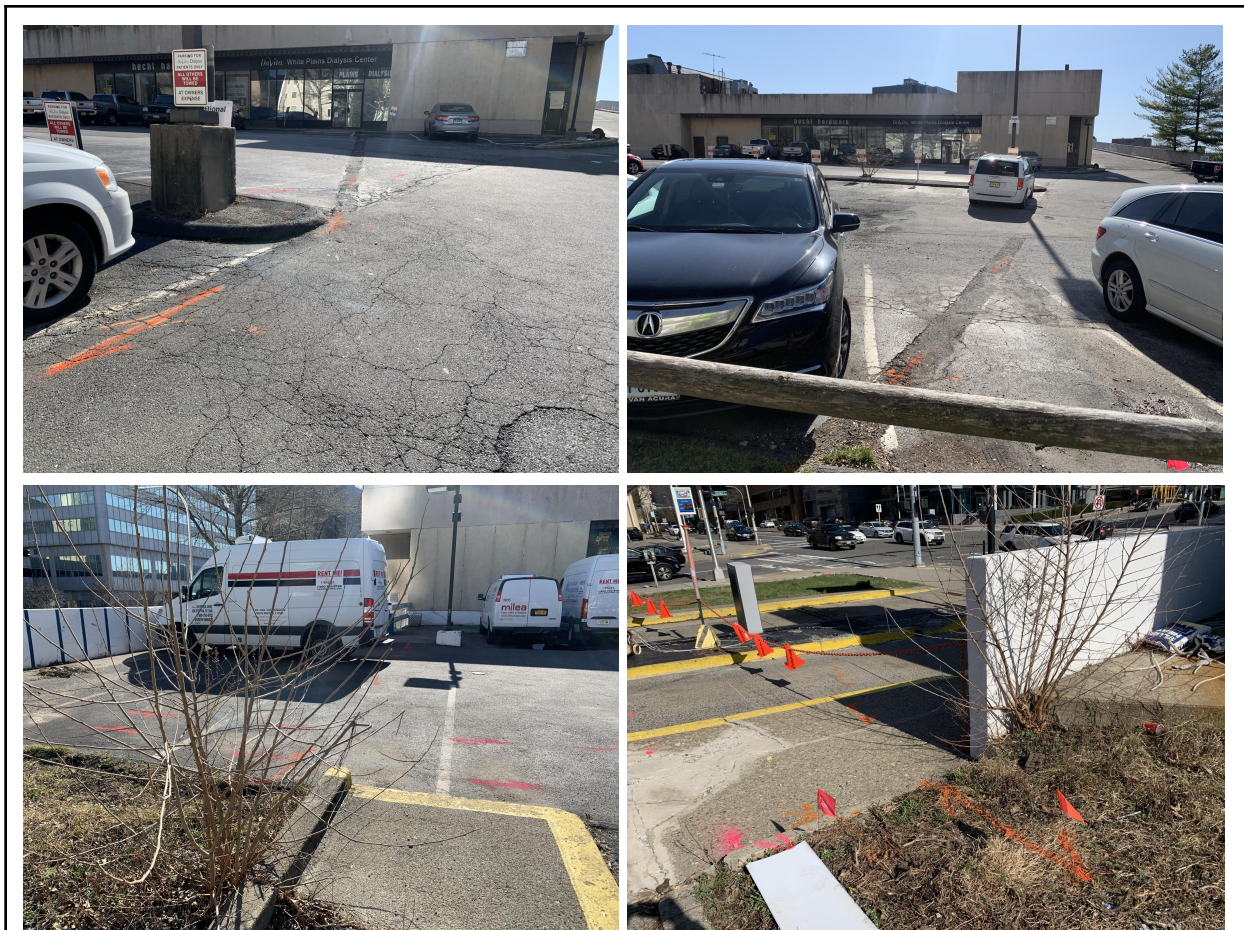
- 4) Two detected communication trenches were detected running east/west from the building to the street, on the south and north sides of the parking lot. They were marked with orange paint and flags.

Fig. 3: Images of the two communications trenches detected.

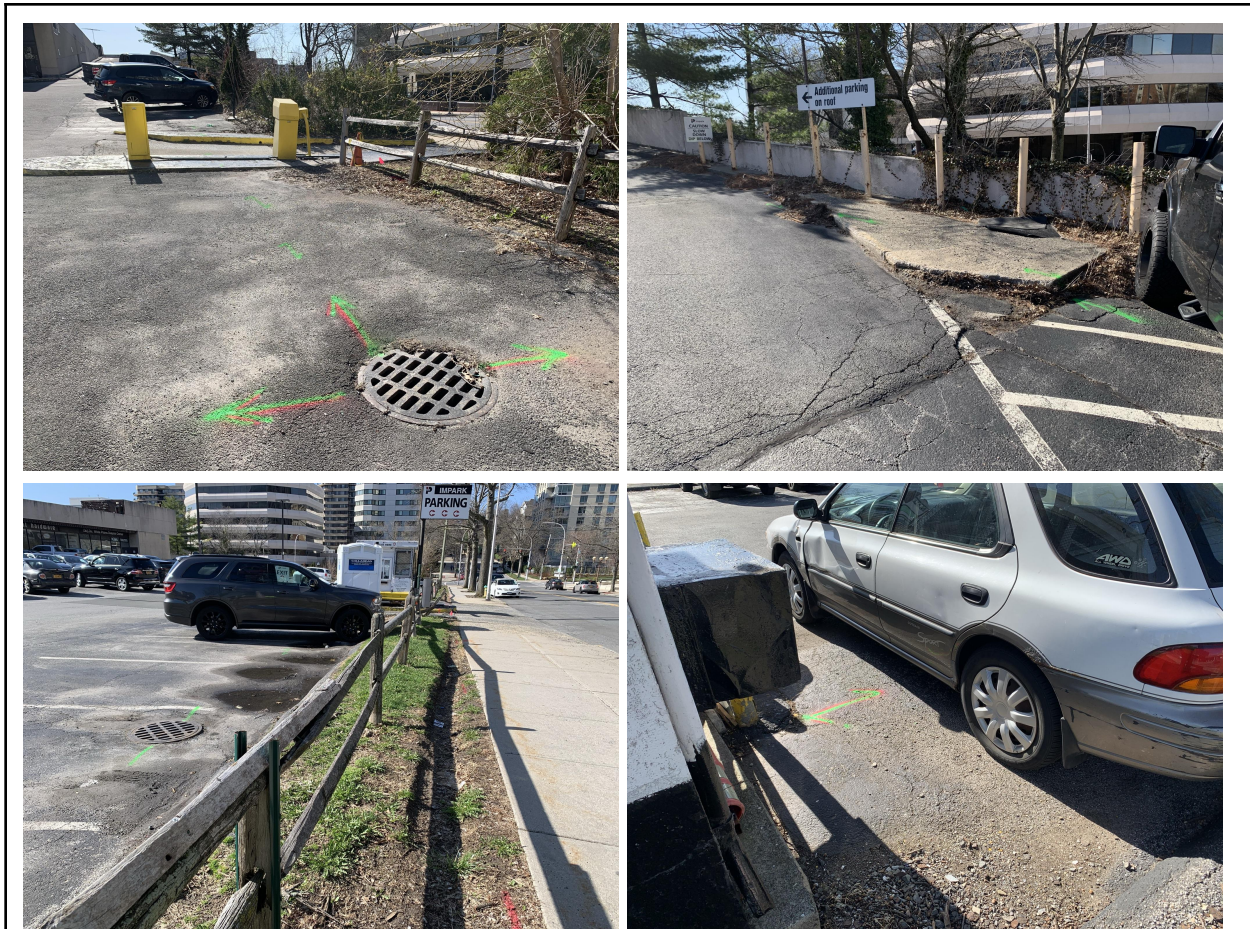
- 5) Storm sewer was detected running parallel to the street along the inside curb of the parking lot. This was marked with green paint.
- 6) An electrical conduit was detected running through the grocery area of the mall at an estimated depth of 6" BGS. This conduit was marked in red paint

Fig. 4: Images of the storm sewer investigated/detected.
