**REMEDIAL INVESTIGATION**

**WORK PLAN**

**Parcel A of the**  
**ALCO-Maxon Site**  
(Formerly a.k.a. Nott Street Industrial Park)

May 24, 2010

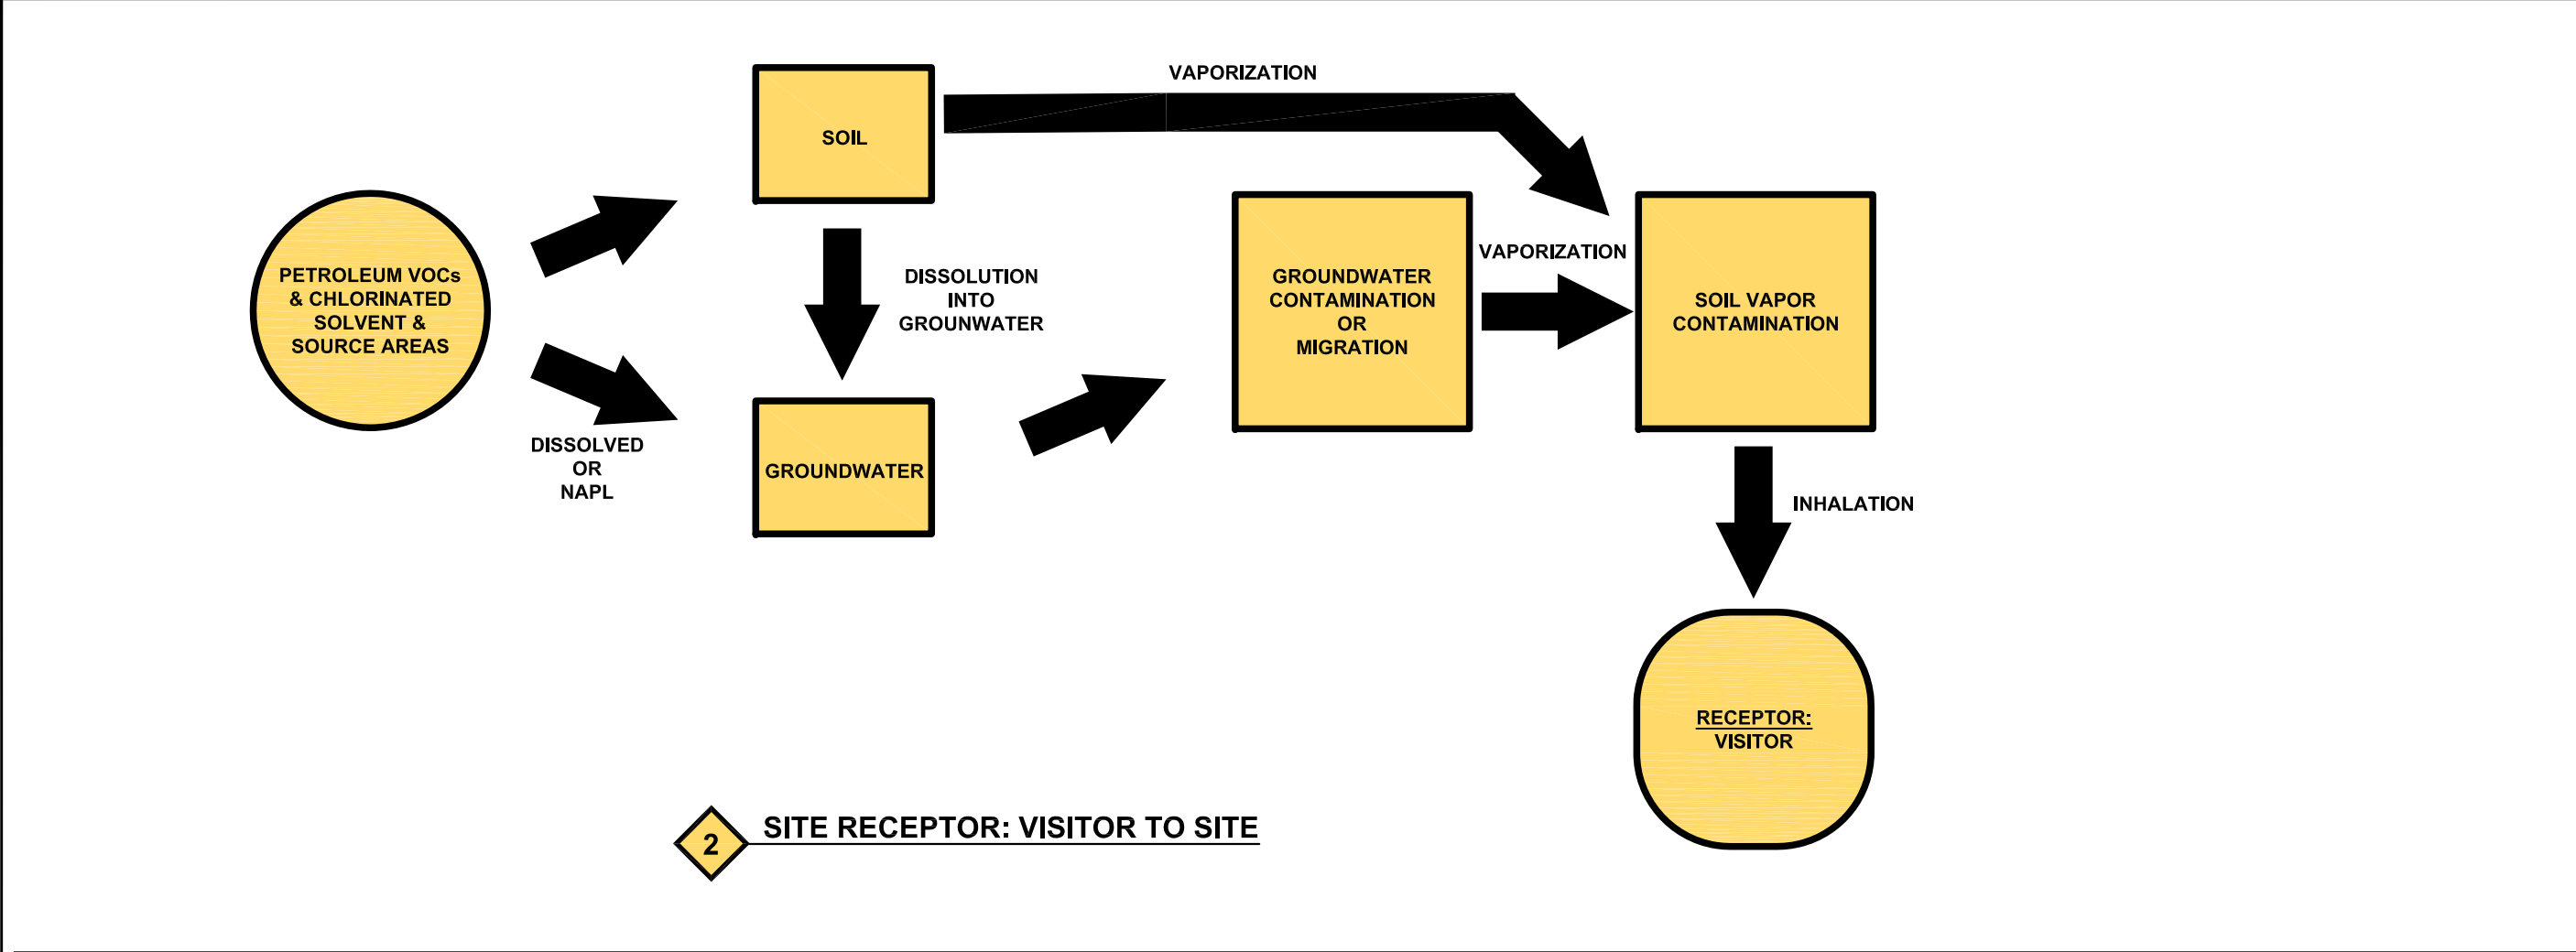
**CONCEPTUAL SITE MODEL**

**On-Site Buildings (to be demolished)**  
Buildings presumably currently contain:  
-Asbestos containing materials  
-Lead based paint  
-Universal waste  
-Mercury switches  
-Polychlorinated biphenyls in lighting ballasts

**Building ID's and current usages**  
336 - General office/commercial space and small materials laboratory  
304 - Owned by STS Steel  
306 - Occupied by various commercial firms (HVAC company, composite materials fabricator)  
308 - Unoccupied  
316 - Temporary storage facility/unoccupied  
318 - Occupied by inactive industrial waste water equipment  
320 - Storage for landscaping equipment and vehicles/unoccupied  
322 - Unoccupied  
324 - Storage of furniture/unoccupied  
332/334 - Used by STS Steel; building and roofing material storage  
336 - Former pump house for paint thinner  
338 - Gas meter house  
340 - Unoccupied  
342 - General but incomplete decommissioning in process  
344 - Occupied by a landscape company  
346 - Occupied by Dimension Fabricators to prepare pre-fabricated re-bar structures

- AREAS 1, 2 - AREAS ORIGINALLY DEFINED AS PETROLEUM IMPACTED
- AREAS 3, 4, 5 - AREAS SUSPECTED OF FUEL-OIL IMPACTS
- AREA 6 - AREA SUSPECTED OF CHLORINATED SOLVENT IMPACT
- BUILDINGS/STRUCTURES
- EVI PARCEL
- SUSPECTED LNAPL LOCATION
- "RPI" PARCEL
- OTHER PROPERTIES NO PART OF SITE
- REMEDATION AREA
- FORMER UST/AST LOCATIONS

A review of the pertinent environmental data pertaining to this site led to the development of a Conceptual Site Model (CSM, Plate 3, described in the next section) which addresses known source areas and current data gaps. The CSM also includes a tabulation of Recognized Environmental Conditions at the Site. The REC table identifies a variety of data gaps, which are to be filled through the completion of the investigation proposed herein. The AOCs and RECs pertaining to Parcel A are listed below. For details of AOCs and RECs, which were identified in reports for the entire former ALCO site, see Appendix A.

Using the available data and information, KLF prepared a CSM. The purpose of conceptual models is to provide a clear spatial understanding of the Site and immediate area to aid the identification of actual or potential contaminant sources, to present the current understanding of potential environmental transport pathways, to help in the identification of possible human and ecological receptors of hazardous substances, and insight into possible complete routes of exposure. Plate 3 presents the CSM for the Site and shows:
