**REMEDIAL INVESTIGATION**

**WORK PLAN**

**Parcel B of the**

**ALCO-Maxon Site**

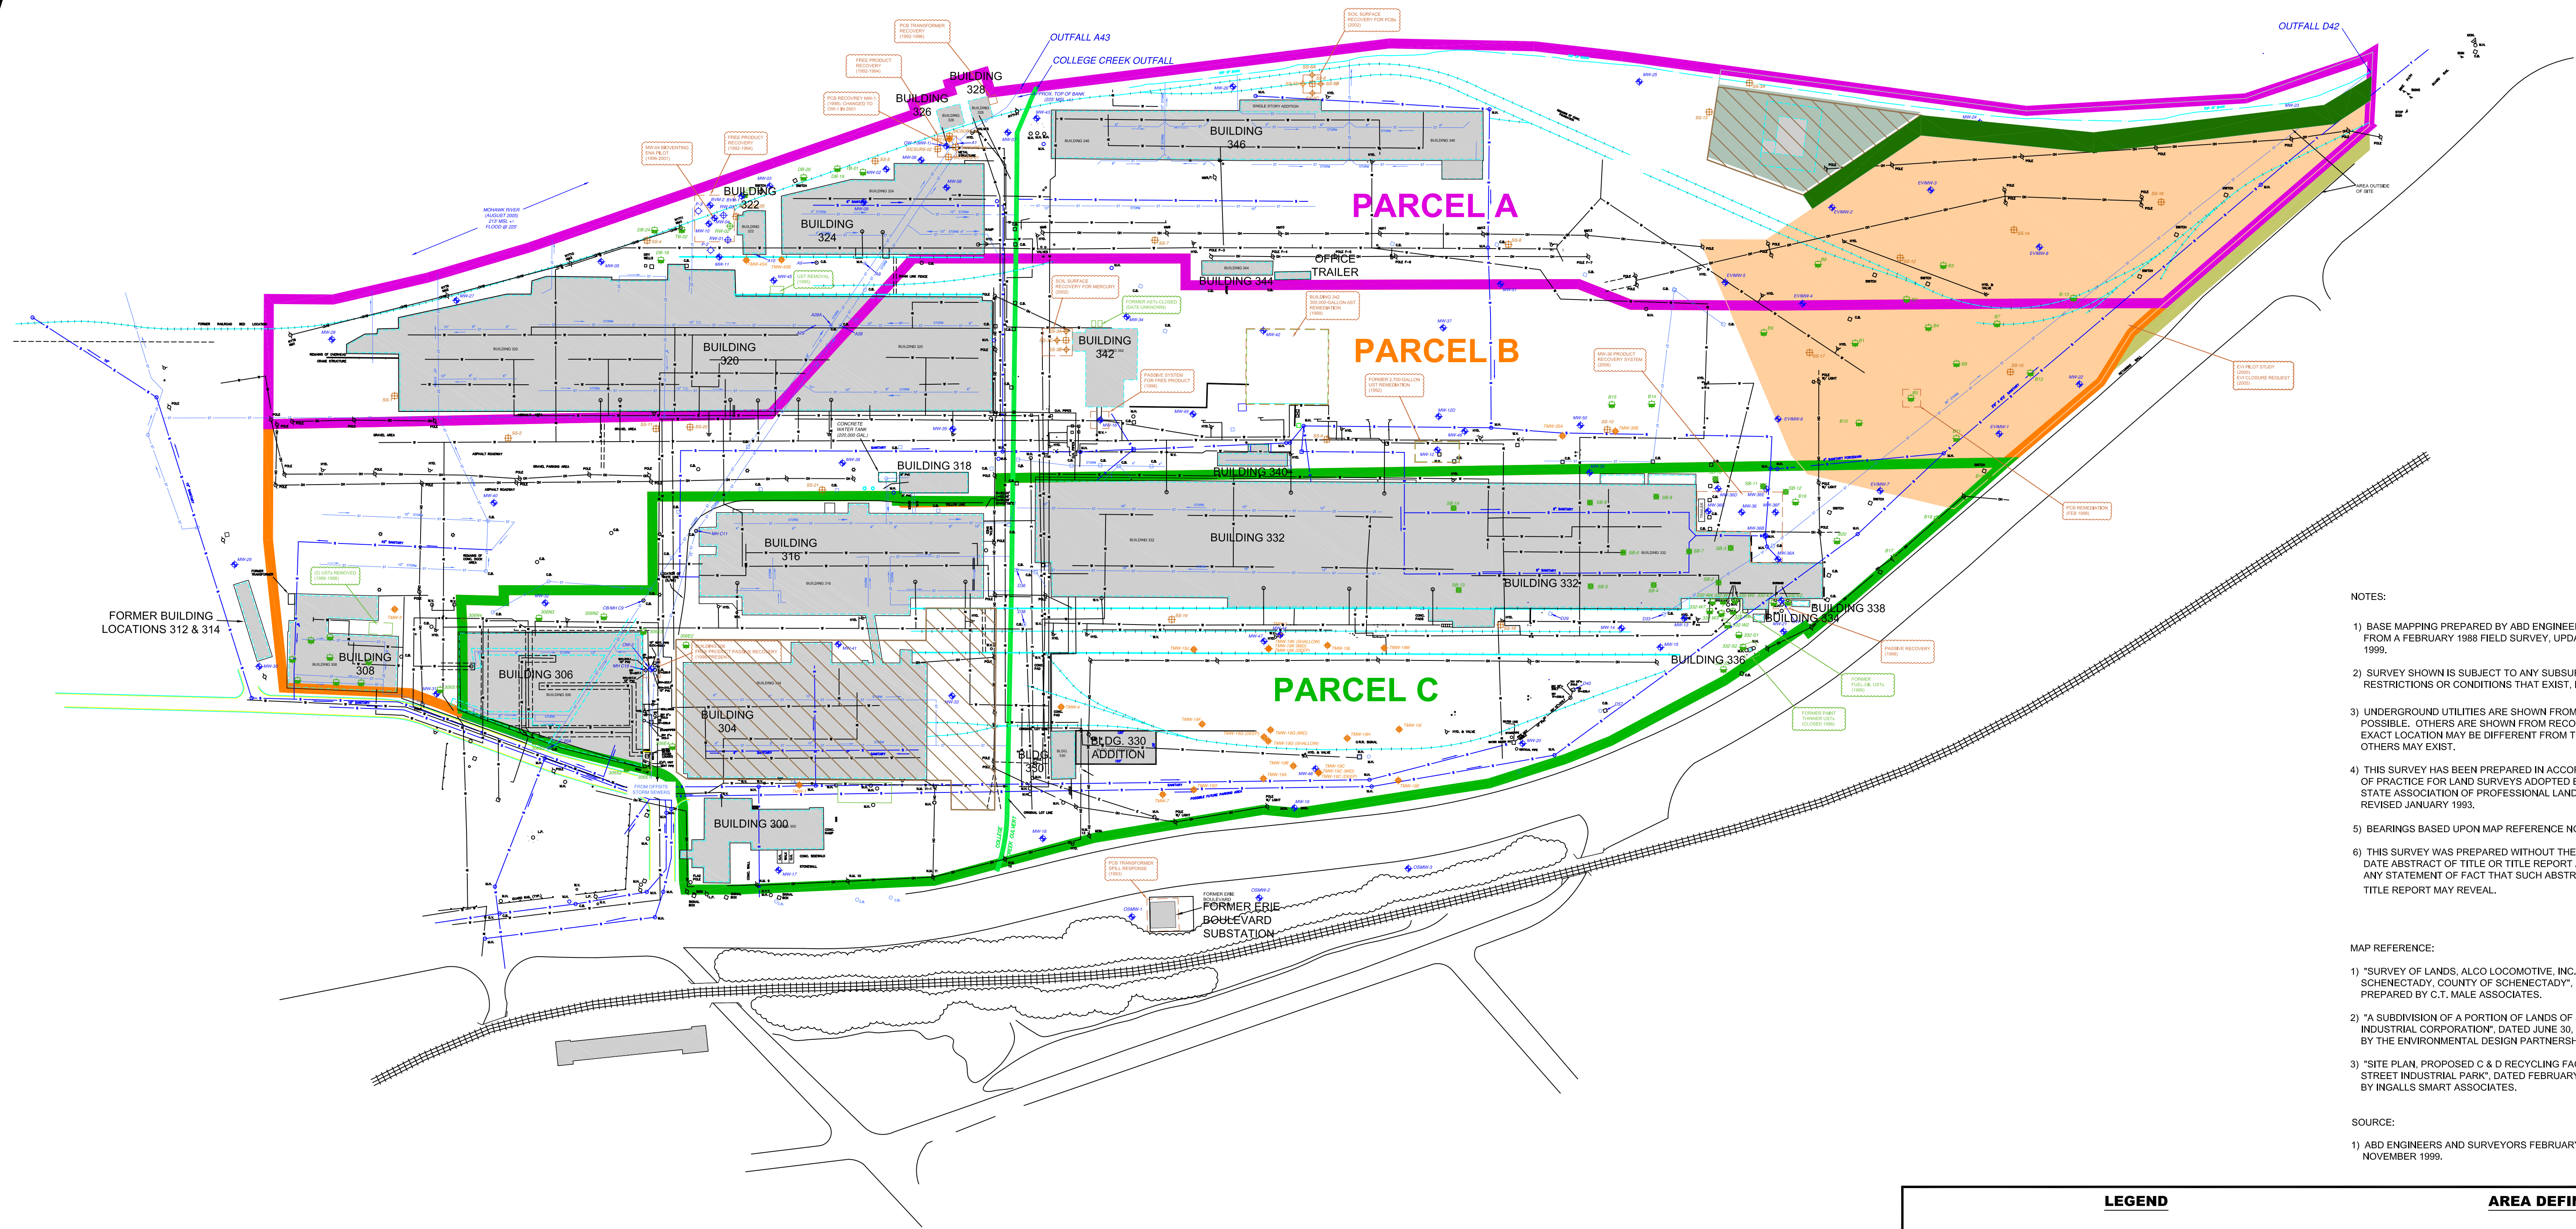
SITE LAYOUT

FORMER UST/AST LOCATIONS

Parcel B has various structures and/or improvements observed (See Plate 2):

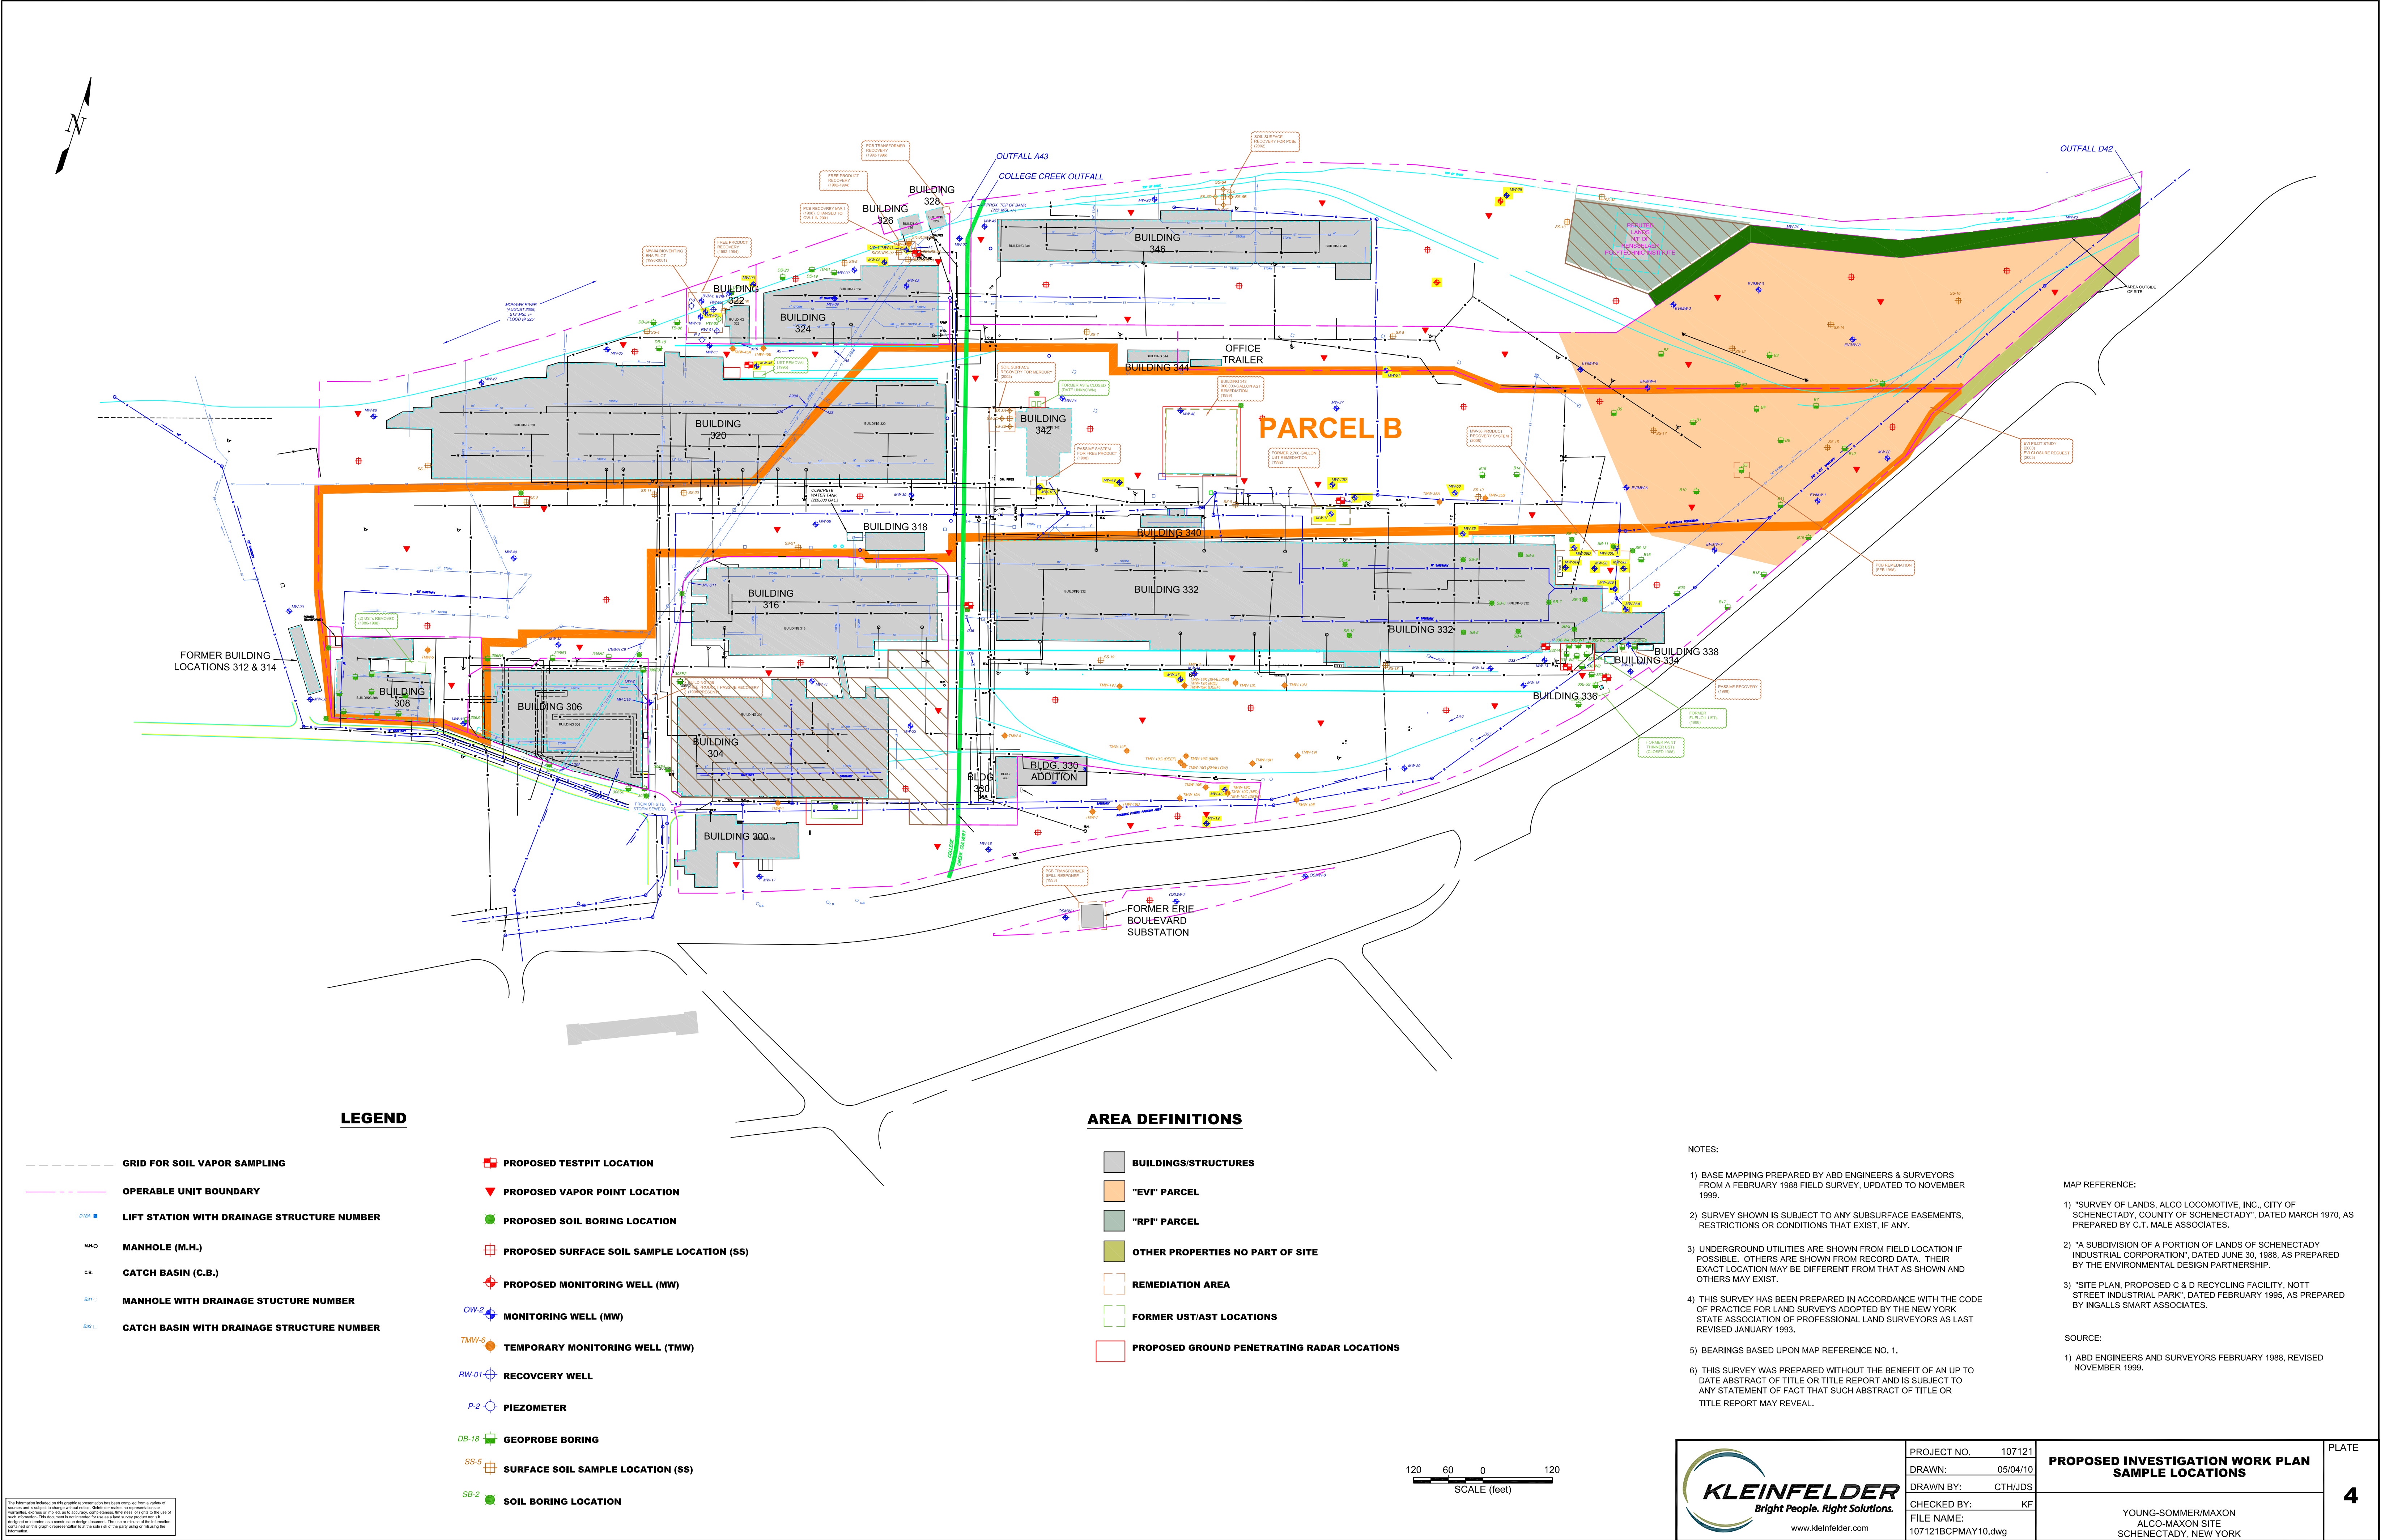
PLATE

**On-Site Buildings (to be demolished)**  
Buildings presumably currently contain:  
-Asbestos containing materials  
-Lead based paint  
-Universal waste  
-Mercury switches  
-Polychlorinated biphenyls in lighting ballasts

**Building ID's and current usages**  
336 - General office/commercial space and small materials laboratory  
304 - Owned by STS Steel  
306 - Occupied by various commercial firms (HVAC company, composite materials fabricator)  
308 - Unoccupied  
316 - Temporary storage facility/unoccupied  
318 - Occupied by inactive industrial waste water equipment  
320 - Storage for landscaping equipment and vehicles/unoccupied  
322 - Unoccupied  
324 - Storage of furniture/unoccupied  
332/334 - Used by STS Steel; building and roofing material storage  
336 - Former pump house for paint thinner  
338 - Gas meter house  
340 - Unoccupied  
342 - General but incomplete decommissioning in process  
344 - Occupied by a landscape company  
346 - Occupied by Dimension Fabricators to prepare pre-fabricated re-bar structures

AREA DEFINITIONS

- AREAS 1, 2 - AREAS ORIGINALLY DEFINED AS PETROLEUM IMPACTED
- AREAS 3, 4, 5 - AREAS SUSPECTED OF FUEL-OIL IMPACTS
- AREA 6 - AREA SUSPECTED OF CHLORINATED SOLVENT IMPACT
- BUILDINGS/STRUCTURES
- EVI PARCEL
- SUSPECTED LNAPL LOCATION
- "RPI" PARCEL
- OTHER PROPERTIES NO PART OF SITE
- REMEDATION AREA
- FORMER UST/AST LOCATIONS

A review of the pertinent environmental data pertaining to this site led to the development of a Conceptual Site Model (CSM, Plate 3, described in the next section) which addresses known source areas and current data gaps. The CSM also includes a tabulation of Recognized Environmental Conditions at the Site. The REC table identifies a variety of data gaps, which are to be filled through the completion of the investigation proposed herein. The AOCs and RECs pertaining to Parcel B are listed below. For details of AOCs and RECs, which were identified in reports for the entire former ALCO site, see Appendix A.

Using the available data and information, KLF has prepared a CSM. The purpose of conceptual models is to provide a clear spatial understanding of the Site and immediate area to aid the identification of actual or potential contaminant sources, to present the current understanding of potential environmental transport pathways, to help in the identification of possible human and ecological receptors of hazardous substances, and insight into possible complete routes of exposure. Plate 3 presents the CSM for the Site and shows:
