**REMEDIAL INVESTIGATION**

**WORK PLAN**

**Parcel C of the**

**ALCO-Maxon Site**

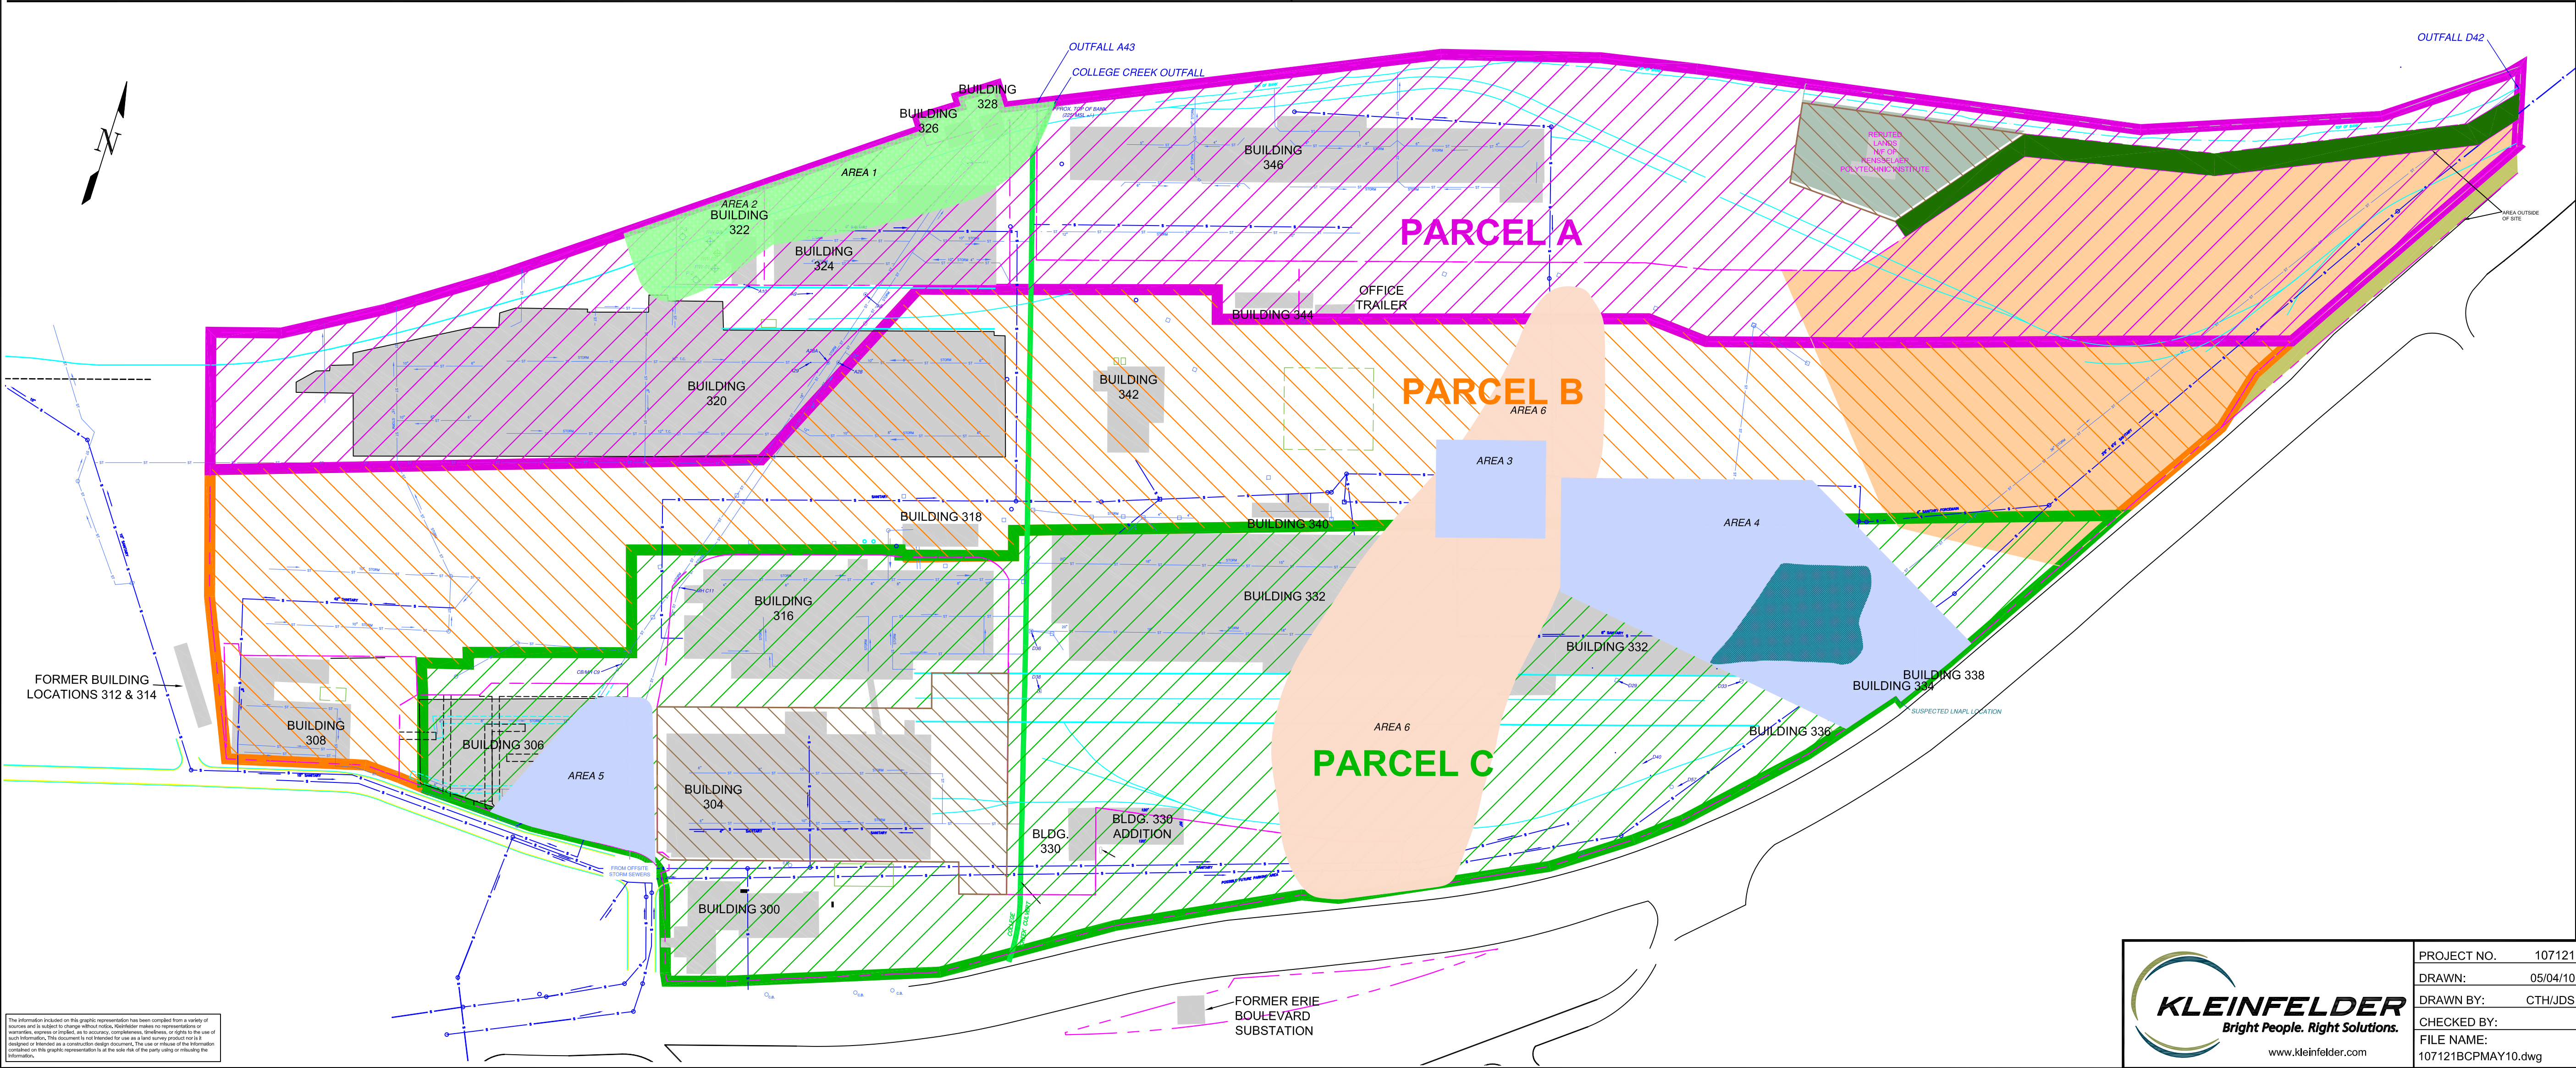
Using the available data and information, KLF prepared a CSM. The purpose of conceptual models is to provide a clear spatial understanding of the Site and immediate area to aid the identification of actual or potential contaminant sources, to present the current understanding of potential environmental transport pathways, to help in the identification of possible human and ecological receptors of hazardous substances, and insight into possible complete routes of exposure. Plate 3 presents the CSM for the Site and shows:

- On-Site Workers and/or Visitors/Trespassers—may potentially be exposed to potentially contaminated surface soils, soil vapor, groundwater seeps, and hazardous building materials.
- On-Site Workers (construction and/or utility)—due to the general subsurface soil contamination, as well as possible contamination associated with buried infrastructure (such as power lines, pipes, and sewers).

- AREAS 1, 2 - AREAS ORIGINALLY DEFINED AS PETROLEUM IMPACTED
- AREAS 3, 4, 5 - AREAS SUSPECTED OF FUEL-OIL IMPACTS
- AREA 6 - AREA SUSPECTED OF CHLORINATED SOLVENT IMPACT
- BUILDINGS/STRUCTURES
- EVI PARCEL
- SUSPECTED LNAPL LOCATION
- "RPI" PARCEL
- OTHER PROPERTIES NO PART OF SITE
- REMEDATION AREA
- FORMER UST/AST LOCATIONS

A review of the pertinent environmental data pertaining to this site led to the development of a Conceptual Site Model (CSM, Plate 3, described in the next section) which addresses known source areas and current data gaps. The CSM also includes a tabulation of Recognized Environmental Conditions at the Site. The REC table identifies a variety of data gaps, which are to be filled through the completion of the investigation proposed herein. The AOCs and RECs pertaining to Parcel C are listed below. For details of AOCs and RECs, which were identified in reports for the entire former ALCO site, see Appendix A.

- Former tank/piping release—there is sufficient data to suggest that both off-site and on-site former tanks leaked resulting in petroleum fuel releases into the subsurface on the site.

- Migration along buried infrastructure—the available data support the conclusion that leaked fuels flowed within sewers or their bedding from off-site as well as on-site through the site traveling east to west.

- Volatilization into Air—the potential for volatile organic compounds (VOCs), such as the chemicals observed in soil or groundwater, to volatilize into soil gas and then into either ambient air or intrude into indoor air at buildings on-site.

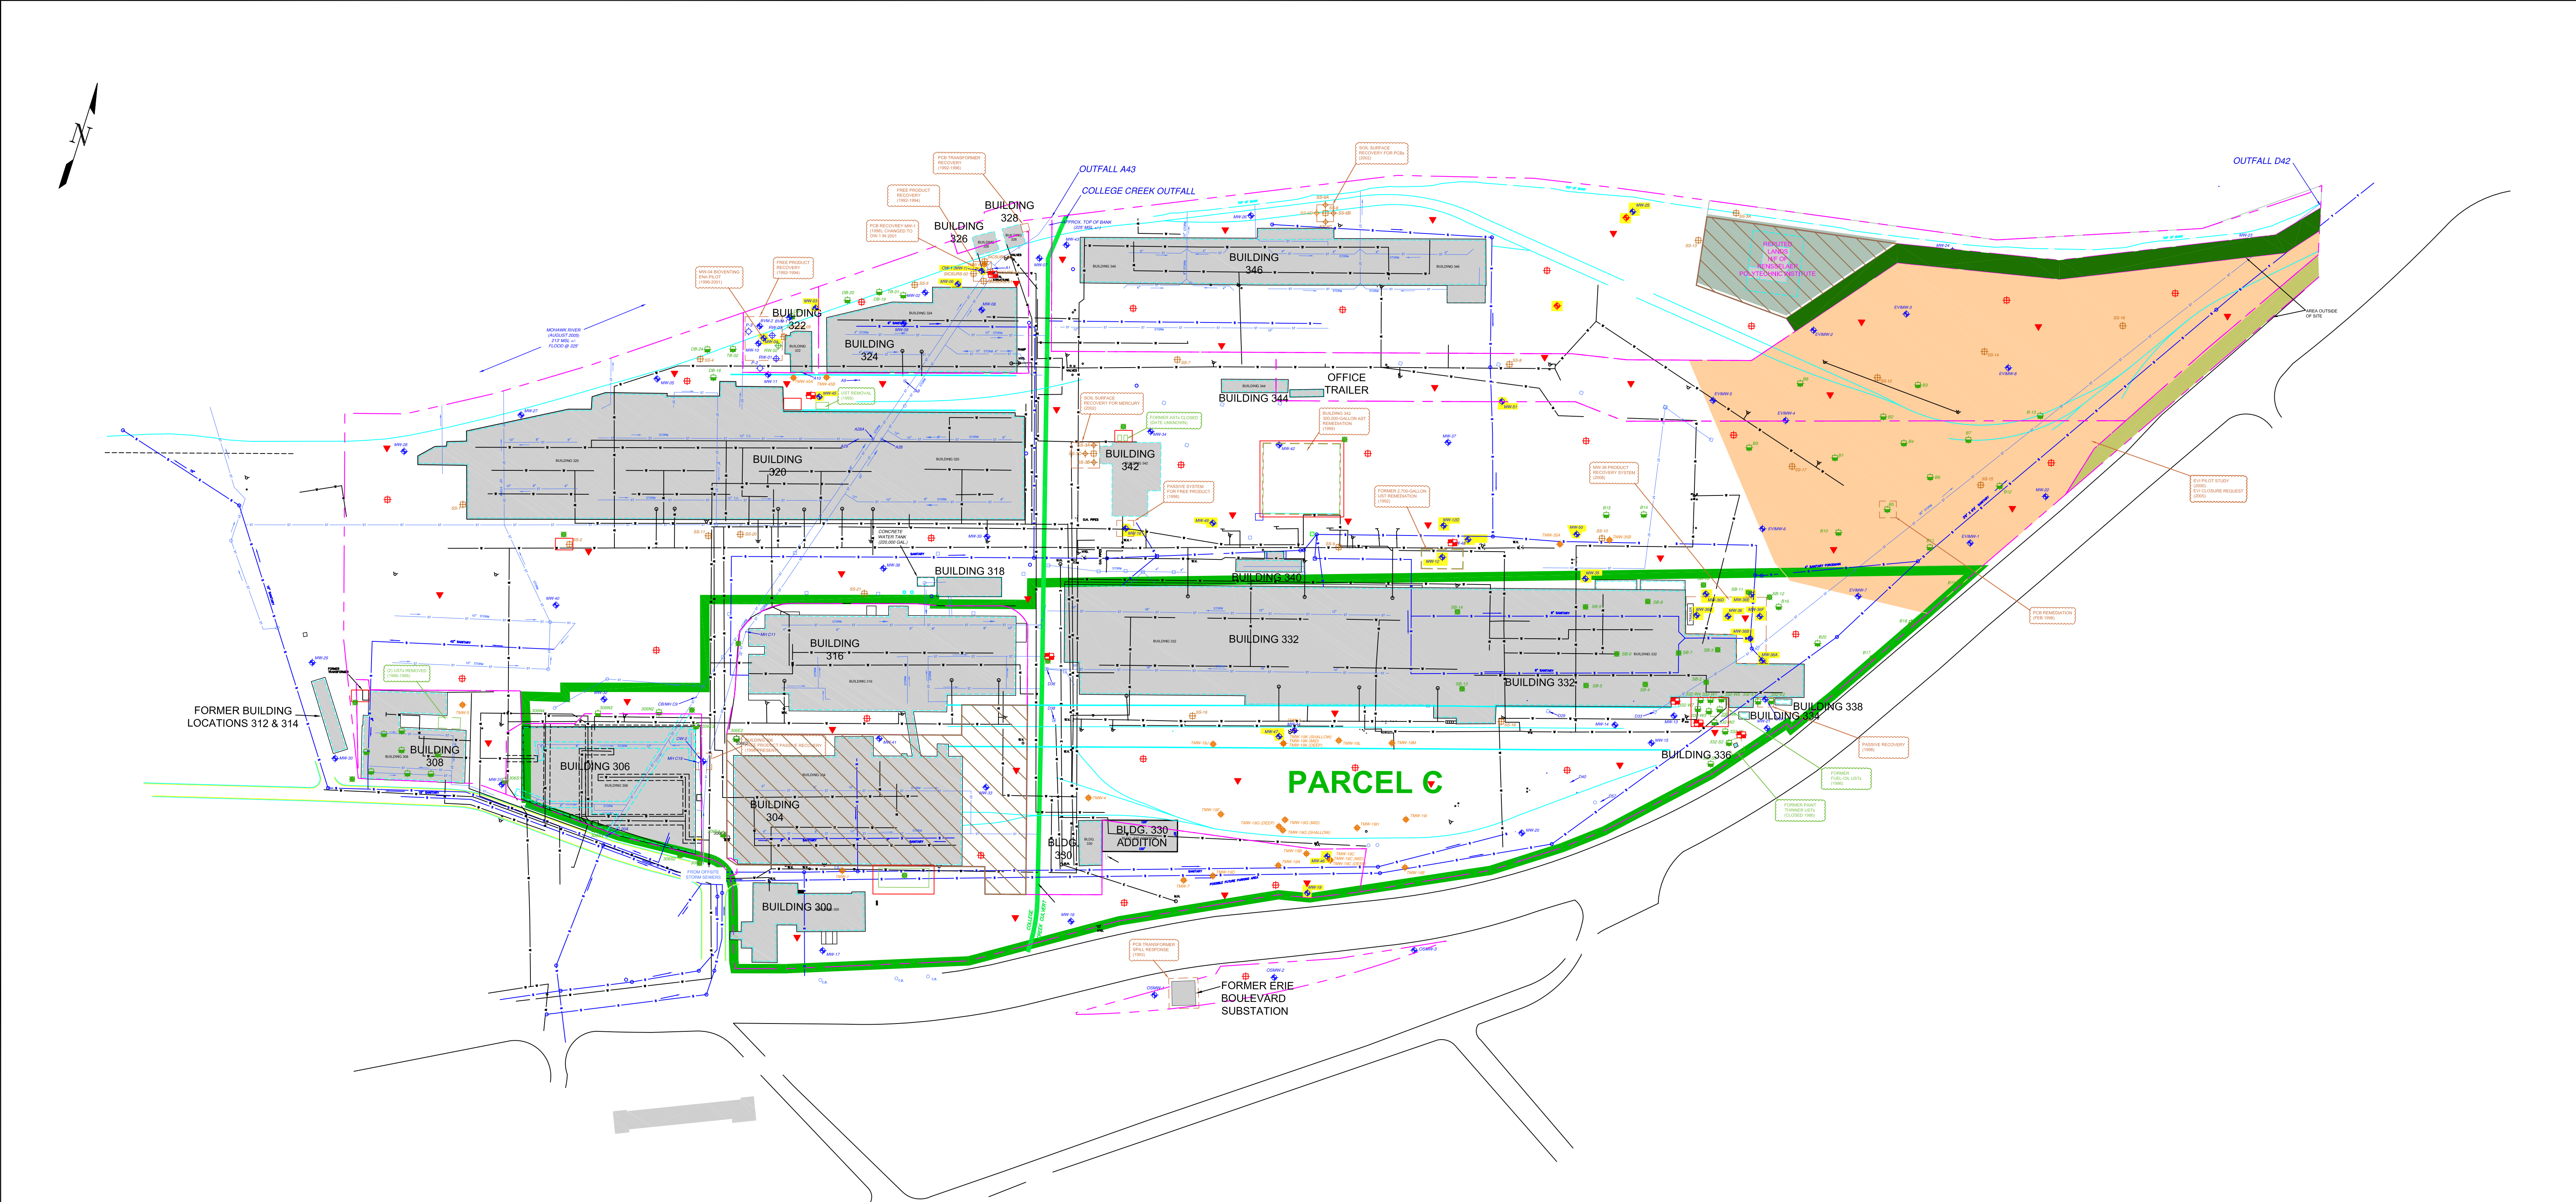
| <br>Bright People. Right Solutions.<br>www.kleinfielder.com | PROJECT NO. 107121 | <b>PROPOSED INVESTIGATION WORK PLAN<br/>SAMPLE LOCATIONS</b> | <b>4</b> |

Because of known historic conditions, four areas on the Site, and the main portion of the Site, have known data gaps concerning subsurface conditions and associated sewer lines that transect Parcel C, namely:

- **Southern Edge of Area 3**—A 2,700-gallon UST, suspected to have been used for the storage of fuel oil, was removed from Area 3 in November 1992. The UST was located adjacent to the north side of Building 332. UST closure samples contained concentrations of VOCs which exceeded regulatory criteria. KLF recommends advancing a soil test pit and installing a soil vapor point within this area to determine current impact levels. KLF recommends investigation downgradient of this Area from Parcel B, rather than from within Parcel C.

- **Area 4**—Area 4 has an active remedial system present. The system is used to address what is thought to be a fuel oil release from certain former tanks on the southwest side of Building 332. There also is a stormwater conduit running through this area. KLF recommends visual inspection of this sewer line from catch basins D29, -33, and -40 and from D-7 to their convergence, which then leads off to the outfall D42 at the Mohawk River. This investigation would clarify if the sewer lines (and possibly associated annulus) act as a storage area or a conveyance system for possible petroleum materials. This data, together with the previously developed Area 3 and 4 data are expected to be sufficient to recommend an overall remedial approach to resolving the petroleum hydrocarbon contamination in this area of the site.

- **Area 5**—On-site storm water sewers are located in this area, which carry off-site storm water to the Mohawk River. Small amounts of free product were observed within an excavation adjacent to the north side of Building

306. In addition, free product was observed within observation well OW-2, located between Buildings 306 and 304, in 1998. KLF recommends installing a soil vapor point downgradient of building 306 and 304 and collecting soil samples from upgradient and downgradient of Area 5 to determine the current extent of impact.

- **Area 6**—Area 6 is a chlorinated solvent plume running from Erie Boulevard (MW-19) beneath Building 332, towards the Mohawk River (MW-51), the main portion of Area 6 is within the boundary of Parcel C. KLF recommends advancing two soil borings and installing groundwater monitoring wells further downgradient from MW-51, to evaluate the groundwater quality nearer to the river. This would include adding a deeper (approximately 65 ft bgs) nested pair with the existing shallow MW-25. These activities will be completed from within Parcel A. Within Parcel C, KLF recommends installing several soil vapor points (see below).

- **Erie Boulevard Substation**—Leakage from substation transformers was observed on February 1, 1993. NYSDEC Spill No. 92-12366, was assigned, although a subsequent investigation in 2009 only identified SVOCs as present in soil above applicable regulatory standards and VOCs in groundwater at concentrations above applicable regulatory standards. KLF recommends collecting a surface soil sample to identify new releases since the investigation in 2009.

- **Other Portions of the Parcel**—in addition to the Areas mentioned above, KLF recommends further evaluating the nature of possible impacts within the Parcel C by installing a test pit and several soil borings/surface soil samples and collecting soil samples. This set of soil test pits and borings will be coordinated with the anticipated geotechnical evaluation of the property. As such, this investigation component will include approximately 6 borings advanced within Parcel C, generally advanced to 20 feet bgs, unless deeper extents are essential as part of the geotechnical investigation.
