**RE: Remedial Investigation Work Plans Response to Comments – ALCO-Maxon Site
Parcels A, B, and C
NYSDEC BCP #s: C447042, C447043, and C447044
CHA Project #: 14600**

**Response to DEC Comments
on the
Remedial Investigation Work Plan, Parcels A, B, and C
ALCO-Maxon Site
BCP #s: C447042, C447043, and C447044
Dated April 22, 2011**

PROPOSED INVESTIGATION WORK PLAN SAMPLE LOCATIONS	
YOUNG-SOMMERMAXON ALCO-MAXON SITE SCHENECTADY, NEW YORK

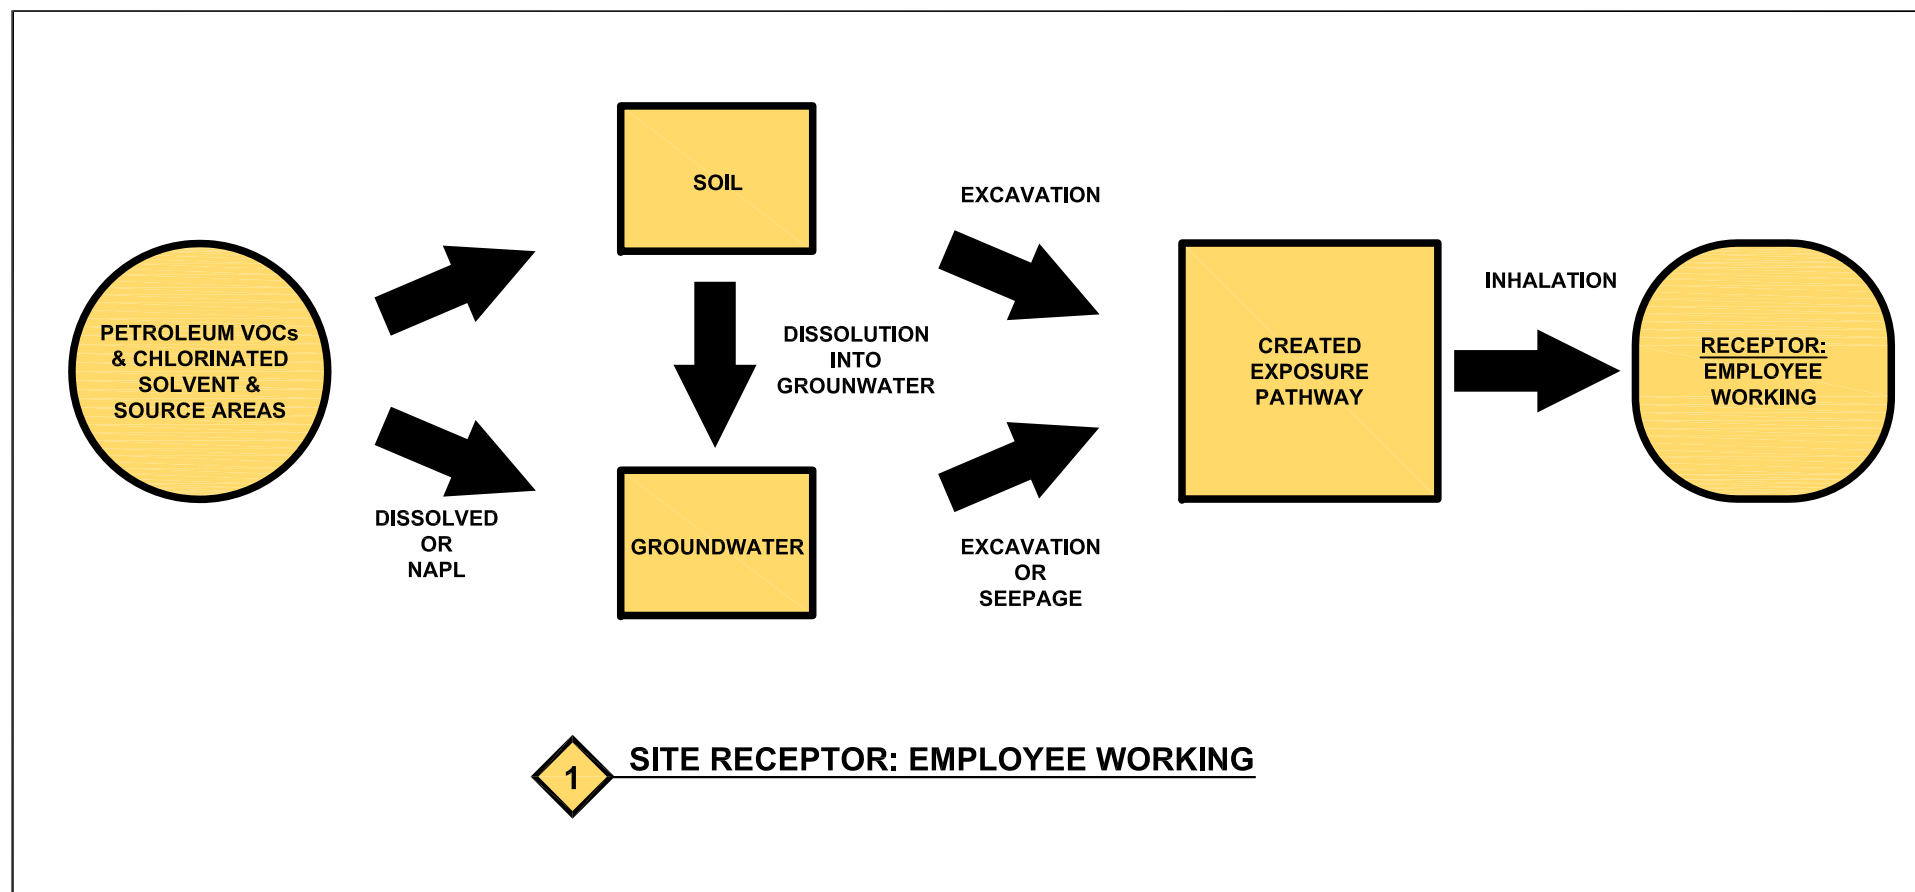
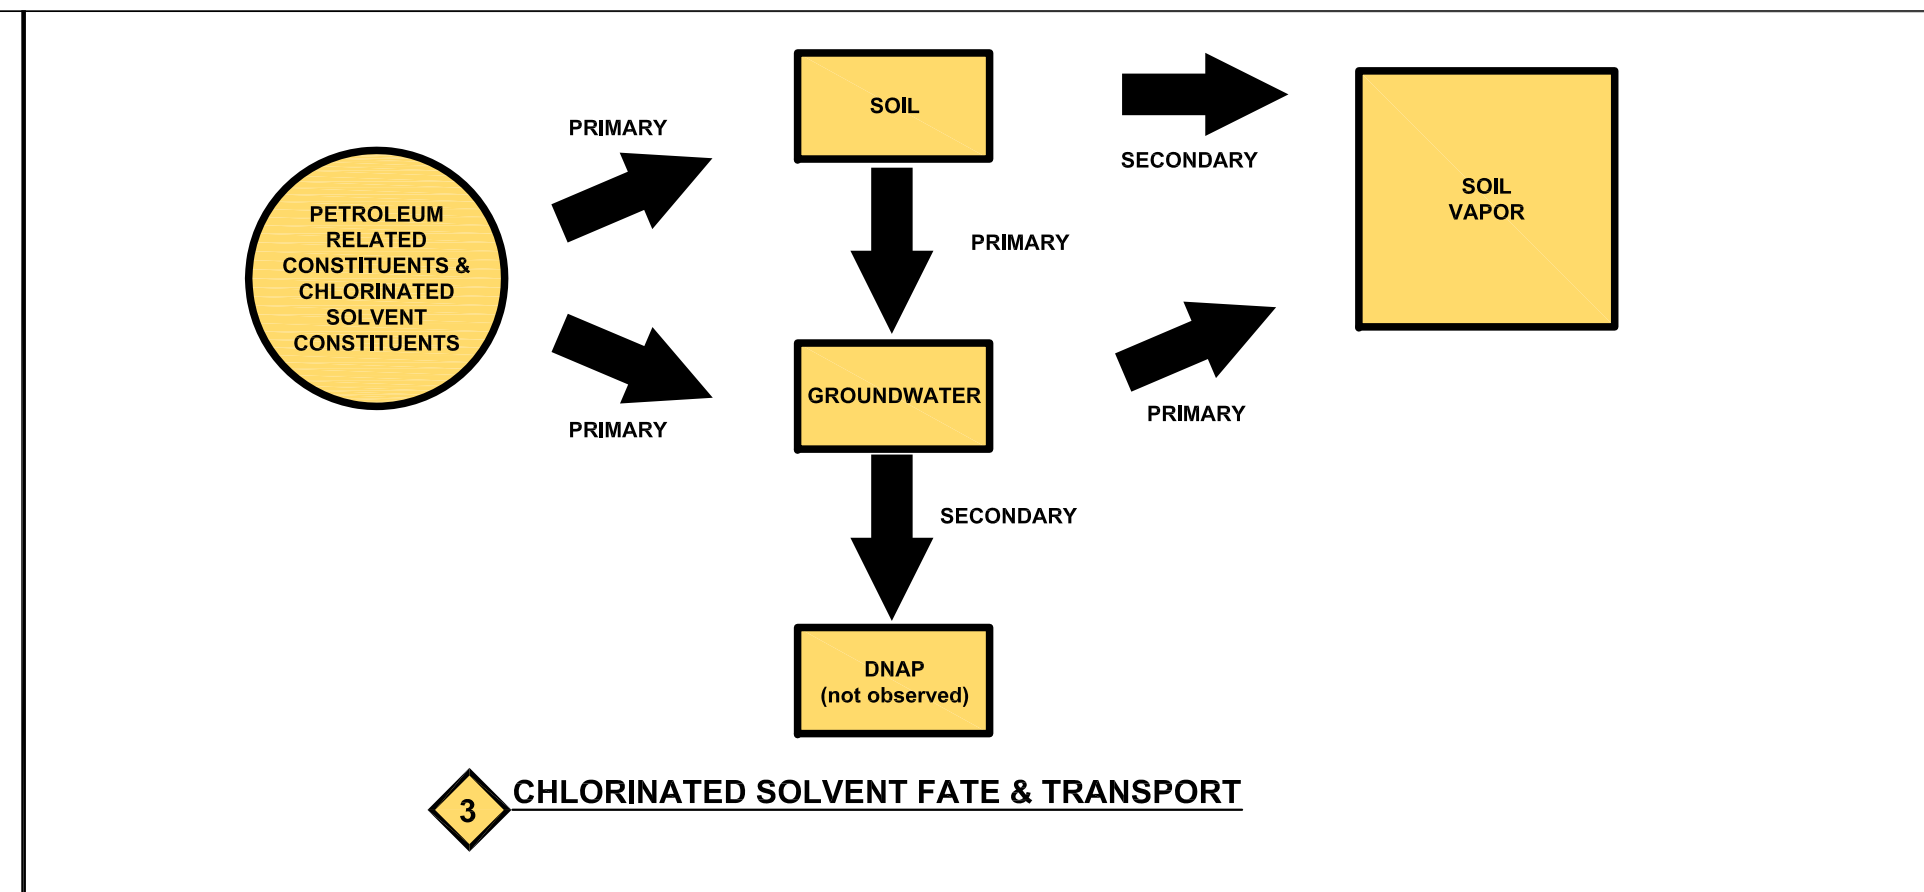
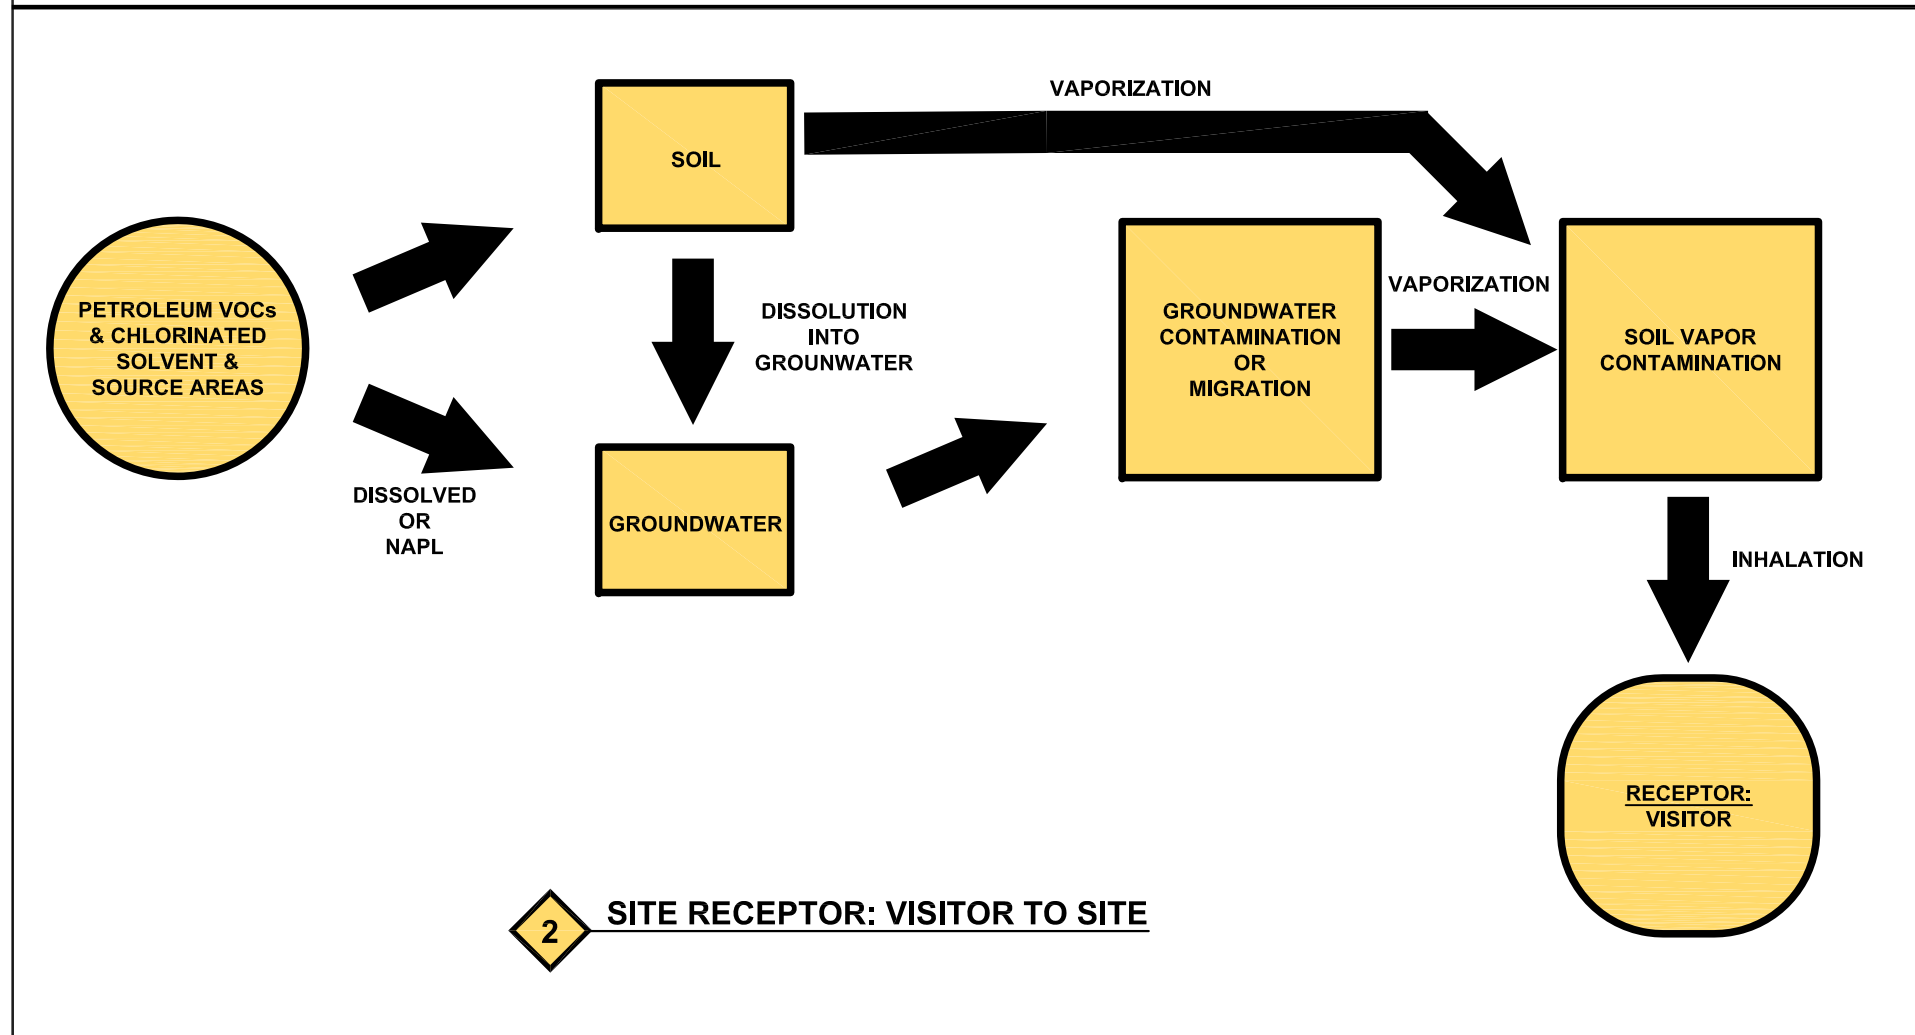
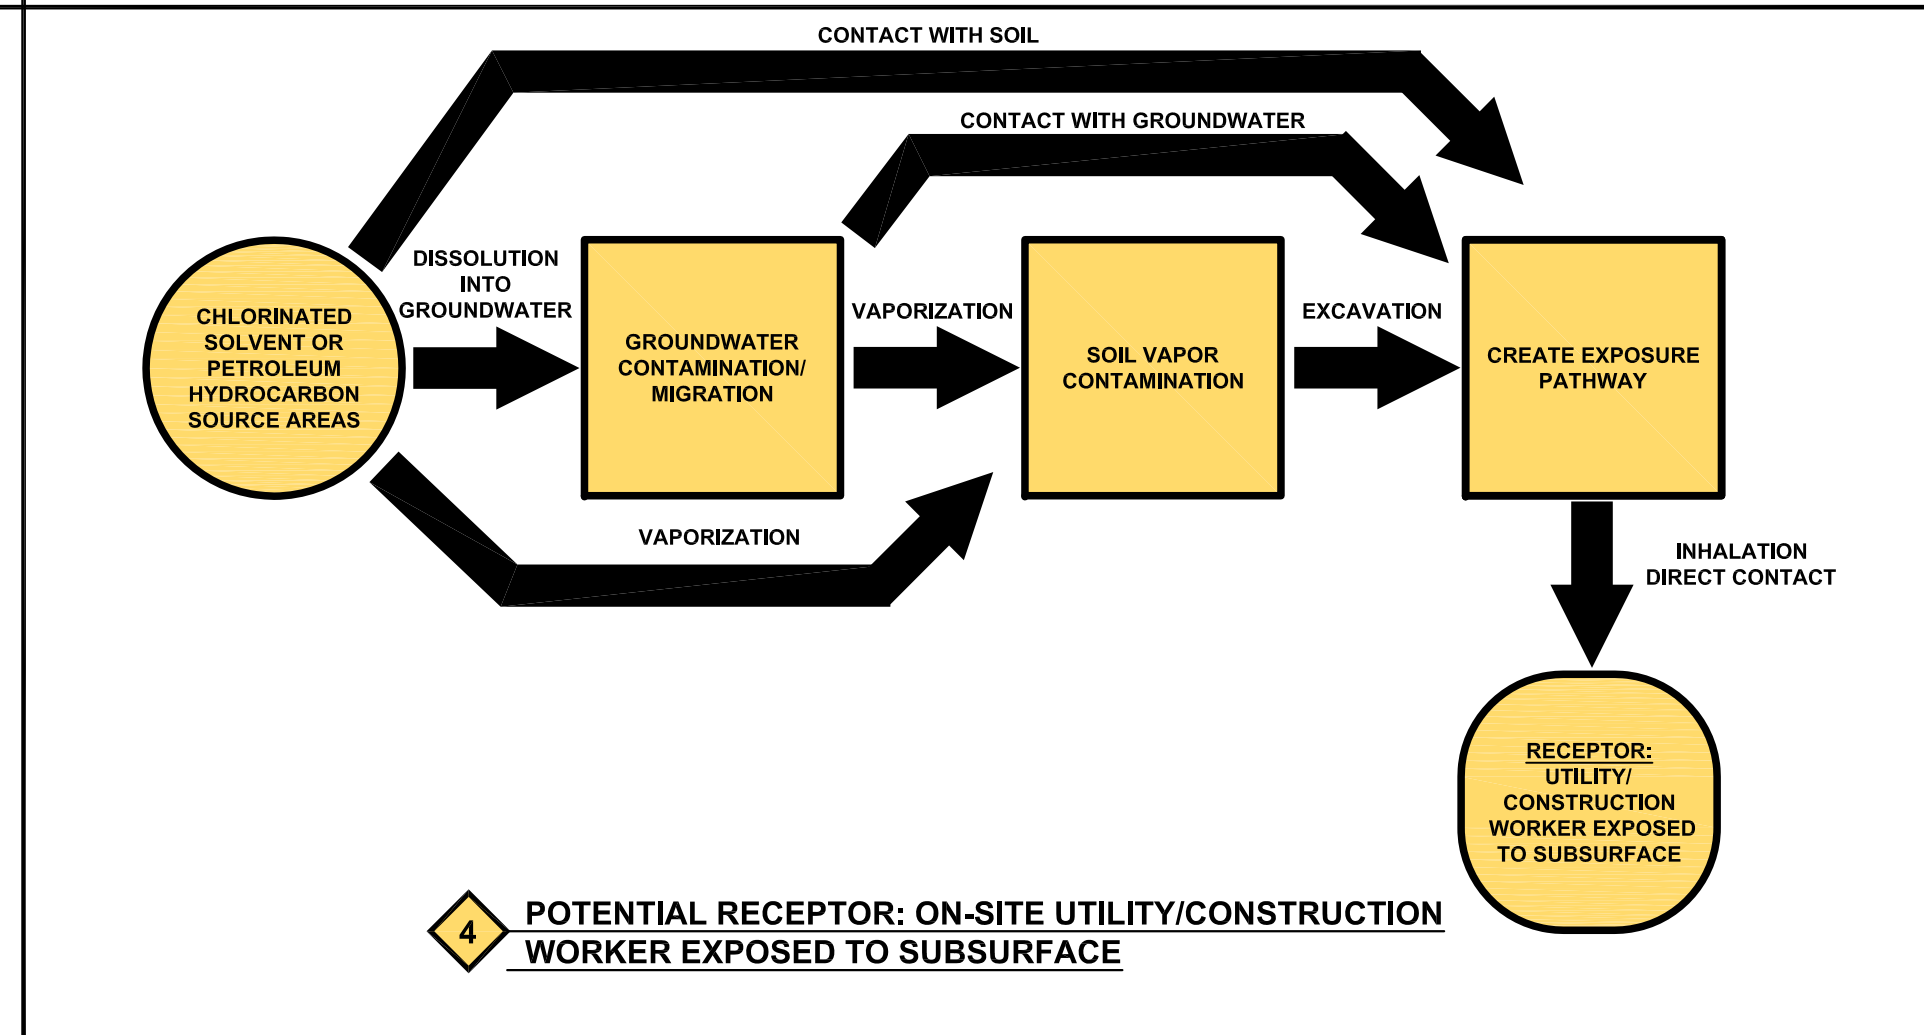
CONCEPTUAL SITE MODEL

On-Site Buildings (to be demolished)
Buildings presumably currently contain:
 -Asbestos containing materials
 -Lead based paint
 -Universal waste
 -Mercury switches
 -Polychlorinated biphenyls in lighting ballasts

Building ID's and current usages
 336 - General office/commercial space and small materials laboratory
 304 - Owned by STS Steel
 306 - Occupied by various commercial firms (HVAC company, composite materials fabricator)
 308 - Unoccupied
 316 - Temporary storage facility/unoccupied
 318 - Occupied by inactive industrial waste water equipment
 320 - Storage for landscaping equipment and vehicles/unoccupied
 322 - Unoccupied
 324 - Storage of furniture/unoccupied
 332/334 - Used by STS Steel; building and roofing material storage
 336 - Former pump house for paint thinner
 338 - Gas meter house
 340 - Unoccupied
 342 - General but incomplete decommissioning in process
 344 - Occupied by a landscape company
 346 - Occupied by Dimension Fabricators to prepare pre-fabricated re-bar structures

- AREAS 1, 2 - AREAS ORIGINALLY DEFINED AS PETROLEUM IMPACTED
- AREAS 3, 4, 5 - AREAS SUSPECTED OF FUEL-OIL IMPACTS
- AREA 6 - AREA SUSPECTED OF CHLORINATED SOLVENT IMPACT
- BUILDINGS/STRUCTURES
- FORMER BUILDINGS (PREVIOUSLY DEMOLISHED)
- EVI PARCEL
- SUSPECTED LNAPL LOCATION
- "RPI" PARCEL
- OTHER PROPERTIES NO PART OF SITE
- REMEDIAION AREA
- FORMER UST/AST LOCATIONS

A review of the pertinent environmental data pertaining to this site led to the development of a Conceptual Site Model (CSM, Plate 3, described in the next section) which addresses known source areas and current data gaps. The CSM also includes a tabulation of Recognized Environmental Conditions at the Site. The REC table identifies a variety of data gaps, which are to be filled through the completion of the investigation proposed herein. The AOCs and RECs pertaining to Parcel C are listed below. For details of AOCs and RECs, which were identified in reports for the entire former ALCO site, see Appendix A.

Using the available data and information, KLF prepared a CSM. The purpose of conceptual models is to provide a clear spatial understanding of the Site and immediate area to aid the identification of actual or potential contaminant sources, to present the current understanding of potential environmental transport pathways, to help in the identification of possible human and ecological receptors of hazardous substances, and insight into possible complete routes of exposure. Plate 3 presents the CSM for the Site and shows:

- On-Site Workers and/or Visitors/Trespassers—may potentially be exposed to potentially contaminated surface soils, soil vapor, groundwater seeps, and hazardous building materials.
- On-Site Workers (construction and/or utility)—due to the general subsurface soil contamination, as well as possible contamination associated with buried infrastructure (such as power lines, pipes, and sewers).
