Reference Pass & Seymour Boyd Ave. Site, Solvay, NY  
NYSDEC Site # C734102  
2022 Periodic Review Report  
Response to Comments

**Pass & Seymour (P&S) Boyd Ave Site  
ONONDAGA COUNTY, NEW YORK**

**PERIODIC REVIEW REPORT**

**NYSDEC BROWNFIELD Site Number C734102**

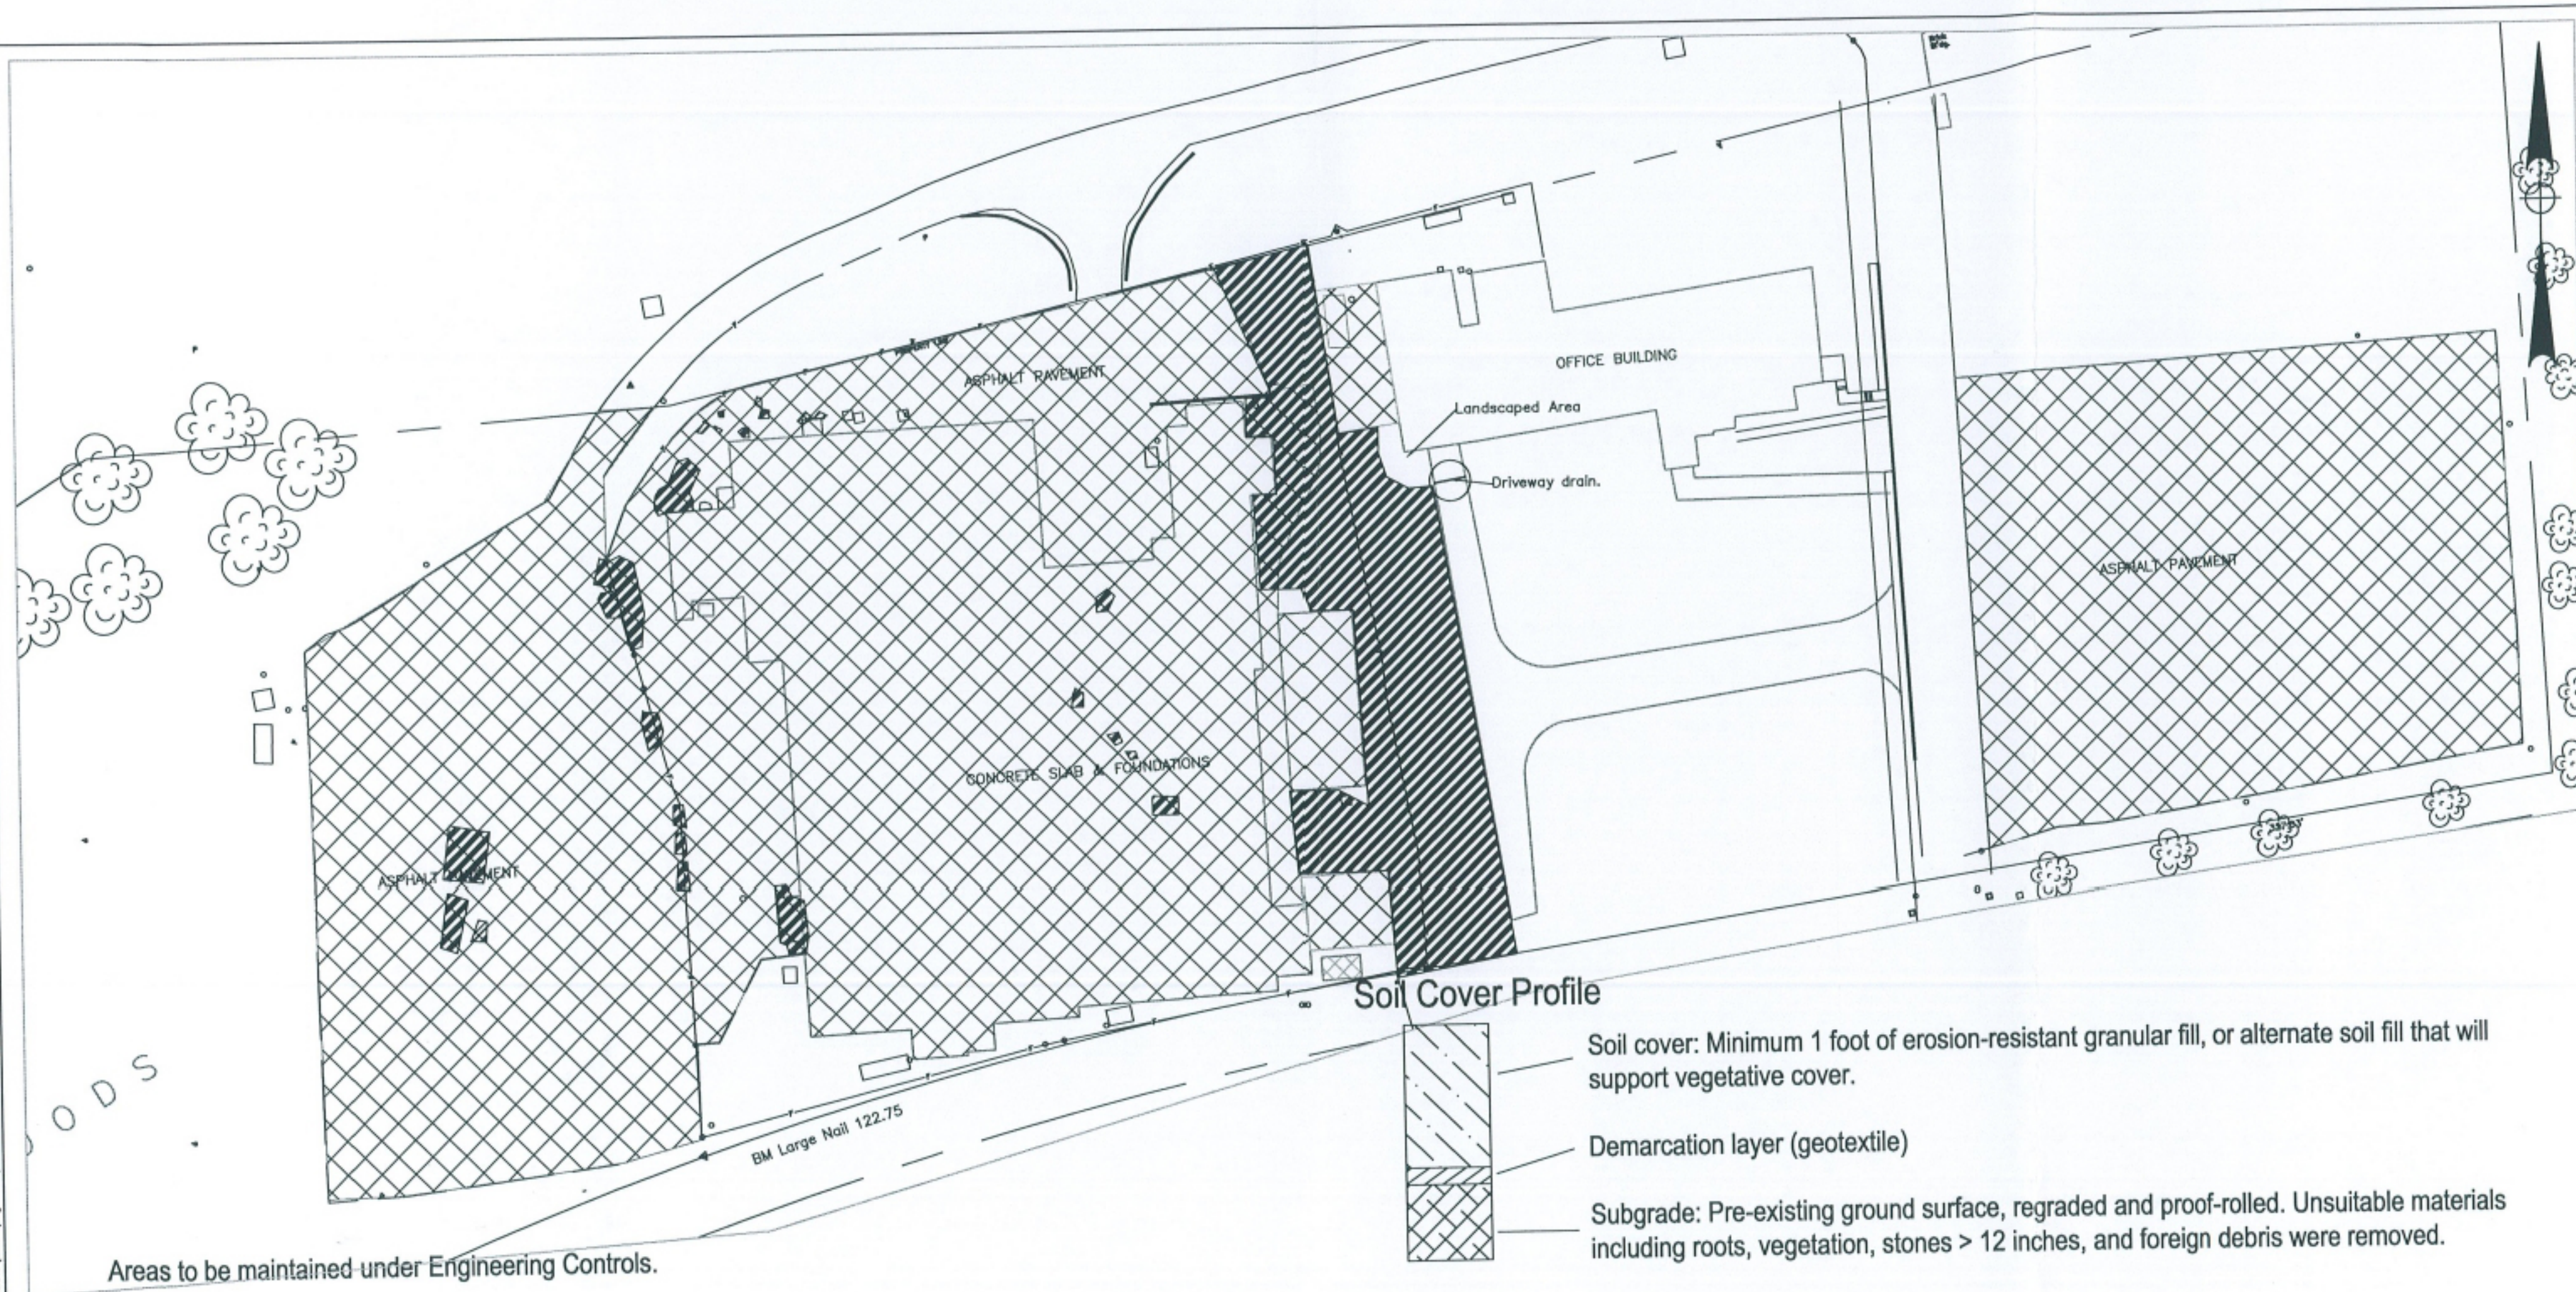
Figure 2  
Engineering Soil Cover

The engineering cover system (Figure 2) is comprised of (1) pre-existing cover of asphalt pavement or concrete and (2) constructed soil cover. During the excavation of soil in areas SB-11 and SB-12 the engineered cover system was removed but after excavation was complete the demarcation layer was reestablished and the crushed stone surface layer was replaced. Much of the western portion of the site (former building slabs) is also fenced and that fence has been maintained.

- Areas to be maintained under Engineering Controls.
-

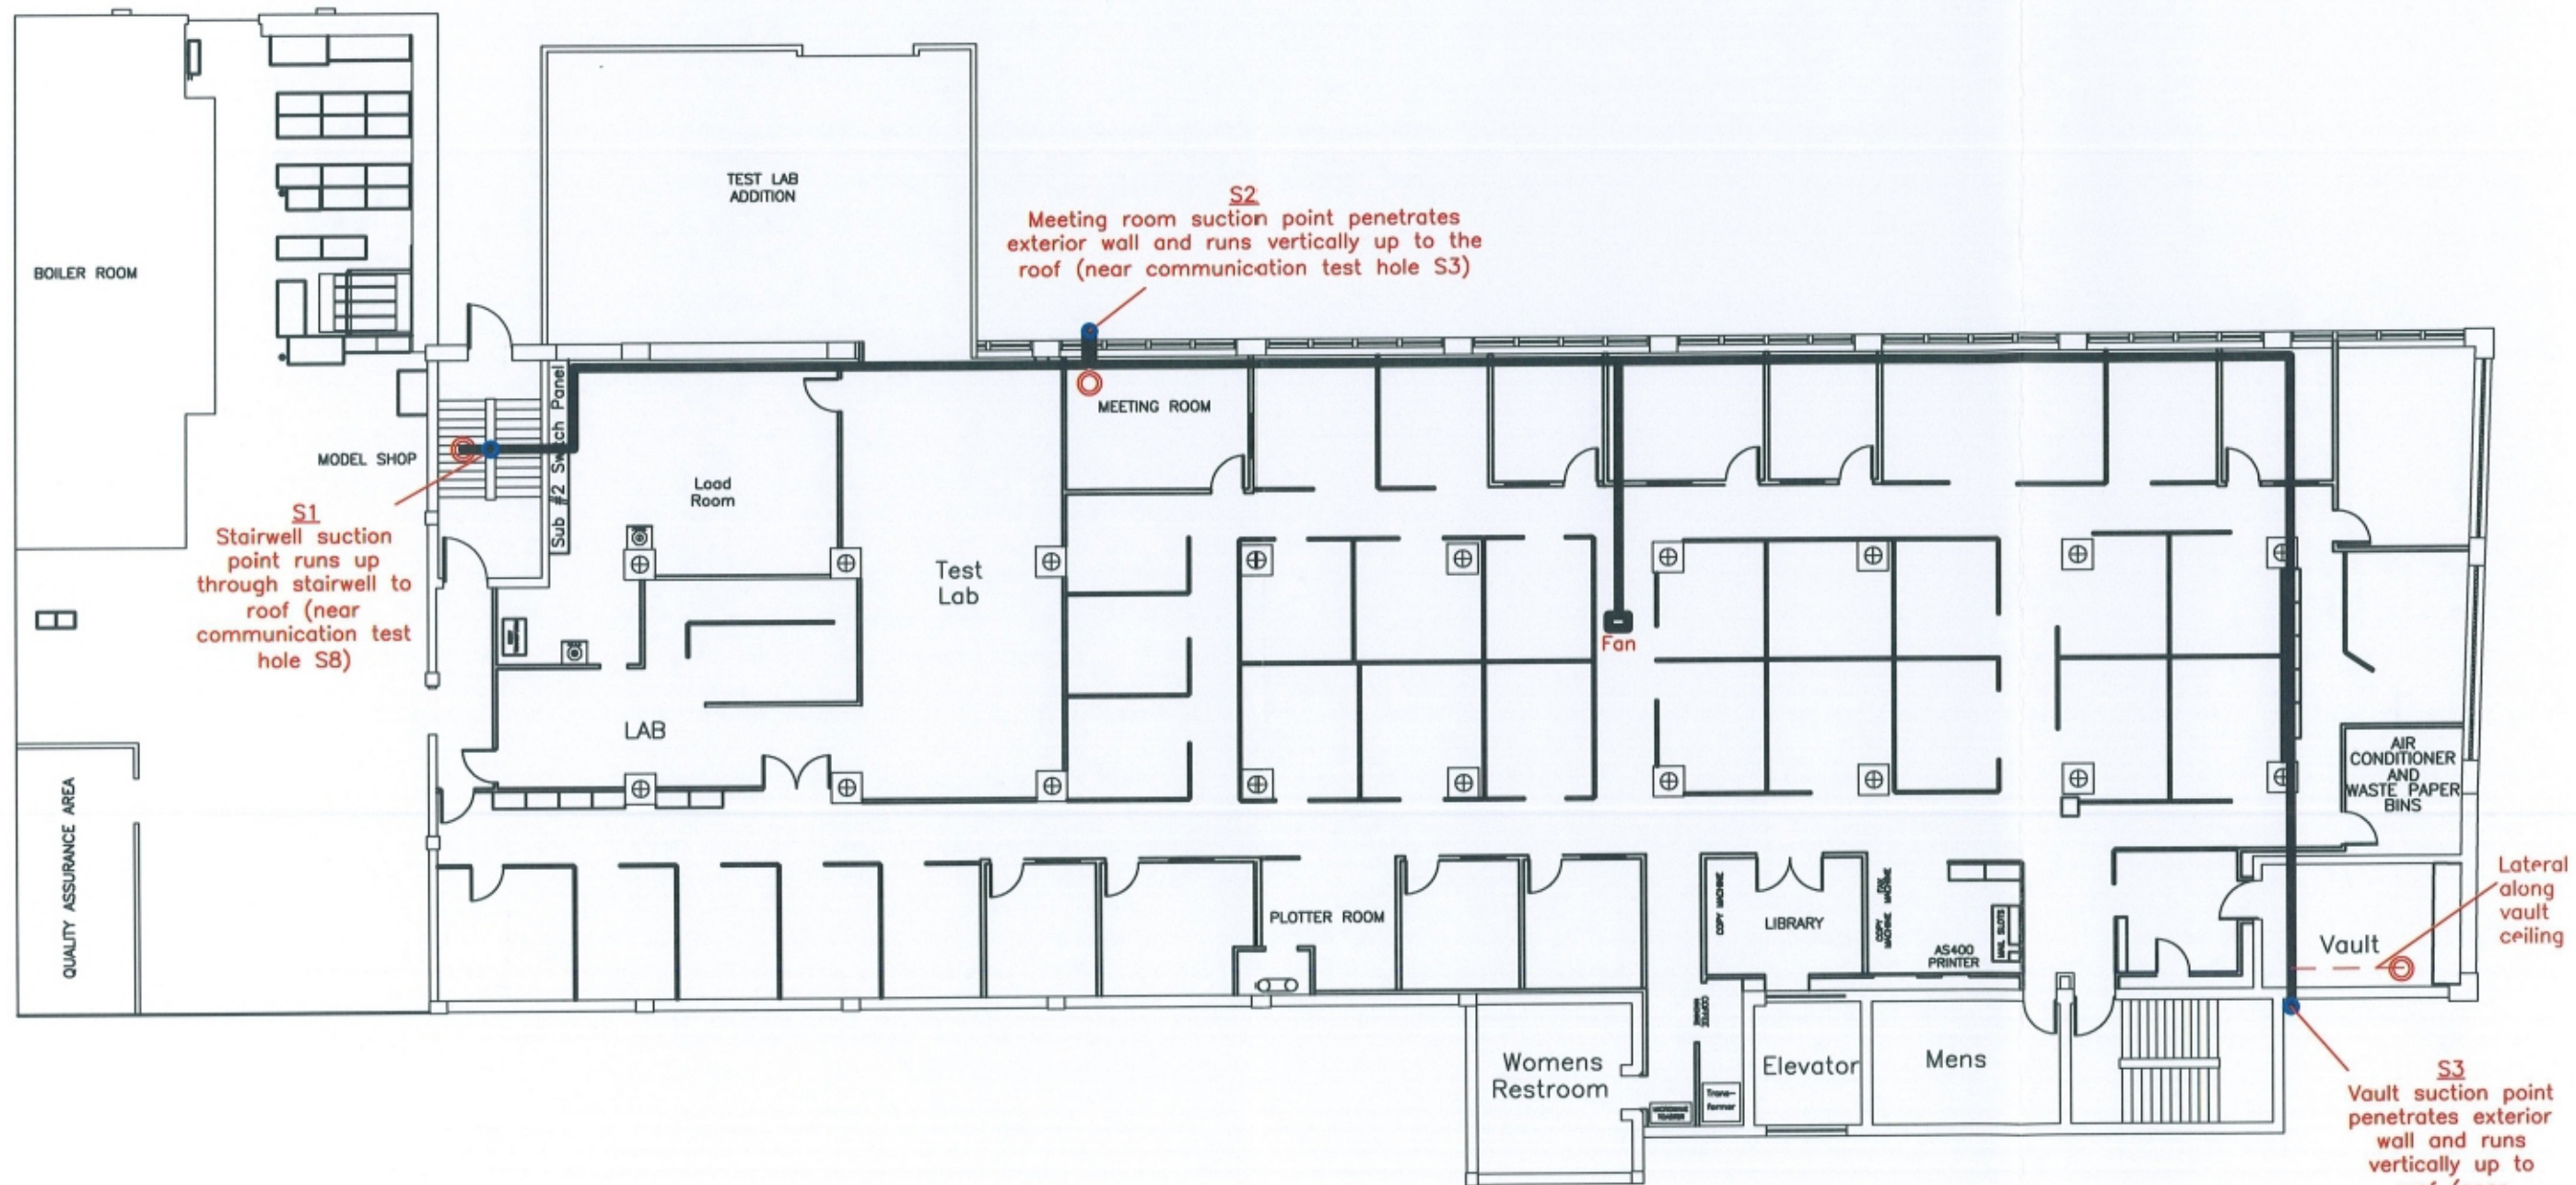
As described in the Final Engineering Report and the Site Management Plan, a subslab depressurization system was installed to prevent the migration of volatile organics from the subsurface to the occupied Pass and Seymour building. Pass and Seymour personnel have implemented a periodic (at least monthly) inspection of the two manometers and one pressure gauge to demonstrate that the system is operating as intended. The following table (Table 4) shows the monthly readings from each gauge.

Vertical piping riser to the roof

As indicated by the results shown in Table 4 the pressure gauge for the S2 portion of the system has not been working and arrangements have been made to replace it as of the date of this report. The blower that creates the vacuum for all three sections of the system has malfunctioned at least twice and will also be replaced. There has been a delay in obtaining the parts needed to make these repairs but that work is now scheduled to be done by the end of March or sooner. The new blower and the manometers will be inspected regularly to make sure that they are operating properly and will be repaired as necessary.
